RESEARCH PROGRAMME FOR THE **RESTORATION AND REHABILITATION** OF THE HISTORIC BUILDING COMPLEX AND RECONFIGURATION OF THE ENVIRONMENT OF THE MONASTERY

PROJECT PHASE B: IMPLEMENTATION MEDIEVAL CHAPEL (MC)

ADMINISTRATIVE COMMITEE OF THE HOLY MONASTERY OF APOSTOLOS ANDREAS RIZOKARPASSO, CYPRUS

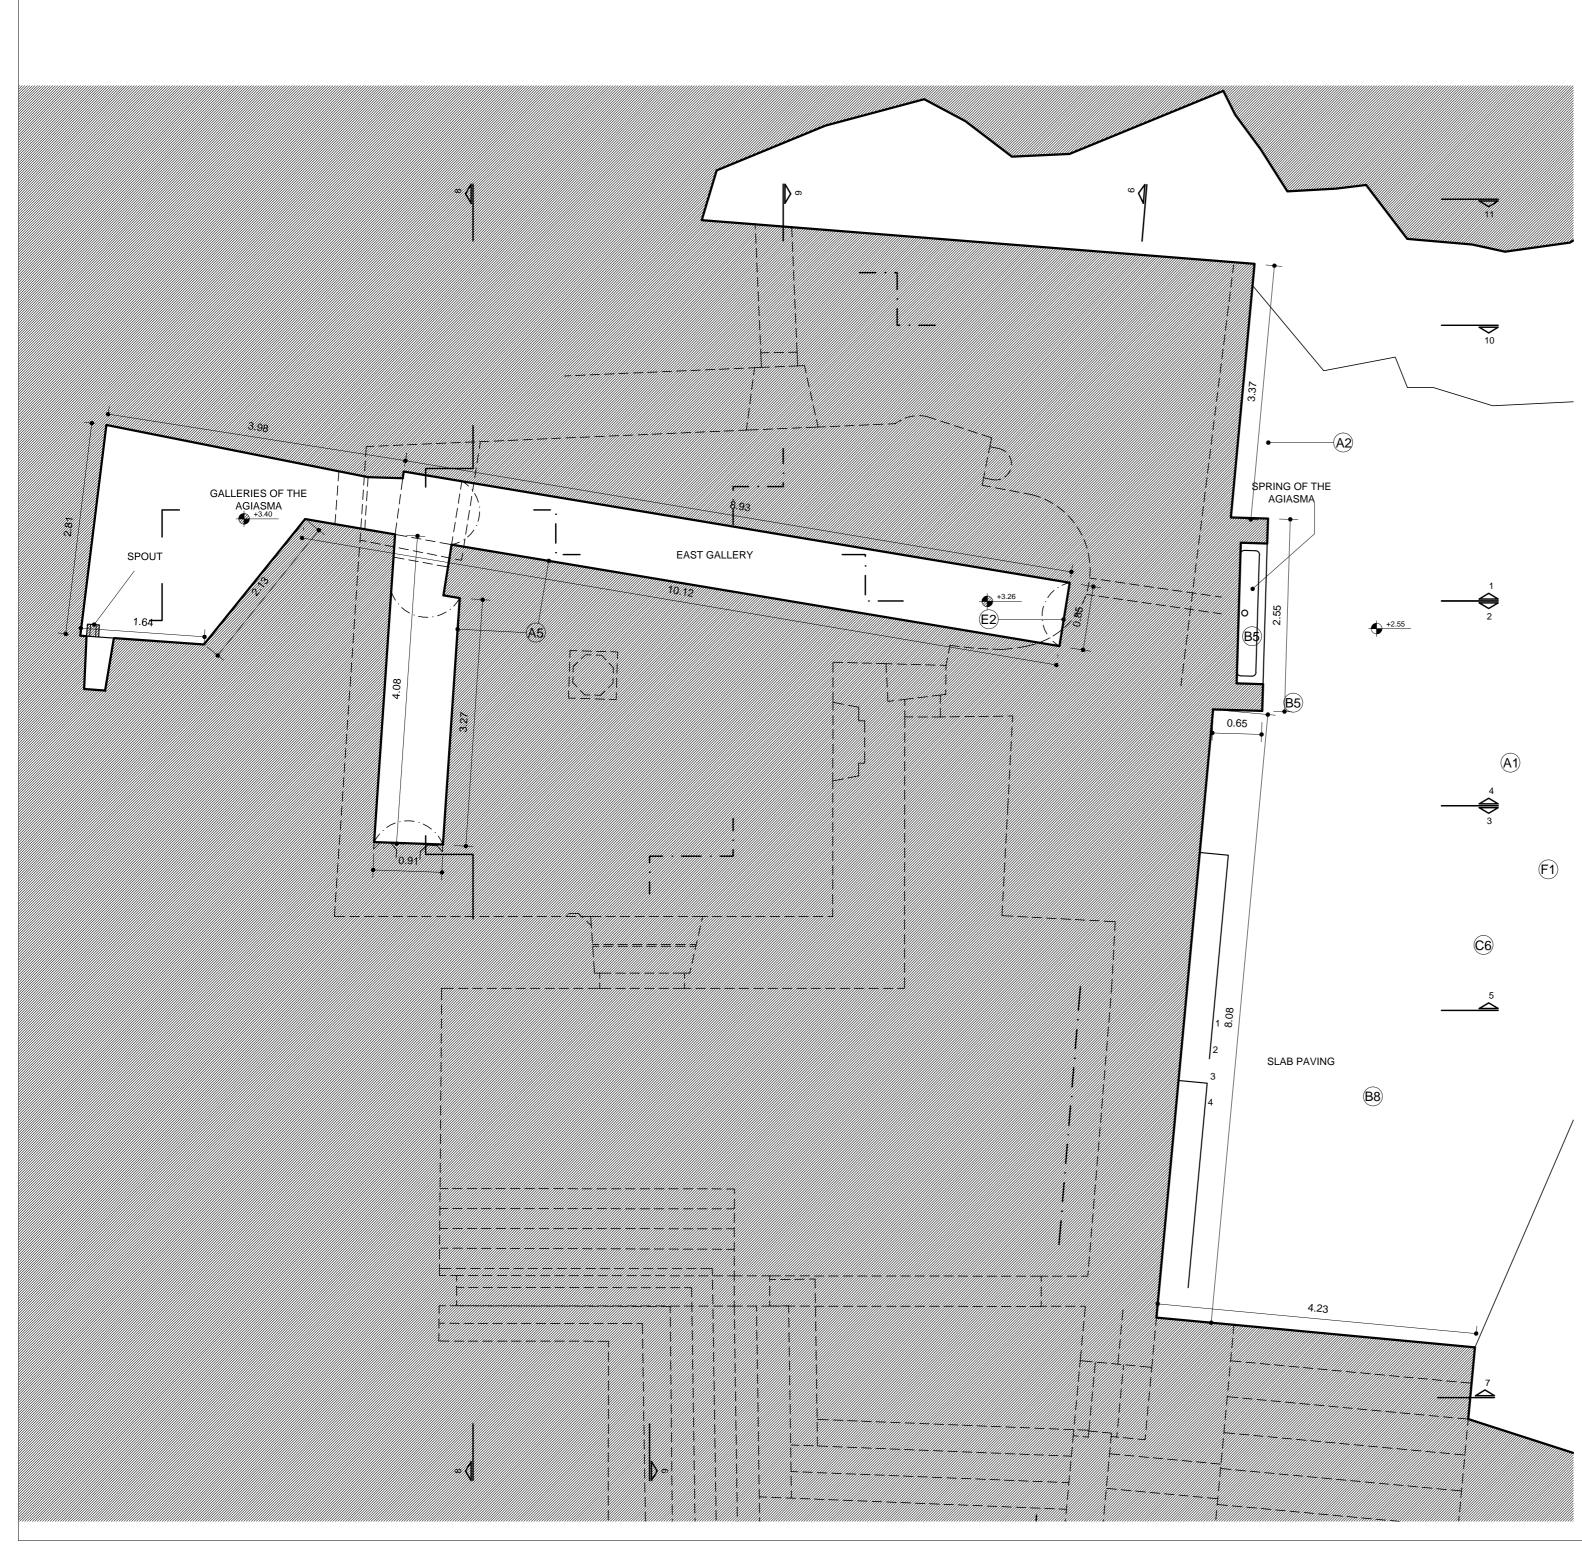
A1 Area with problems of substratum differential settlement (see structural study) A2 Differential settlement of foundation (see structural study) A3 Area of the masonry showing cracks A4 Area of the masonry which needs solidification A5 Area of the masonry which needs conservation A6 Area of the extrados of the domes which needs consolidation A7 Unknown preservation state of the extrados of the arcade dome A8 Areas of the masonry which need additions Construction works **B1** Poorly constructed cornice of cement mortar **B2** Area with problems in draining rainwater

B3 Absence of Altar **B4** Poorly constructed cover plate of the well which leads to the underground galleries of the Agiasma B5 Spring of the Agiasma showing traces of form alterations B6 Blocked window **B7** Surface of the masonry which needs conservation **B8** Area where steps need to be constructed in order to improve the transition from one level to the other **B9** Stone steps showing local problems of detachments and fragmentation of their compartments B10 Absence of access to the sea B11 Areas of render showing decay

C2 Recent floor of cement tiles which was laid 10-15cm higher than the original one C3 Problems of rising dampness C4 Recent floor of cement tiles which needs replacement C5 Poorly constructed floor of cement mortar

C6 Stone floor in a bad preservation state and with poor concrete repairs C7 Poor repair of the steps with cement mortar

E1 Unknown preservation state of the Agiasma supply E2 Water overflow in high locations of the arcades of the Agiasma

F1 Position of the old parapet with ashlar stone small piers which are not preserved **F2** Position of the cover plate of the well which needs excavational research

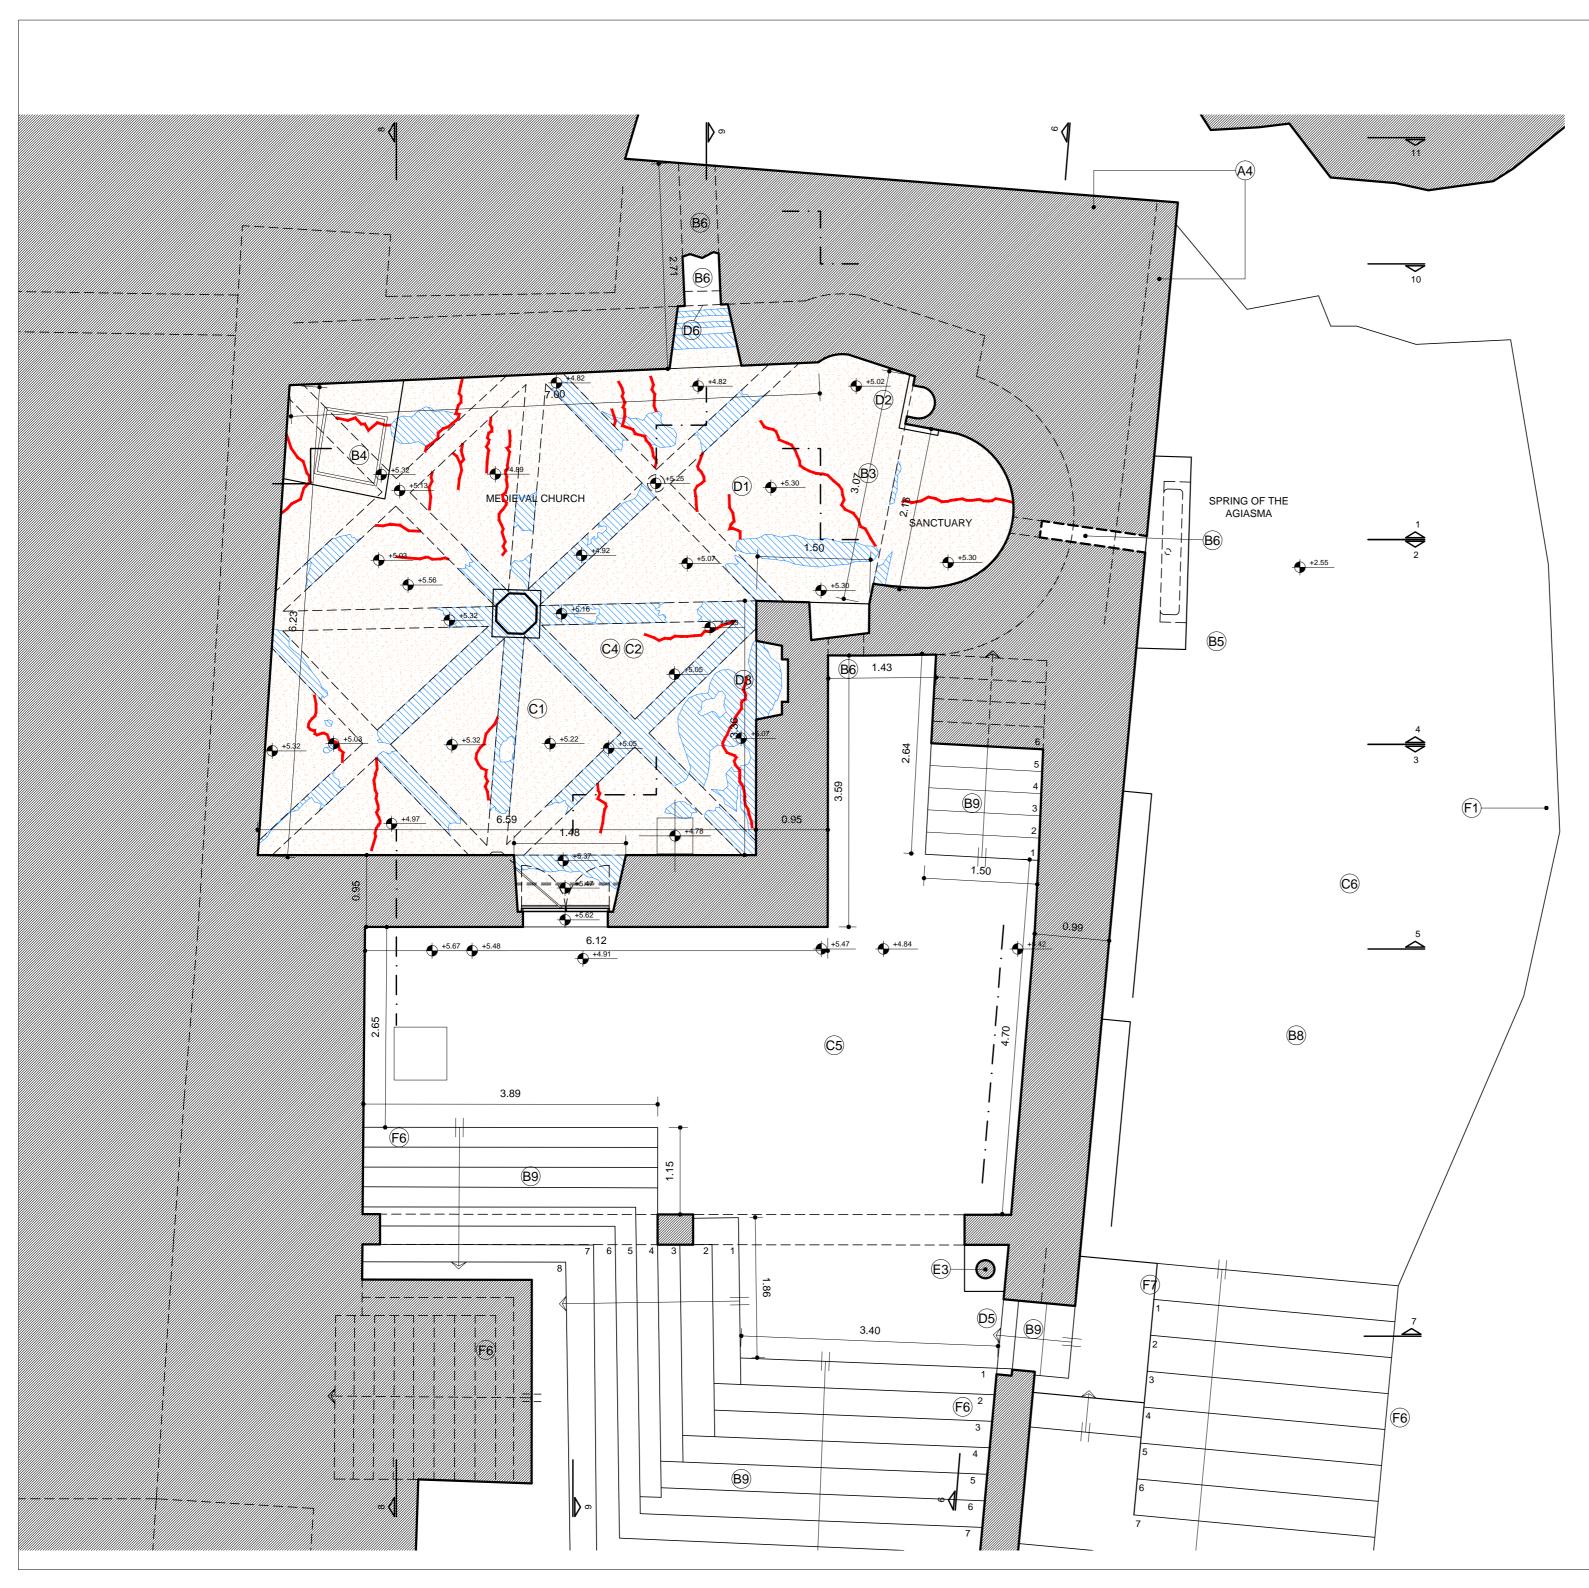
May 2007 Rev. February 2016 Date: Plate number: MCE02

settlement (see structural study) A2 Differential settlement of foundation (see structural study) A3 Area of the masonry showing cracks A4 Area of the masonry which needs solidification A5 Area of the masonry which needs conservation A6 Area of the extrados of the domes which needs consolidation A7 Unknown preservation state of the extrados of the arcade dome A8 Areas of the masonry which need additions Construction works

B1 Poorly constructed cornice of cement mortar B2 Area with problems in draining rainwater B3 Absence of Altar B4 Poorly constructed cover plate of the well which leads to the underground galleries of the Agiasma B5 Spring of the Agiasma showing traces of form alterations B6 Blocked window **B7** Surface of the masonry which needs conservation

B8 Area where steps need to be constructed in order to improve the transition from one level to the other **B9** Stone steps showing local problems of detachments and fragmentation of their compartments B10 Absence of access to the sea B11 Areas of render showing decay

C2 Recent floor of cement tiles which was laid 10-15cm higher than the original one

C3 Problems of rising dampness C4 Recent floor of cement tiles which needs replacement

C5 Poorly constructed floor of cement mortar

C6 Stone floor in a bad preservation state and with poor

C7 Poor repair of the steps with cement mortar

D1 Absence of icon screen D2 Absence of furniture of the Prothesis D3 Existing masonry recess D4 Timber 19th C doorway

E1 Unknown preservation state of the Agiasma supply

piping **E2** Water overflow in high locations of the arcades of the

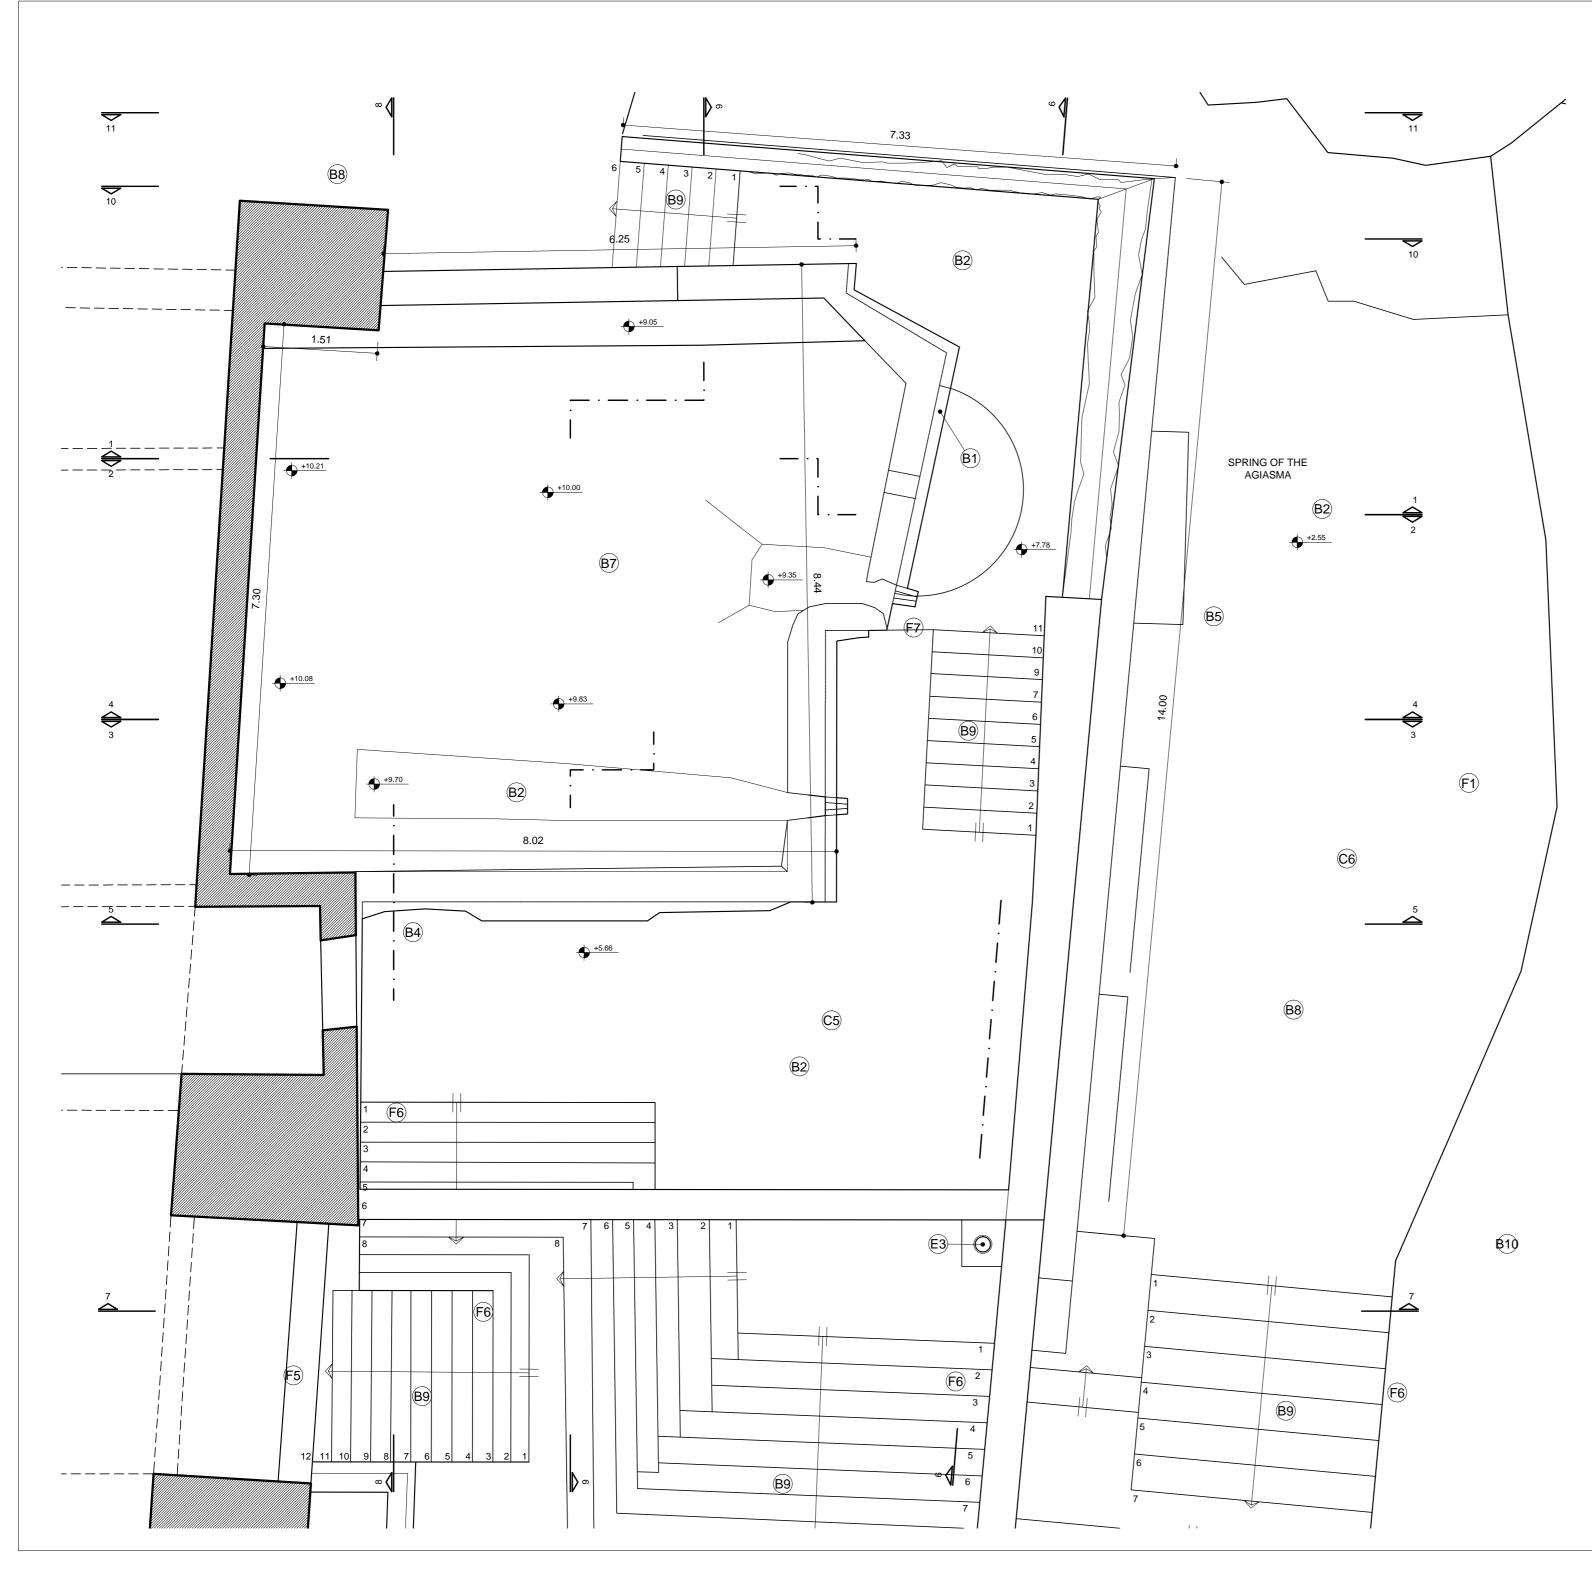
Plate number: MCE03

B6 Blocked window
B7 Surface of the masonry which needs conservation
B8 Area where steps need to be constructed in order to improve the transition from one level to the other
B9 Stone steps showing local problems of detachments and fragmentation of their compartments
B10 Absence of access to the sea
B11 Areas of render showing decay

C2 Recent floor of cement tiles which was laid 10-15cm higher than the original one

higher than the original one C3 Problems of rising dampness

C4 Recent floor of cement tiles which needs replacement

C5 Poorly constructed floor of cement mortar

C6 Stone floor in a bad preservation state and with poor

concrete repairs C7 Poor repair of the steps with cement mortar

D1 Absence of icon screen D2 Absence of furniture of the Prothesis

D3 Existing masonry recess D4 Timber 19th C doorway D5 Absence of door

E1 Unknown preservation state of the Agiasma supply piping

piping E2 Water overflow in high locations of the arcades of the Agiasma
