Scope of Work

Institute Description

The Building institute is located in the residential Area No3 in the city of Sirte which had suffered a fighting during the last war, which led to a wide destruction in this area, and Institute had suffered some of this destruction.

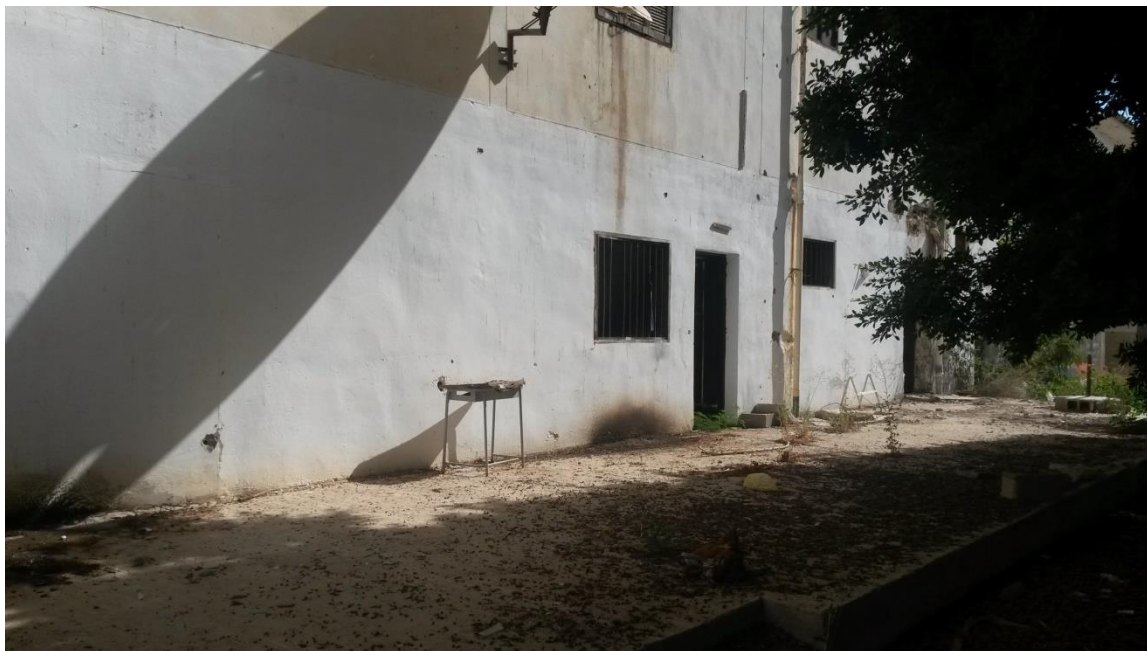
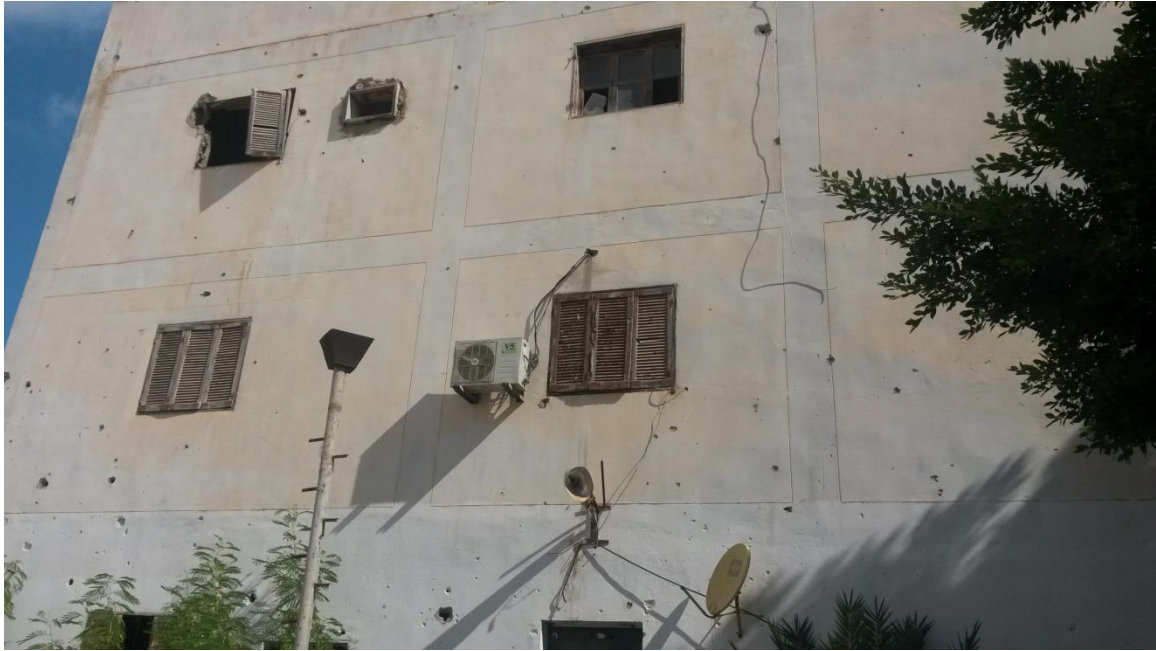
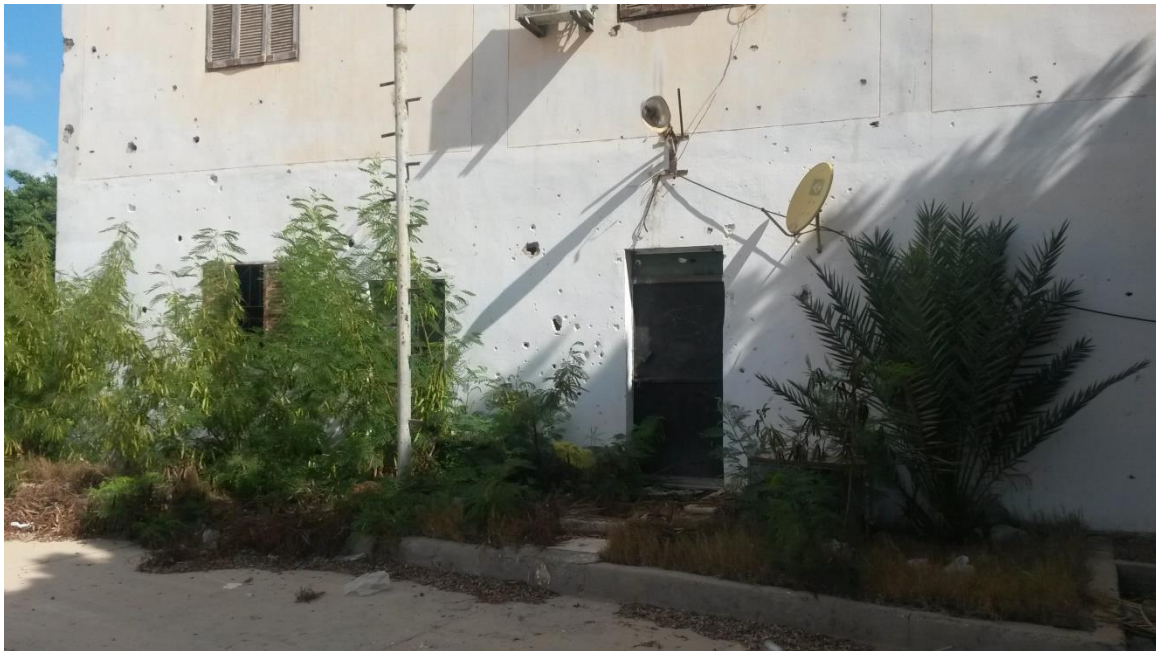
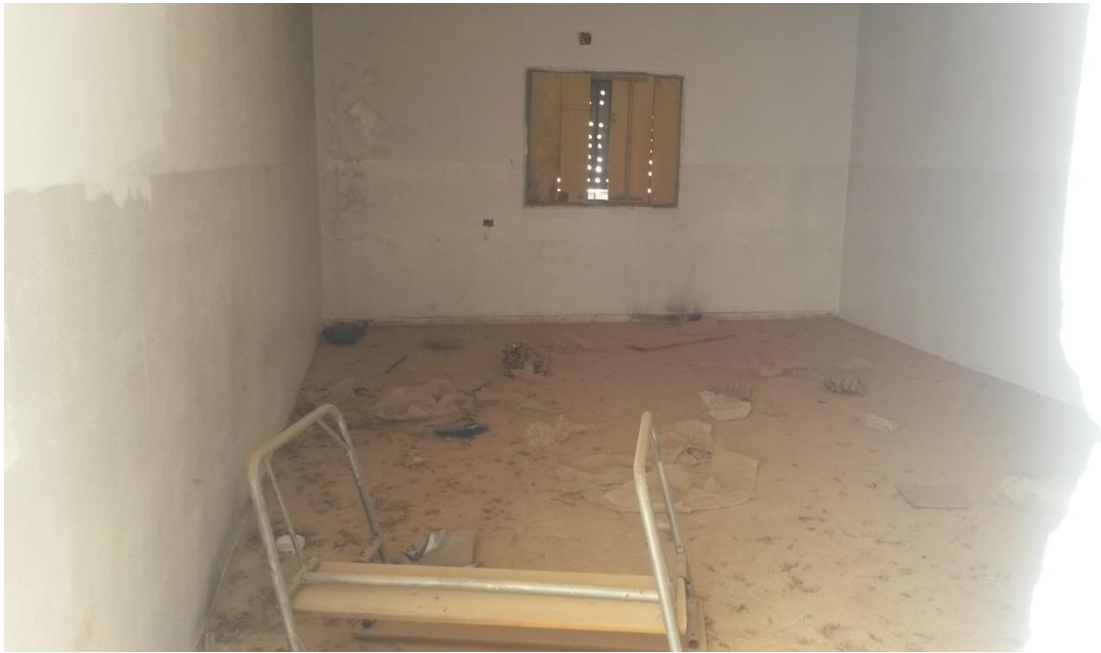
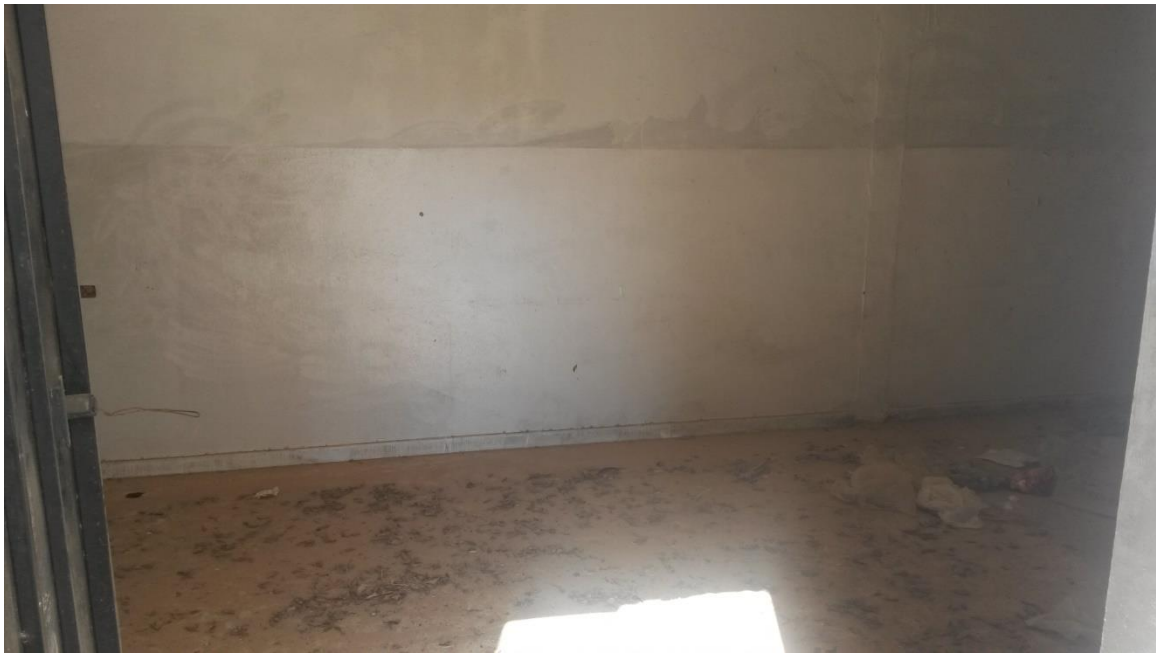
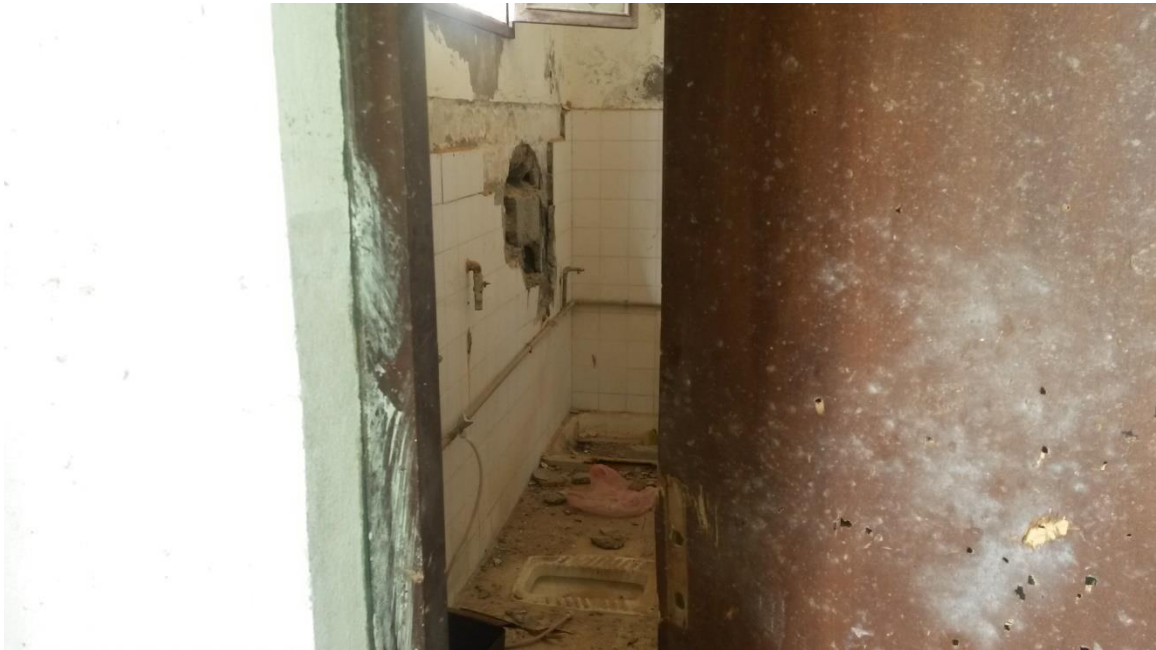
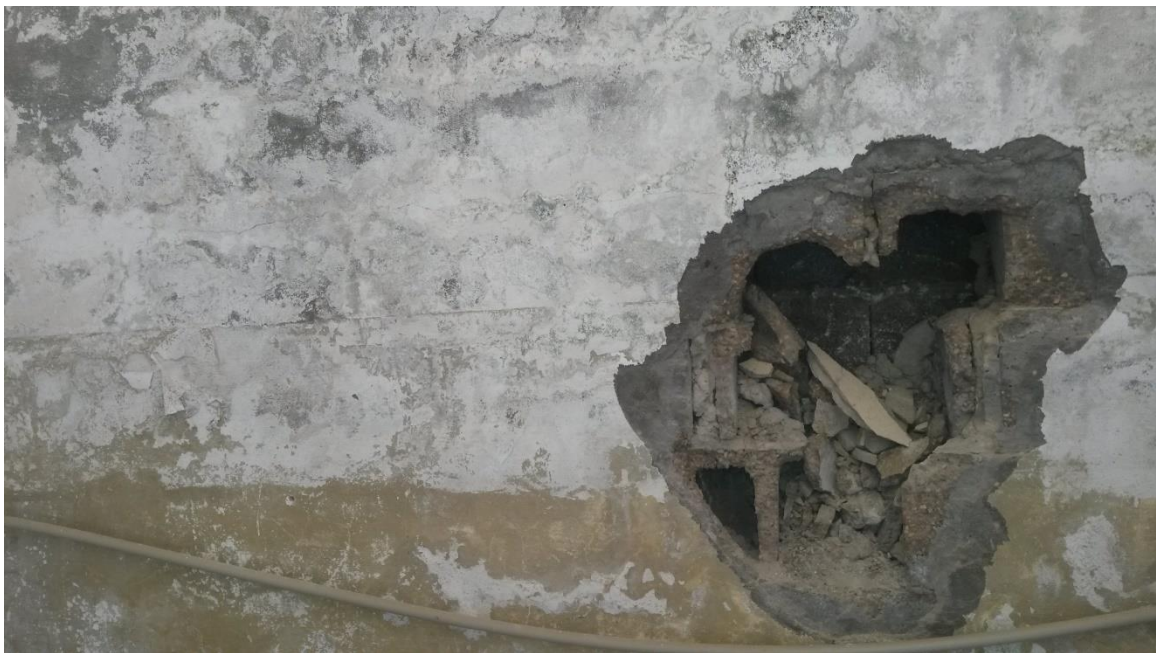
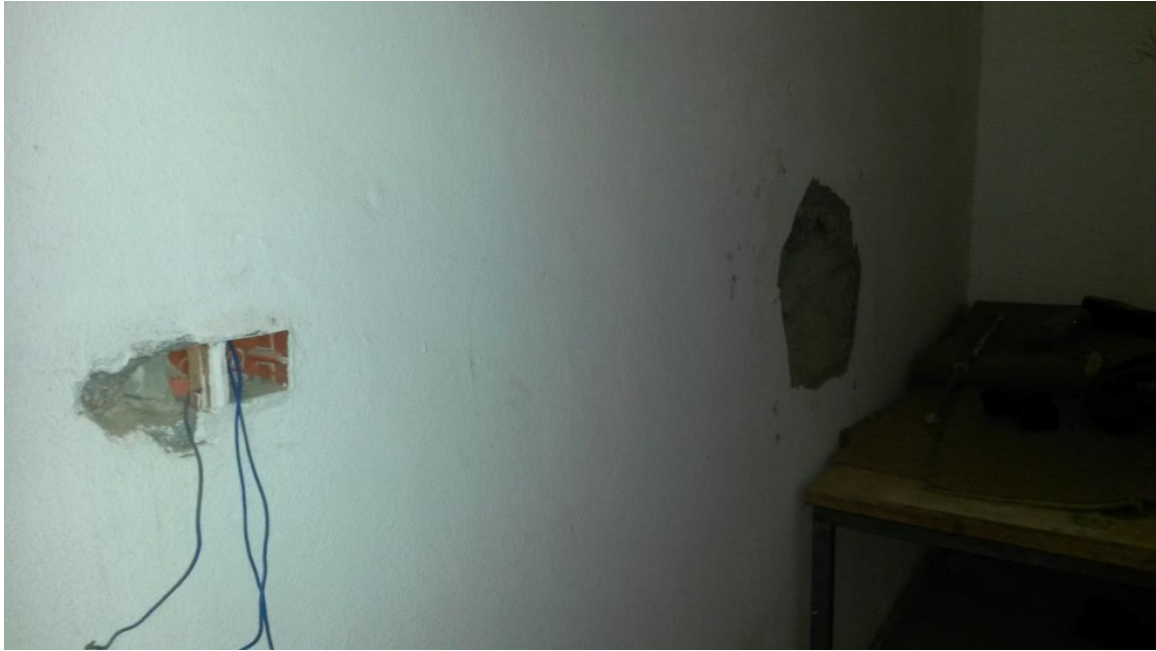
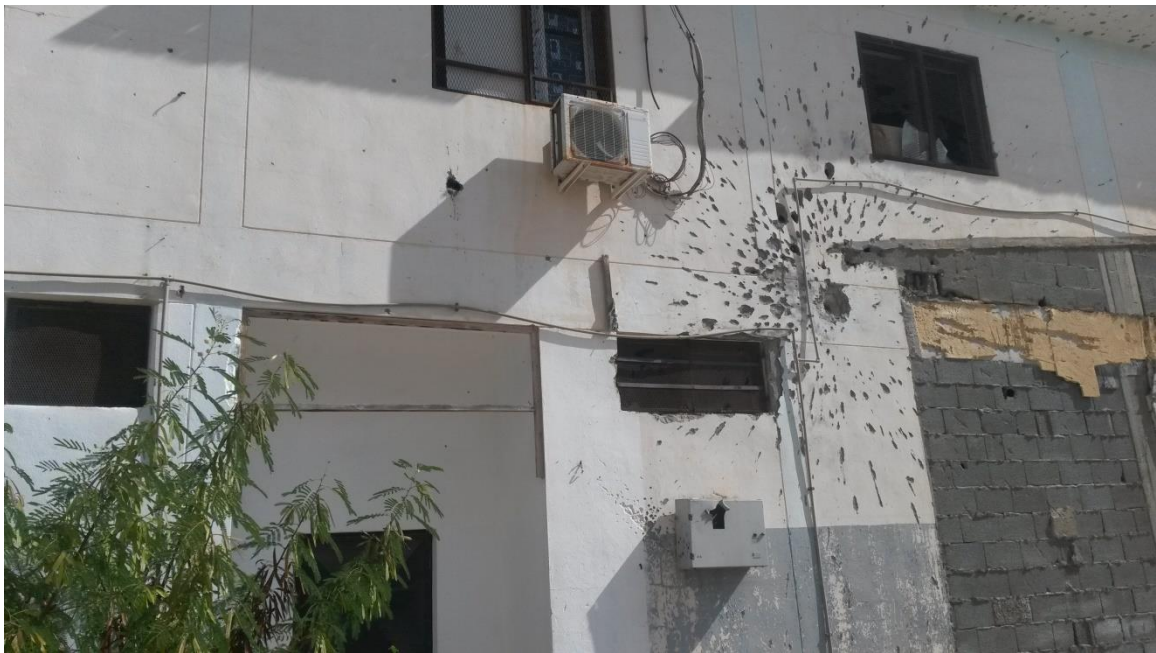
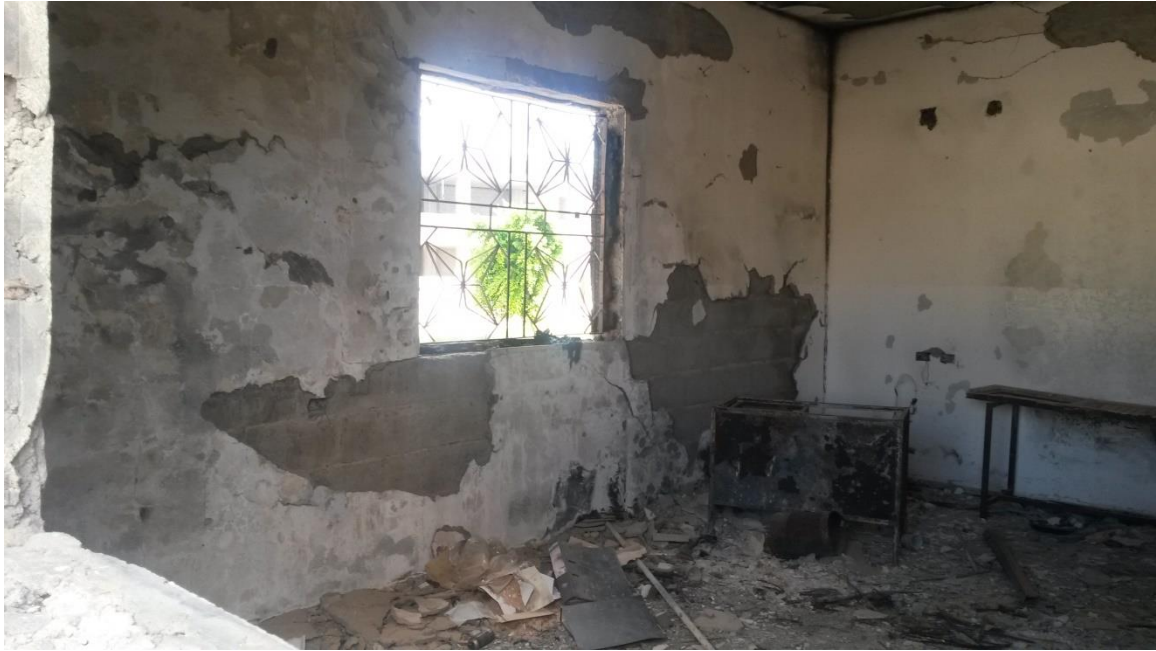
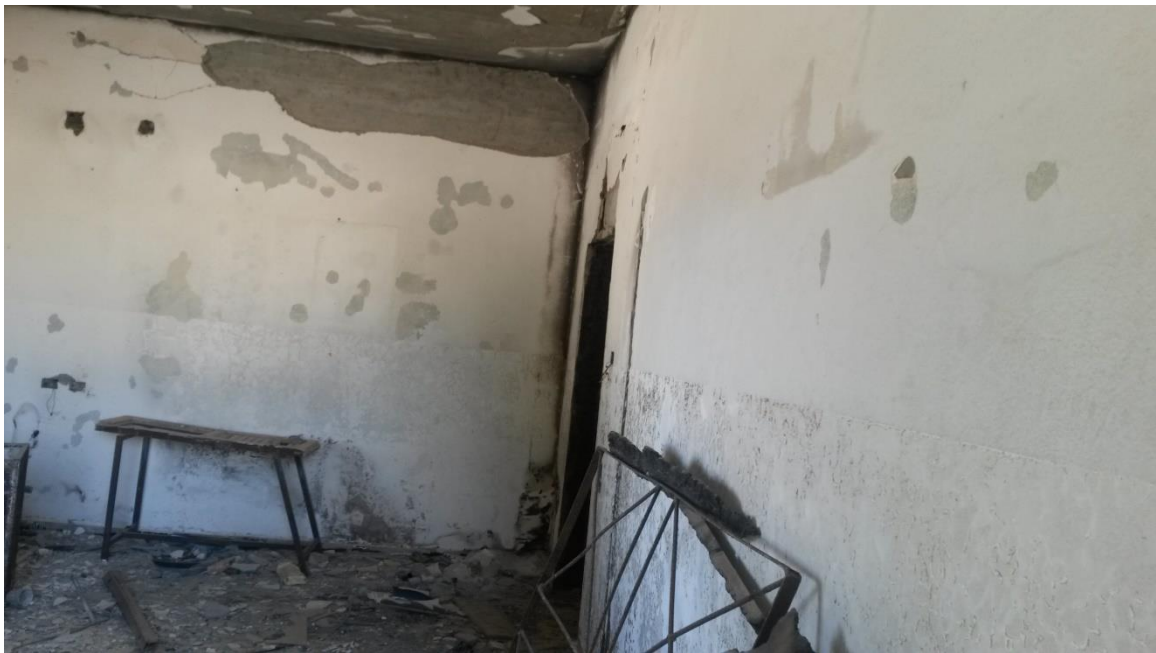
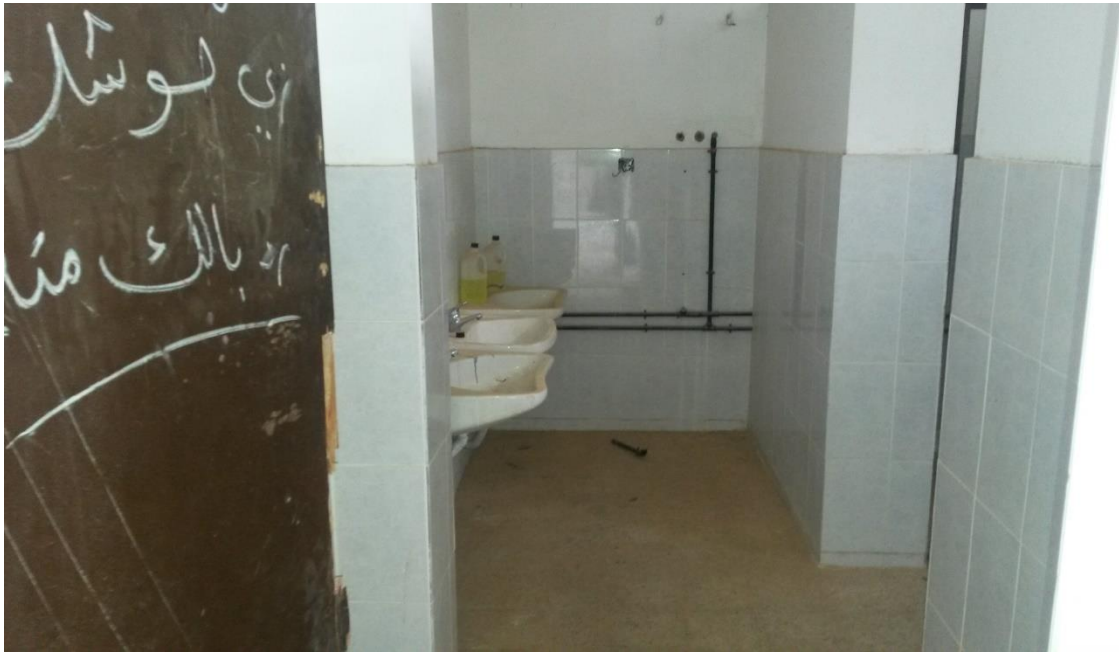
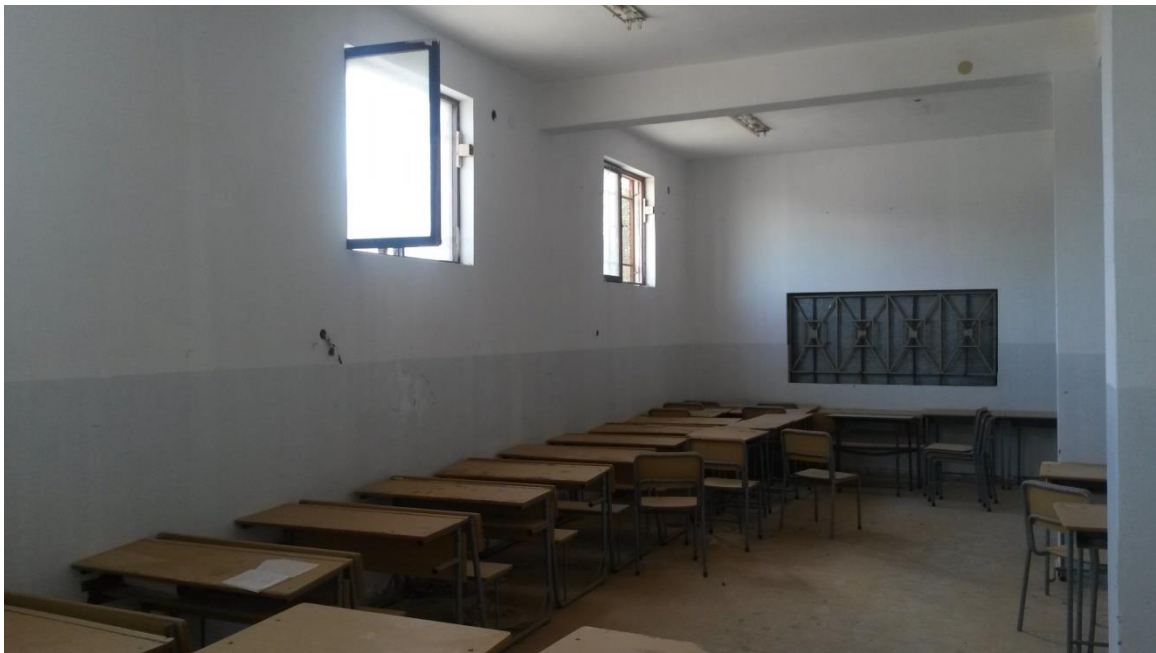
Some openings in the walls of the institute has resulted from the conflict and its shown in the accompanied photos in this report. The rooms' doors need the repairing of the locks and some needs handles as well, so as some windows in the facility as shown in pictures and BOQ.

The institute requires rehabilitation mainly in the broken glass of windows and doors, as well as the repairing of those windows and doors as detailed in the draft BOQ.
