Scope of Work

The Alrebaat “Aljeeza” HCU is in the residential area of Aljeeza in the eastern side of the city of Sirte which had suffered a fighting during the last war, which led to a wide destruction in this area, and Institute had suffered some of this destruction.

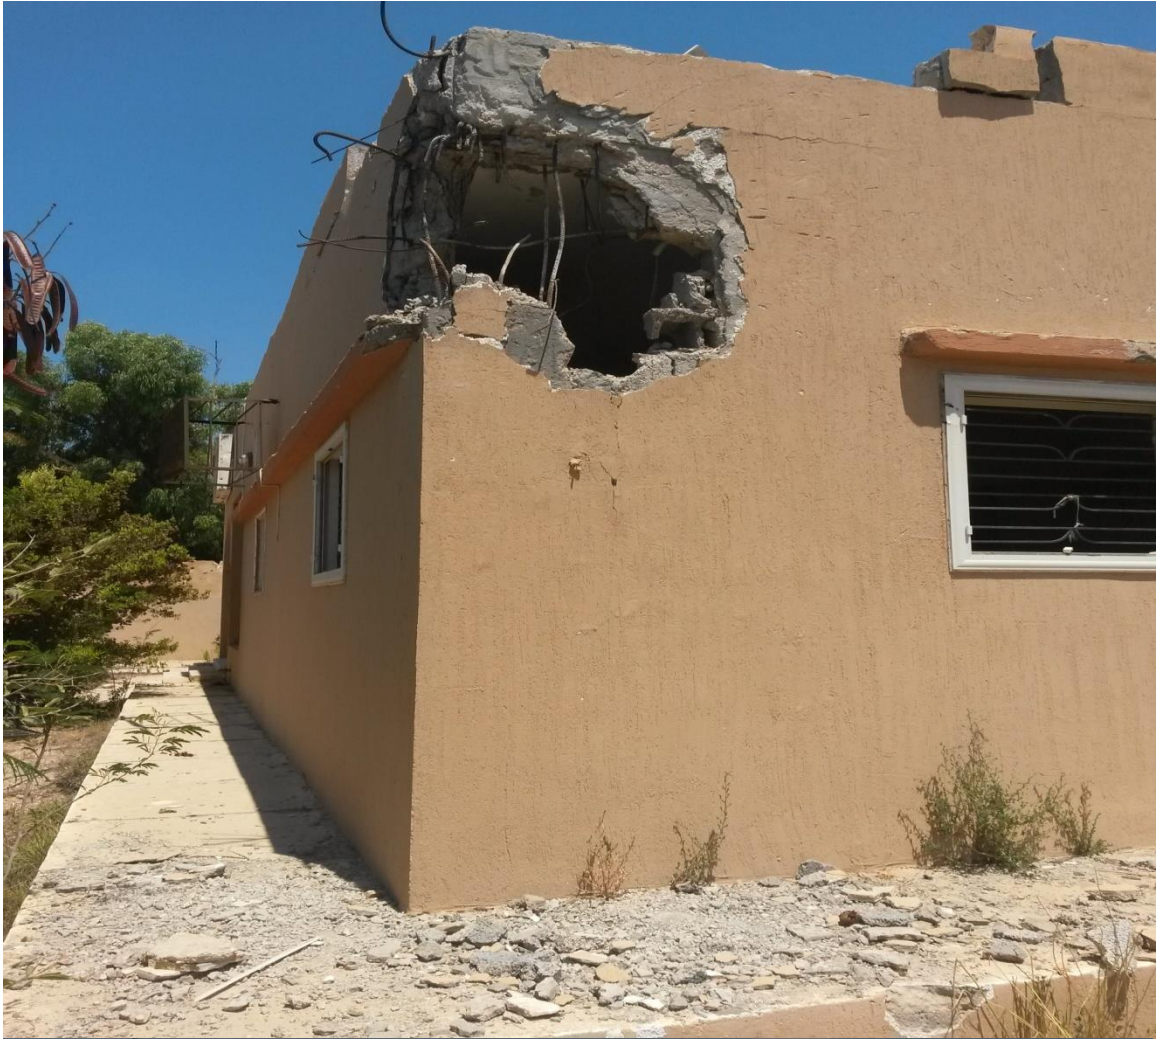
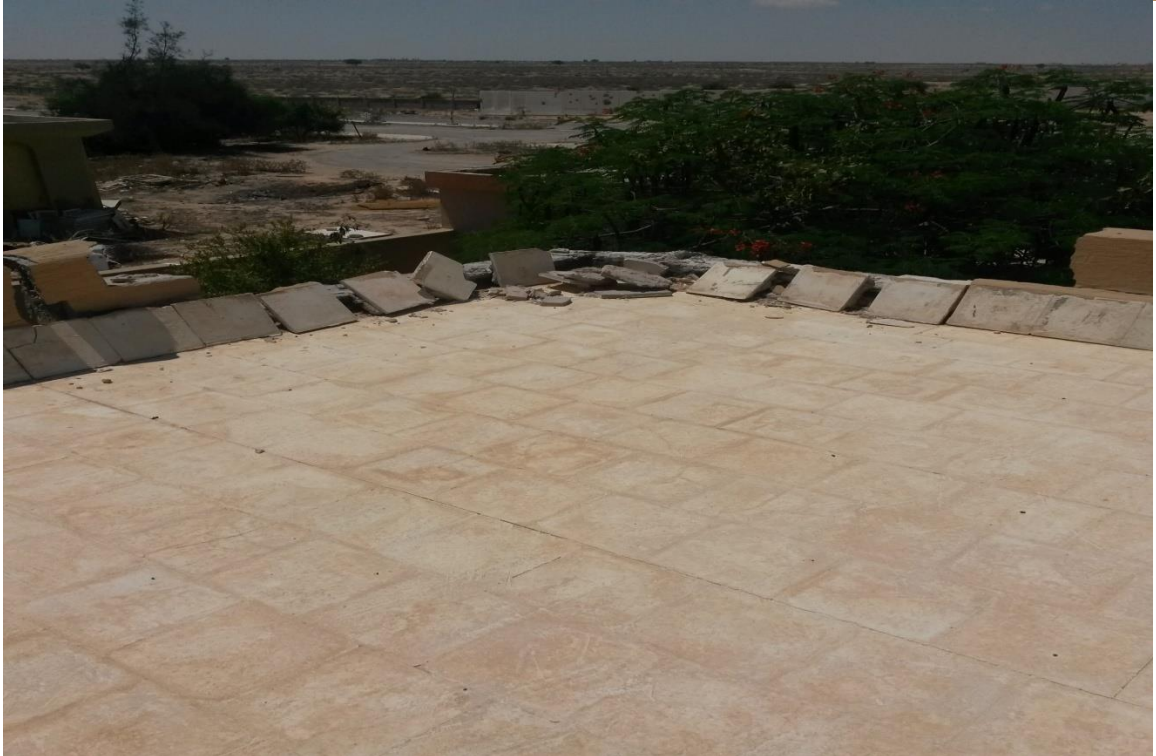
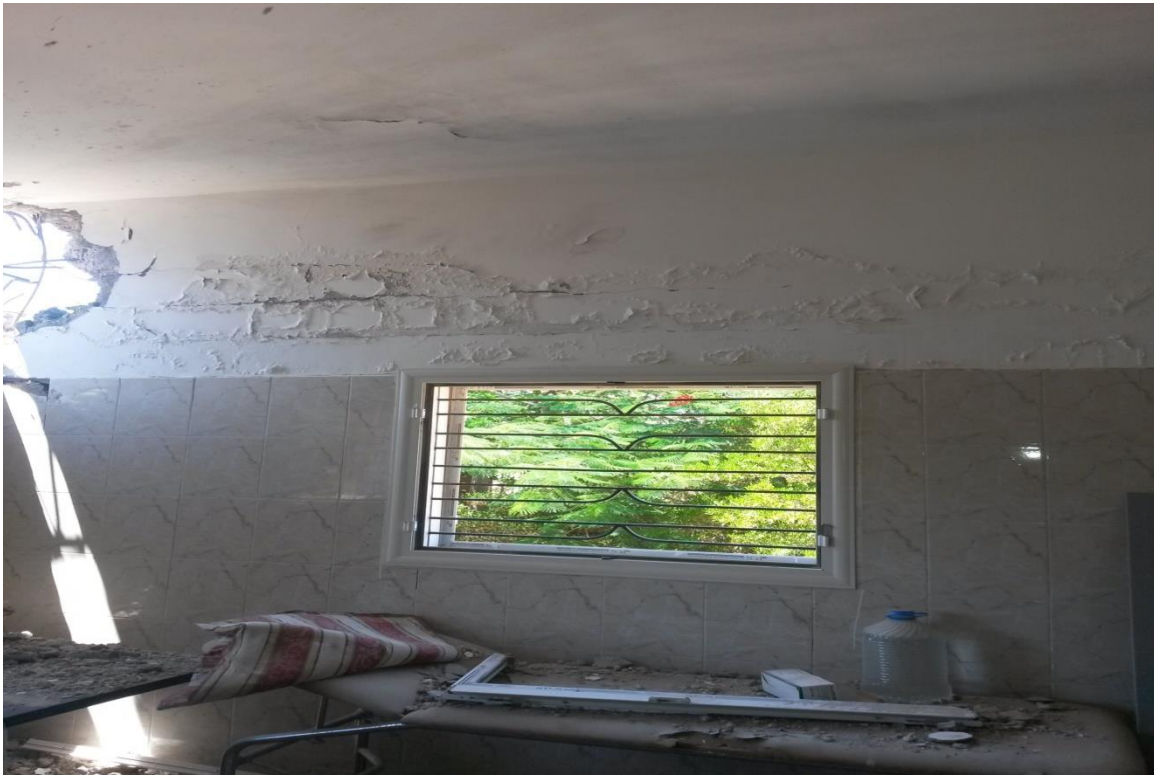
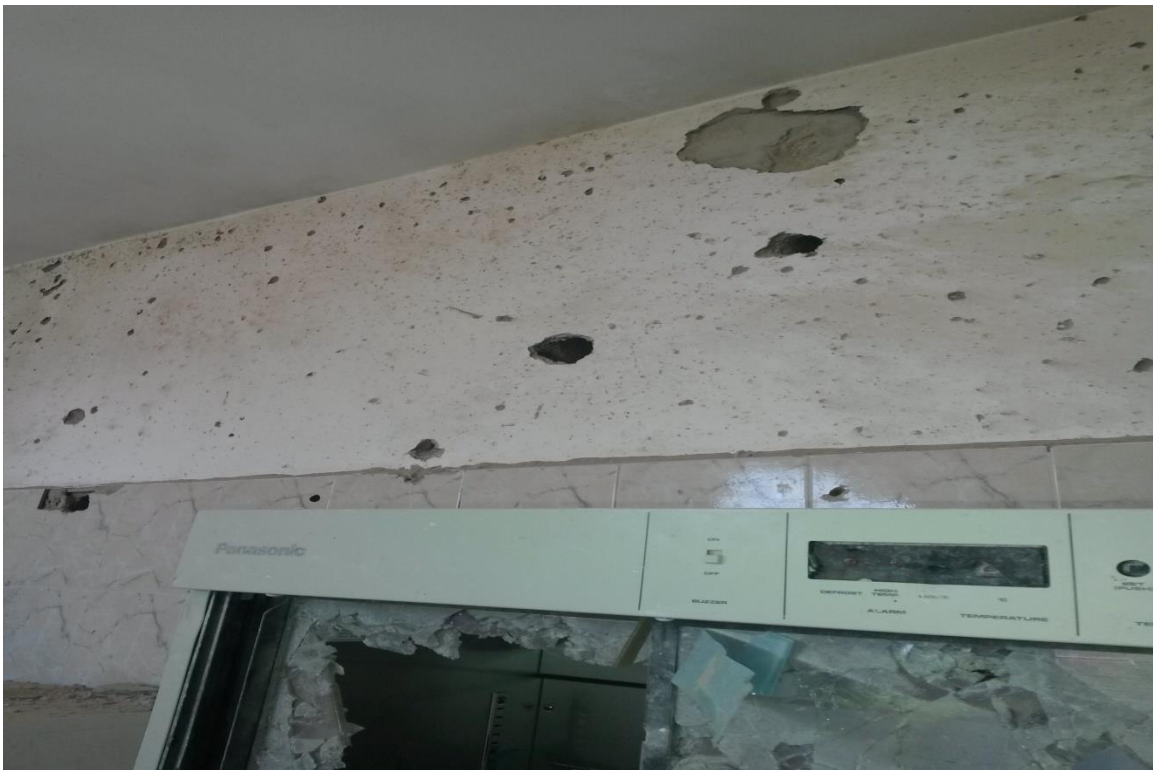
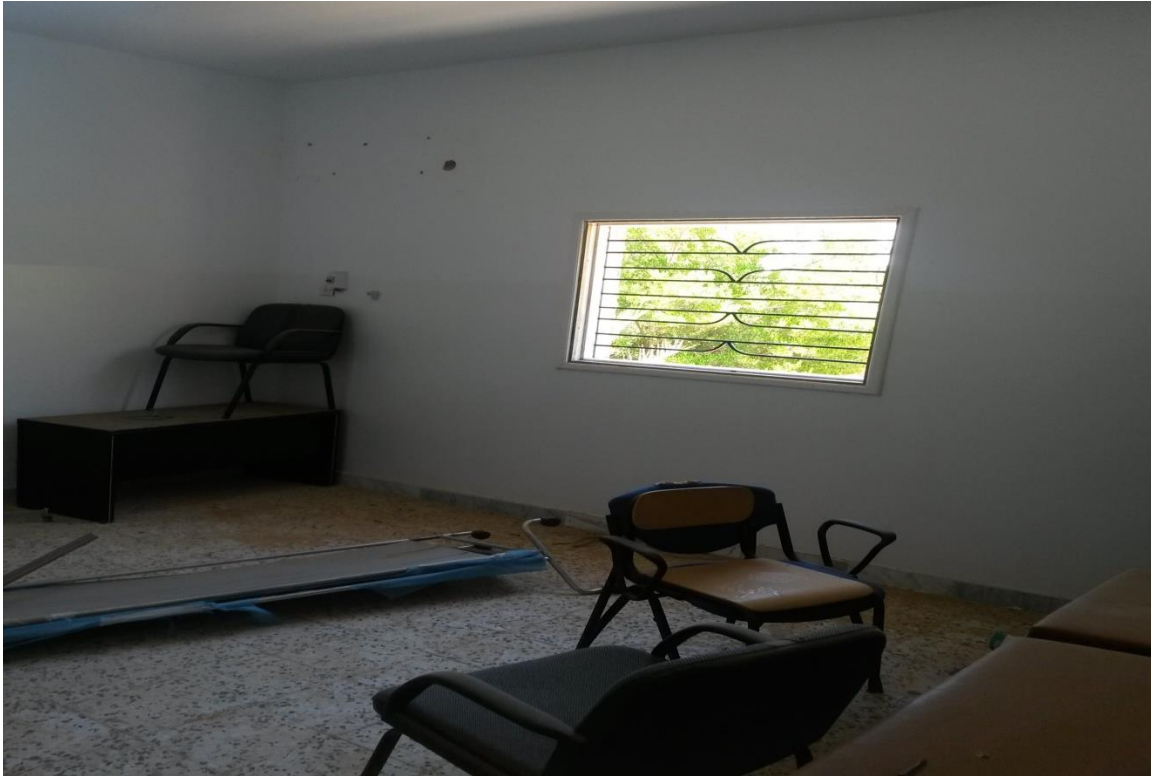
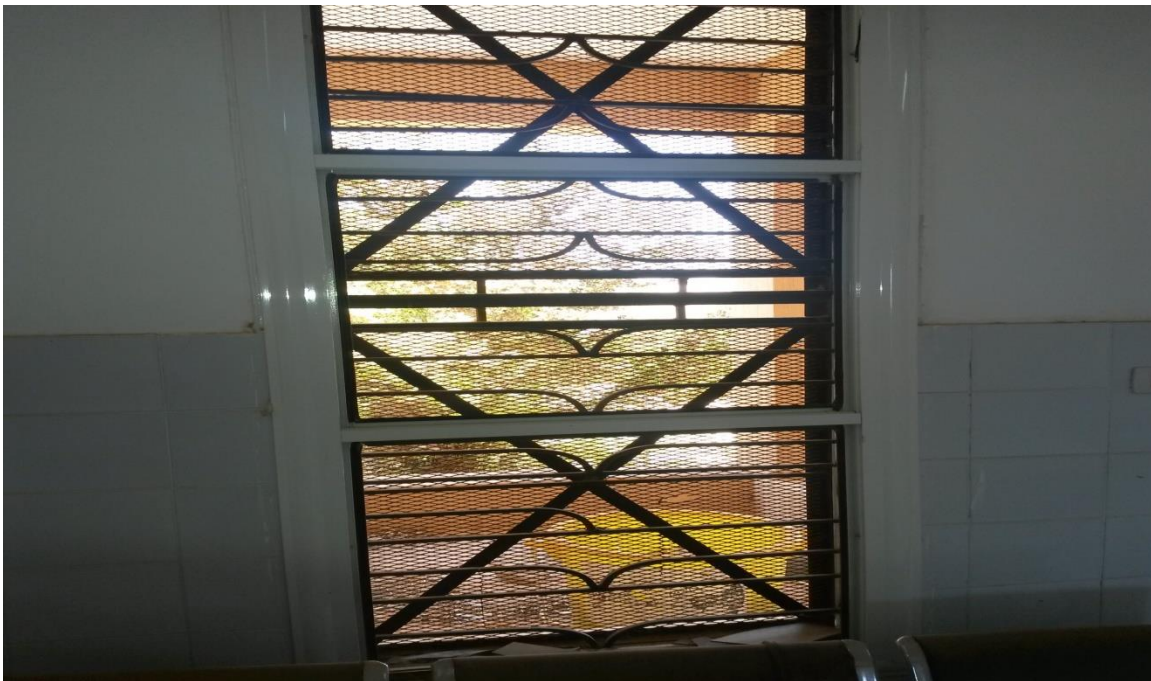
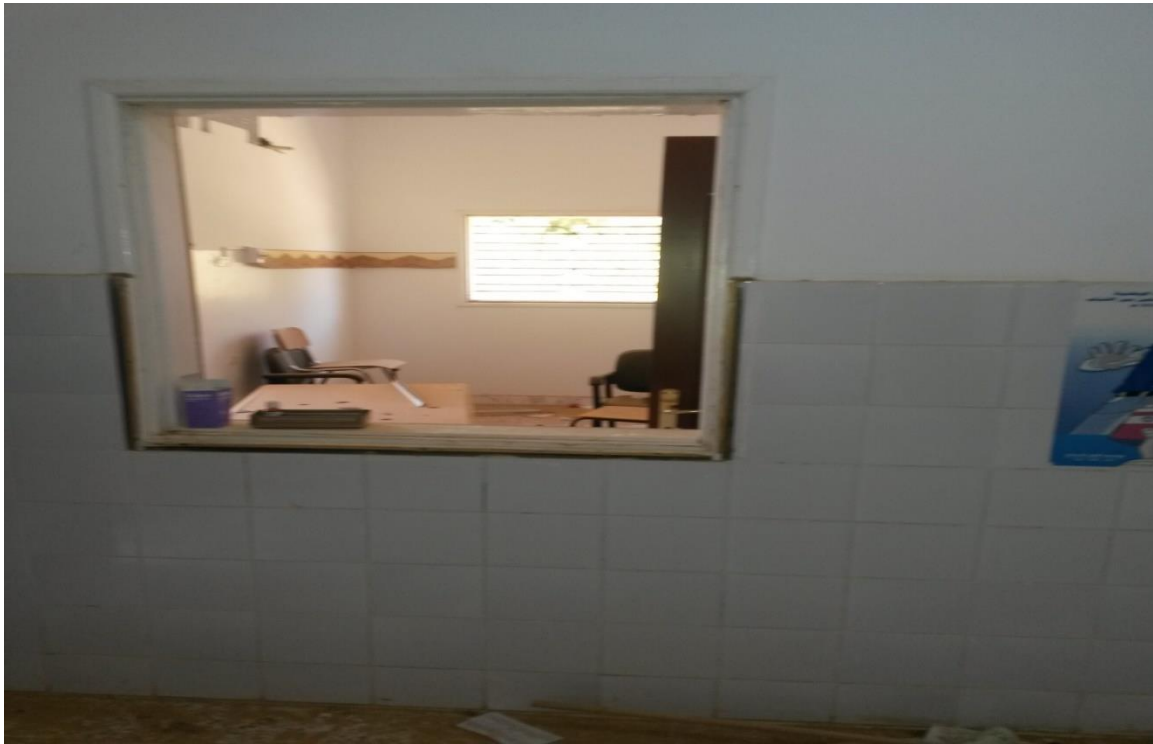
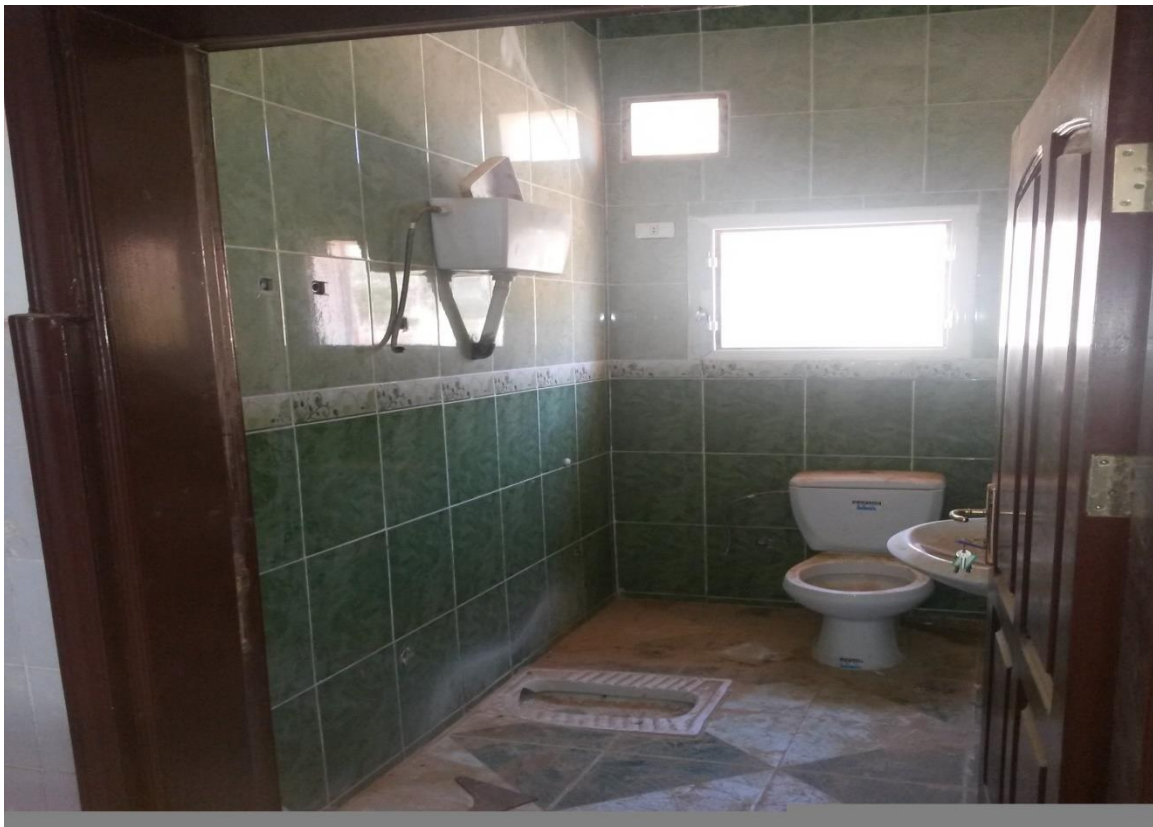
Some openings in the walls of the HCU has resulted from the conflict and its shown in the accompanied photos in this report. The rooms' doors need the repairing of the locks and some needs handles as well, so as some windows in the HCU as shown in pictures and BOQ.

The HCU requires rehabilitation mainly in the broken glass of windows and doors, as well as the repairing of those windows and doors as detailed in the draft BOQ.
