**Project Title :**  
**Church of AG. SERGIOS AND BACCHUS**  
**in Ag. Sergios / Yeni bogazici**

Drawing name:  
**1. EXISTING SITUATION  
2. BUILDING ANALYSIS**

## 8. Damages - Failures

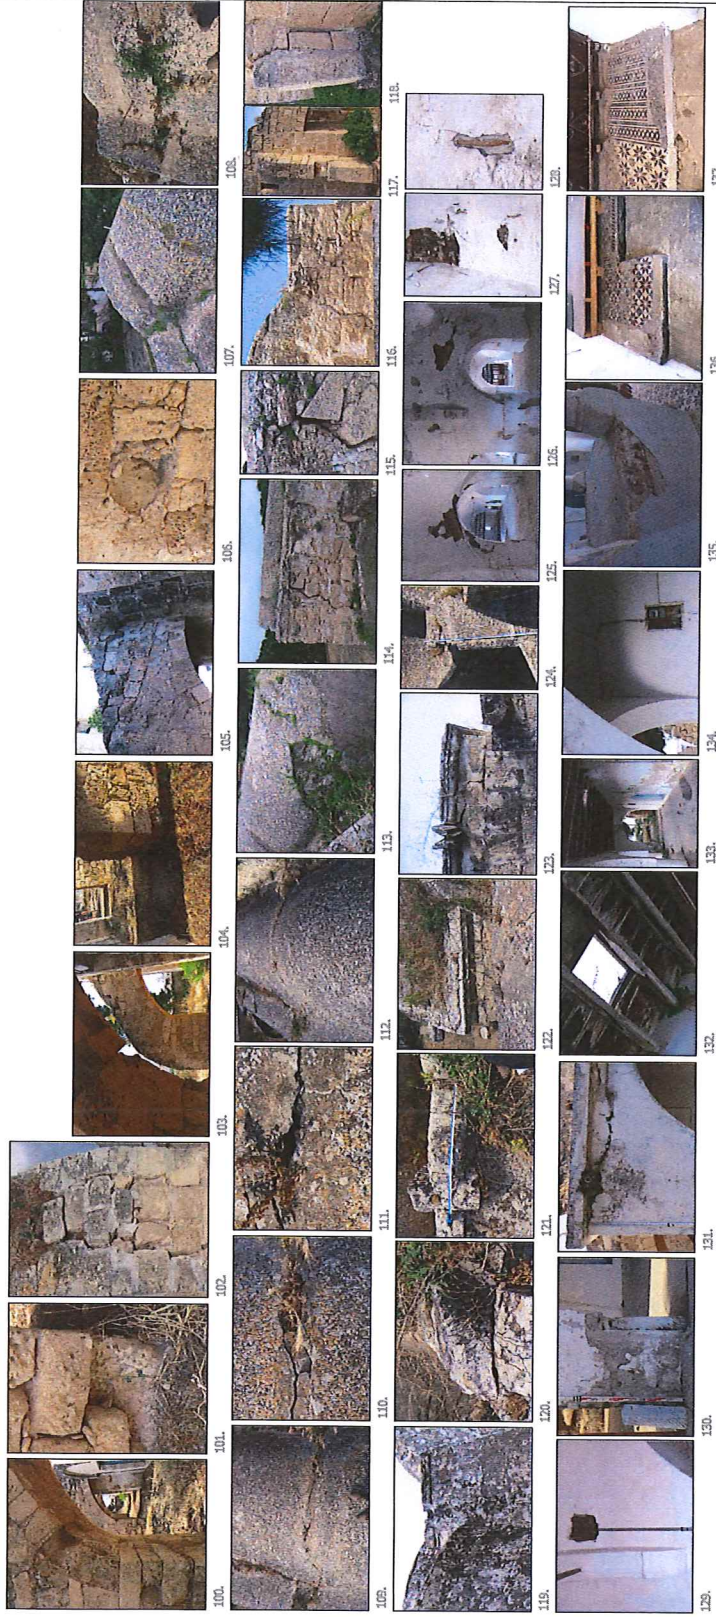
1. Buildings
  - Disintegration of the masonry (102)
  - Vegetation growth (101, 103)
  - Storm damage (103, 104, 105, 106)
2. Roof
  - Multiple cracks on lower walls (107, 108, 109, 110, 111, 112)

- Missing part of the roof of the northern wall (113)
  - Extensive Check on the southern side of the northern wall (114, 115, 116)
  - Displacement and displacement of a part of the planter, on the north side (117, 118)

- Missing spout (119)
  - Damaged part of wall, stone, vegetation and masonry located at the west edge of the main beam wall (120, 121)
  - Check and displacement of the north upper part on the roof of the north wall (122)

- Missing spout (124)
  - Displacement of the geyser wall, deep cracks on the walls of the north wall (125, 126, 127, 128)
  - Four missing geyser from the walls of north wall (129)

- Neglected masonry and plaster, corrosion of iron and masonry failure, on the walls of porches (130, 131)
  - Corrosion of wooden beams on the roof of porches (132, 133)
