ANNEX 1 - DESCRIPTIONS & SPECIFICATIONS

1-Condition Assessment

Ag. Georgios Church is located in Ardana/Ardahan, Cyprus. The apses area where heavy deteriorations are seen is constructed with two leaved wall system. The internal wall is curved and the external wall is polygonal. Main arch before the half dome is 4 meters in diameter. The half dome is 2.7m meters in diameter and the thickness of the walls vary from 1 meter to 70 cm.

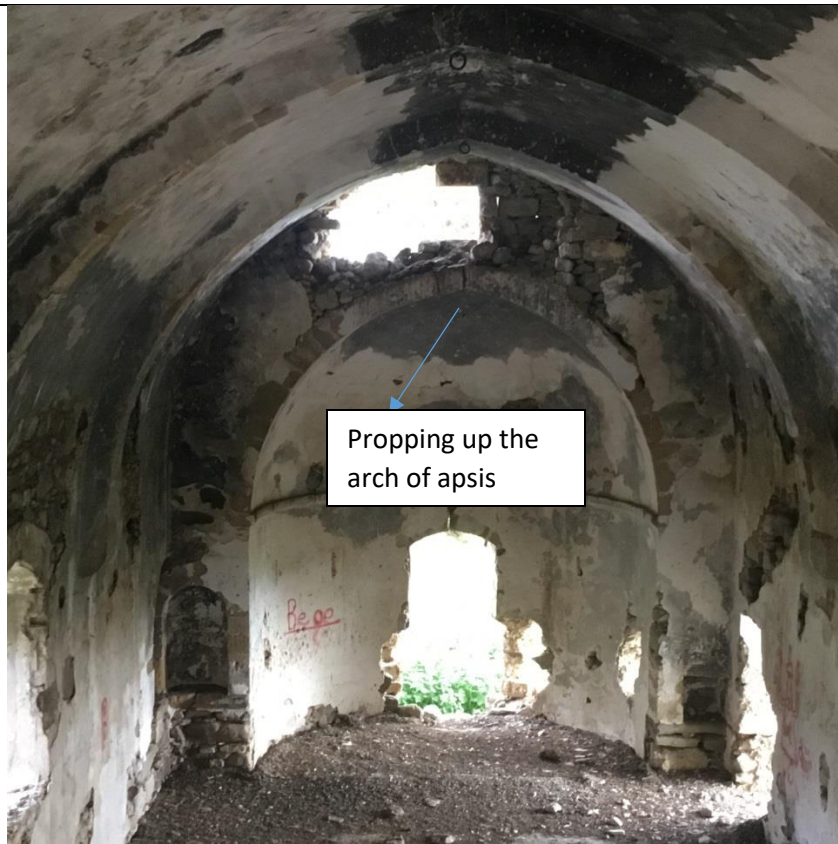
Picture 1

The arch of the apses has a dislocated key stone and deformation in shape especially on the right side of it when looking from west.

There is extensive material loss from the infill material above the arch and the half dome.

A support system is proposed for the gap under the arch and under Eastern window. Ring lock scaffold system with supports will be used as indicated in the drawings. For the diagonal supports cuff system complying with standard EN74-1 10BM have to be used. All scaffold set up and materials used have to comply with EN 12811. Connection details of the supports and scaffolds are also provided.

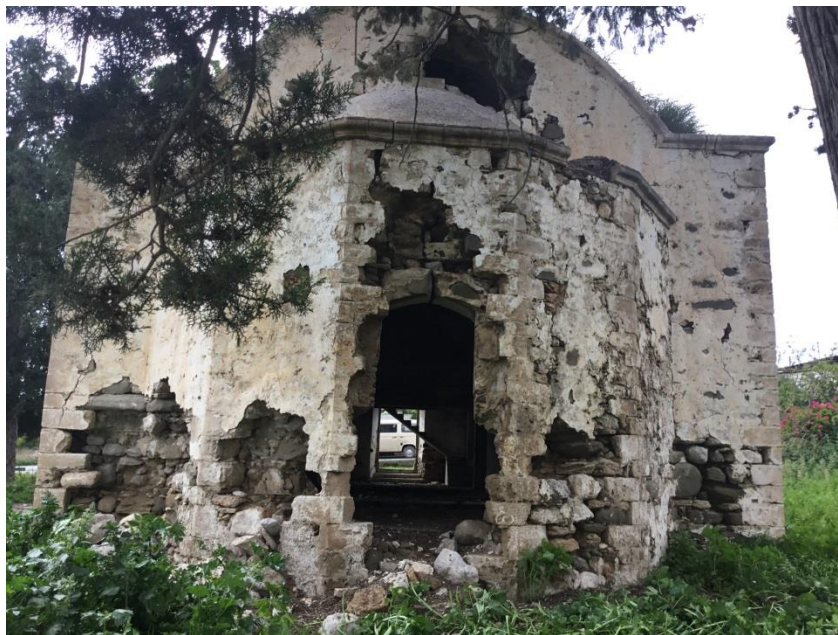
Picture 2

Extensive stone and infill material loss are present 4 different locations on the apses wall and 2 locations on the eastern wall of the main church.

3	Infill Works	<p><u>Apsis and Eastern Walls</u></p> <p>Extensive stone and infill material loss are present 4 different locations on the apsis wall and 2 locations on the eastern wall of the main church these locations are indicated in proposal drawings. The discontinuity of the walls in shown areas disrupt the uniform load transfer. In order to transfer load to the ground, the voids will be filled with wooden elements.</p> <p>Stones lying under the voids and interfering with the installation of base board will be removed and piled next to the place.</p> <p>Wooden infill will be made with verticals of 4x4inches Romanian soft wood painted with dark coloured sylvanol, at every 20cm. Verticals will be connected to wooden base boards on the ground.</p> <p>Struts to connect the verticals will be 4x2 and 2x2 Romanian softwood and painted again with dark coloured sylvanol. Struts can be put at every 30cm.</p> <p>On both sides (inside and outside) 6mm OSB will be affixed with nails. No treatment of the OSB will be required.</p> <p>Nails must be galvanized.</p> <p>If needed, interface of verticals with the walls will be filled with lime mortar. No portland cement will be used.</p>

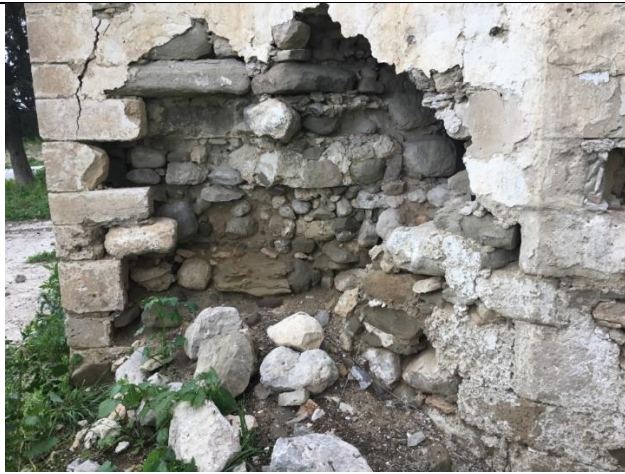
Picture 3

Stone and infill material loss seen at South side of the eastern wall and the south wall of the apses

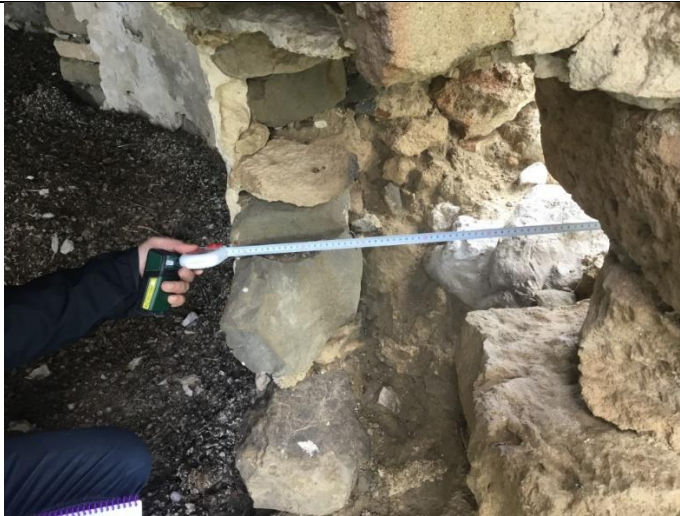
Picture 4

Complete loss of infill material between the two leaves of the apses wall. The internal wall is curved and the external wall is polygonal. The infill material contains earth and stone fragments.

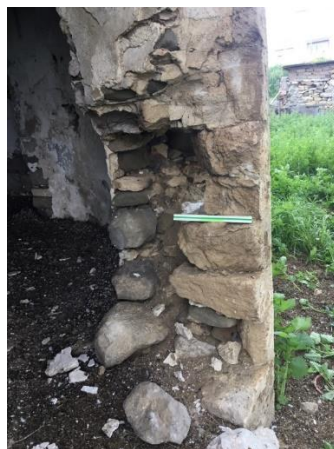
Picture 5

Internal stones and the infill stones are rounded "river rocks" with minimal friction and the external stones are cut limestone. The infill material contains earth and stone fragments.

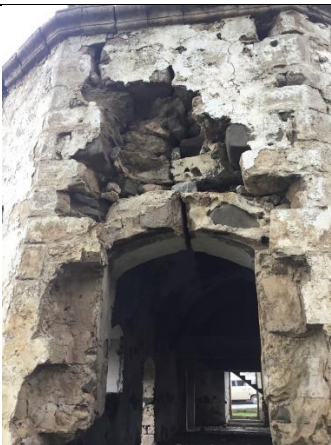
<p>Bottom part of the Eastern apses window is completely collapsed. External wall stones and infill material loss is present above the keystones of the Eastern window</p>

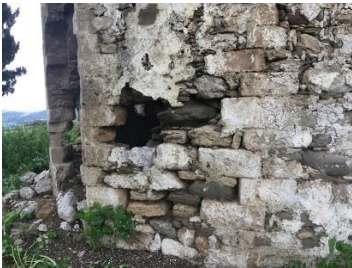
<p>Picture 6</p>	<p>Stone and infill material loss seen at North side of the eastern wall and the north wall of the apses.</p>

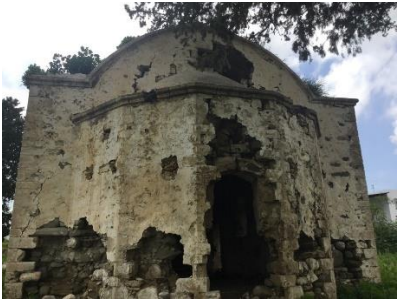
<p>Picture 7</p>	<p>Critical stone deterioration (approximately 50%) is present on the south and east of the opening under the eastern window.</p>
