Annex 4.1: Technical Report of DGM: proposed landslide mitigations in P/Ling Thomde (PPG study)

The main objective of the PPG technical feasibility study was to assess the geological and geotechnical conditions of critical landslides and to propose various remedial measures (in terms of civil structures, drainages and bio-engineering) in the landslide prone areas under P/ling Thromde.

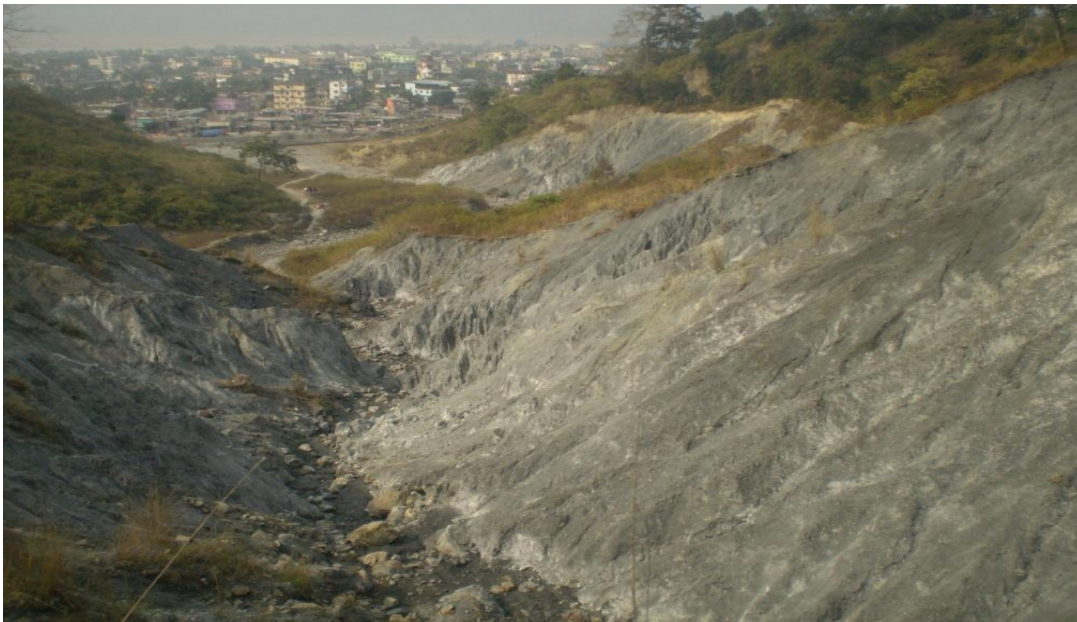
Figure 16: Photograph showing the active landslides due to toe scouring and rapid incision of the Stream/gully bed especially during peak monsoon.

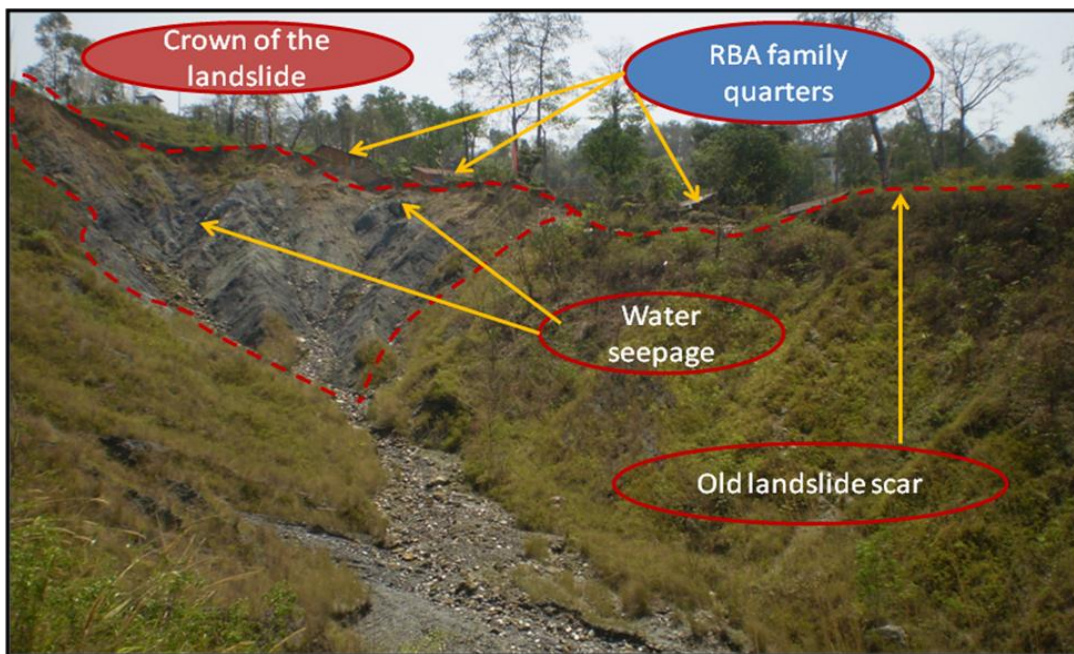
Figure 17: Photograph showing the propagating landslide near the RBA family colony

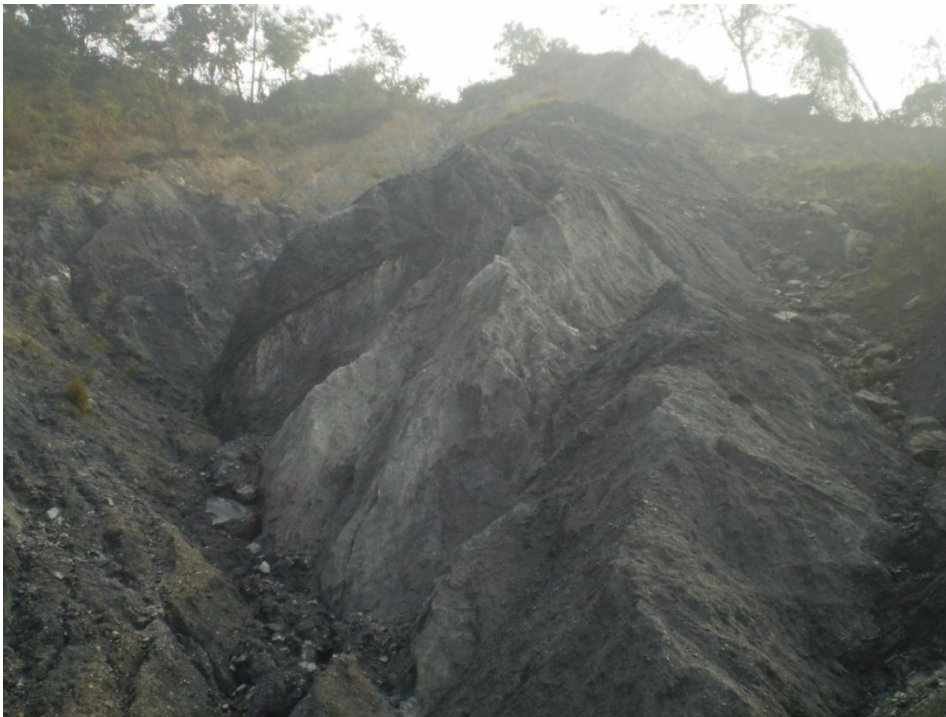
Figure 19: Active landslide to the west of Reldri Higher Secondary School

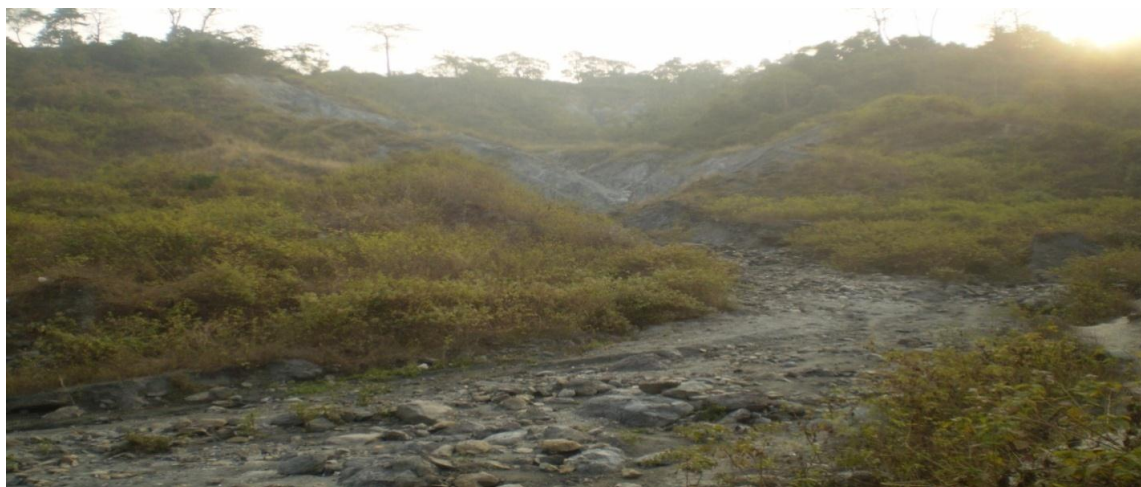
The landslide is very active and propagating to North East, South East and also North West. It has a steep slope face angle of more than 50° facing 280° (NW). This is one of the major landslides which have an approximate area of 28.39 acres. The top 2 meters thick of reddish brown residual soil followed by intensely fractured and crumpled carbonaceous phyllite with variegated colored (gray, purple, green) phyllite and thin lenses of clay are the main rock types present in this active slide zone. Seepages of water were seen at number of places. Numerous tension cracks are developed with ground subsidence of more than 10cm all along the foot trail (Railing) leading to Old General Hospital (MSD). Even the foot path is seen to tilt 10° towards 055° (NE).

Figure 27: Photograph showing the active and dormant landslide

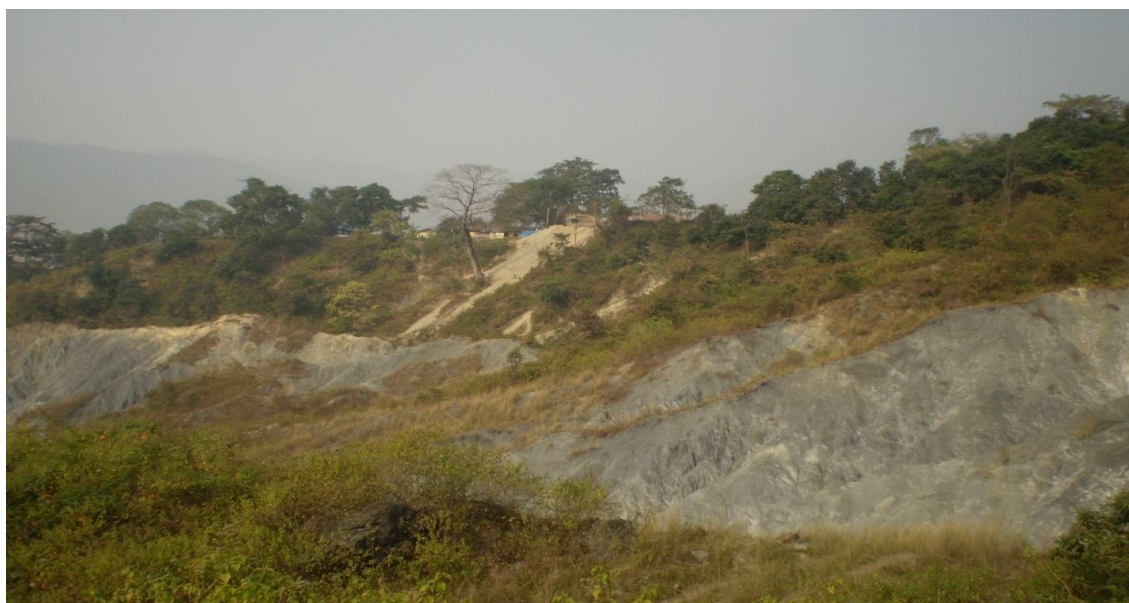
Figure 28: Active landslide propagating towards the east of the Old Hospital area (MSD)

The active landslide is propagating further as the SSM68 (eroding more than 5m) has been already eroded by these landslides which were very much present during the 2008-2009 Hazard assessment of extended Phuentsholing Township from Kabreytar east to Ahalay-Toribari areas. Slope movement of this landslide is also very complex, as the processes involved appear to be multiple. Numbers of cracks were seen developing on the plinth areas of FQ7, FQ8 & FQ9. Some of the old landslide scars are presently in a dormant state with vegetation cover.

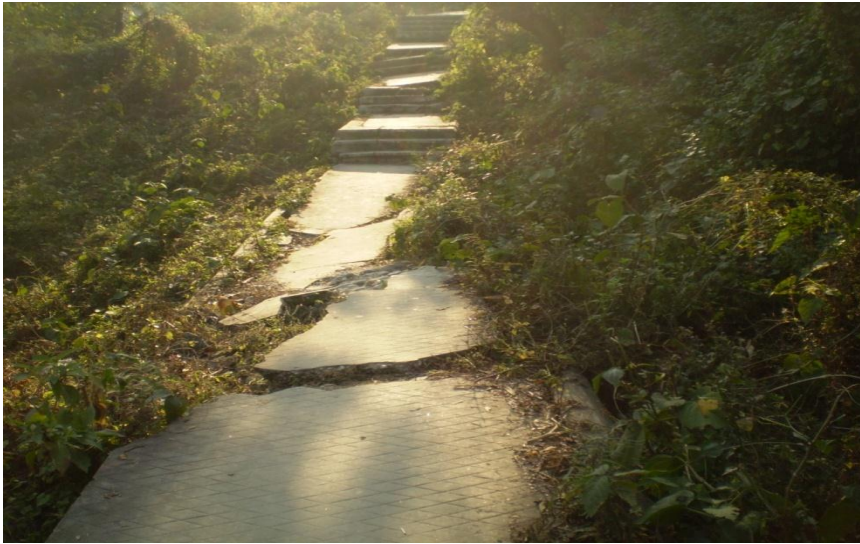
Figure 29: Subsidence of the foot trail leading to old Hospital (MSD) area

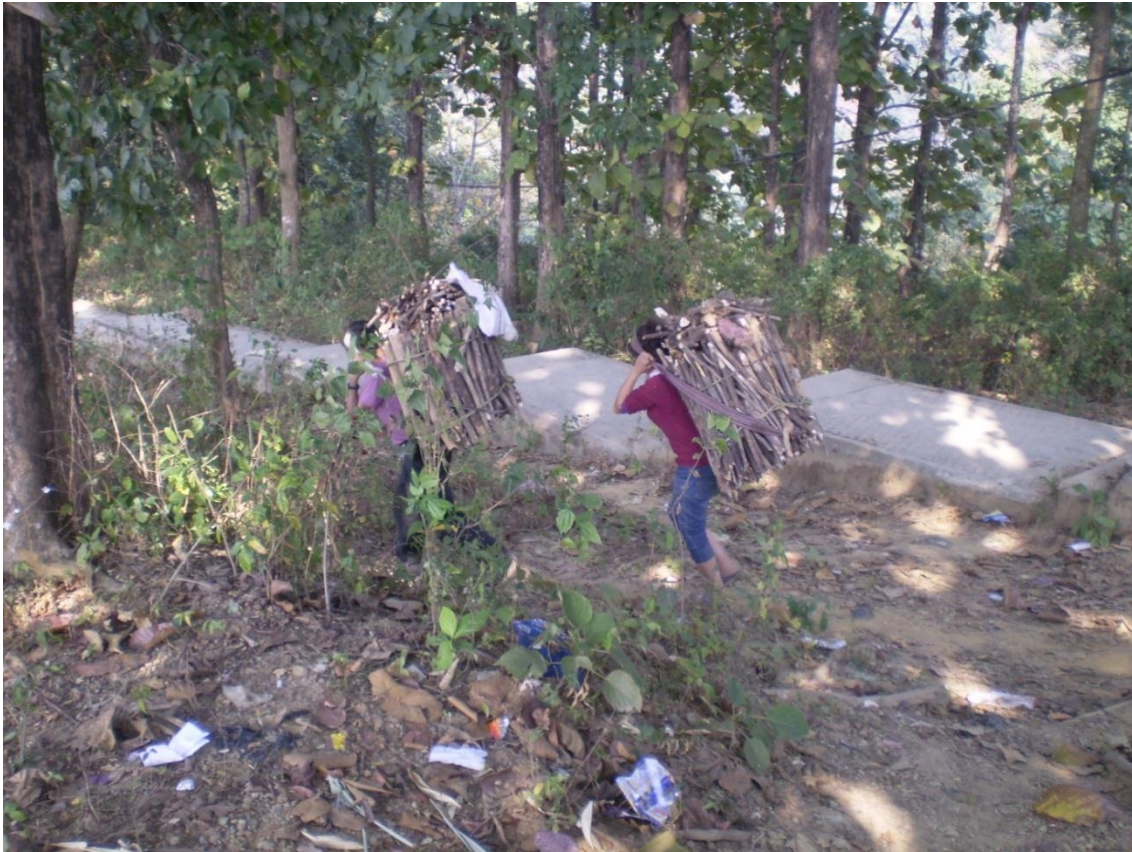
Figure 30: Photograph showing the people from Jaigaon fetching firewood from these landslides areas

Cutting down of the trees for firewood and over grazing also further triggers the slope instability in the landslide prone areas. Landslide areas will be amplified in such places if such activities are not prohibited by the local authorities. Further, dumping the excavated materials downhill/ old landslide areas will also accelerate the mass movement under wet condition.

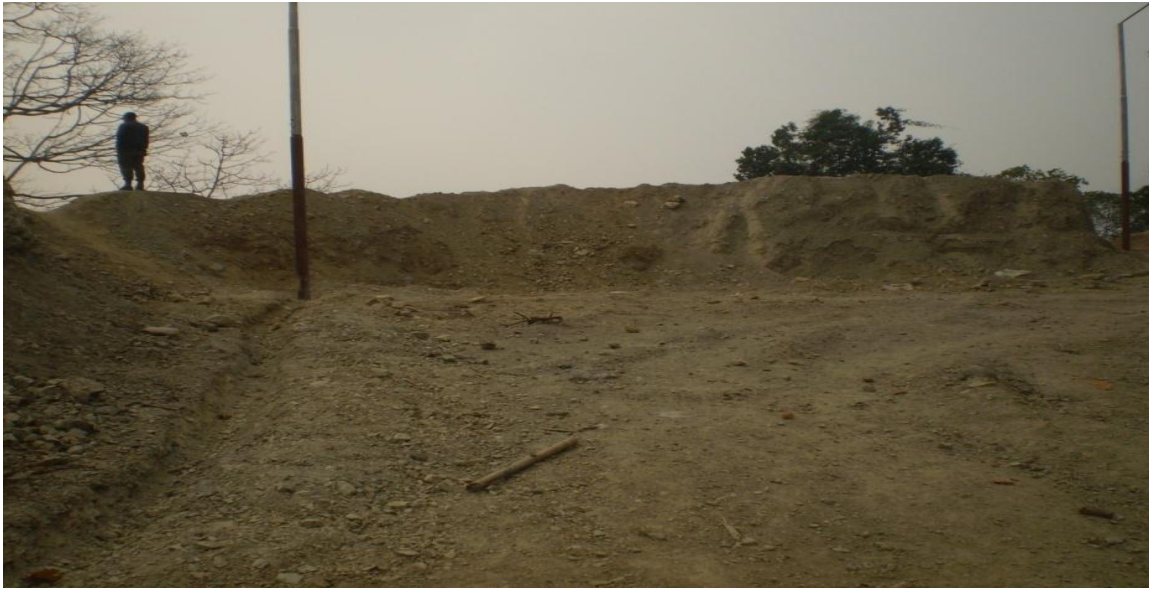
Figure 31: Excavated materials stacked on the edge of the slope near the Old Hospital

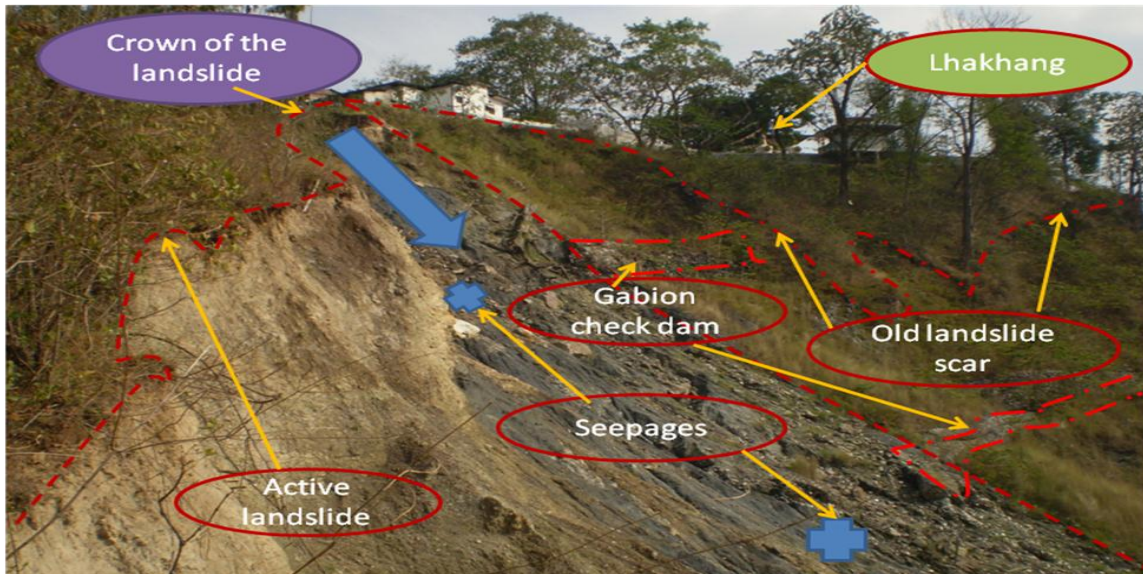
This landslide was encroaching to Rinchening Goenpa in the past which has an area of 16.83 acres. Currently this landslide is propagating towards NNW. This is one of the very active landslides with complex phenomenon. This has a more than 10m slip face at the crown. Numerous remedial measures were done in the past to contain the landslide. However, the landslide appears to be in a dormant state especially in the left flank (Fig. 38) most probably due to counter measures as applied by the Department of Roads and the Phuentsholing Thromde in the past and also further supported by the growth of vegetation. The rock types observed in the area is predominantly carbonaceous phyllite with intercalations of variegated phyllite and thin bands of grayish white quartzite. These rock units are overlain by dark gray colored, fine to medium grained dolomite band. The thickness of dolomite band ranged from 2m to 10m for a strike length of 500m. But this dolomite band gradually pinches towards the north western section of the area. No water seepages were observed near the crown of the landslide, but these rock units appear to hold water reservoir especially during rainy season.

Figure 33: Photograph showing the active landslide during 2009

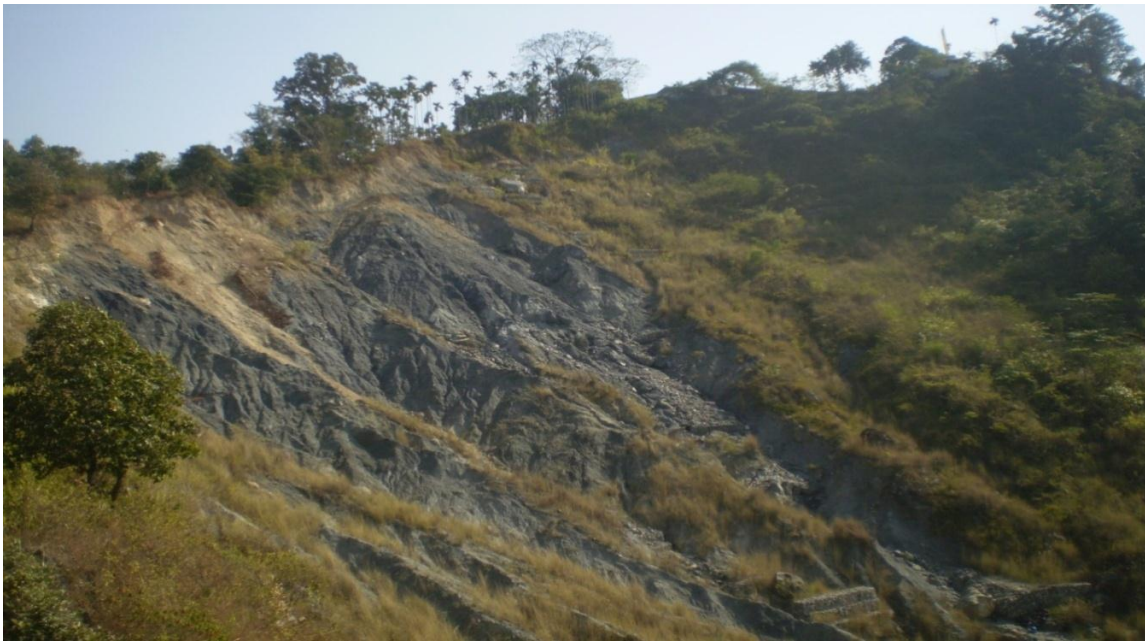
Figure 34: Photograph showing the propagation of landslide during 2012-2013

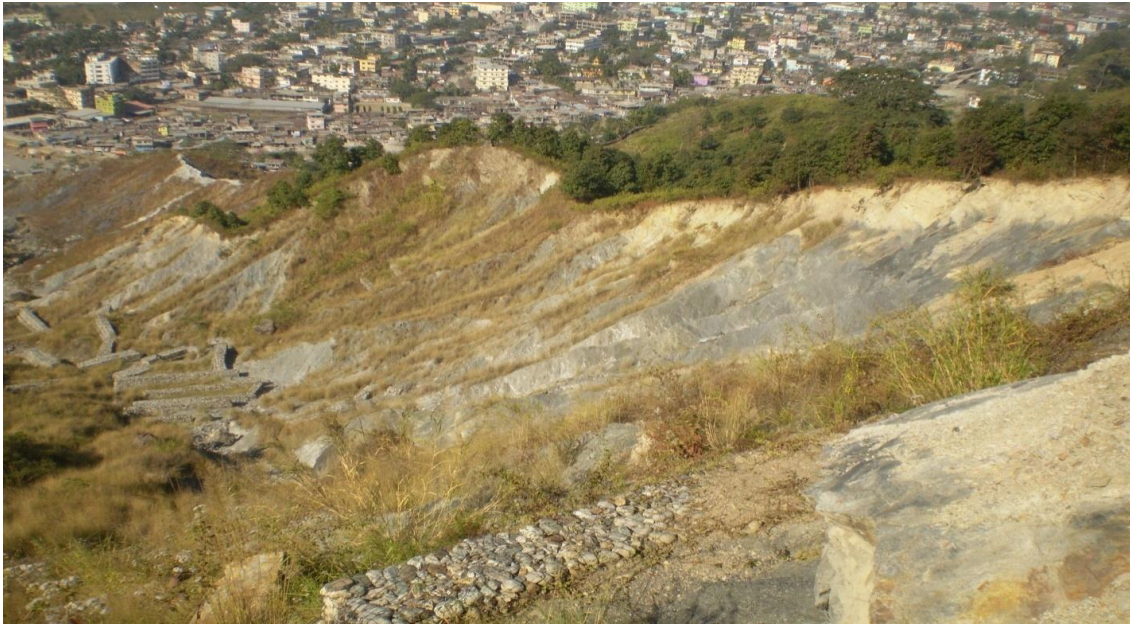
Minor cracks near the edge of the vehicle parking area and cracks on the wall of Rinchending Goenpa area are the first sight indications and identification of the mass movement in the area. This is followed by numerous tension cracks and subsidence of the ground particularly near the edge of the crown of the landslides. Tilted trees were observed and some of them have been already uprooted due to active mass movement.

Figure 35: Photograph showing the different stages of landslide in the NW of Rinchening Goenpa area

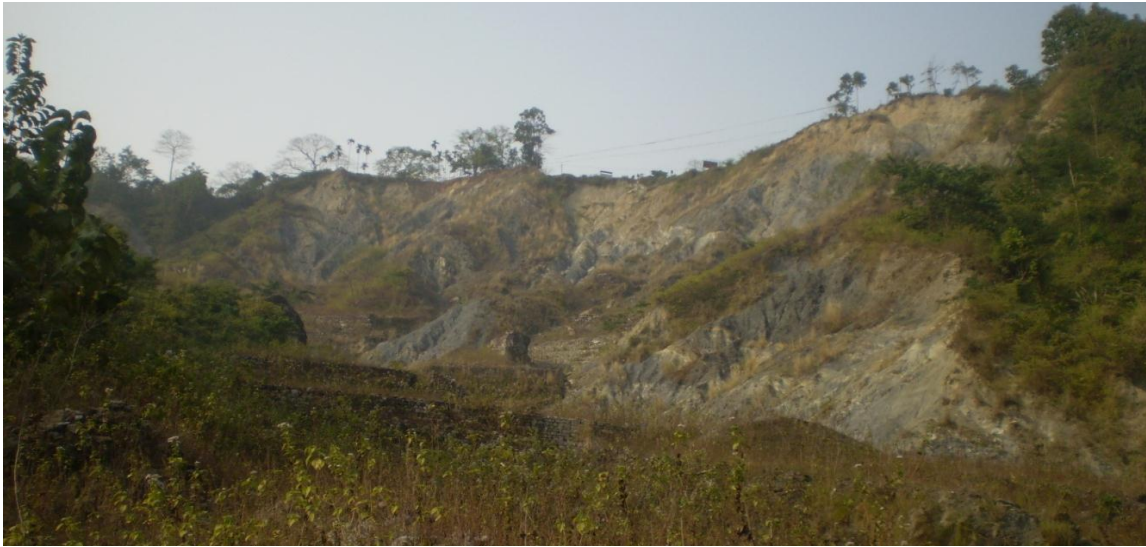
This is the biggest landslides in the area and propagating NW. Few small landslides are found re- activated even in the north east of the Kharbandi Check Post. It has an area of 38.65 acres approximately. This landslide has a high slip face angle ranging from 55° to more than 70°.

Figure 37: Photograph showing the active landslide near the Kharbandi Check Post

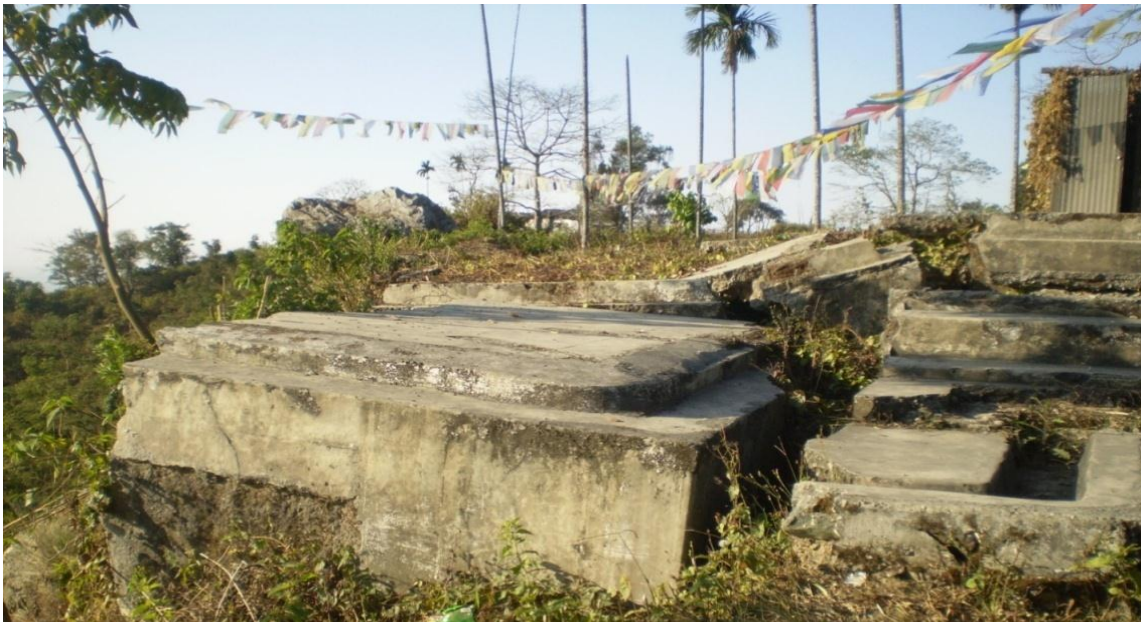
Numerous tension cracks followed by subsidences of the ground are the main indicator of active mass movement. The tension cracks are widely opened and are as deep as 1.5m to 2m deep. The retaining walls are found to bulged and other structures are seen tilted. Even the trees around these areas are found to tilt to some angle.

Figure 38: Picture showing the ruined office of the Revenue and Custom due to landslide

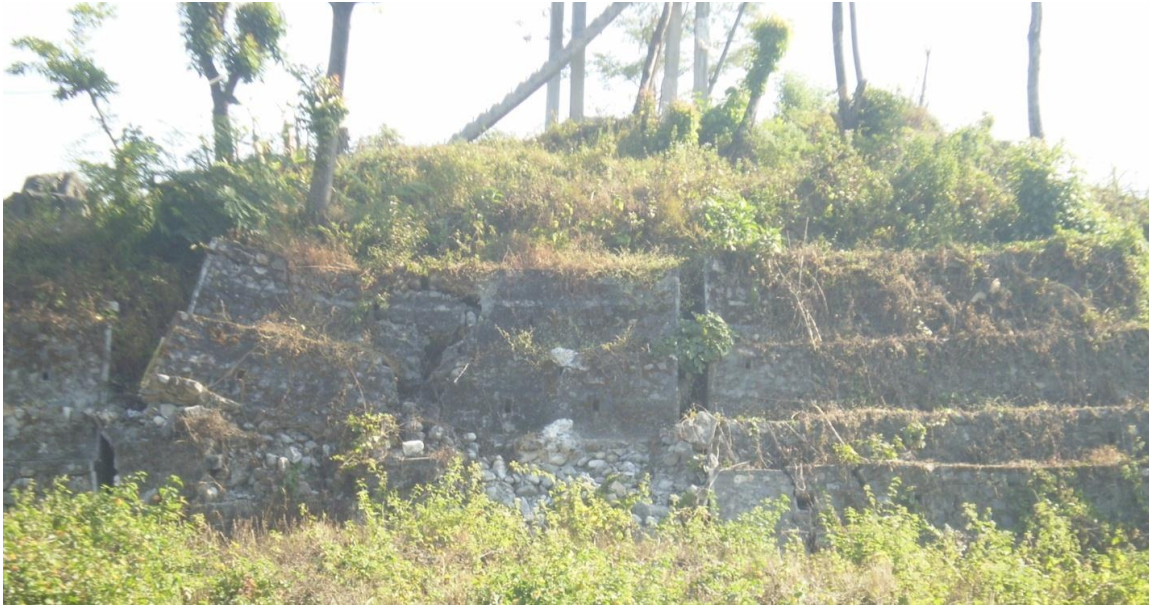
Figure 39: Picture showing the bulged retaining wall with wide open tension cracks

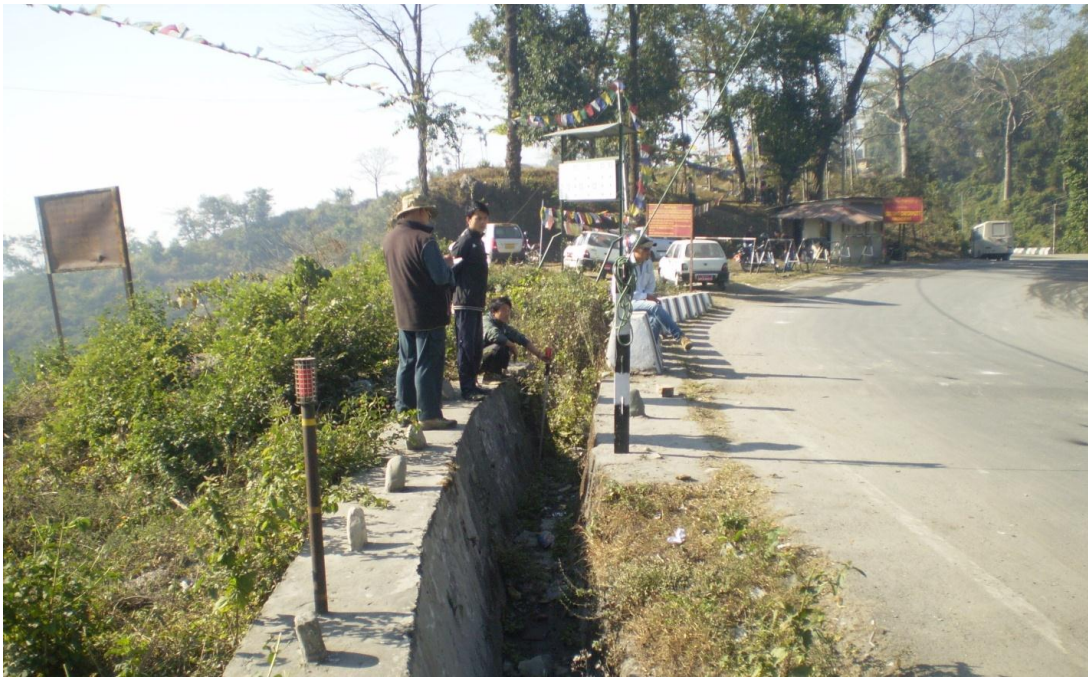
Due to very poor management of the drainage system in the area, mass movement is actively taking place. The collected water from the road side drain enters directly onto the crown of the landslide (Fig. 45) Cutting down of the trees in the unstable slope is also found to be another factor for slope instability.

Figure 40: The rain water drains into the landslide crown

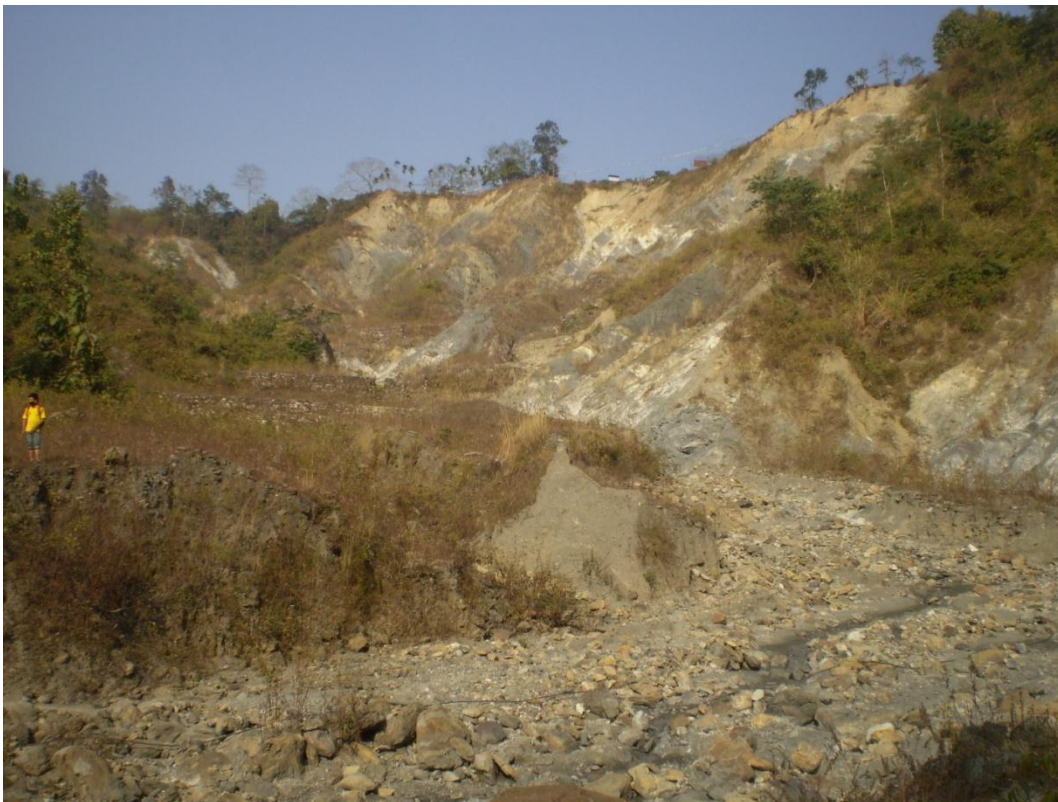
The fact that the soil is very loose, fraible and porous in nature allows rain water to penetrate the soil, which decreases the shear strength of the soil or crumpled rocks. Such process in due course of time leads to incision of the either banks and bed of the gullies or stream.

Figure 41: Picture showing the incision of the river/stream bed by storm water

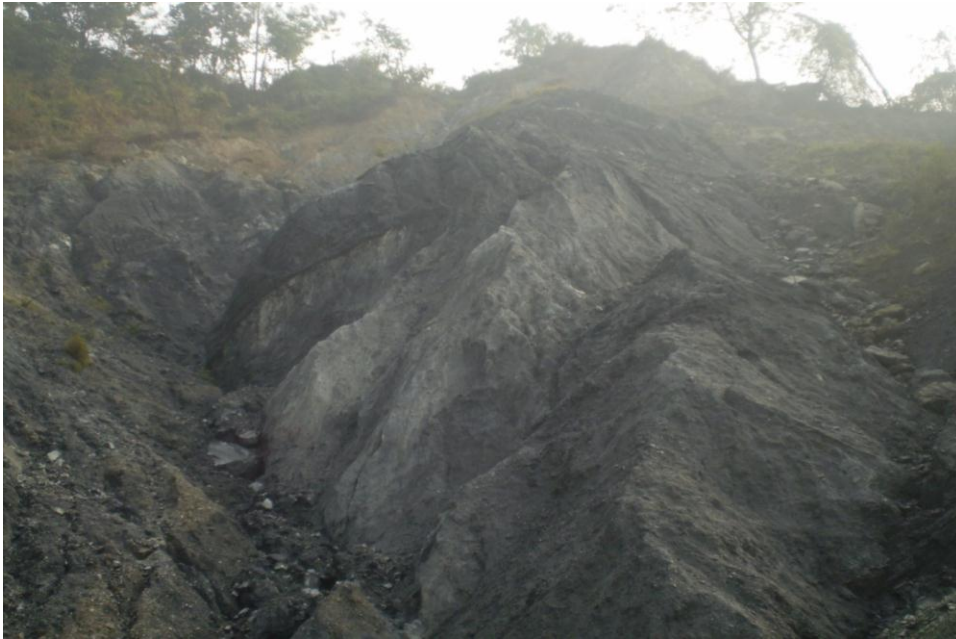
Unlike the other landslides, this landslide is propagating towards North easterly direction threatening the infrastructure of the Reldri Higher Secondary School. It has an area of 11.78 acres approximately. Although the slip plane appears to be shallow but the mass movement is active in the process.

Figure 43: Photograph showing the active landslide to the west of Reldri Higher Secondary School
