Structural interventions

UNDP Partnership for the Future		TECHNICAL COMMITTEE OF CULTURAL HERITAGE	DIMITRIOS M. MYLIANTHAKIS ARCHITECT LILIA N. DIMOPOULOU ARCHITECT	NIKOS KALITAKIS CIVIL ENGINEER SECOND REGISTRATION CIVIL ENGINEER EMMA ENPA, CIVIL ENGINEER	CHRISTOS MAURIS, QUANTITY SURVEYOR DORA NICKOLAKI, ARCHAEOLOGIST	PROJECT KARPASSIA LOTIS-AYIOS PHELOS CHURCH & BASILICA PROJECT NAME SURVEY DRAWINGS DRAWING TITLE SECTION B-B	DATE REV. MAR-2016 JAN. 2016 DRAWN BY Paraskevi Spanakidou SCALE 1:50	PROJECT CODE C20115 (AP1) DESIGNED BY E 06
--	--	--	---	--	---	--	---	--	---

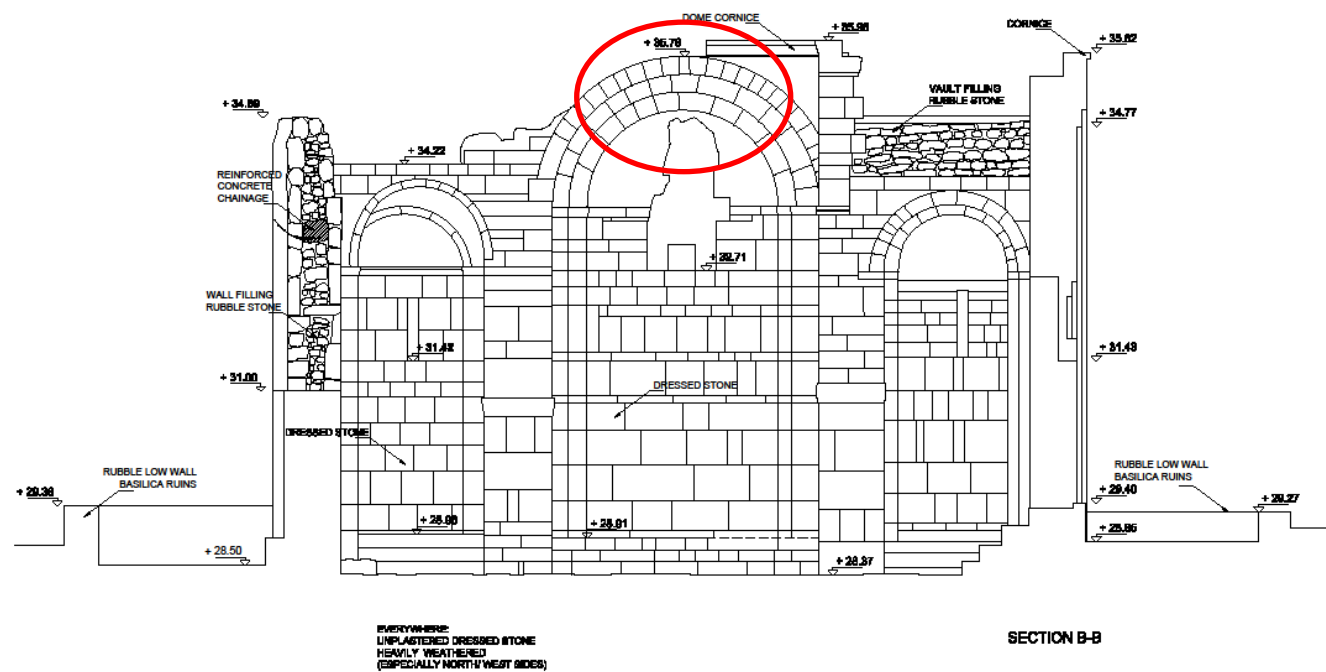
East Arch

- Repair and consolidate the east and south arch of the church which initially were supporting the dome, now lost.

- Consolidate by filling the voids between the stones with lime mortar to create structural unity.

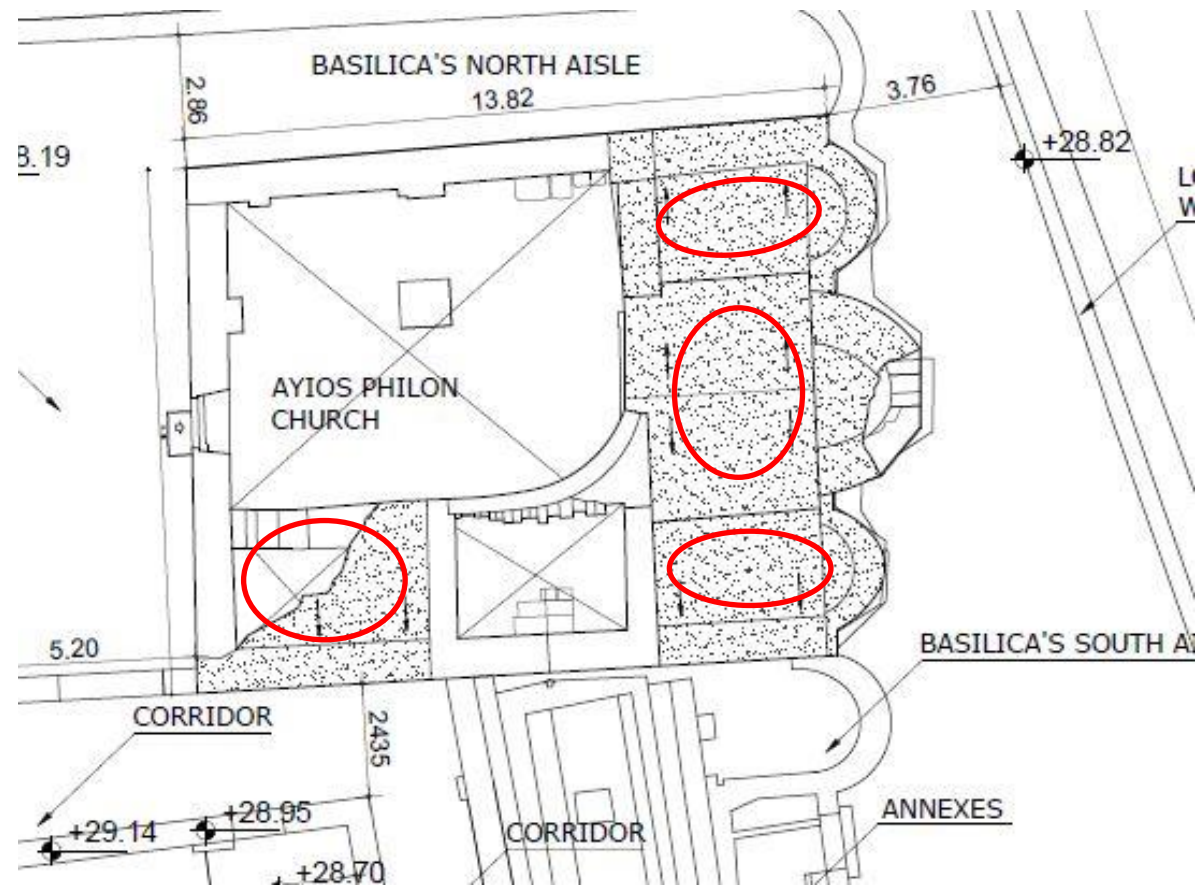
Eastern Vaults (north/central/south) + Southwestern Vault

- Repair and consolidate the deteriorated areas of the vaults as shown on the drawing.

- Re-point the areas shown and use lime mortar and same size rubble stones where missing.

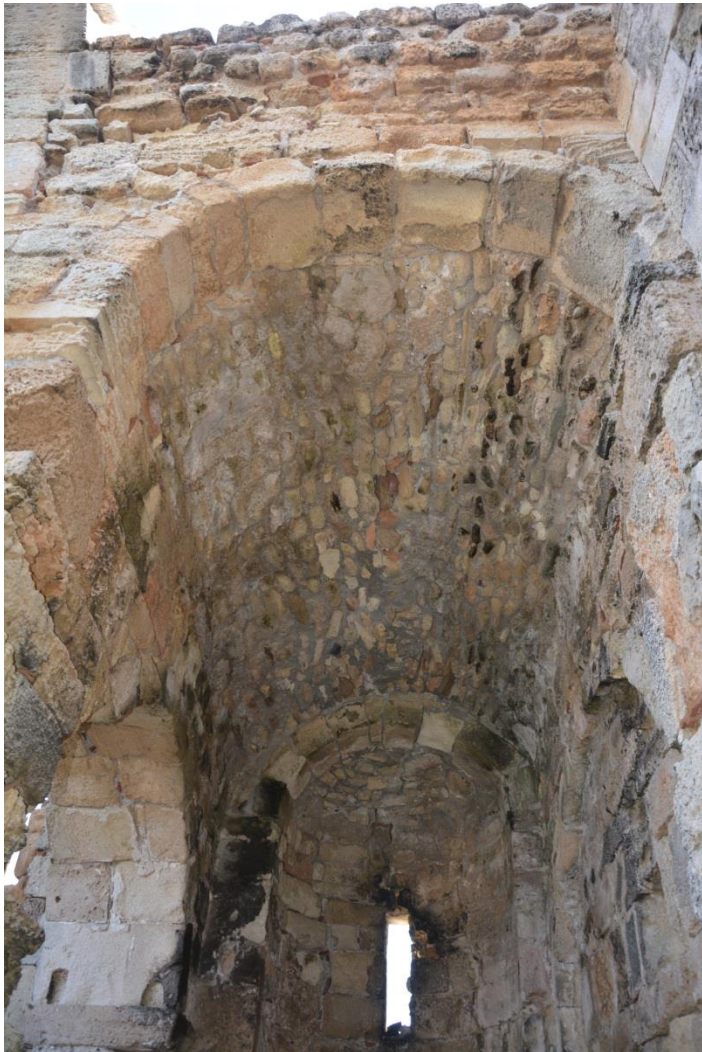
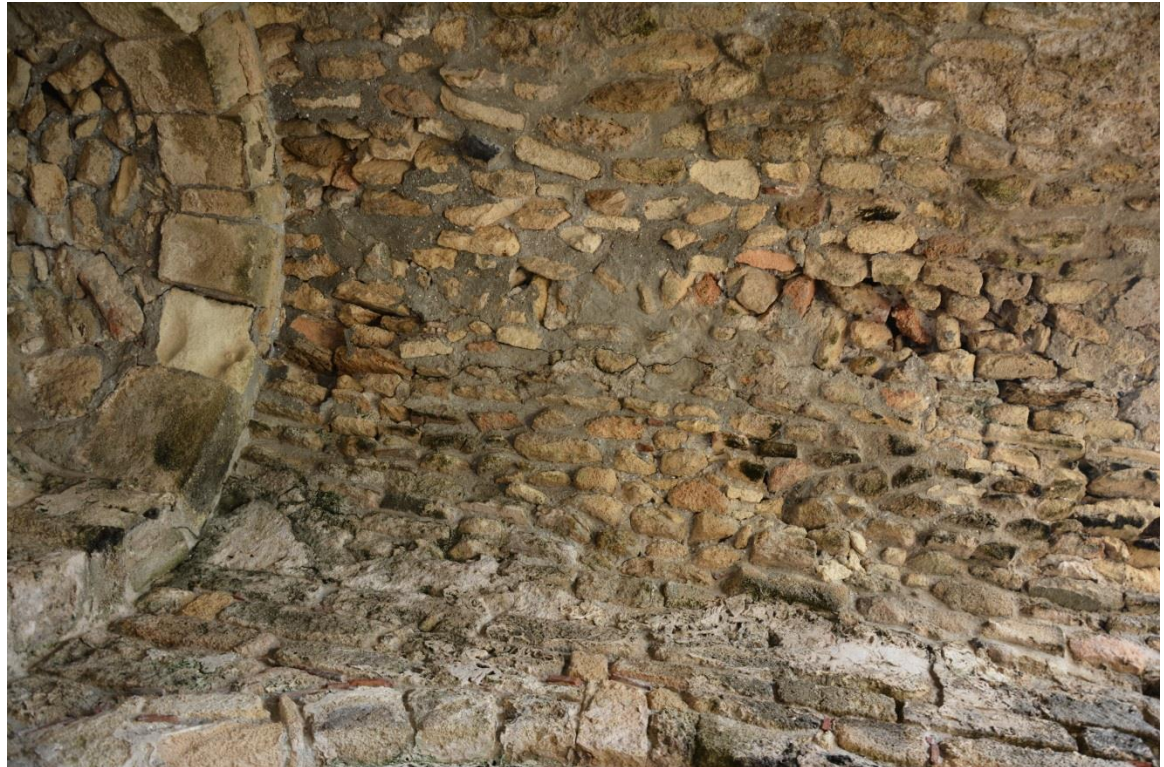
South vault. Re-pointing.

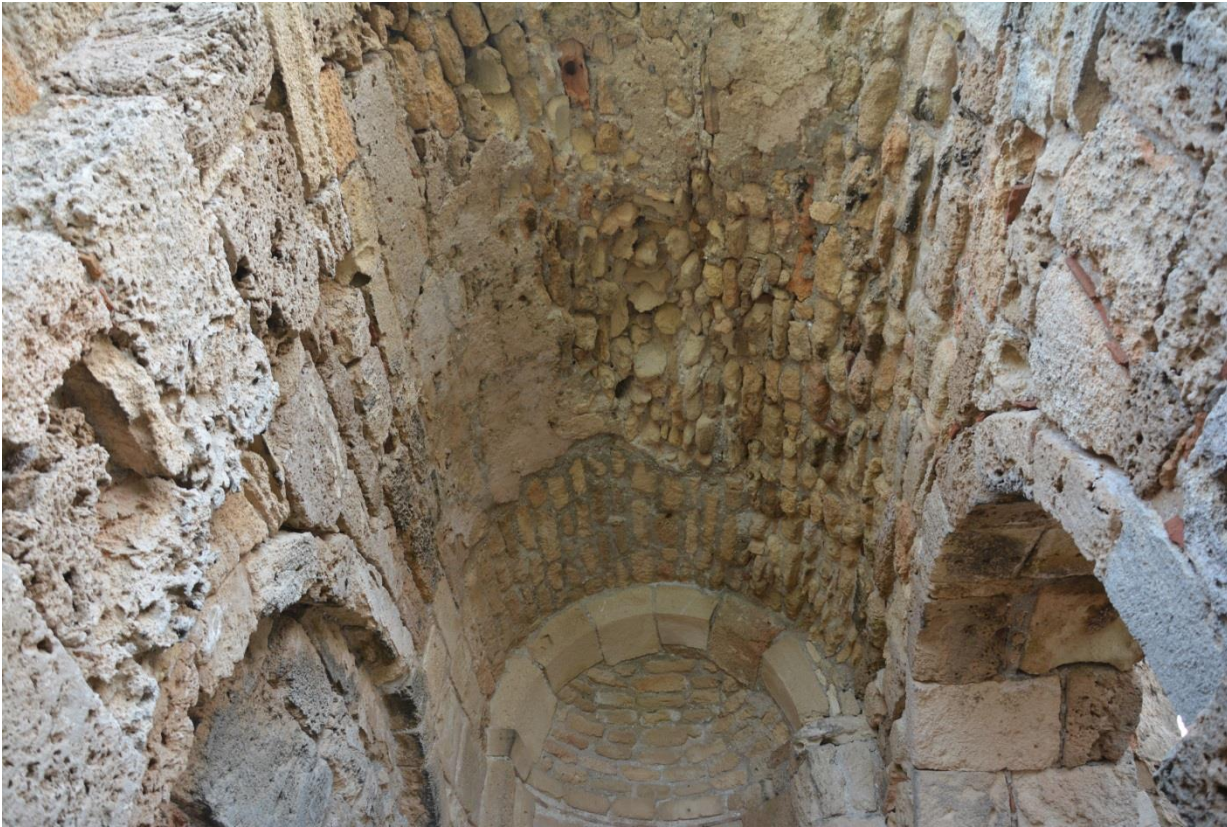
North vault. Re-pointing.

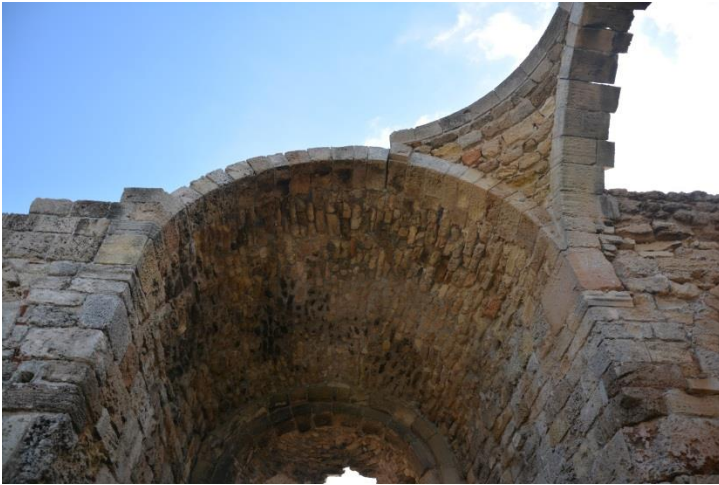
Central Vault. Re-pointing.

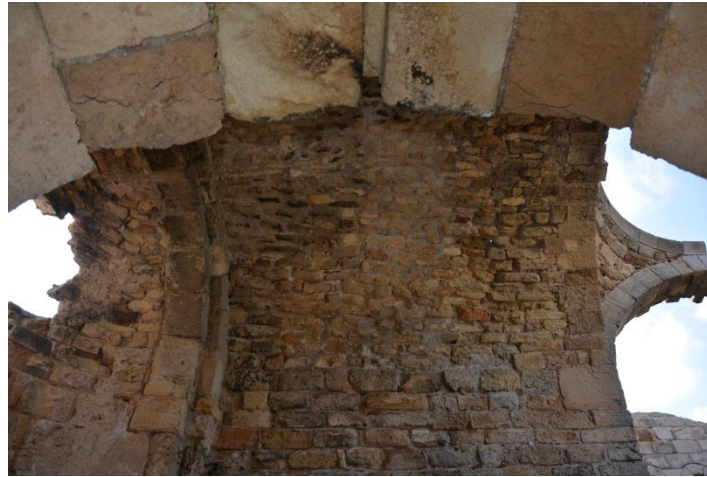
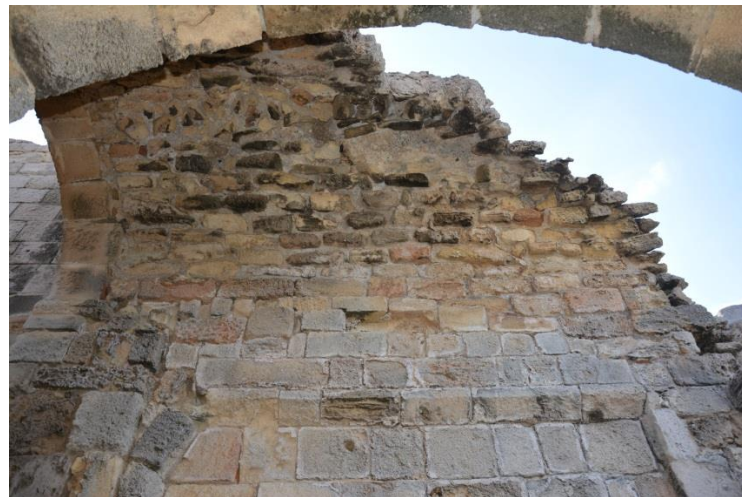
Southwest vault. Re-pointing.
