PANAGIA CHURCH - PHOTOGRAPHS

PROJECT: DESIGNS FOR CONSERVATION INTERVENTION OF THREE SITES LOCATED IN THE NORTHERN PART OF CYPRUS ( RFQ-032/2017)

MONUMENT: PANAGIA CHURCH IN ASKEIA/ PAŞAKÖY

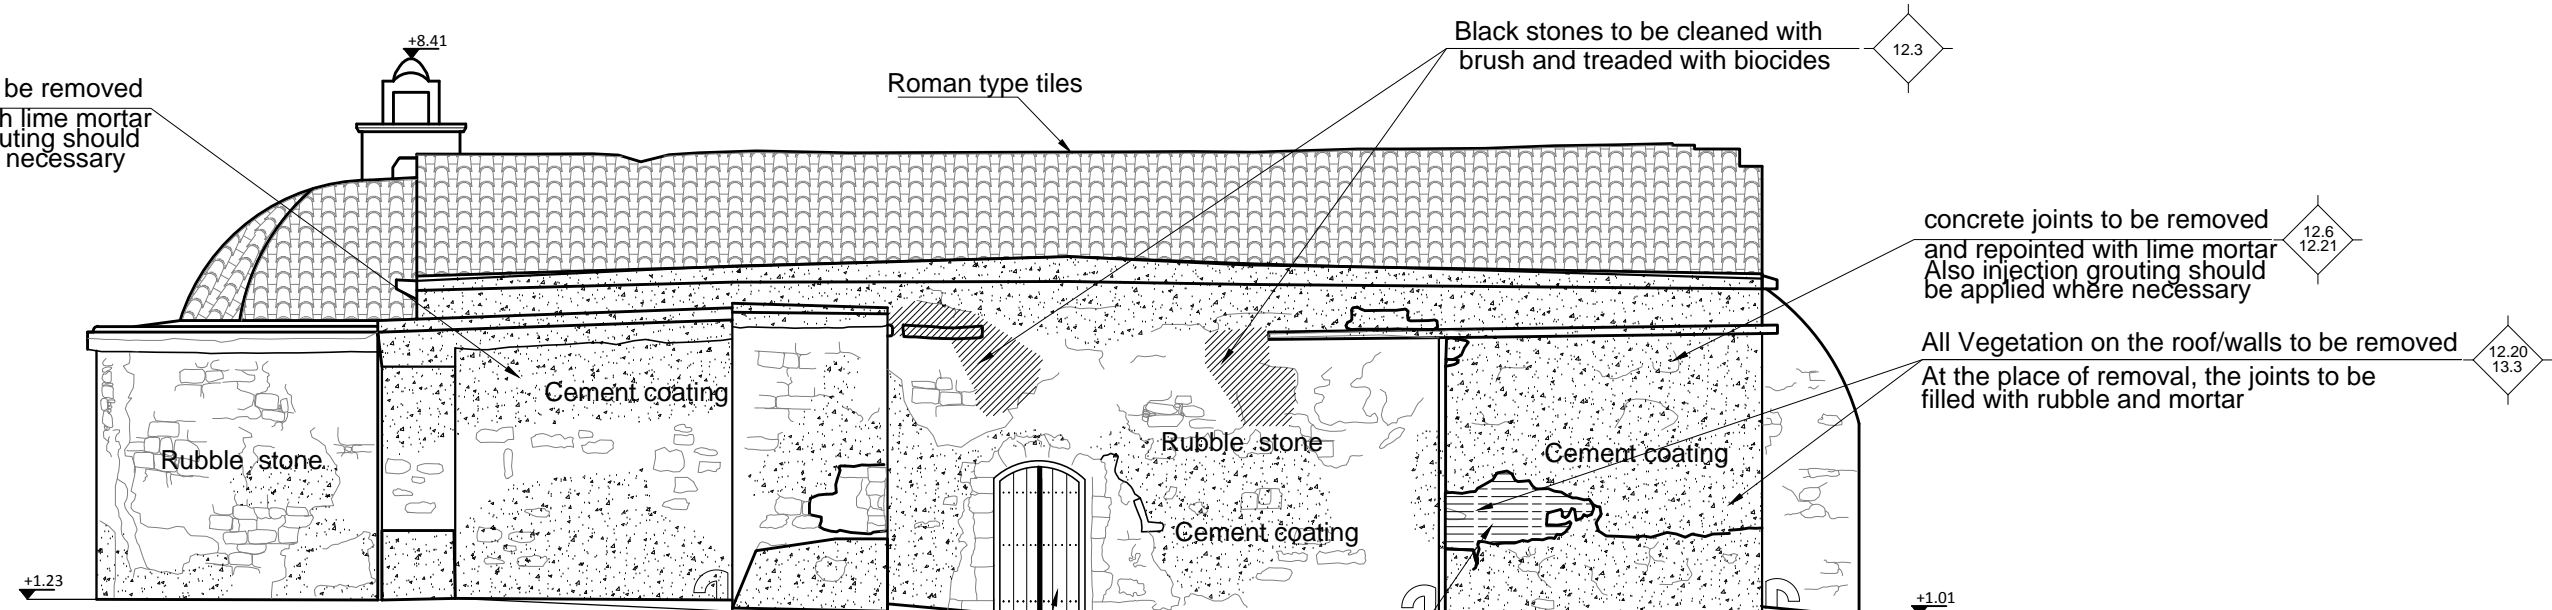
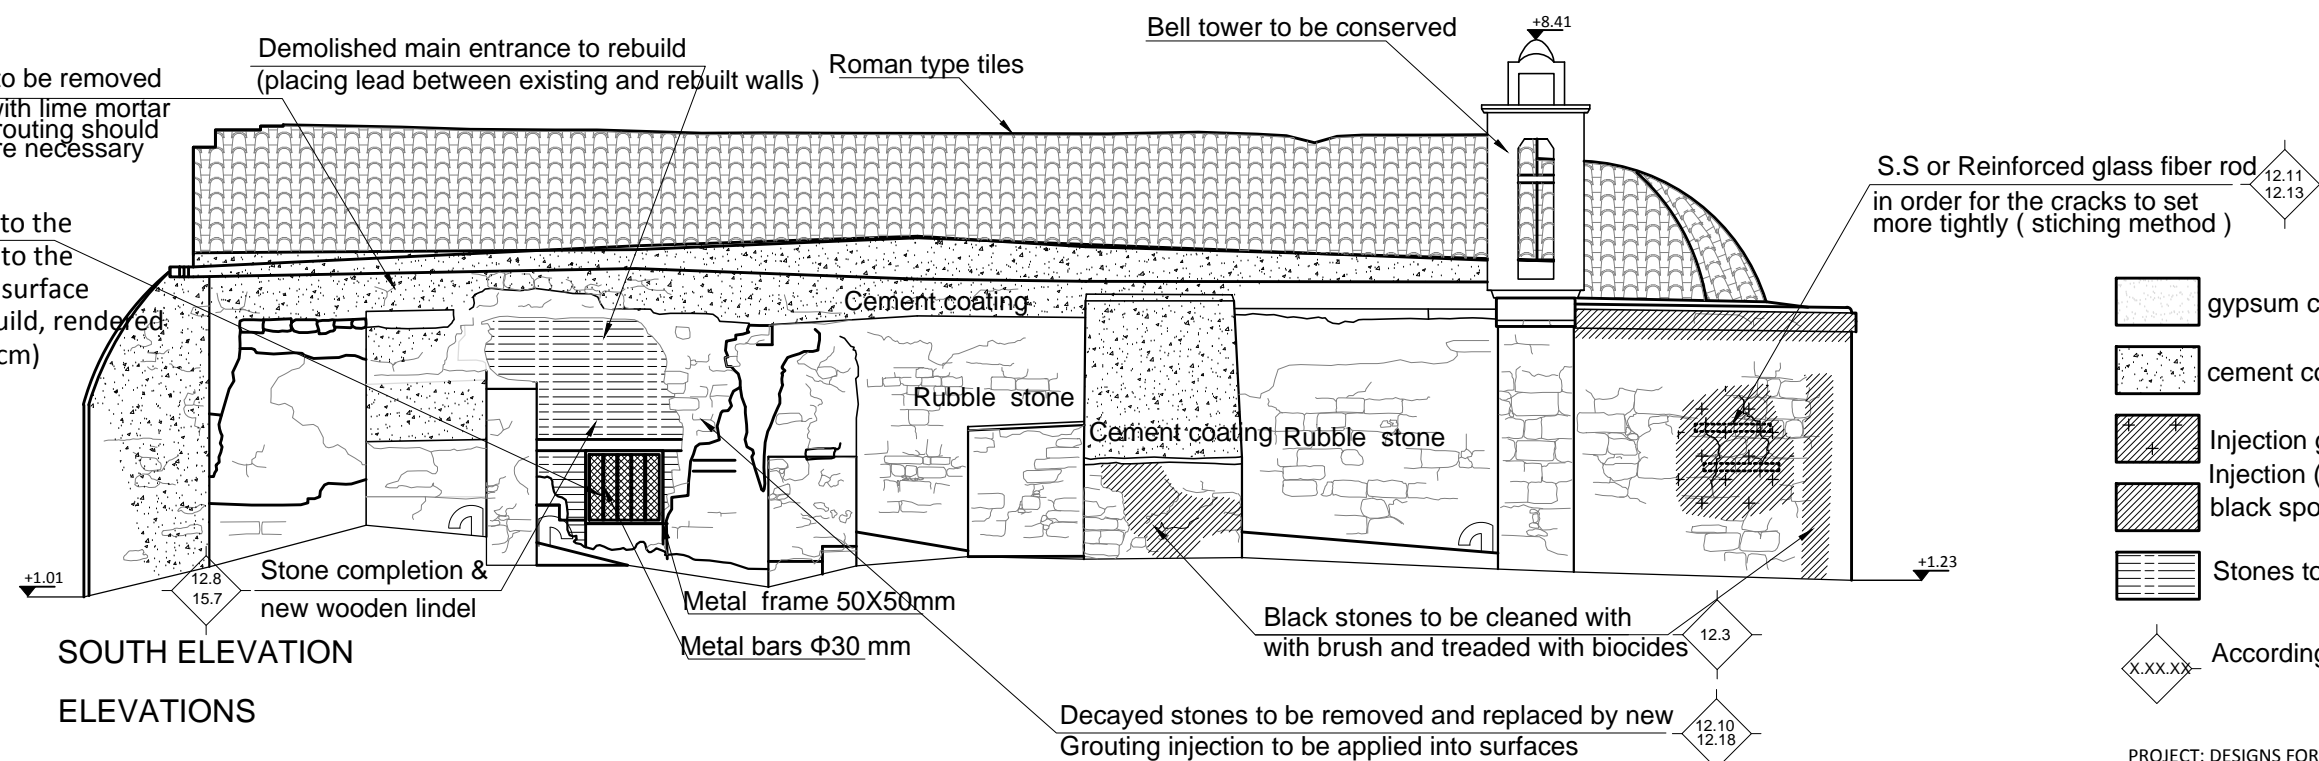
SOUTH ELEVATION  
ELEVATIONS

- At the points where deep and severe cracks are formed, as in the south and east wall, the stones should be carefully dismantled on either side of the cracks. Subsequently, the masonry should be rebuilt with stones similar to the original ones in both size and texture using of " stitching". It is suggested that additional s.s beams are positioned in.
- Thereafter, rubble filling and mortar pointing, to be implemented on the masonry.
- and then lime plaster coatings, to its interior face.
- Other smaller cracks to be filled up with solid rubblework and be properly pointed up, so that the stones which are displaced, and the rest of the masonry are well - bound together.

- The filling stones which either detached, wheathered, decayed or at risk of collapsing, as well as any eroded and cracked mortarjoints should be repointed, removed or replaced, for instance when the mortar joints go deeper than 3 cm from the surface of the stone, then the stone pointing must be renewed with mortar, after having first removed the original pointing.
- Most of the joints of the walls to be pointed.
- Injection grouting to be applied where indicate on drawings
- Apply stone consolidant KimistoneKSF to all exposed stones

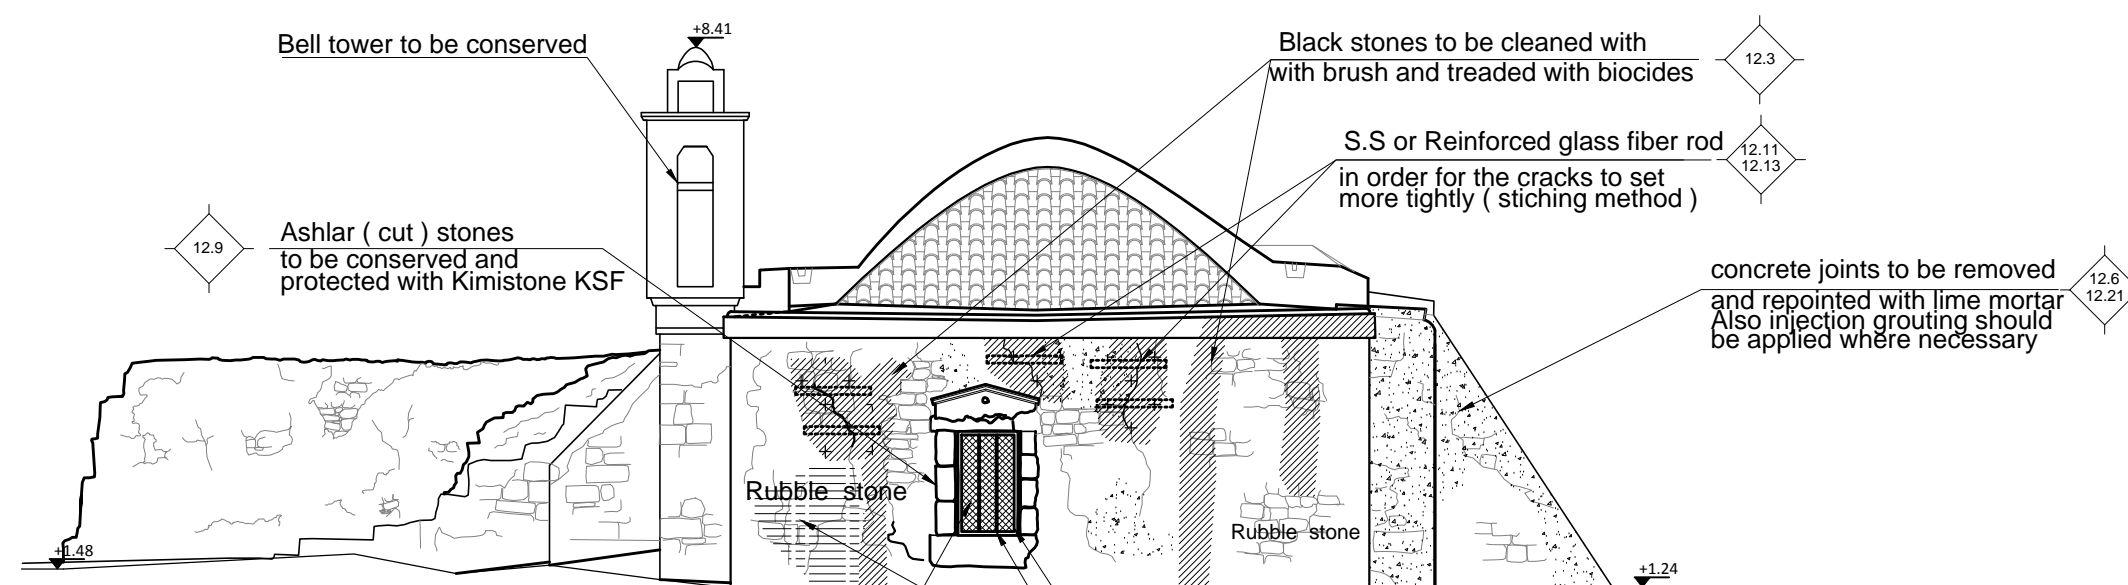
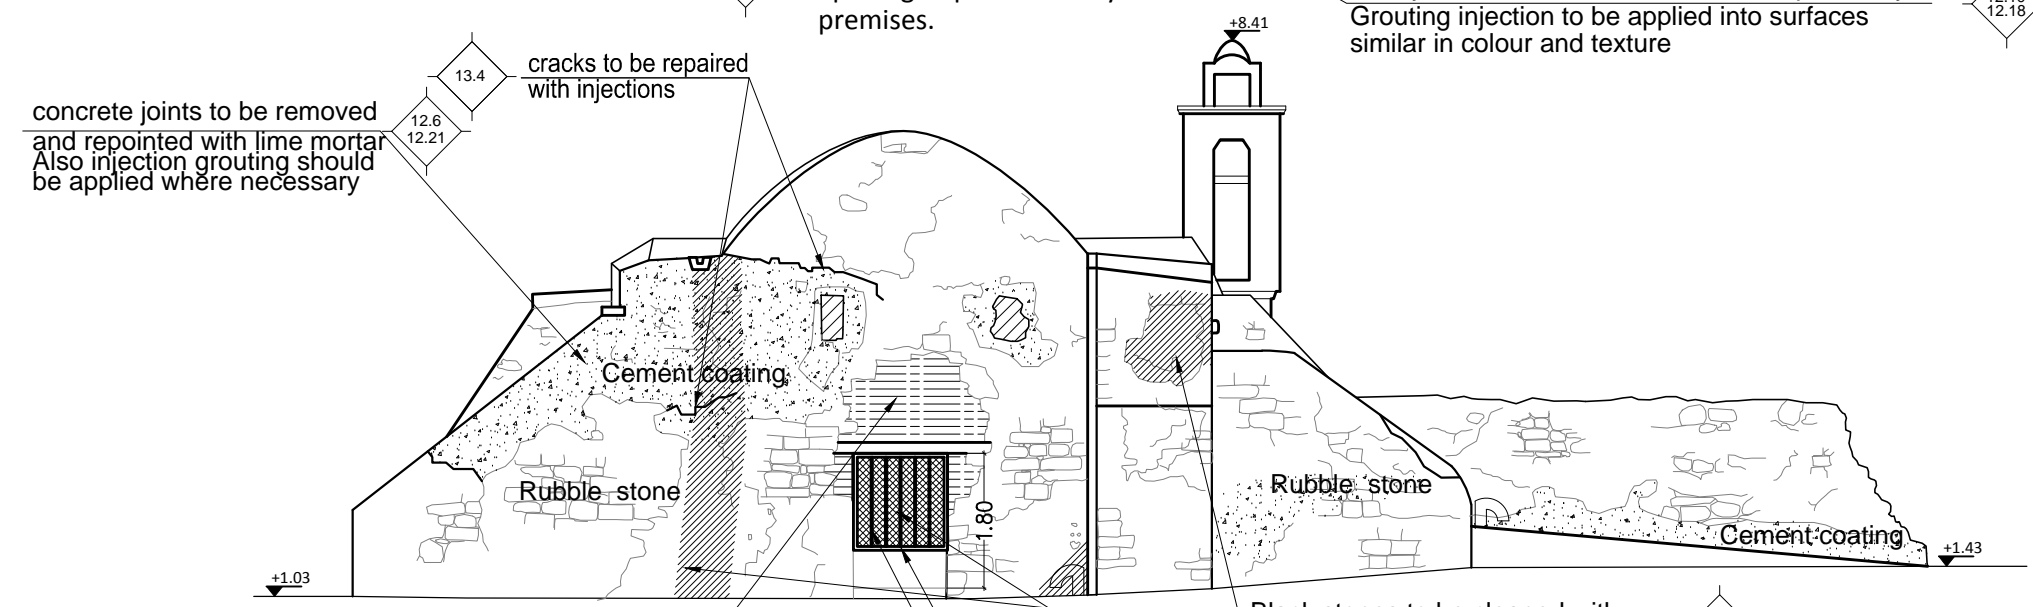
WEST ELEVATION  
ELEVATIONS

- At the points where deep and severe cracks are formed, as in the south and east wall, the stones should be carefully dismantled on either side of the cracks. Subsequently, the masonry should be rebuilt with stones similar to the original ones in both size and texture using of " stitching ". It is suggested that additional s.s beams are positioned in.
- Thereafter, rubble filling and mortar pointing, to be implemented on the masonry.
- and then lime plaster coatings, to its interior face.
- Other smaller cracks to be filled up with solid rubblework and be properly pointed up, so that the stones which are displaced, and the rest of the masonry are well - bound together.

- The filling stones which either detached, wheathered, decayed or at risk of collapsing, as well as any eroded and cracked mortarjoints should be repointed, removed or replaced, for instance when the mortar joints go deeper than 3 cm from the surface of the stone, then the stone pointing must be renewed with mortar, after having first removed the original pointing.
- Most of the joints of the walls to be pointed.
- Injection grouting to be applied where indicate on drawings
- Apply stone consolidant KimistoneKSF to all exposed stones

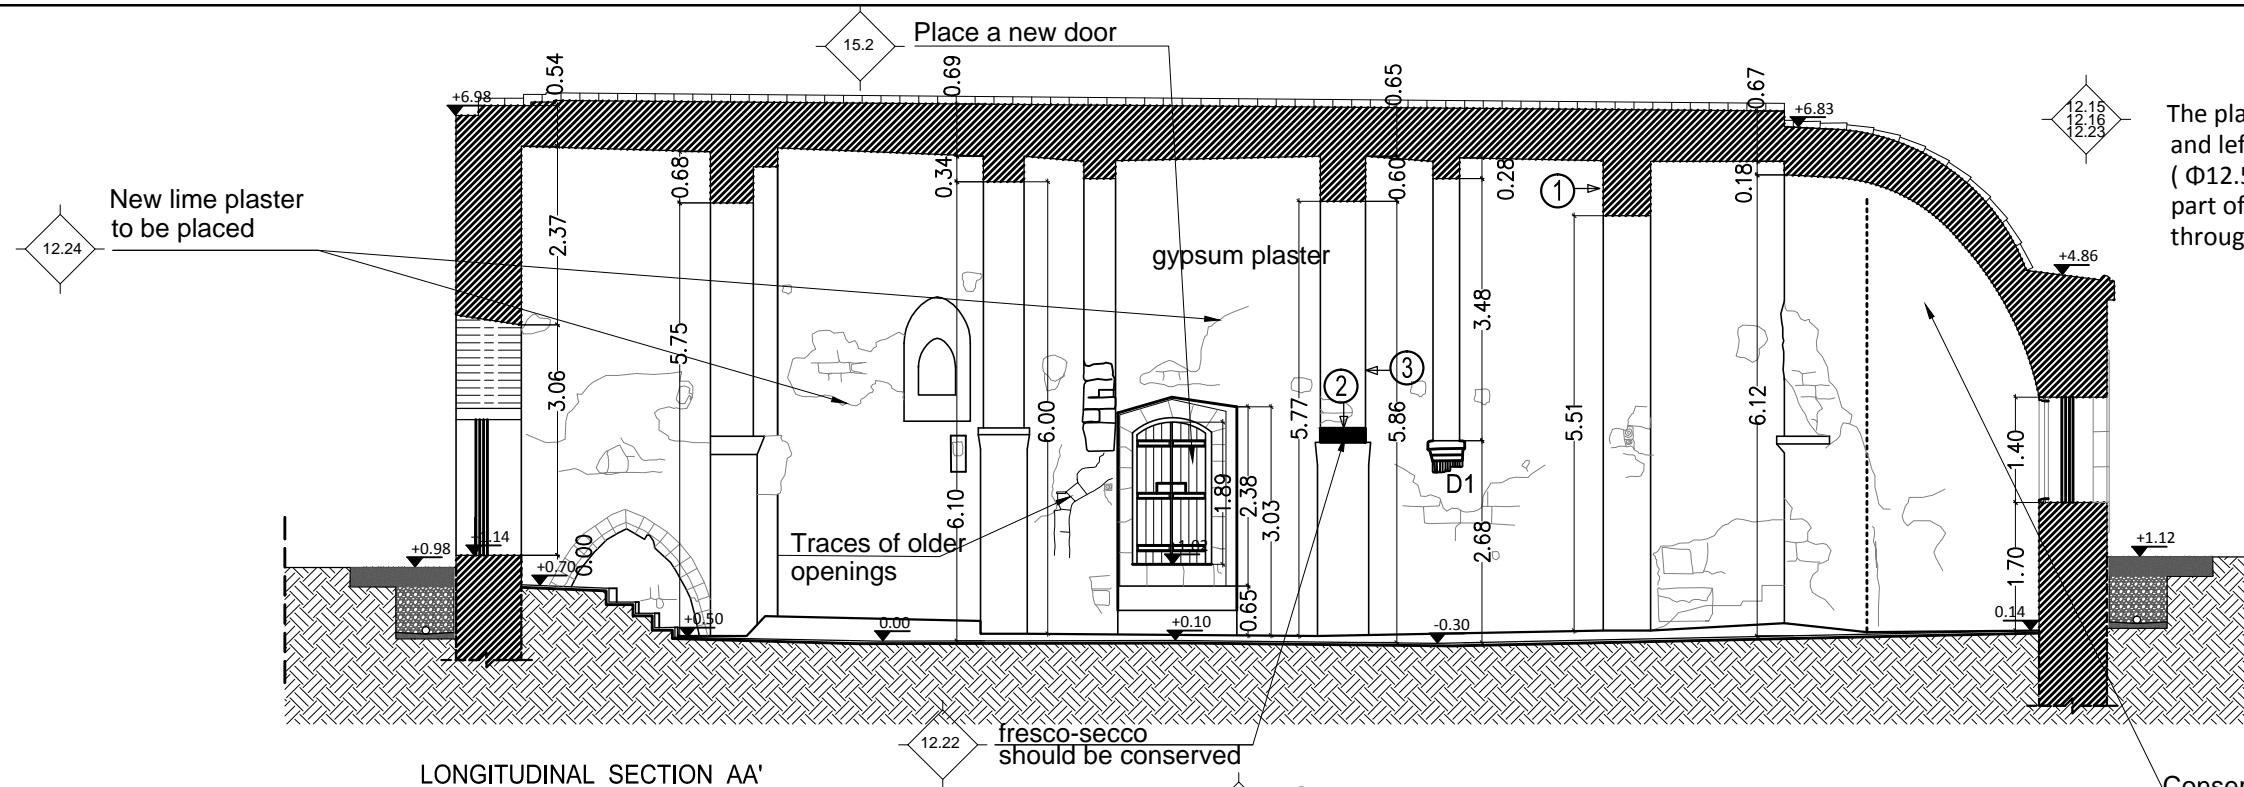
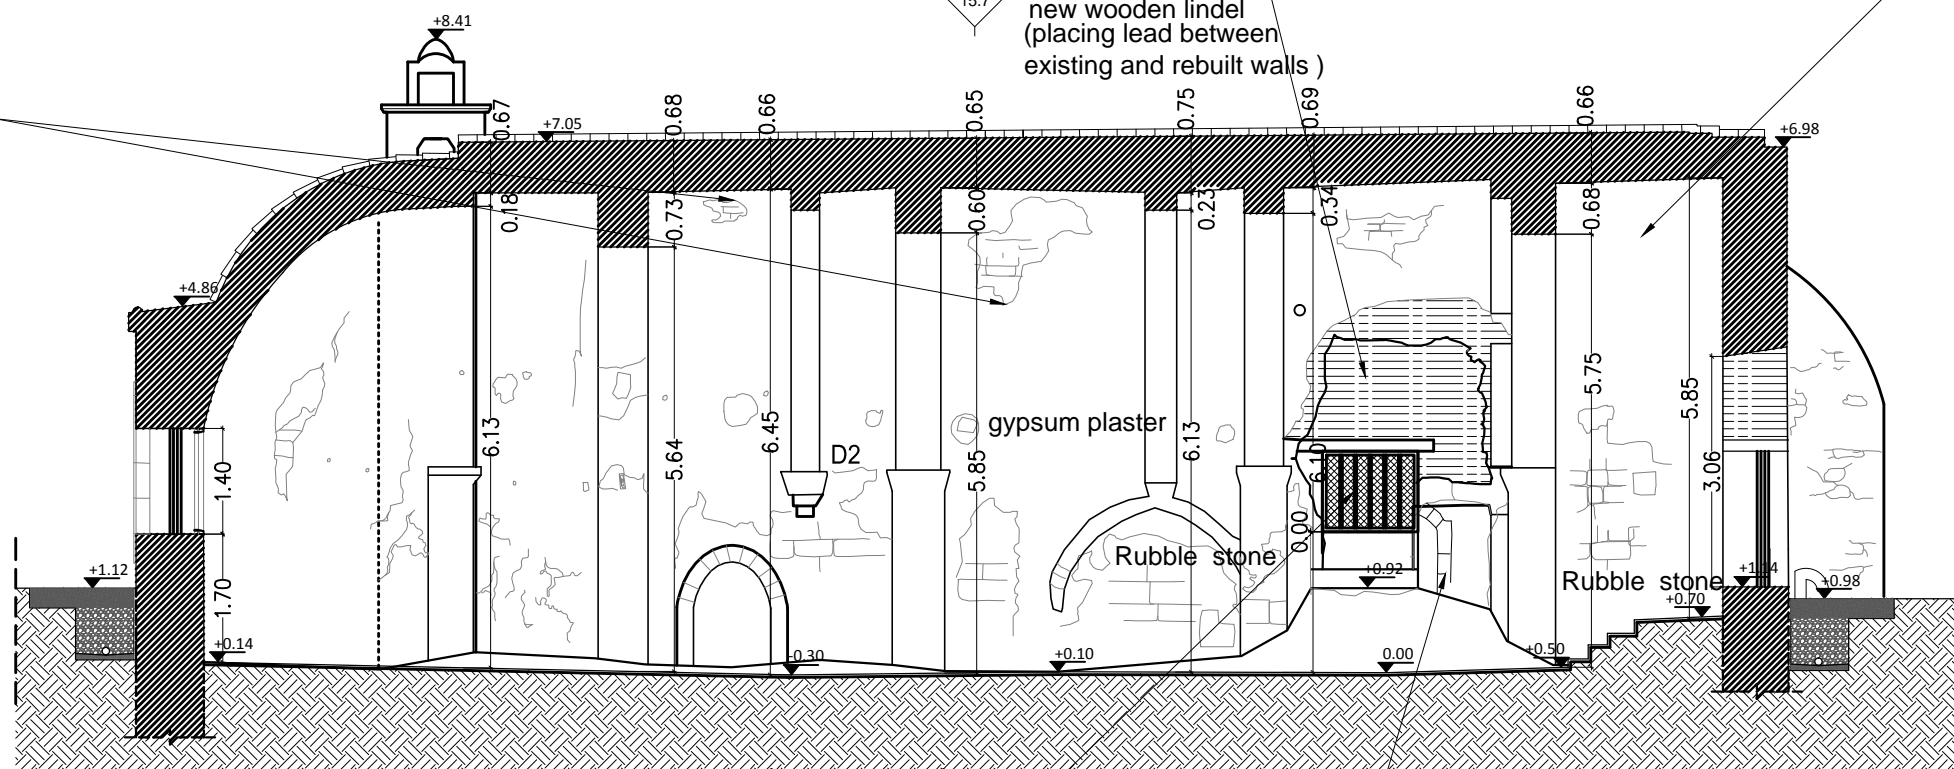
LONGITUDINAL SECTION BB'  
LONGITUDIINAL SECTIONS

- At the points where deep and severe cracks are formed, as in the south and east wall, the stones should be carefully dismantled on either side of the cracks. Subsequently, the masonry should be rebuilt with stones similar to the original ones in both size and texture using of " stitching". It is suggested that additional s.s beams are positioned in.
- Thereafter, rubble filling and mortar pointing, to be implemented on the masonry.
- and then lime plaster coatings, to its interior face.
- Other smaller cracks to be filled up with solid rubblework and be properly pointed up, so that the stones which are displaced, and the rest of the masonry are well - bound together.

- The filling stones which either detached, wheathered, decayed or at risk of collapsing, as well as any eroded and cracked mortarjoints should be repointed, removed or replaced, for instance when the mortar joints go deeper than 3 cm from the surface of the stone, then the stone pointing must be renewed with mortar, after having first removed the original pointing.
- Most of the joints of the walls to be pointed.
- Injection grouting to be applied where indicate on drawings
- Apply stone consolidant KimistoneKSF to all exposed stones

The plaster at the bottom part of the Church should be removed and left to dry out all the remaining moisture Small holes ( Ø12.5mm ) & plastic pipe should be opened along the bottom part of the masonry walls to allow the moisture to dry out faster through them

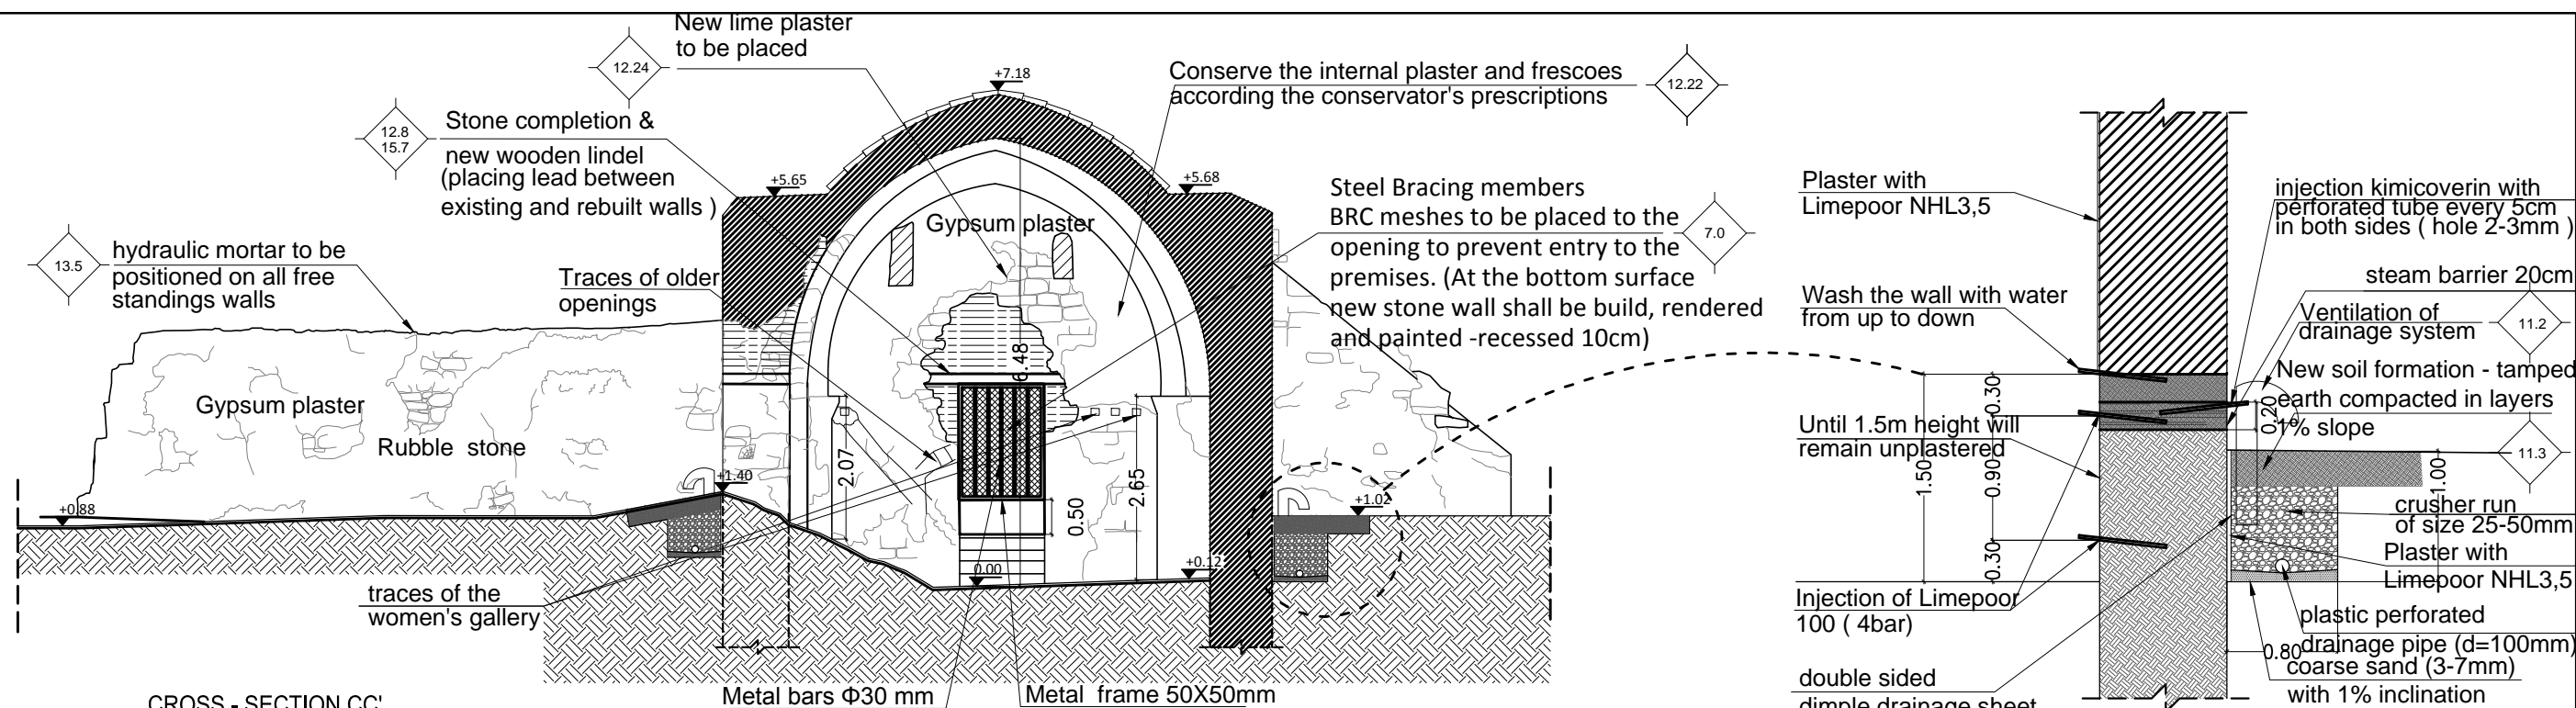
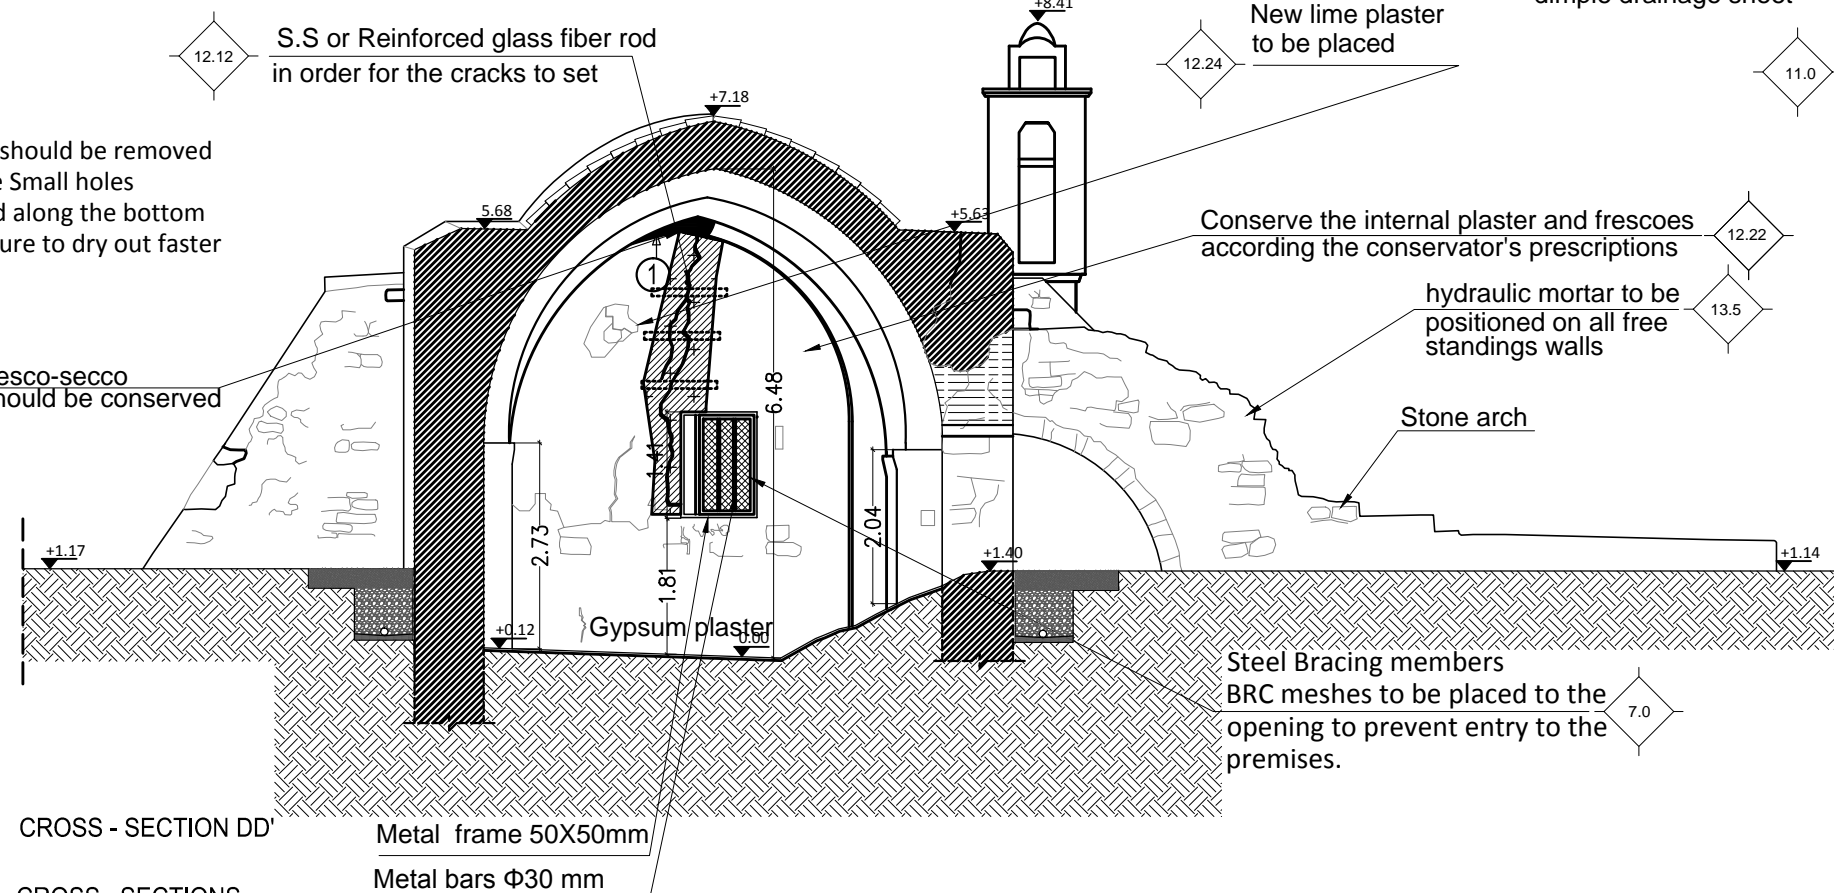
CROSS SECTIONS

- At the points where deep and severe cracks are formed, as in the south and east wall, the stones should be carefully dismantled on either side of the cracks. Subsequently, the masonry should be rebuilt with stones similar to the original ones in both size and texture using of " stitching". It is suggested that additional s.s beams are positioned in.
- Thereafter, rubble filling and mortar pointing, to be implemented on the masonry.
- and then lime plaster coatings, to its interior face.
- Other smaller cracks to be filled up with solid rubblework and be properly pointed up, so that the stones which are displaced, and the rest of the masonry are well - bound together.

- The filling stones which either detached, wheathered, decayed or at risk of collapsing, as well as any eroded and cracked mortarjoints should be repointed, removed or replaced, for instance when the mortar joints go deeper than 3 cm from the surface of the stone, then the stone pointing must be renewed with mortar, after having first removed the original pointing.
- Most of the joints of the walls to be pointed.
- Injection grouting to be applied where indicate on drawings
- Apply stone consolidant KimistoneKSF to all exposed stones
