DESCRIPTION OF THE WORKS

4.4 Repairs on exterior masonry (cut and fill and pointing)

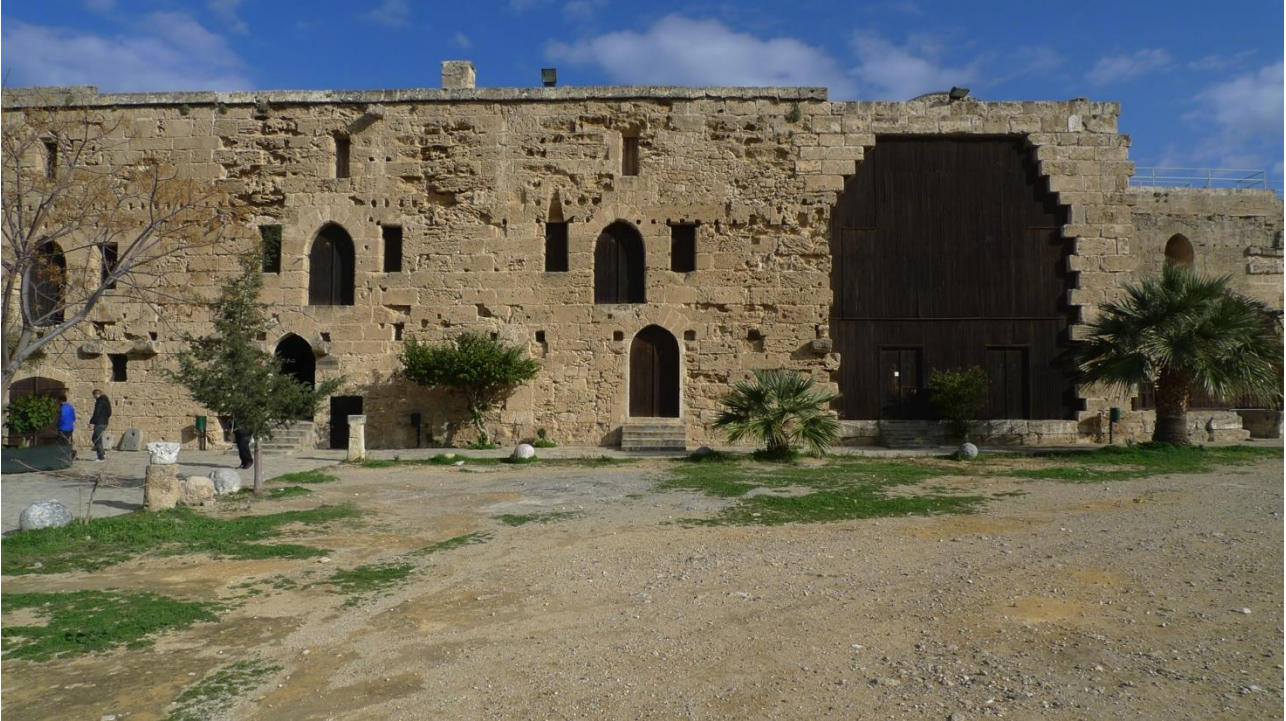
Fig. 1 External view of the hall (West elevation)

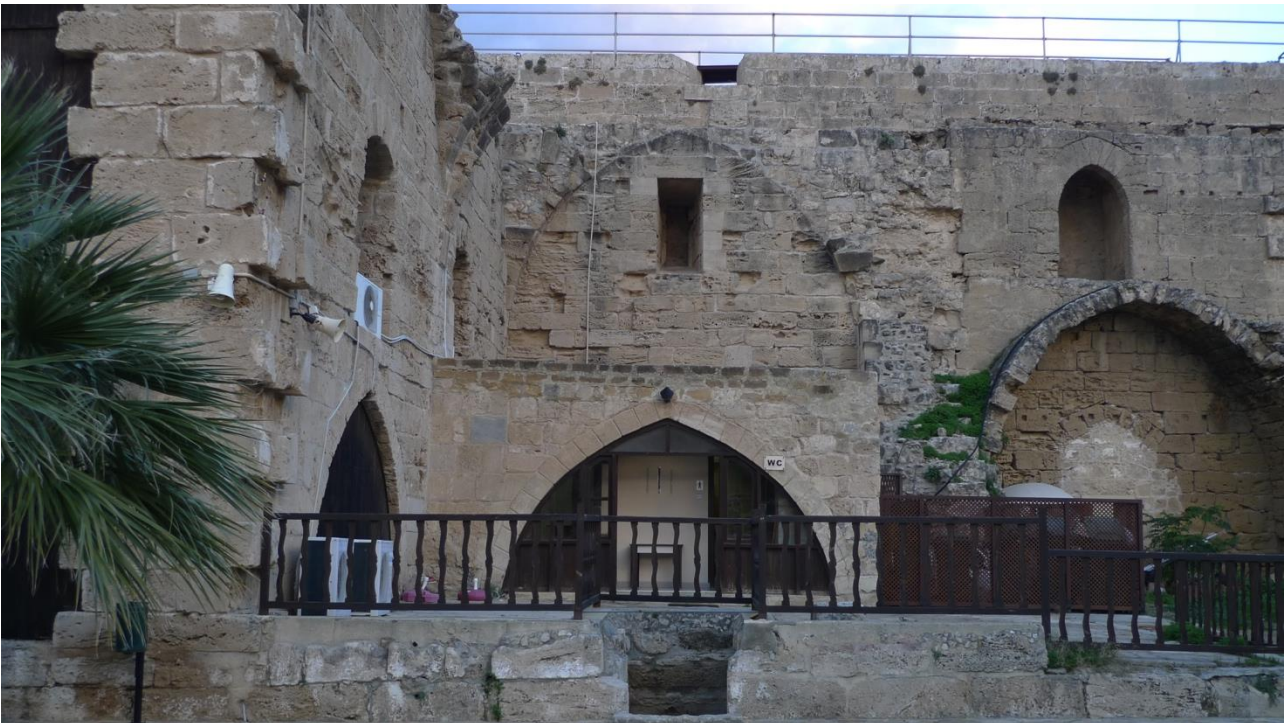
Fig. 2 View of the structures on the South side of the hall with the modern building housing the toilets. Above is visible the original (collapsed) barrel vault.

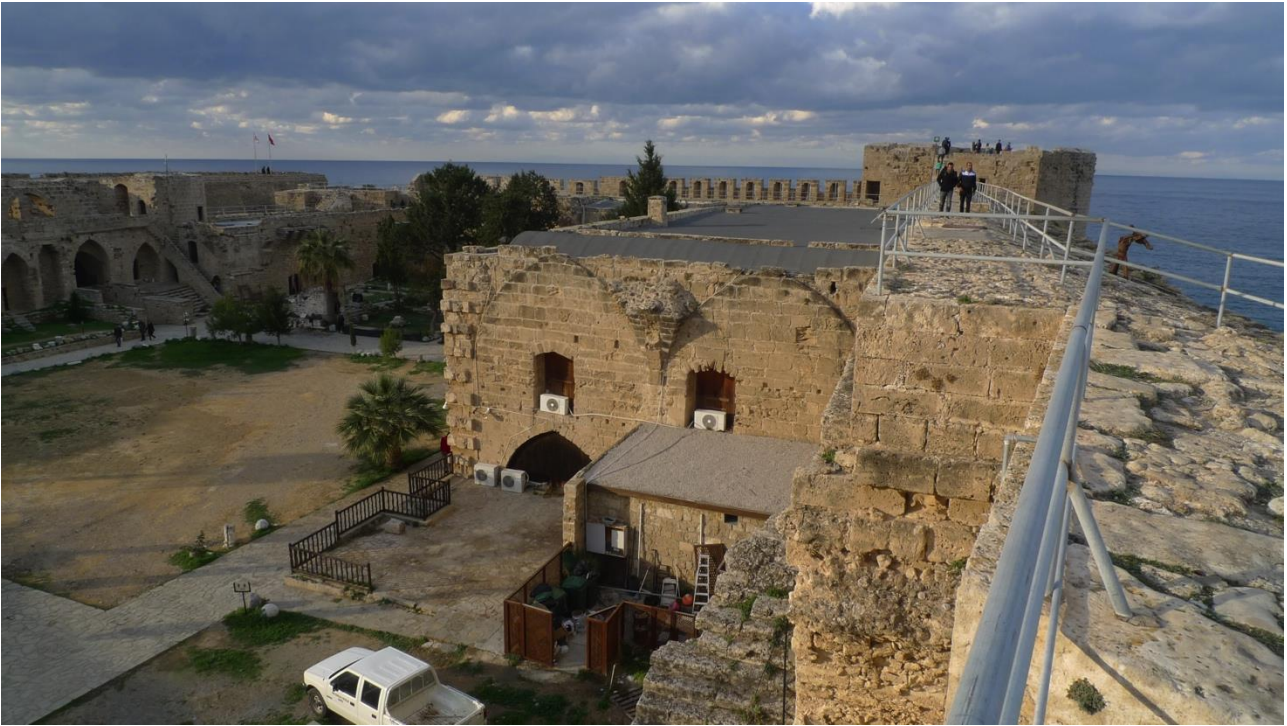
Fig. 3 View from south towards the hall, showing the outer South elevation of the hall with the four external units of the A/C system

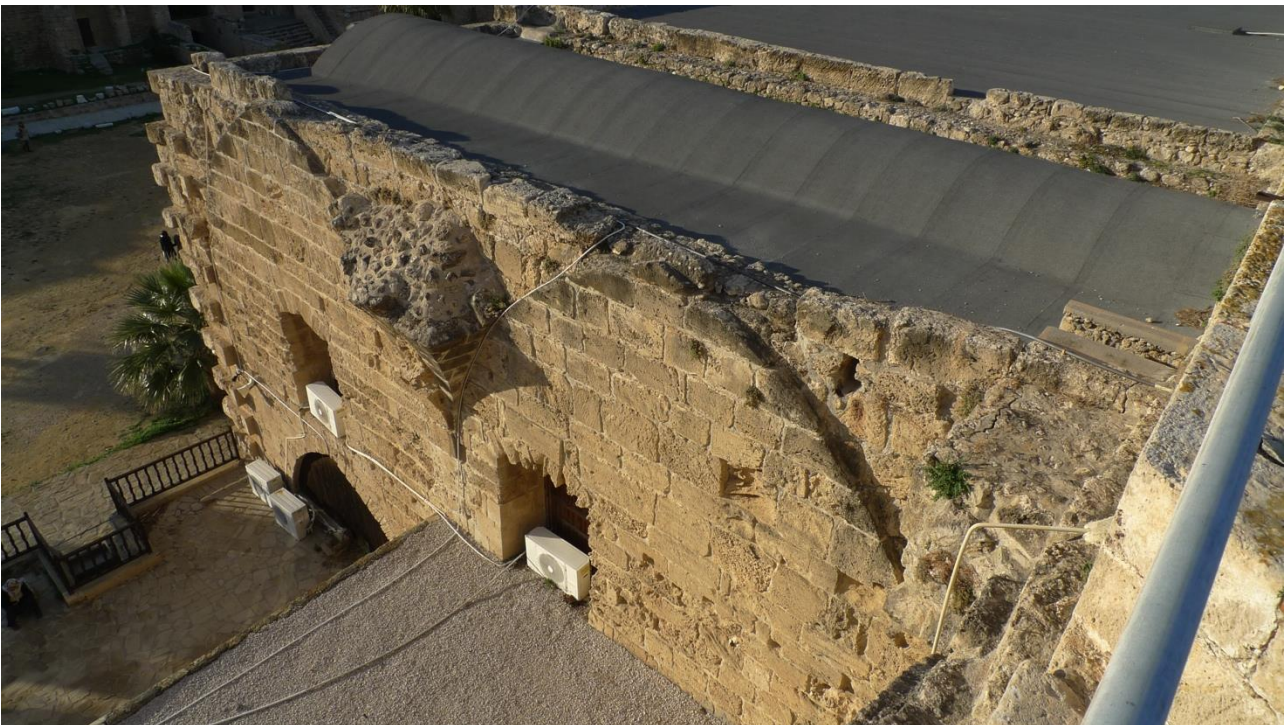
Fig. 11 Exterior view of the extrados of the vault showing recent waterproof membrane shelter.

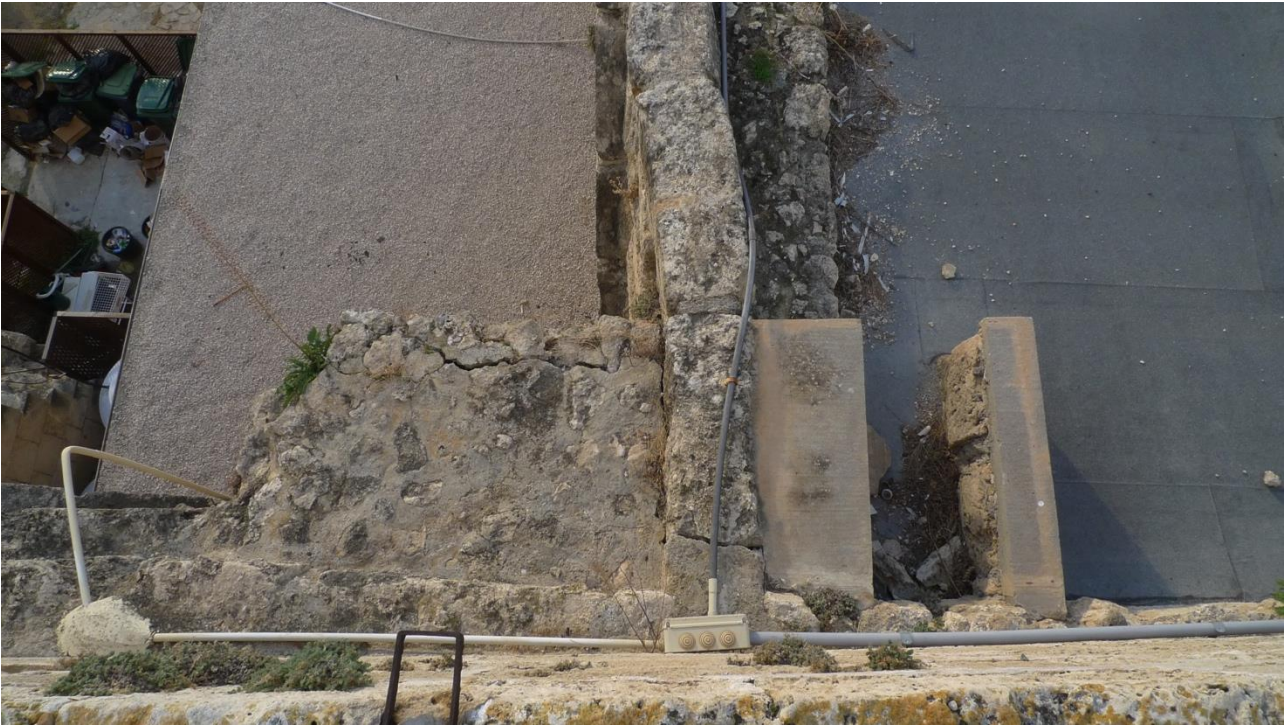
Fig. 12 Detail of the terrace. On the left – remains of a barrel vault with minor crack. On the right – a wall supporting once an external A/C unit (?)

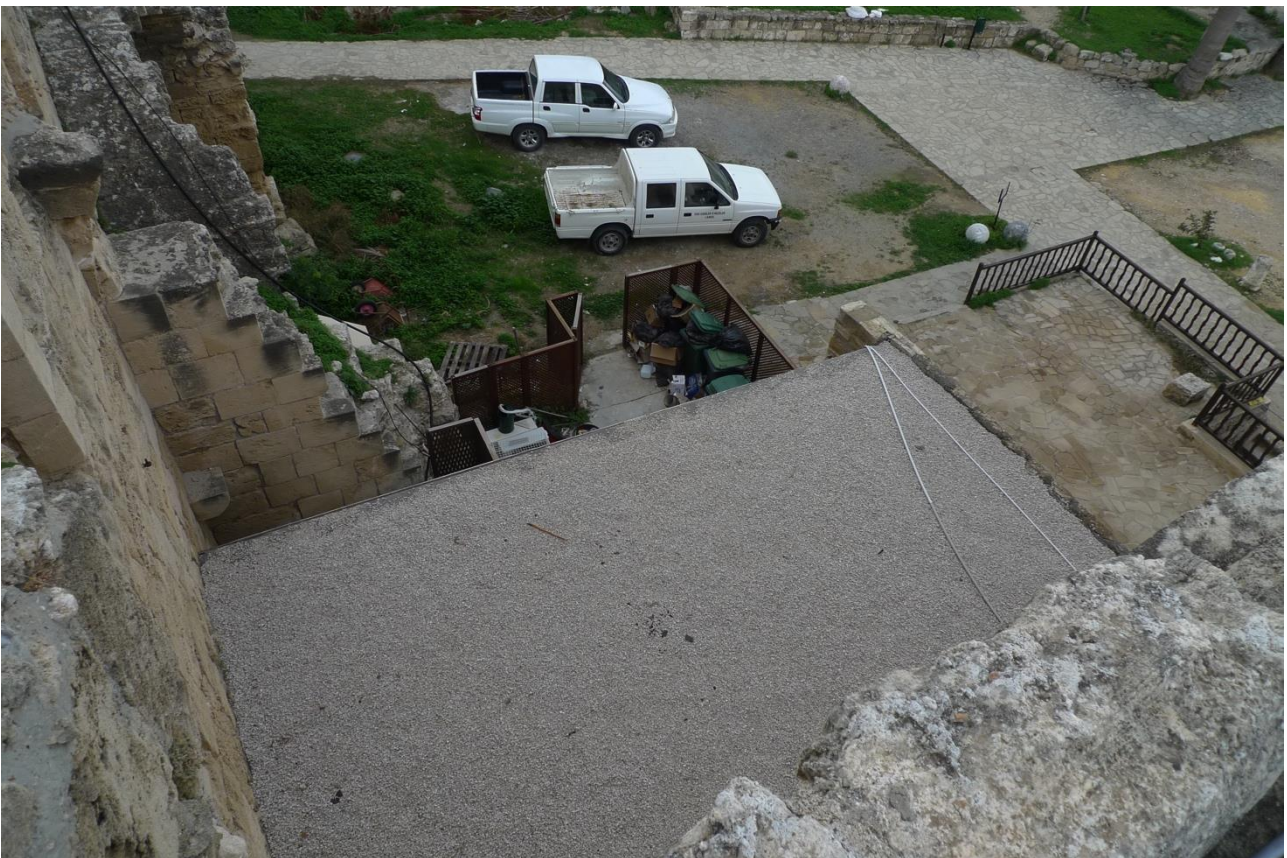
Fig. 13 View of the roof of the toilet and the area destined to wastes.

Remove gravel from the terrace. Verify condition of membrane, if cracked for aging, replace. Verify existing membrane along the joint with the stone wall on the north and east side and supplement/add if necessary. Place back gravel.

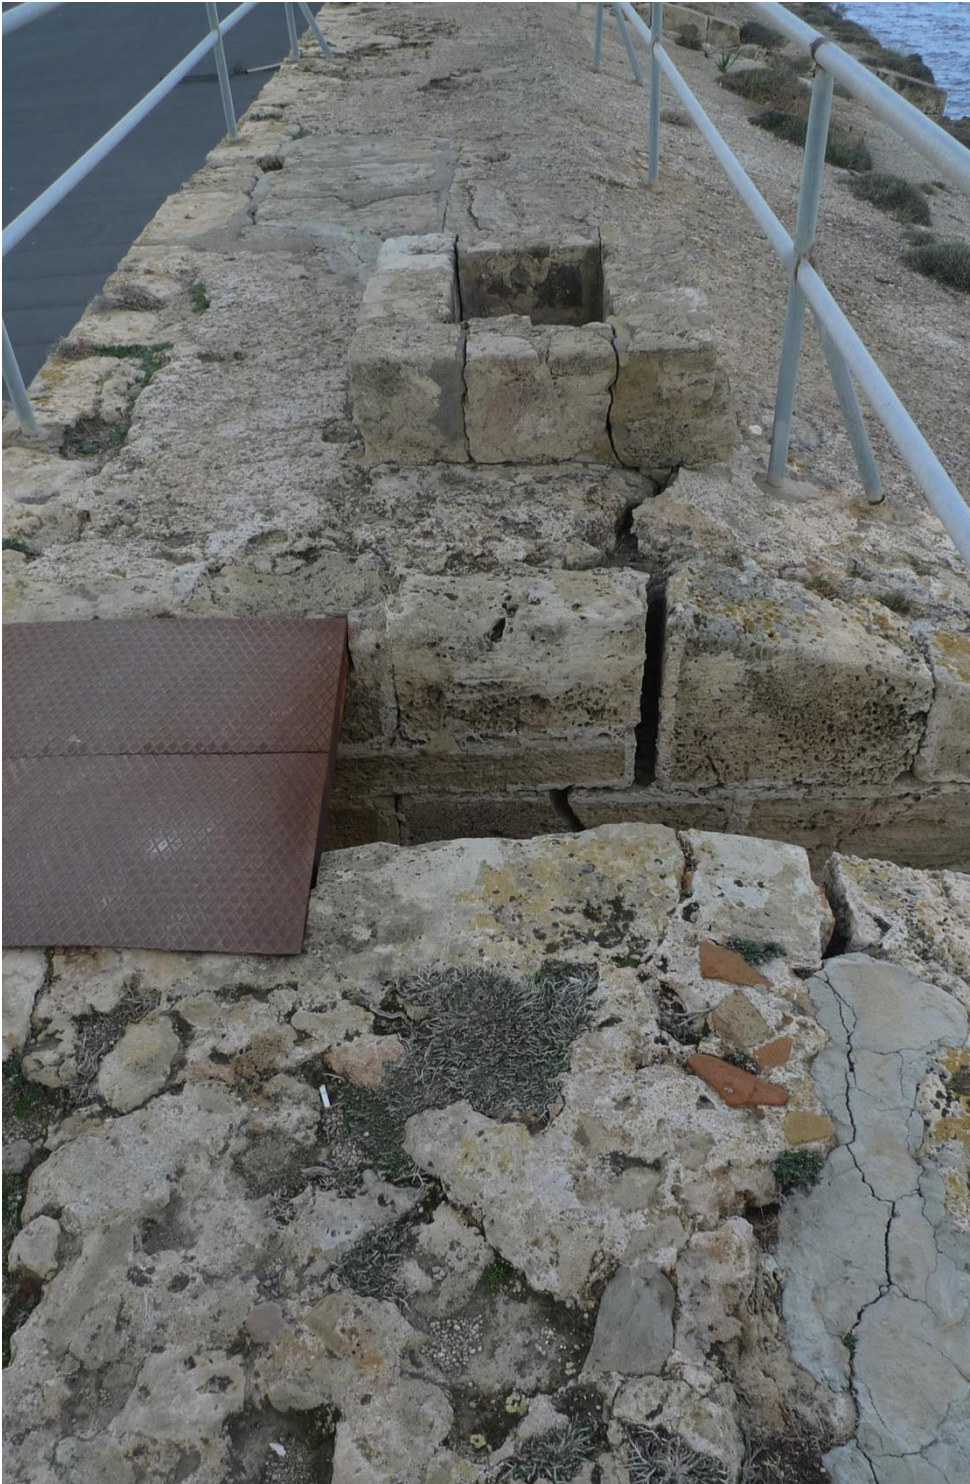
Particularly delicate is the intervention on the top wall. Here a crack has occurred along the joint between two construction phases. The crack was caused by possible subsidence of the exterior wall, which has not affected with the same entity the interior wall. The crack has left a wide open joint (max 10 cm) exposed to the elements, thus allowing rain water to penetrate into the wall and infiltrate into the masonry. The intervention aims at removing ancient repairs, repairing crack masonries and sealing vertical joints.

Fig. 15 View of the top of the exterior wall of the castle. The crack runs along the limit between the 1st and the 2nd phase of the construction.

Joints between two masonries belonging to different construction phases must be kept separated and the joint filled with small rubble as described in 4.4.2. and 4.4.3.

4.4.5. Extra protection of the horizontal joint between two masonries, when exposed to the elements, through a metal sheet (possibly lead) to ensure water not to leak into the joint.

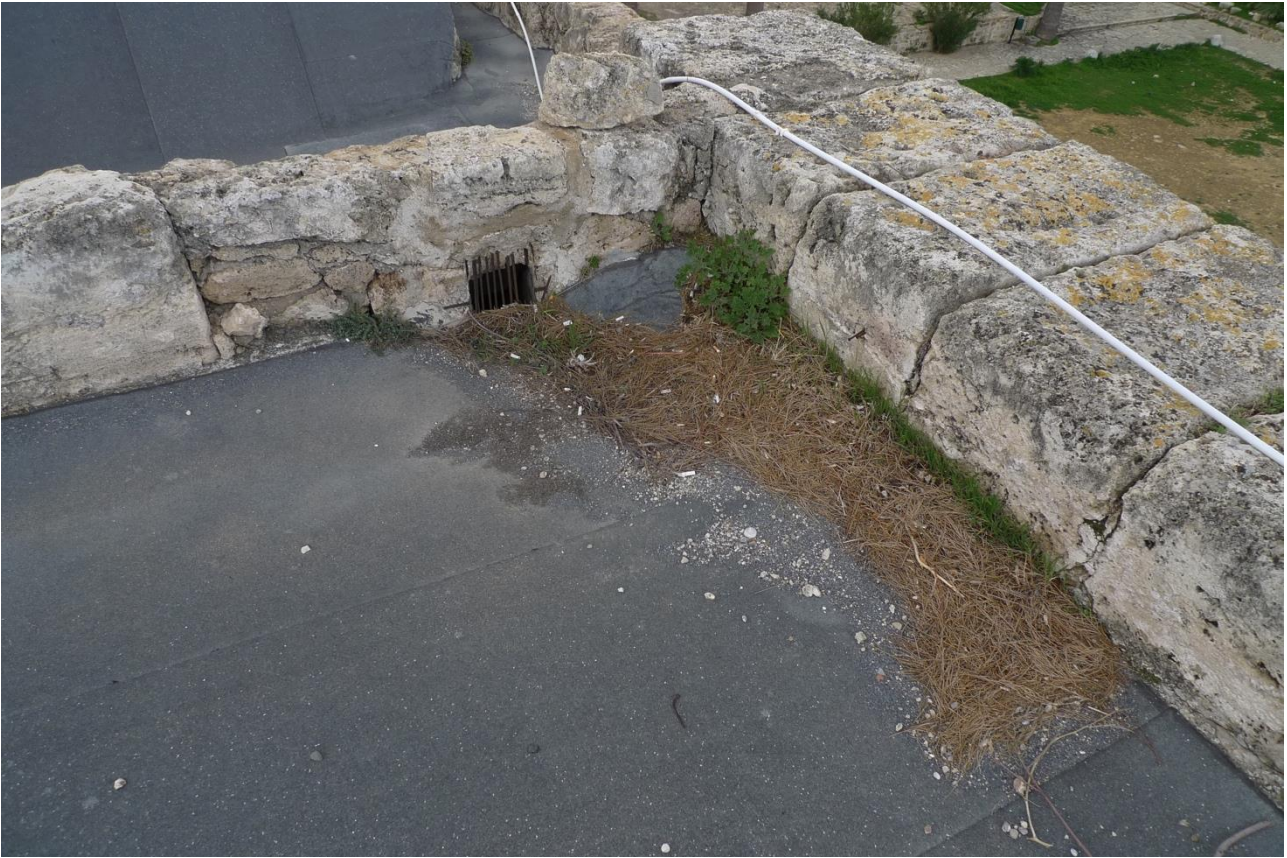
Fig. 16 Detail of the drain of the larger terrace. The membrane doesn't cover the joint between the roof and the walls.

Add membrane along the perimeter wall, reversed for min 10 cm height.

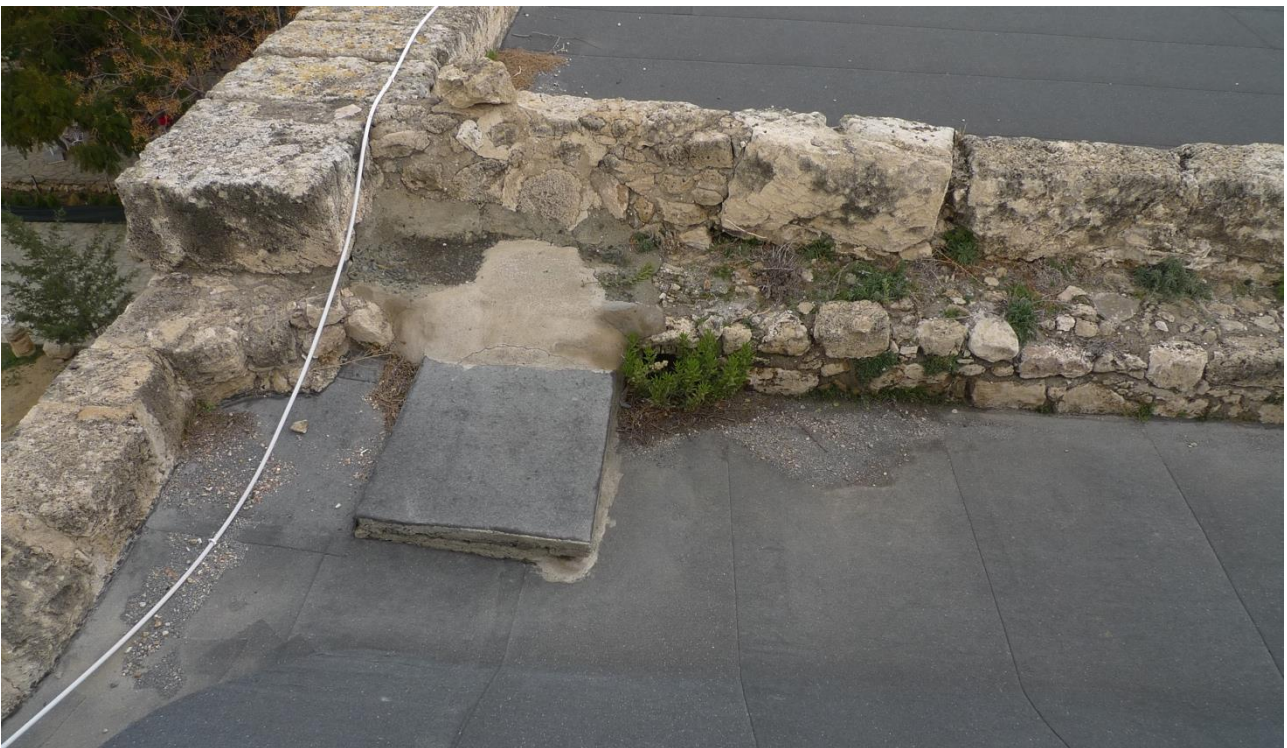
Existing drainage is insufficient to drain water in case of heavy rain. For this reason it is necessary to repair/implement existing water system. Interventions are envisaged only on the drains merging on the downpipe of the hall.

Fig. 17 Detail of the area where the drain of the terrace above the hall is located (hidden by vegetation). The slab is placed on the downpipe.

4.5.3. New pvc downpipe and lower manhole $\varnothing 16$ cm, with watertight manhole cover. Connection of manhole to exterior drain system. On the terrace the downpipe will be properly connected to a drain channel protected by a removable (for inspection) dome grating. Joint between the downpipe and the terrace made with double sealing, with damp-proof fibre-reinforced membrane.

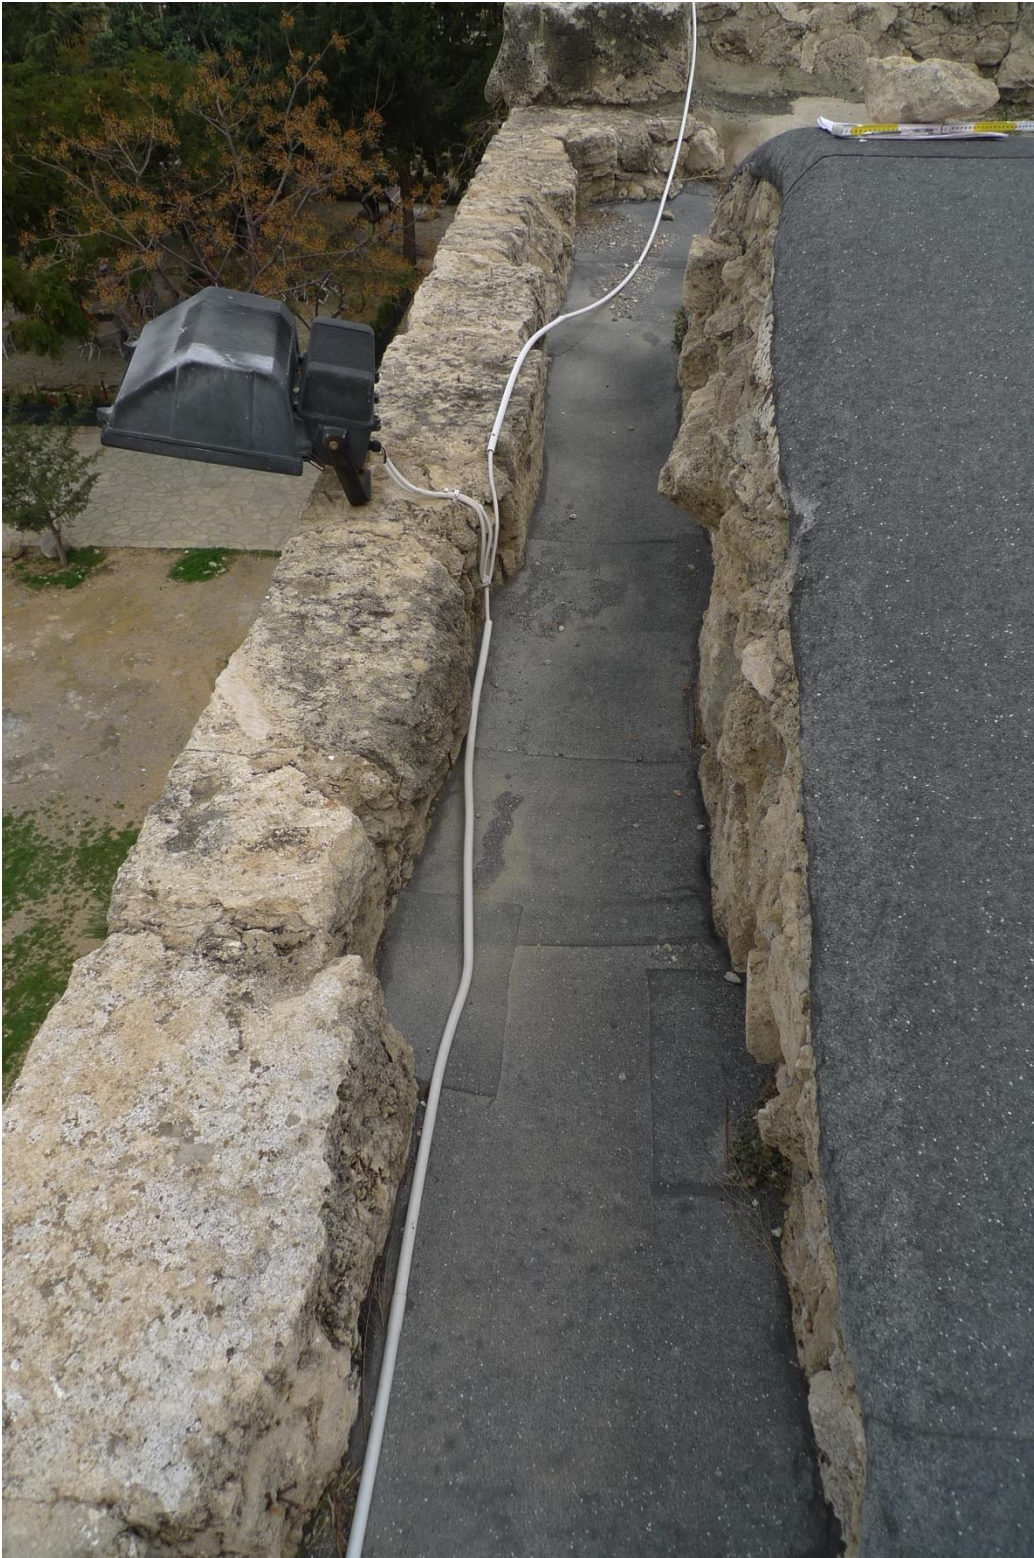
Fig. 18 View towards the Western edge of the roof. On the right – the extrados of the barrel vault covering the hall.

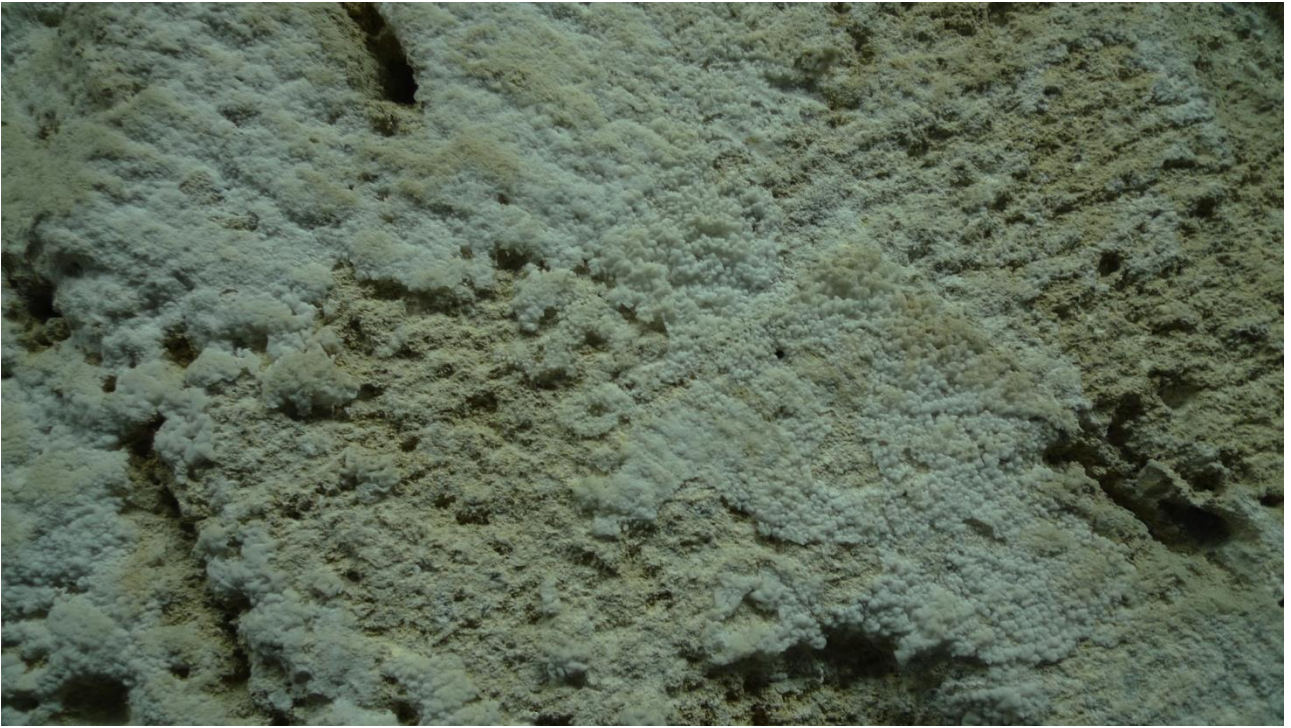
Fig. 22 Salts on the stone surface – detail

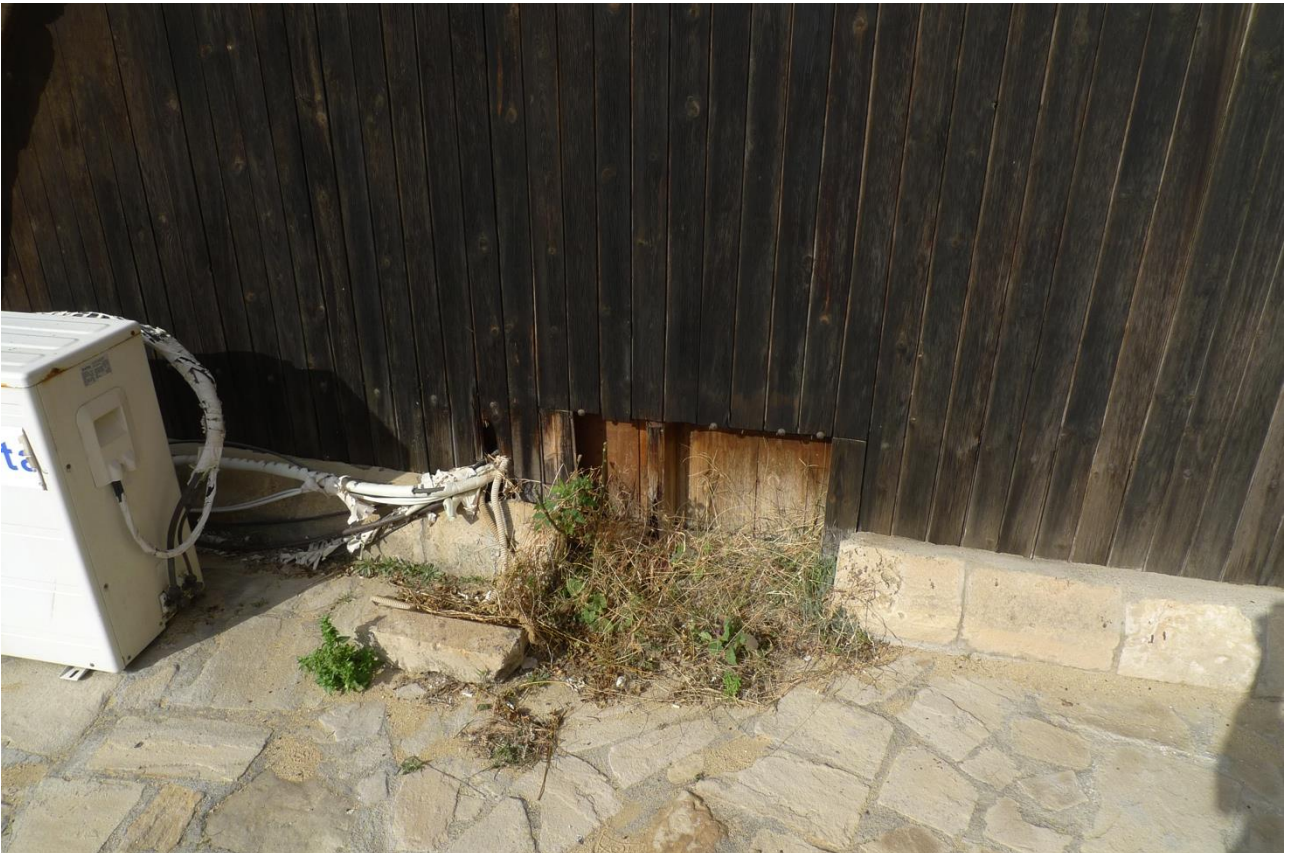
In terms of preservation of the hull, the insulating efficiency of closings affects the climate condition in the hall. High temperature in the exterior and air permeability jeopardize proper conservation of the hull and rise the need of a incisive intervention. Poor insulating capability of the closings as well as aging of wood are two major problems that need to be addressed through a demanding intervention.

Fig. 26 Damage of the timber cladding and detail of the pipes connecting to interior A/C units

The whole dismantling of existing wood sheathing, substitution and enhance insulating properties is the aim of the intervention. The contractor must pay attention to the proper sealing of all the joints between the closings and the walls, as well as the accurate sealing of the custom doors, by means of perimeter gaskets.

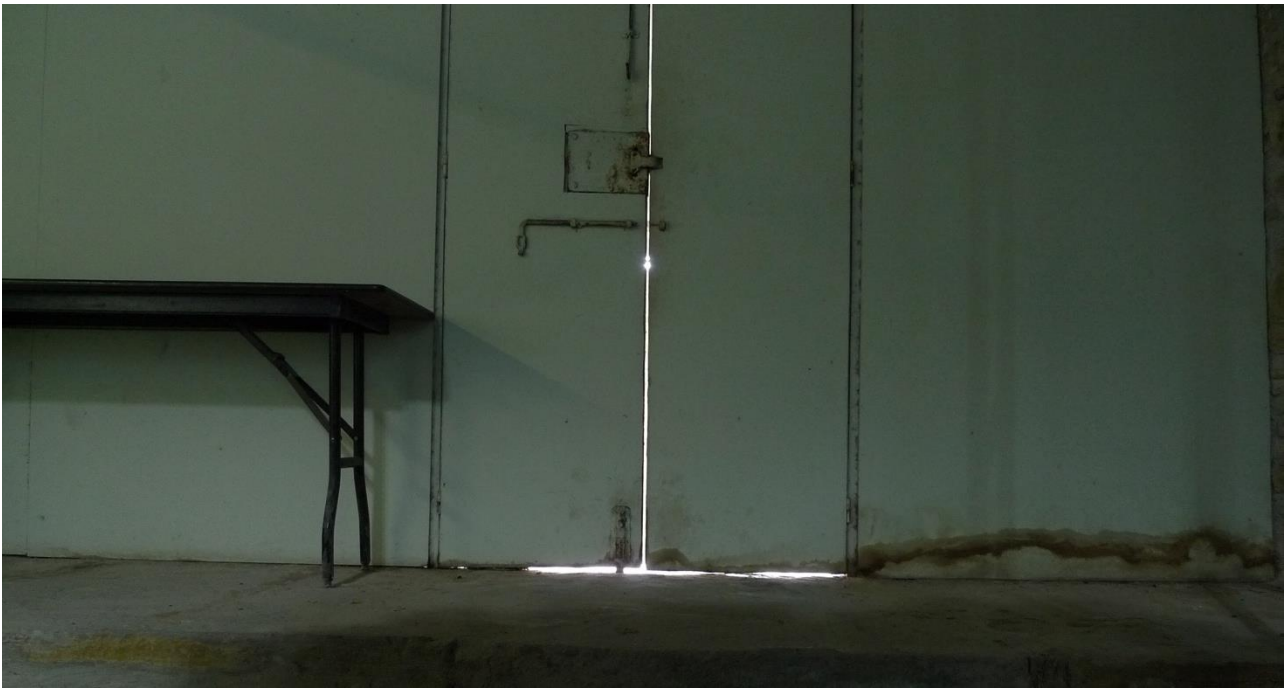
Fig. 27 The entrance door doesn't close hermetically. Damage due to humidity is visible on the interior MDF

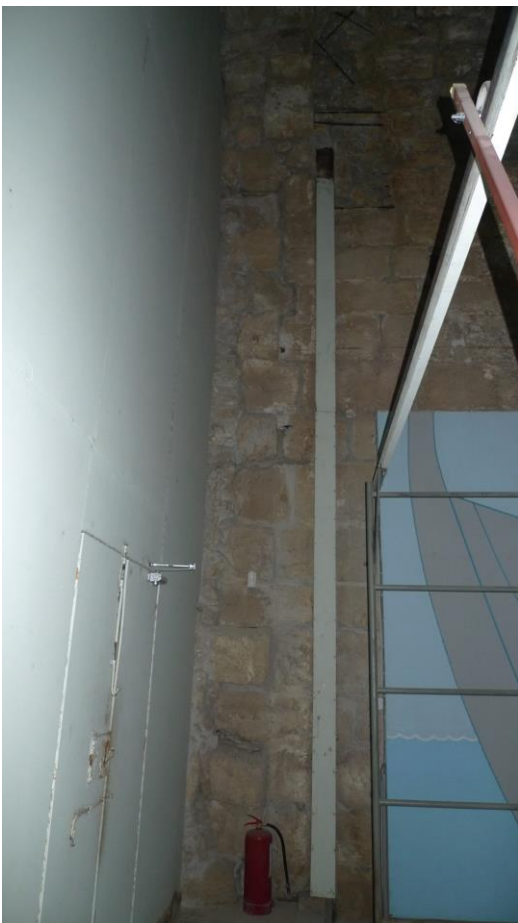
Fig. 28 Downpipe (hidden by an external wooden carter coming from the drains on the roof. There is a concrete patch where the vault was demolished to insert the downpipe.

4.5.2. Demolitions. Demolition of downpipe and of manhole, including concrete masonry in the sector where the downpipe passes into the vault and drain from the manhole to the courtyard. Demolition of the drains to downpipe on the terrace. Demolition of the separation wall between the two roof terraces, as described in the drains. Clear the site of rubbish, grub up bushes, shrubs, vegetation, etc., clear and cart away.

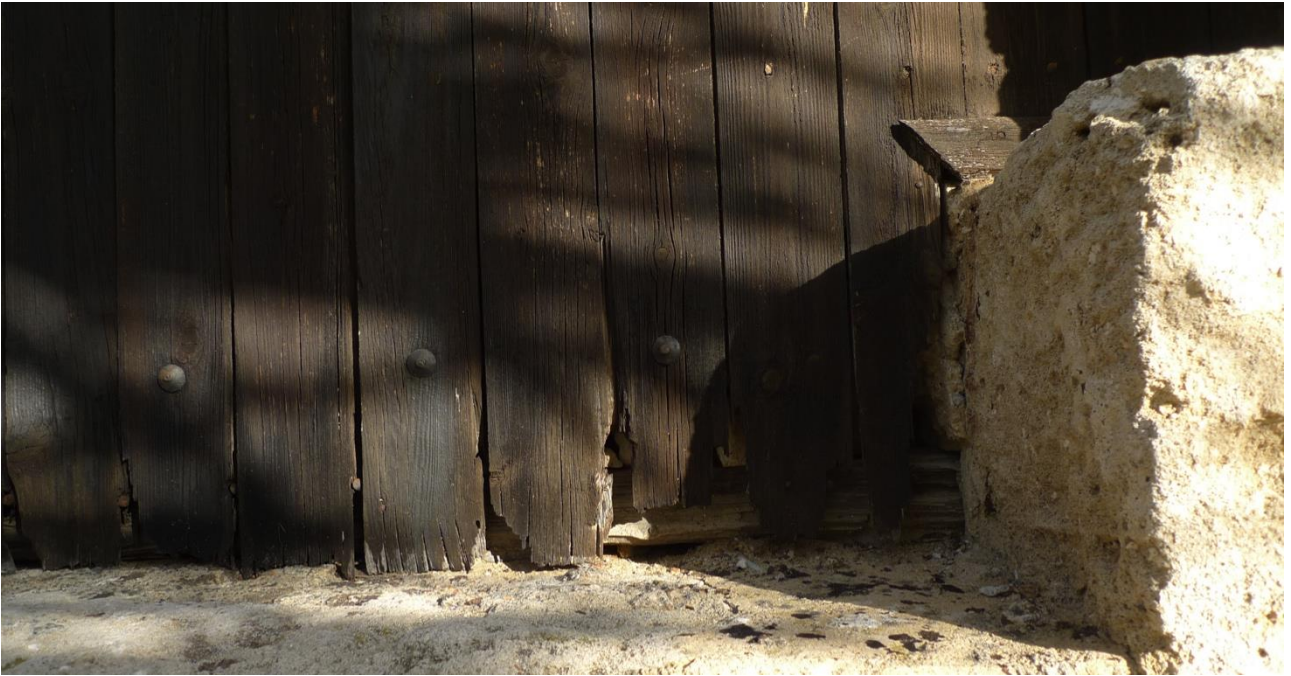
Fig. 29 Bottom side of the timber cladding on the West facade damaged by humidity. The supporting beam is also damaged.

Decayed timber elements must be cut off and supplemented with new ones in order to transfer properly loads into the shear walls. New timber must be scarfed to existing, wedged and bolted top to bottom.

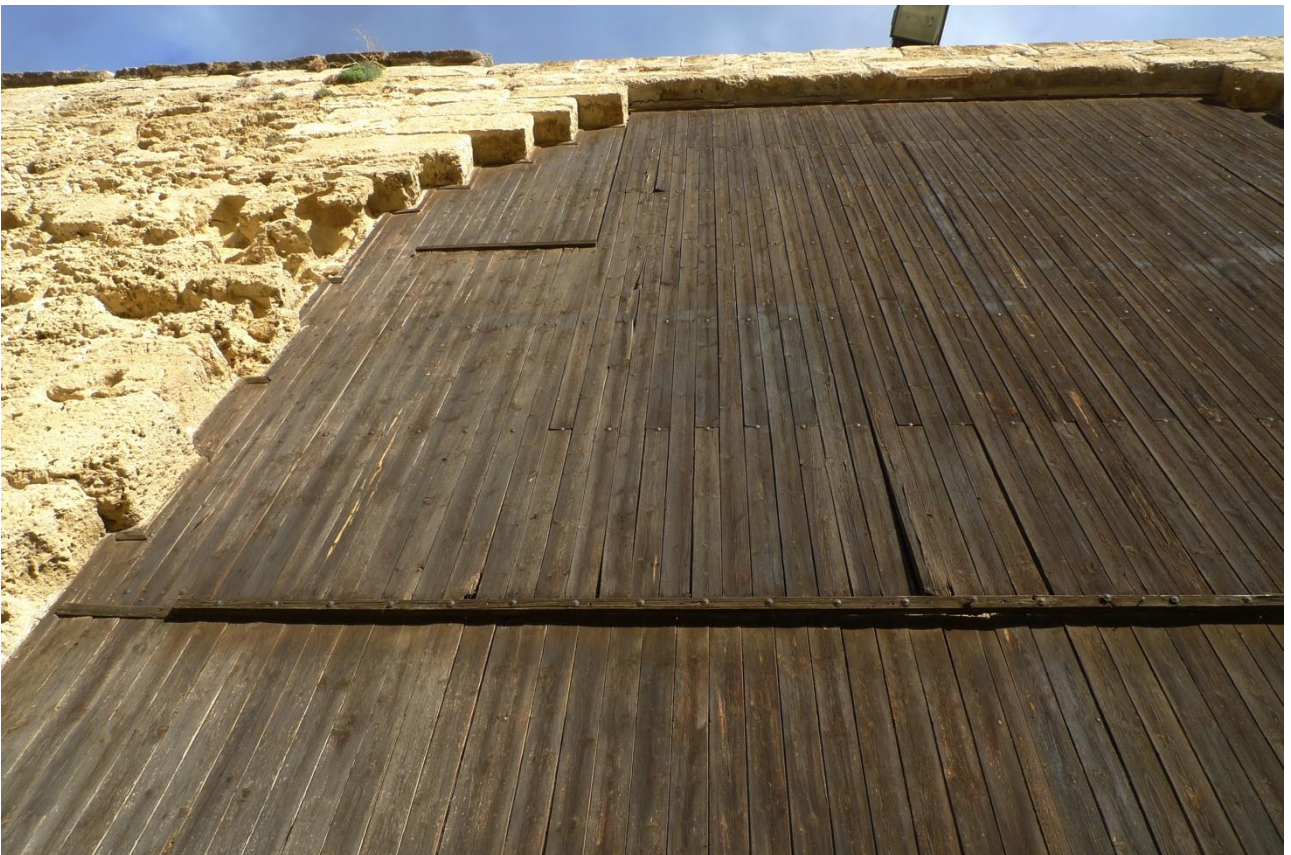
Fig. 30 View of the West closing of the West facade from below.

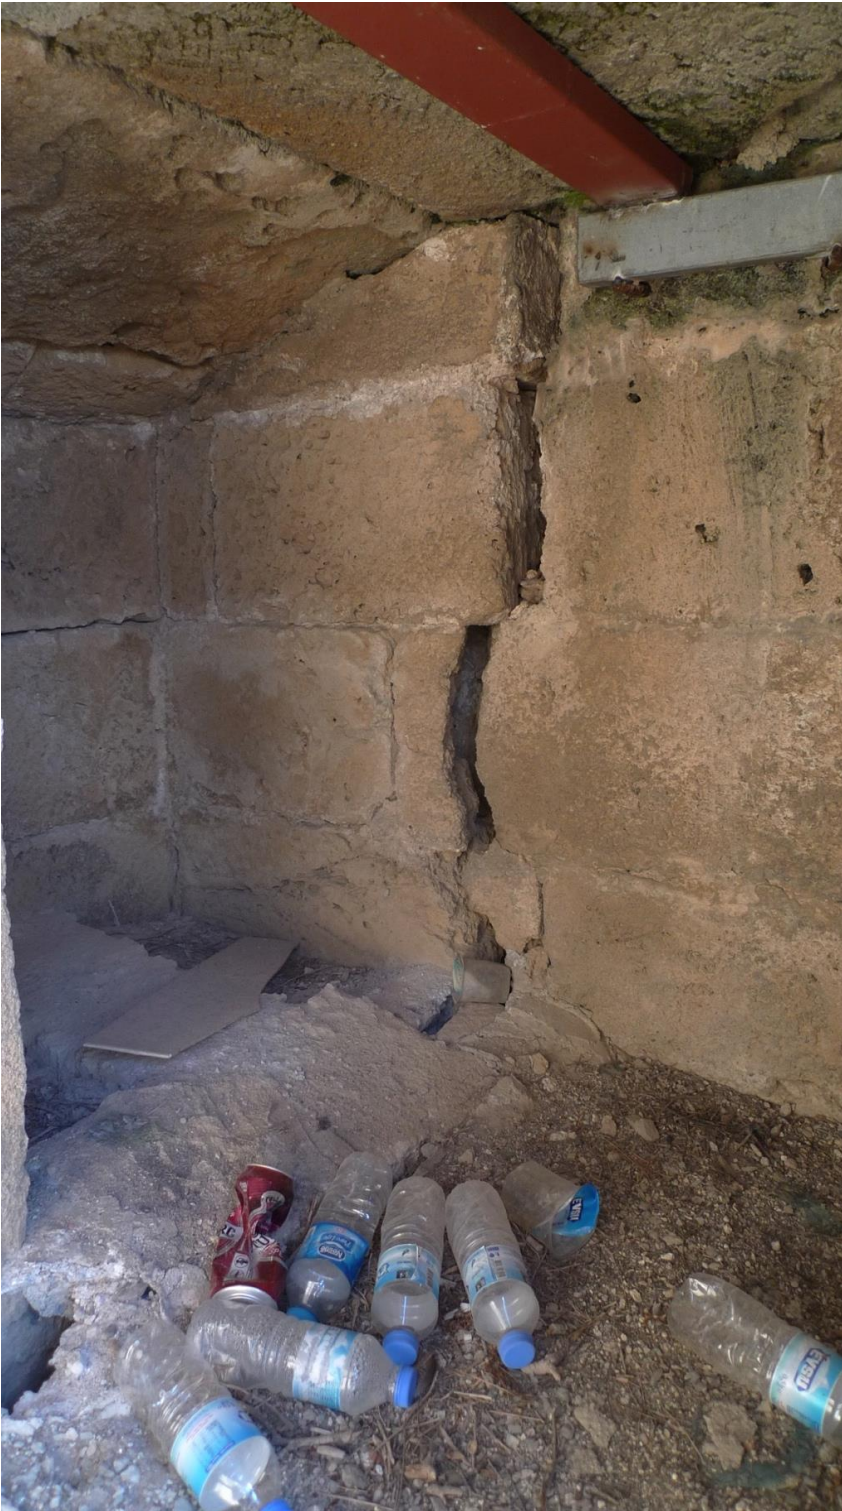
Fig. 31 Crack in a small room under the upper exterior passage way.

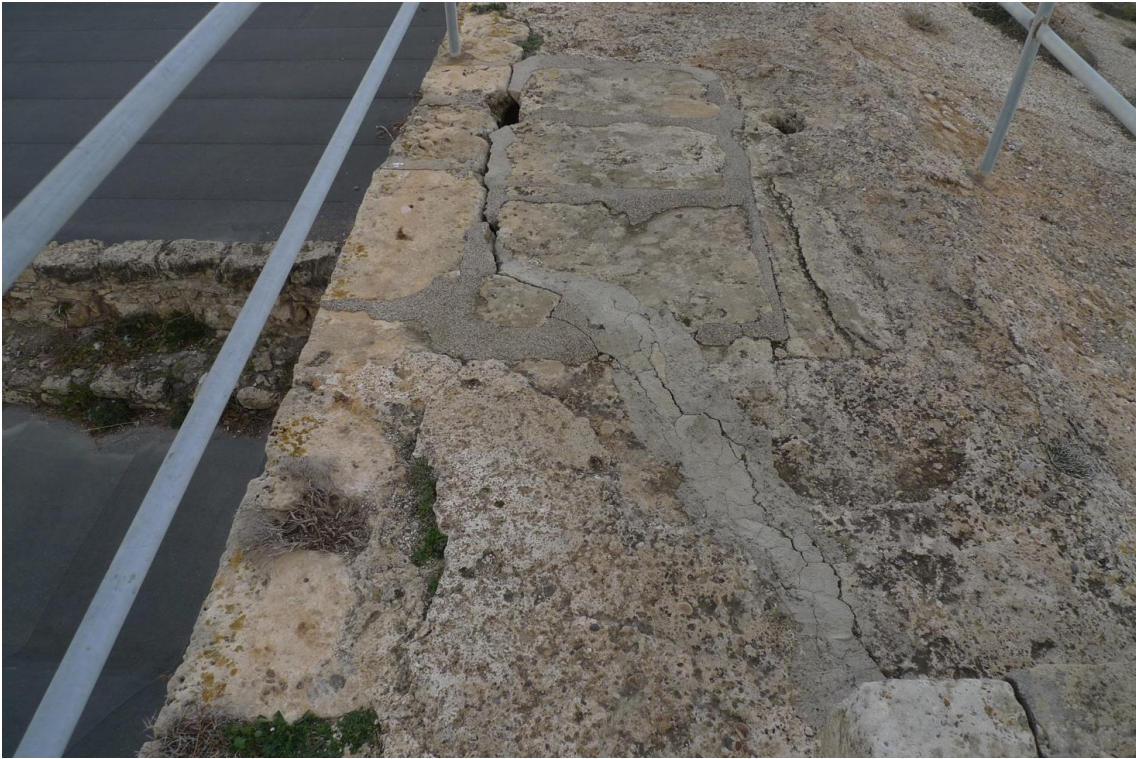
Fig. 35 Cement patches on the crack along the passage way on the top of the external wall of the castle.

4.4.1. Removal of all cement-mortar repairs and replacement with new mortars (bedding-mortar + pointing).

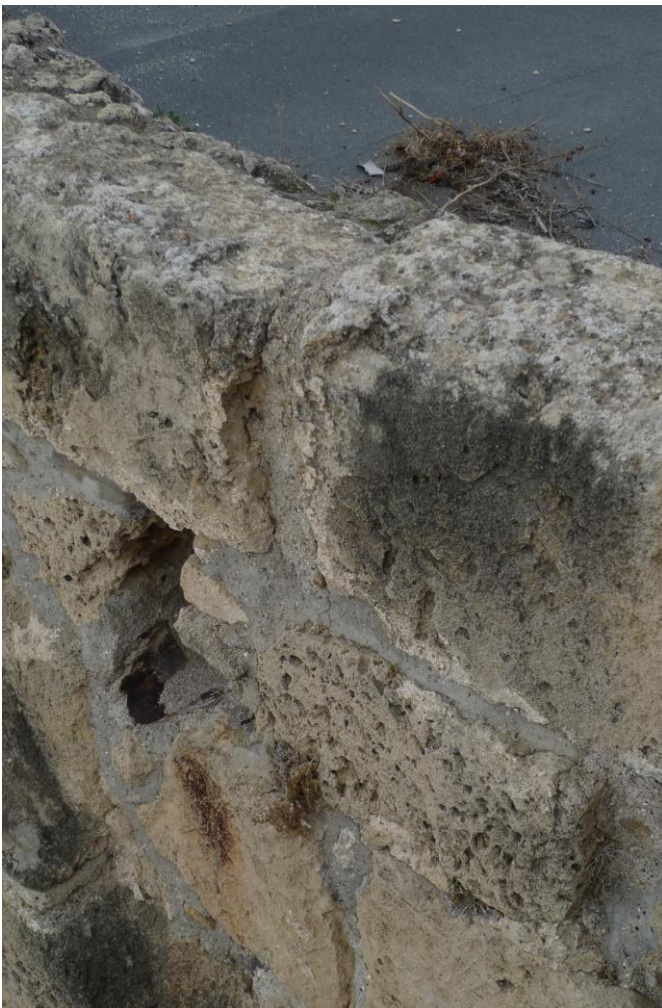
Fig. 36 Water spout originally used for the terrace above the hall. At present unused.

masonry intervention to reactivate the water spout of the east end of the wall, which will include: demolition of the masonry; new masonry to create a drain on the roof terrace, including membrane and lead protection; down tube connected to the water spout;
