Improvement works at the cemetery in the Paphos area; Description and details

Site Identification

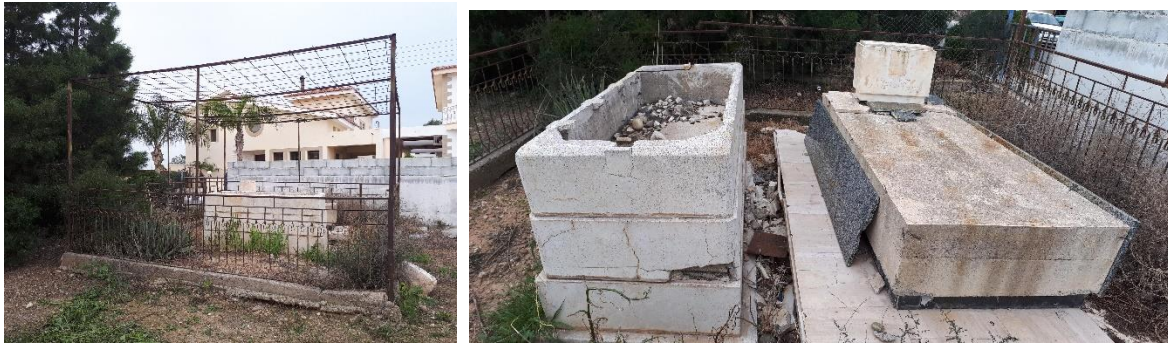
Figure 9 Fenced tombs on northwest corner.
