## **Terms of Reference – Emergency works at the belfry of Panagia Evangelistria church**

### **I. Brief description and Condition assessment**

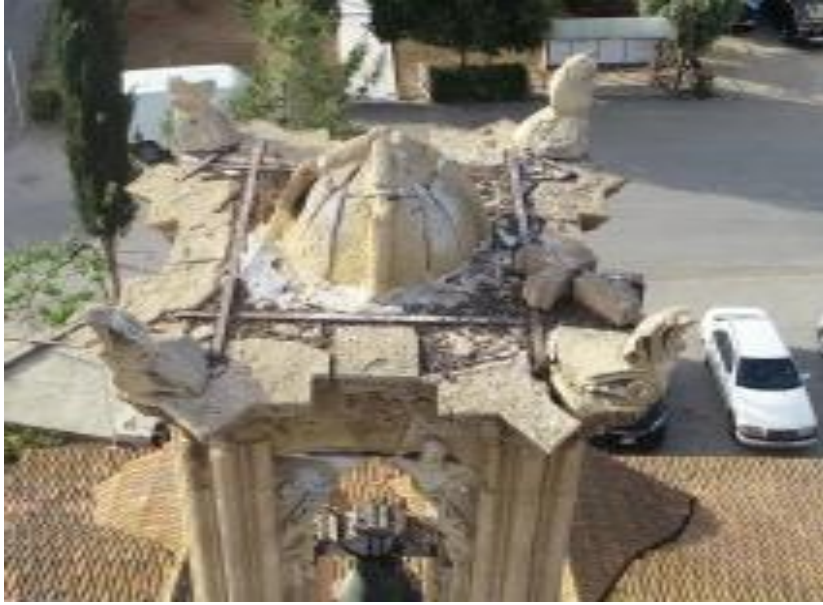
Picture 1

Extensive cracking and dislocation between the stones are seen especially on the uppermost cornice level where the iron structural reinforcement is exposed and corroded.

Original cross is also fallen from its place but still present on the top level

Main Interventions are proposed on the cornice level. i.e replacement of the corroded iron elements with same size iron elements protected with water resistant, anti – corrosive primer such as (sika Armatec 100 master seal 300) or equivalent. After replacement the coated iron will be covered with lime mortar. All the exposed iron elements in the facades and levels will be coated after mechanically removing the superficial rust and then covered with 2 cm thick lime mortar. The existing cross will be placed on the dome and the missing stone on the dome will be replaced. Pointing will be done as specified on the solid base level and until the ground on southern façade of the bell tower. Rusted metal elements on the belltower will be treated for rust. All the wooden and iron mechanisms of the existing bells will be mechanically cleaned and treated against deterioration.

| No. | Work Item | Description |
|---|---|---|
| 4 | Structural Reinforcement Upper Cornice level and | Main Interventions are proposed on the cornice level. i.e replacement of the corroded iron elements with same size iron elements protected with water resistant, anti – corrosive primer |

| | treatment of all partially exposed iron elements | <p>such as (sika Armatec 100 master seal 300) or equivalent. After replacement the coated iron will be covered with lime mortar</p> <p>All the exposed iron elements in the facades and levels will be coated after mechanically removing the superficial rust and then covered with 2 cm thick lime mortar (MasterEmaco® N 275 TIX Formerly known as Albaria® Intonaco).</p> <p>The existing cross will be placed on the dome and the missing stone on the dome will be replaced. The iron used will be protected with water resistant, anti – corrosive primer such as (sika Armatec 100 master seal 300) or equivalent.</p> |

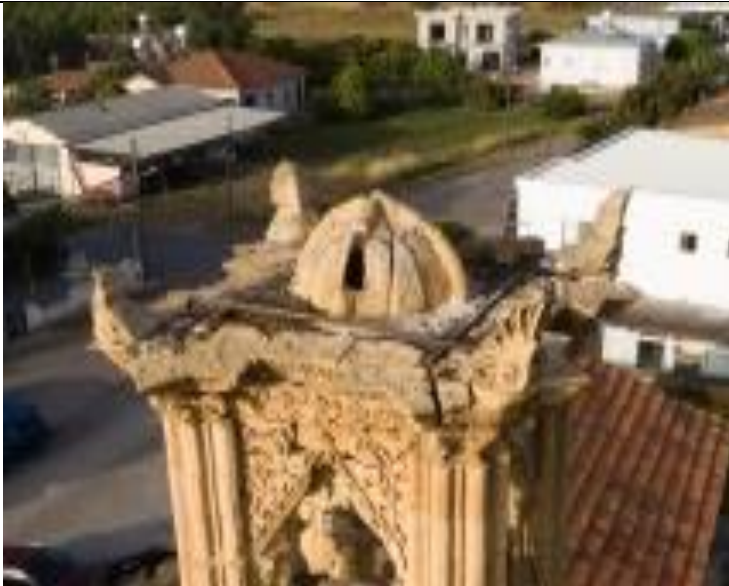
Picture 2

There is stone loss at the dome creating a void for water infiltration.

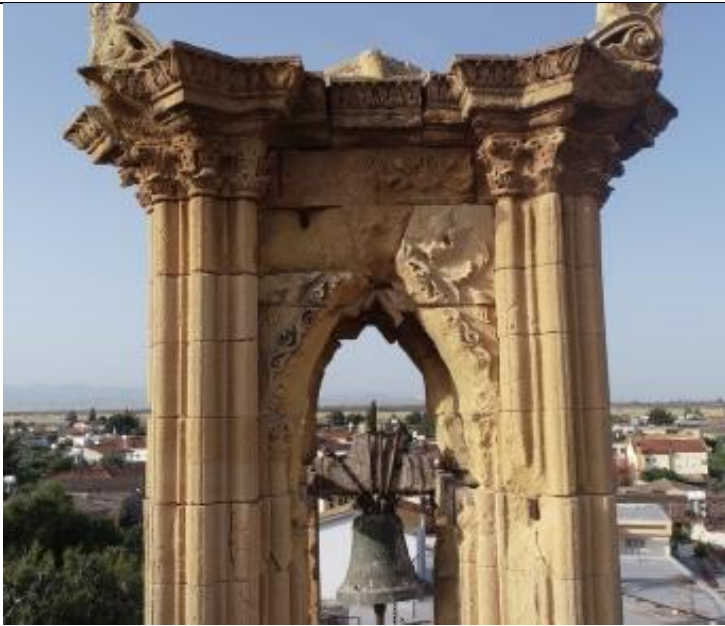
Picture 3

Superficial material deterioration is seen especially on the carved areas of the Bell Tower.

There are iron stone connecting members exposed after these deteriorations.

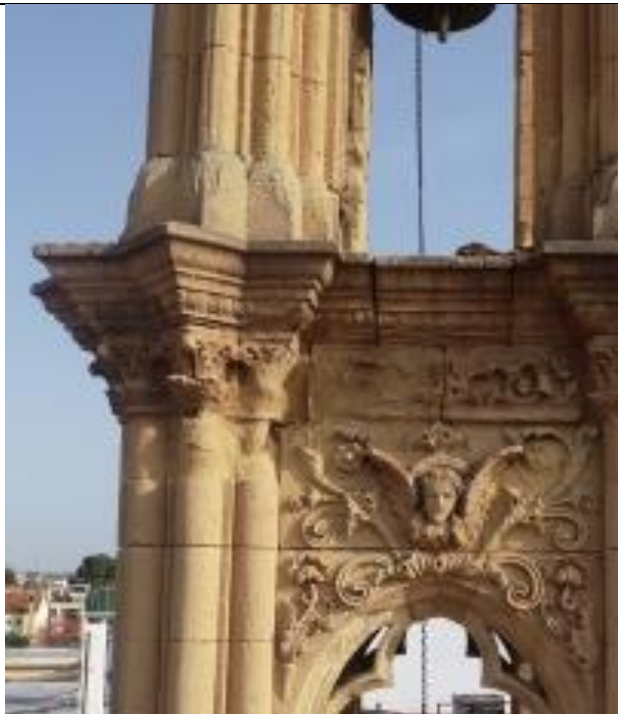
Picture 4

Superficial material deterioration is seen especially on upper parts of the pillars

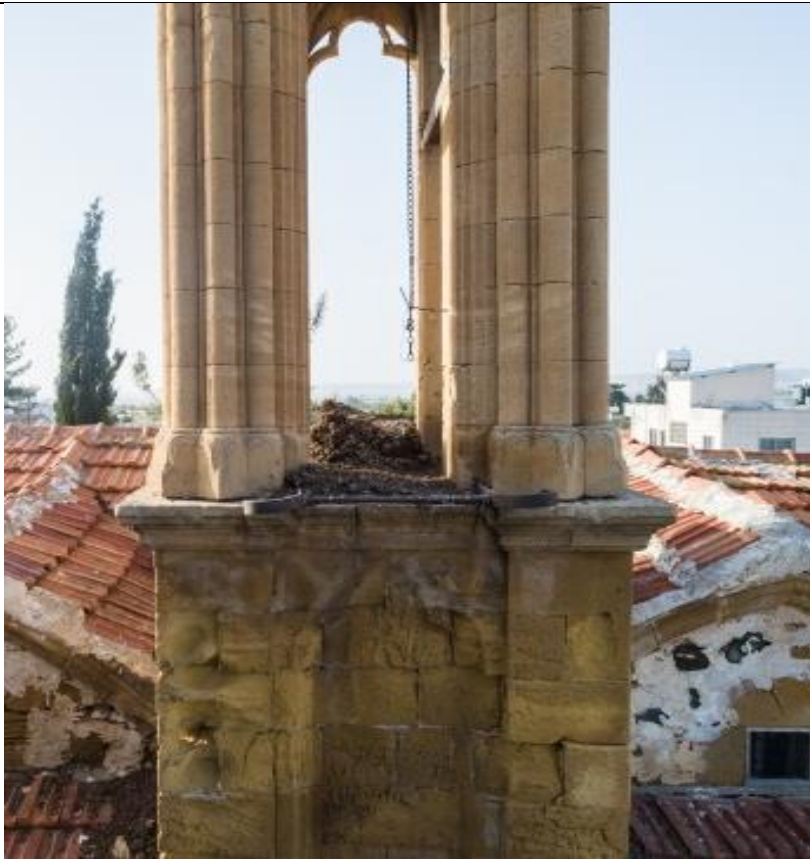
Picture 5

There are material loss at the original pointing of the stones at the solid base level and at the base stones of the pillars.

| 6 | Deep Pointing-solid base part and until the ground on south facade | <p>Clean the joints with stone dressing tools with care so that the surrounding stone is not scratched, and joints are not widened. All cutting out of mortars should leave a square face in the back of the joint. Cleaning should be done in 5cm depth.</p> <p>Remove deteriorated material and loose deposits with soft bristle brushes.</p> <p>Clean the joints with air and water under pressure.</p> <p>Mix mortar whereby aggregates are mixed dry, and the binder is separately mixed with the pigments. All constituents are mixed together, and the optimum amount of water is added.</p> <p>Point joints by careful packing of the mortar in layers according to original form/profile.</p> <p>Protect mortar from rapid drying by covering with PVC membrane or damp cloth. Regular spraying with water in order to keep the mortar humid should take place for a minimum of 15 days.</p> <p>New mortars should be mixed according to manufacturer's specifications. The joints should have the final appearance of the original ones, subject to the engineer's decision both in the solid base part and the rebuilt first and second levels. For pointing purposes MasterEmaco® N 275 TIX (Formerly known as Albaria® Intonaco) or equivalent will be used.</p> |

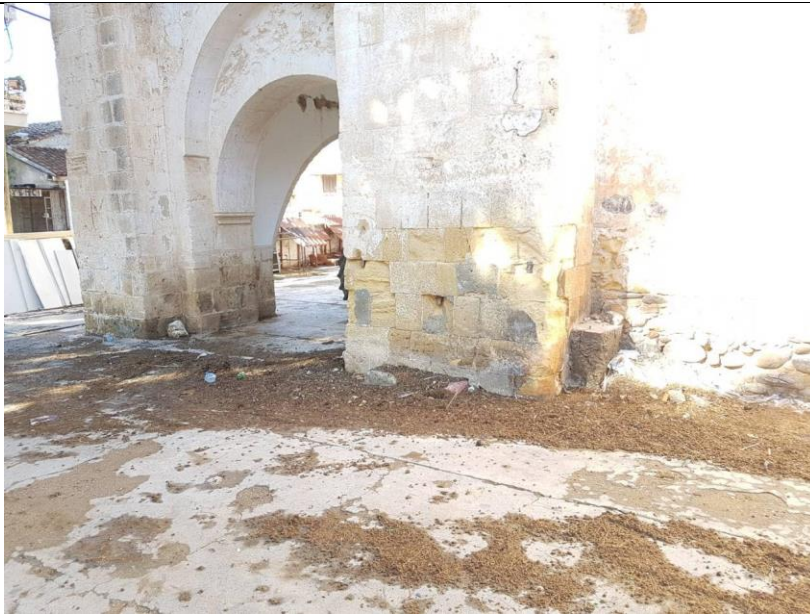
Picture 6

Rusting is noted on the iron clamps at the basis of the bell tower. Some material loss on the stones of the basis is also noted.

| 7 | Iron clamps/elements at the base of belfry | <p>The exposed steel bars located at the basis of the belfry shall be cleaned from corrosion (rust) by using wire brushing, taking care not to damage the stone.</p> <ul style="list-style-type: none"> <li>- If corrosion has reduced the cross section of the steel bar to less than 80% of its original diameter then the contractor should provide a method statement for the removal of the steel bars or part of the steel bars to the UNDP Engineer for approval.</li> <li>- For the protection of all existing exposed steel bars, they shall be painted with an active primer (sika Armatec 100 master seal 300 or equivalent) which contains active corrosion inhibiting additives.</li> </ul> |

| | | <ul style="list-style-type: none"> <li>- Provide and apply special protective paint on the exposed reinforcement bars – at least 2 coats</li> <li>- Hydraulic mortar should be used to cover the iron elements as previously described in section 6.</li> </ul> |
| 8 | Replacement of stones in the basis of the bell-tower where necessary | <p>Stones in the basis of the bell tower which are heavily weathered - over 50% of material loss – should be replaced. The exact number of stones to be replaced will be specified by the engineer after cleaning. New stones should be of similar characteristics as the stone to be replaced (colour, texture, hardness, size etc).</p> <p>For the stone replacement this method should be followed:<br/> Careful removal of decayed block using metal chisel avoiding any damage to the neighboring stones. Cleaning and wetting of the area that will house the new stone. Insertion of new stone, to be fixed with lime mortar (same used for pointing). Where possible new stones must be 1cm recessed from original surface. In case stone/s need to be replaced from the areas where the iron clamps are positioned the contractor has to provide a method statement for the approval of the Engineer for the stone removal and replacement with new stone.</p> |
