Description of works – Emergency works at the belfry of Panagia Evangelistria church

I. Brief description and Condition assessment

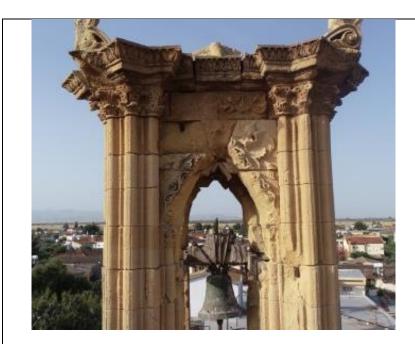
Picture 3

Superficial material deterioration is seen especially on the carved areas of the Bell Tower.

There are iron stone connecting members exposed after these deteriorations.

Main Interventions are proposed on the cornice level. i.e replacement of the corroded iron elements with same size iron elements protected with water resistant, anti – corrosive primer such as (sika Armatec 100 master seal 300) or equivalent. After replacement the coated iron will be covered with lime mortar. All the exposed iron elements in the facades and levels will be coated after mechanically removing the superficial rust and then covered with 2 cm thick lime mortar. The existing cross will be placed on the dome and the missing stone on the dome will be replaced. Pointing will be done as specified on the solid base level and until the ground on southern façade of the bell tower. Rusted metal elements on the belltower will be treated for rust. All the wooden and iron mechanisms of the existing bells will be mechanically cleaned and treated against deterioration.

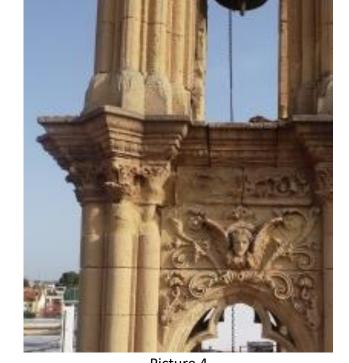
Picture 4

Superficial material deterioration is seen especially on upper parts of the pillars
