All works are described in detail in the Bill of Quantities of rehabilitation works in the cold chain refrigerator in Sirte City.

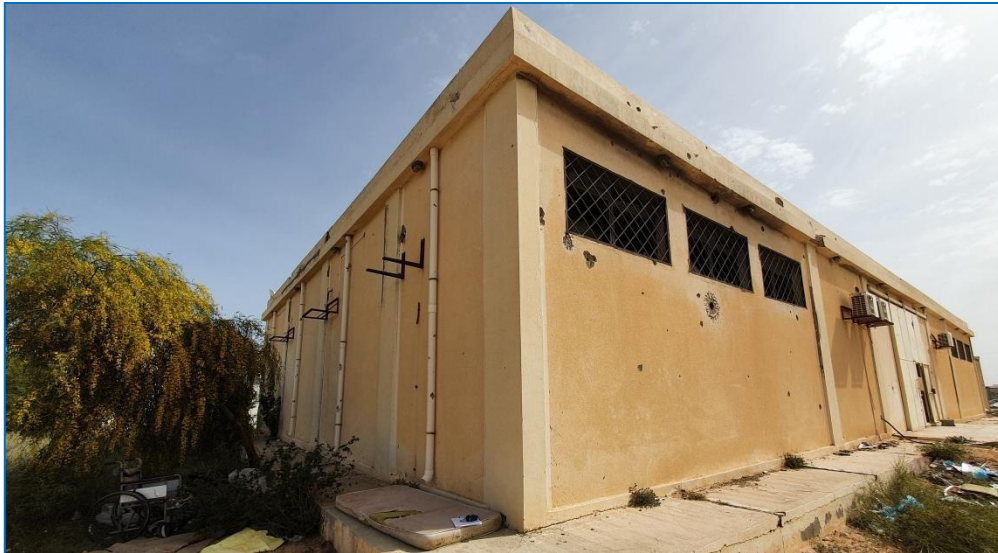
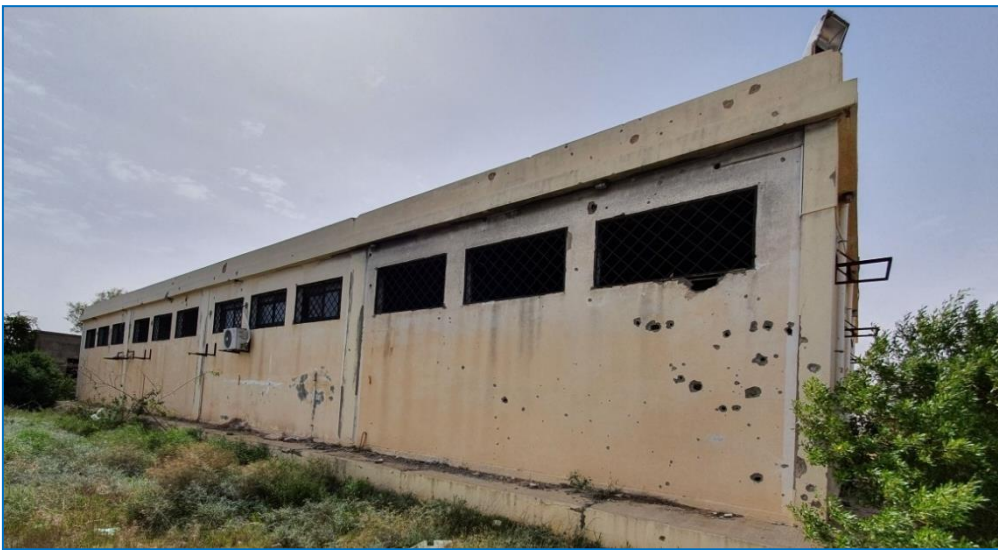
Also, some floorings, parapet and structural elements have suffered many deterioration which needs to be constructed and rehabilitated similar to the existing as shown in the photos and detailed in the BOQ.

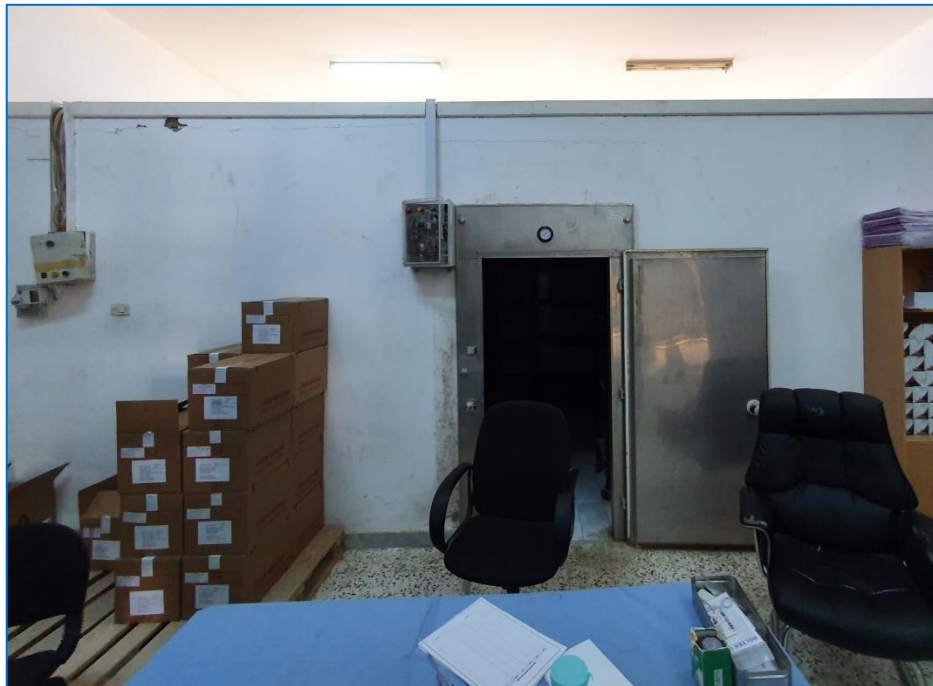
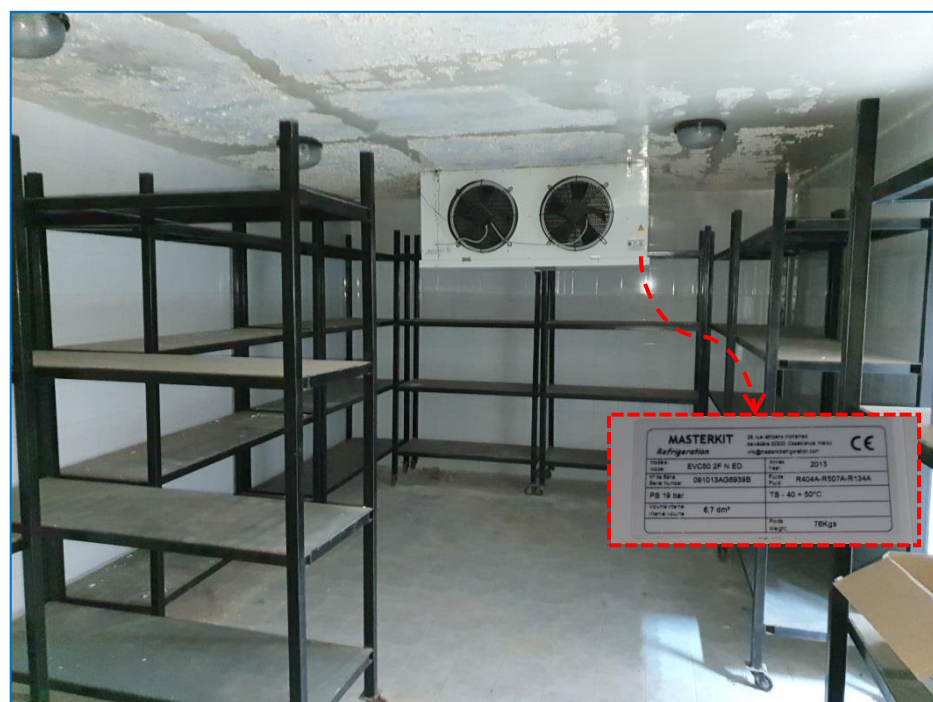
The building requires rehabilitation in many items including repair steel doors and supply PS doors, as well as repairing steel protection grille and supply a new PVC windows instead of defective windows, moreover supplying and installing backup generator, air-condition, and other electrical works as detailed in the BOQ and the shown pictures.
