PREPARATORY CHECKLIST: PROVINCIAL SITE ASSESSMENTS (DRAFT)

(for inclusion in RFP Scope of Services for each site)

Prepared by: PMU Palu Date: 08 June 2020.

PROVINCE	PROVINCE Central Sulawesi		KABUPATEN Kab. Sigi		KECAMATAN	Gumbasa			
SANITATION FACILITY		No		Gol Facility na	ame	Pasar Omu	*		
Street Address Jalan Raya			Raya Po	ros Palu-Kulaw	i		Postco	de

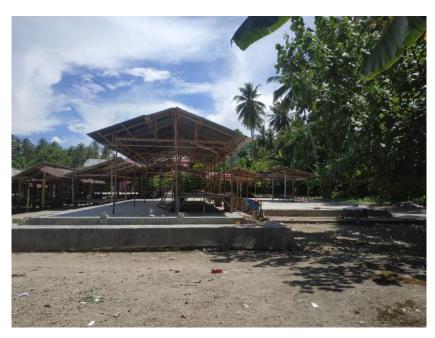
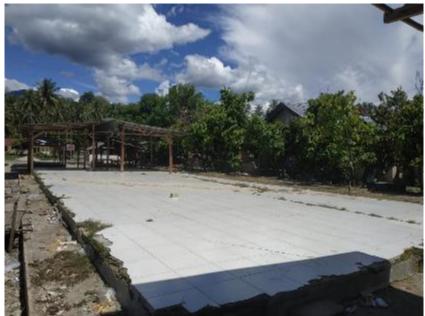
GPS COORDINATE	- 0144729 BT; 2182235 LS							
Damage Severity	HEAVY	Х	MODERATE		LIGHT

PHOTOGRAPHS OF DAMAGE TO BE ADDRESSED THROUGH RFP DCS CONSULTANTS & LATER ITB WORKS

The scope of works to be covered:

1. Reconstruction of office building: 36 m²

2. Reconstruction of Los Bangunan 1: 188 m²

3. Reconstruction of Los Bangunan 2: 176 m²

4. Reconstruction of Los Bangunan 3: 151 m²

5. Site drainage: est. 550 m'

6. Reconstruction of toilet (4 rooms): 6.5 m²

7. Waste collection site: 10 m²
