PREPARATORY CHECKLIST: PROVINCIAL SITE ASSESSMENTS (DRAFT)

Prepared by: PMU Palu Date: 08 June 2020.

PROVINCE Central Sulawesi			KABUPATEN	Kab. Donggala		KECAMATAN	Sir	Sirenja		
SANITATION FACILITY		No		Gol Facility name Pasar Sibado						
Street Address			Jalan 9	Samidjo	amidjo, Tompe, Sirenja			Pos	tcode

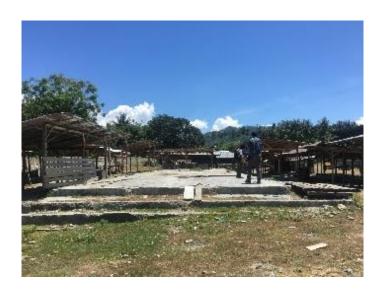
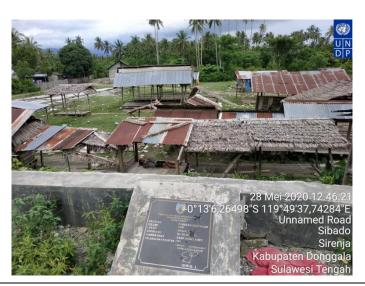
GPS COORDINATE	-0024840 BT; 2168770 LS							
Damage Severity	HEAVY	Х	MODERATE		LIGHT

PHOTOGRAPHS OF DAMAGE TO BE ADDRESSED THROUGH RFP DCS CONSULTANTS & LATER ITB WORKS

The scope of works to be covered:

1. Reconstruction of Los Bangunan 1: 186 m²

2. Reconstruction of Los Bangunan 2: 189.63 m²

3. Site drainage: est. 400 m'

4. Reconstruction of toilet (4 rooms): 6.5 m²

5. Waste collection site: 10 m²
