Terms of Reference – Emergency Conservation works at the church of Agios Charalambos

I. Brief description and Condition assessment

Name: Agios Charalambos church

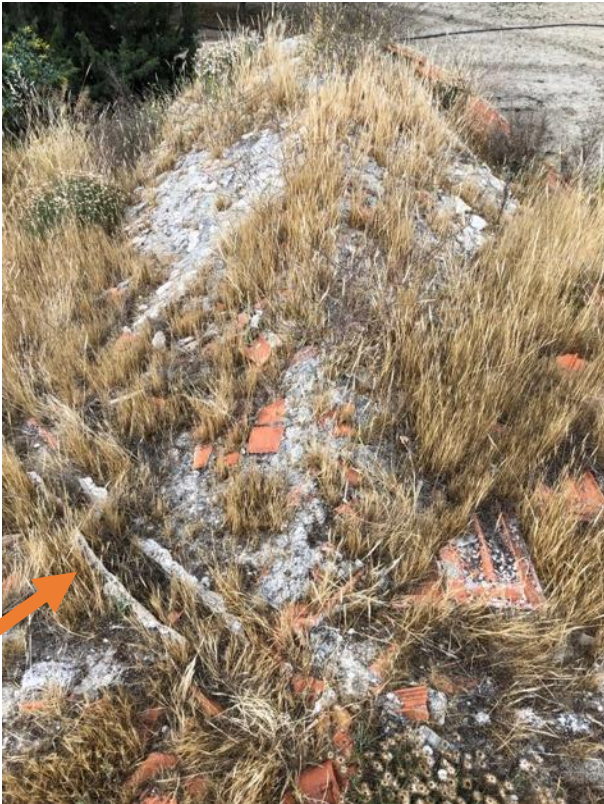
Photos 7 and 8: Roof photos existing drainage system channels are indicated

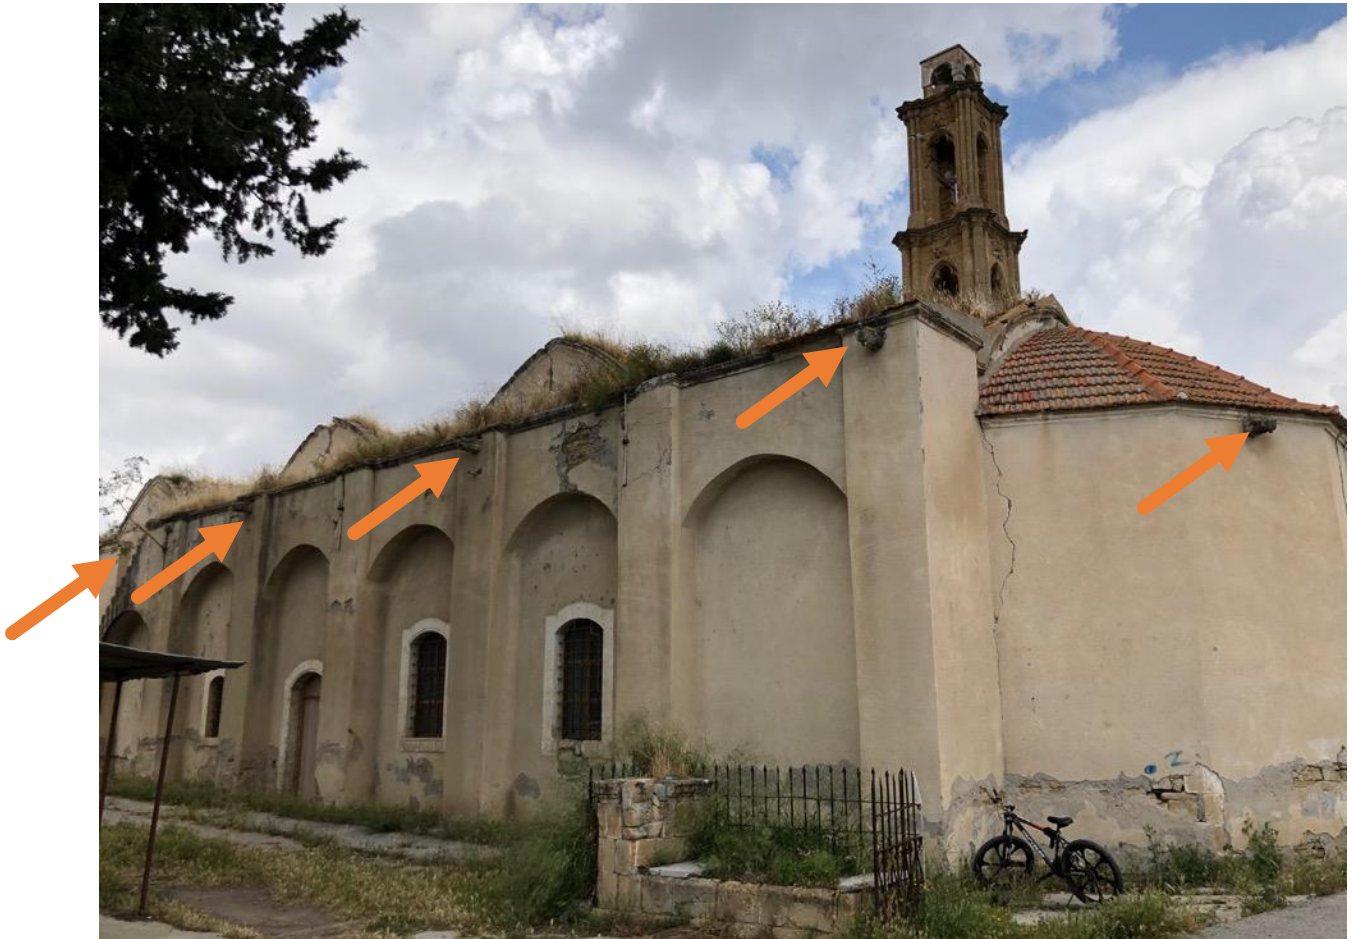
Photo 10: Existing waterspouts/ South facade

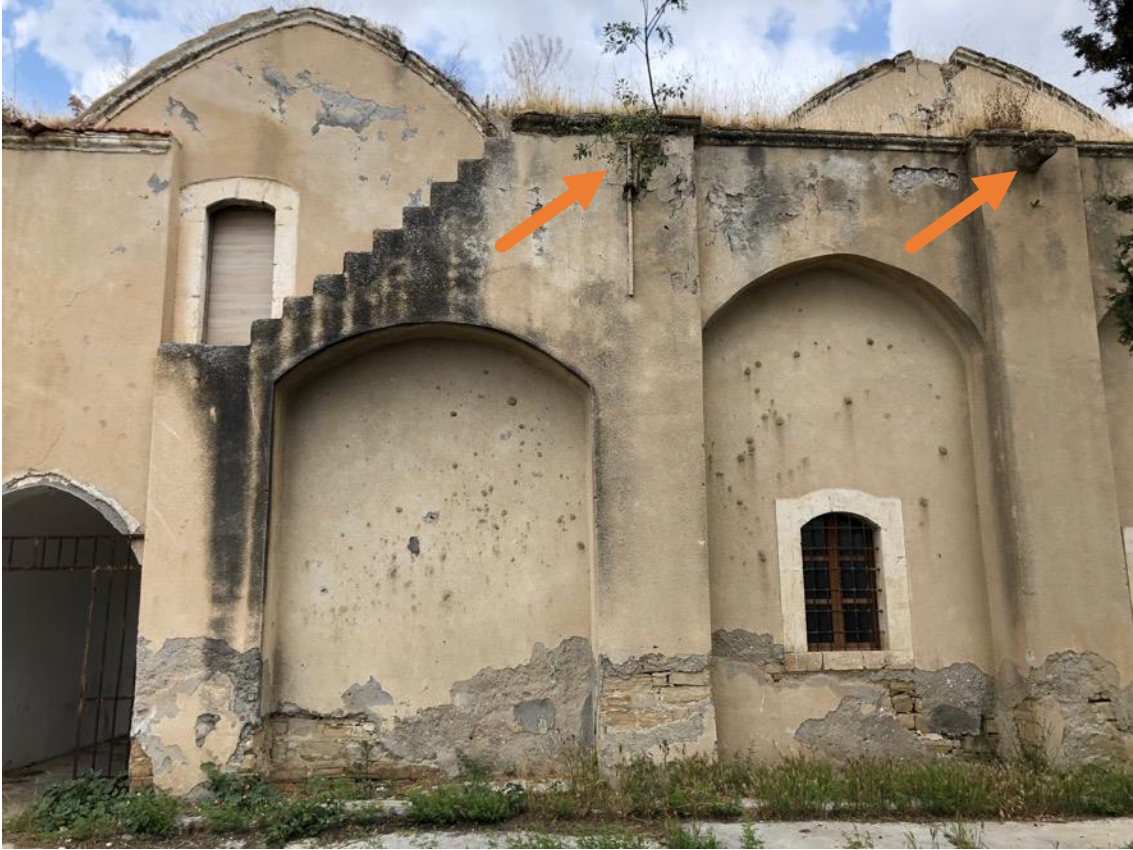
Photo 11: Existing waterspouts/ South facade

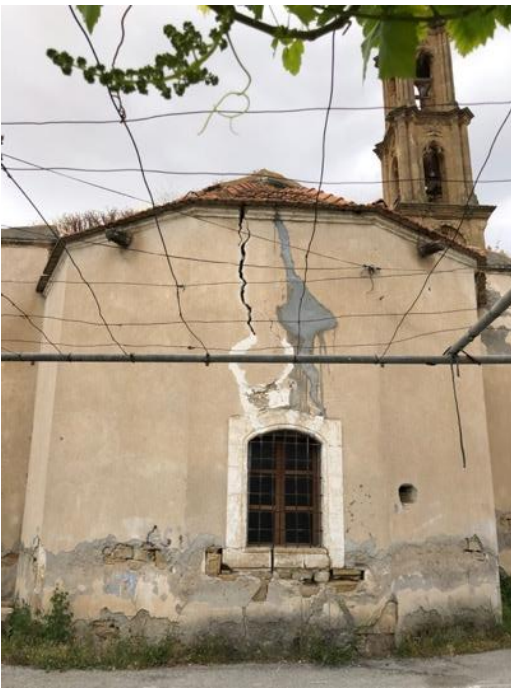
Photo 12: Existing waterspouts/ East facade

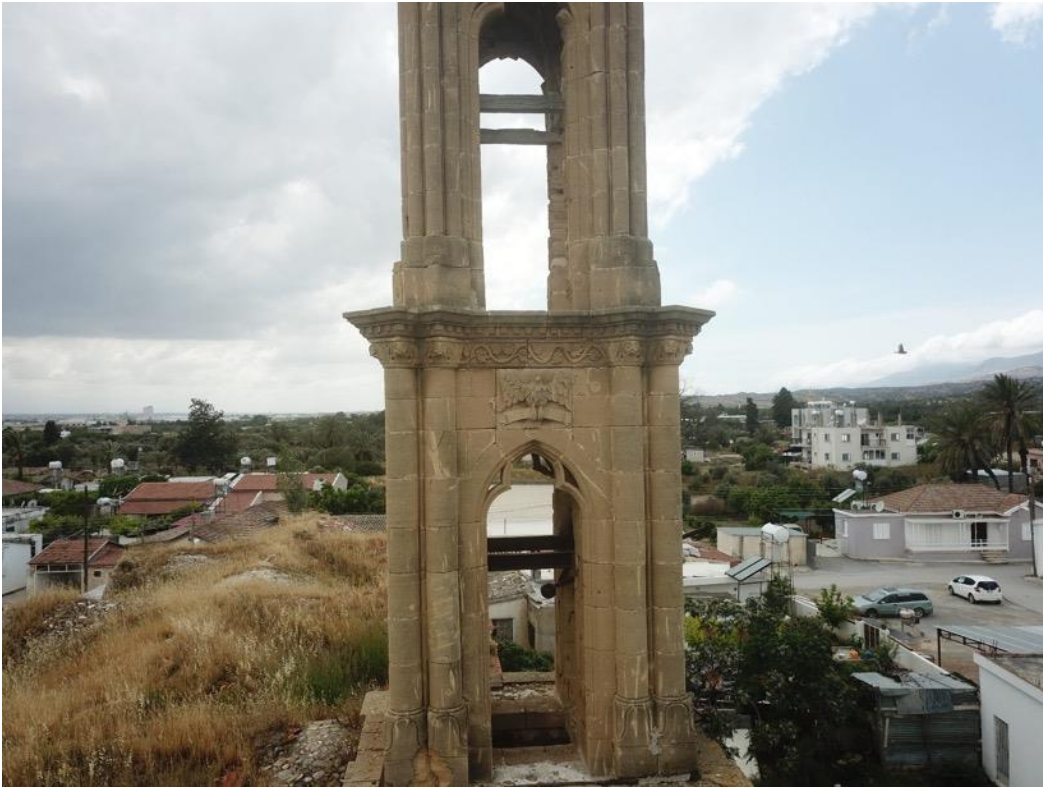
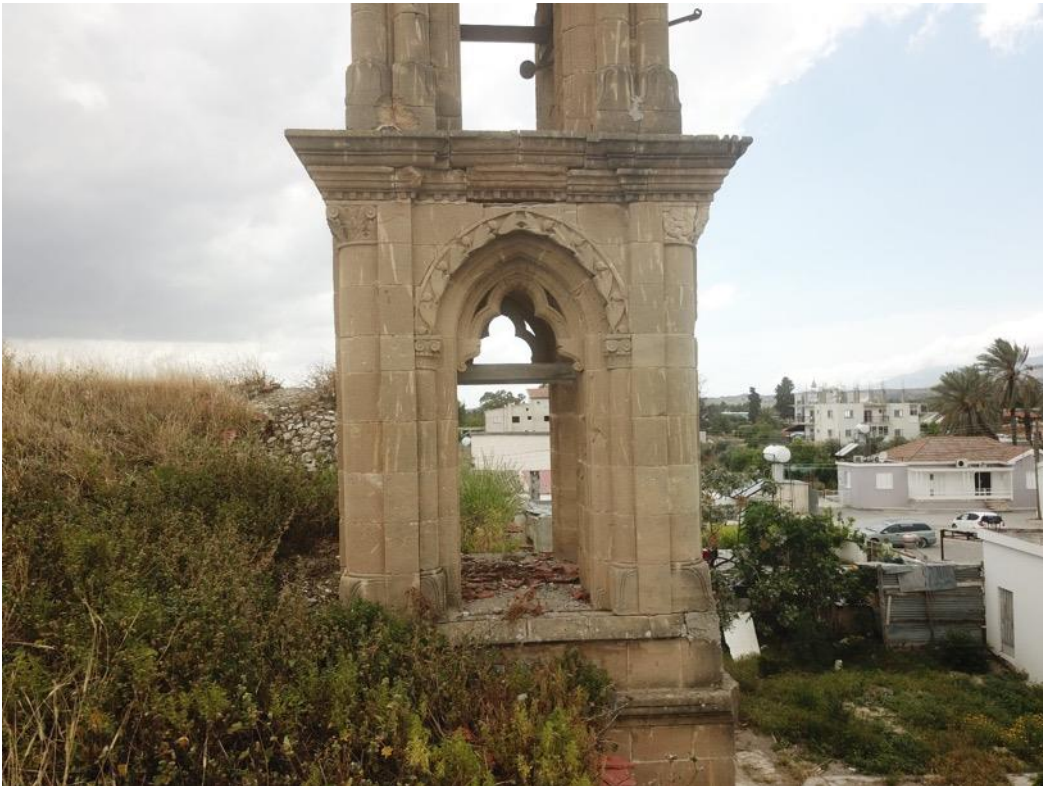
- **Bell-tower:** Furthermore, the bell-tower is in poor condition. The bell tower constitutes a later addition to the church, constructed by ashlar sandstone masonry with carved elements. There are missing carved stone elements on the bell tower and some deteriorated stone areas. Metal elements are introduced in the stone structure by inappropriate workmanship, materials and technique and present extensive rusting. In addition to the above inappropriate cement repairs exist on the bell tower.

Photos 28 and 29 Bell tower: suffering from vegetation, deterioration and loss of materials, erosion of metal elements and inappropriate repairs.

1.8 Strengthening and restore of belfry

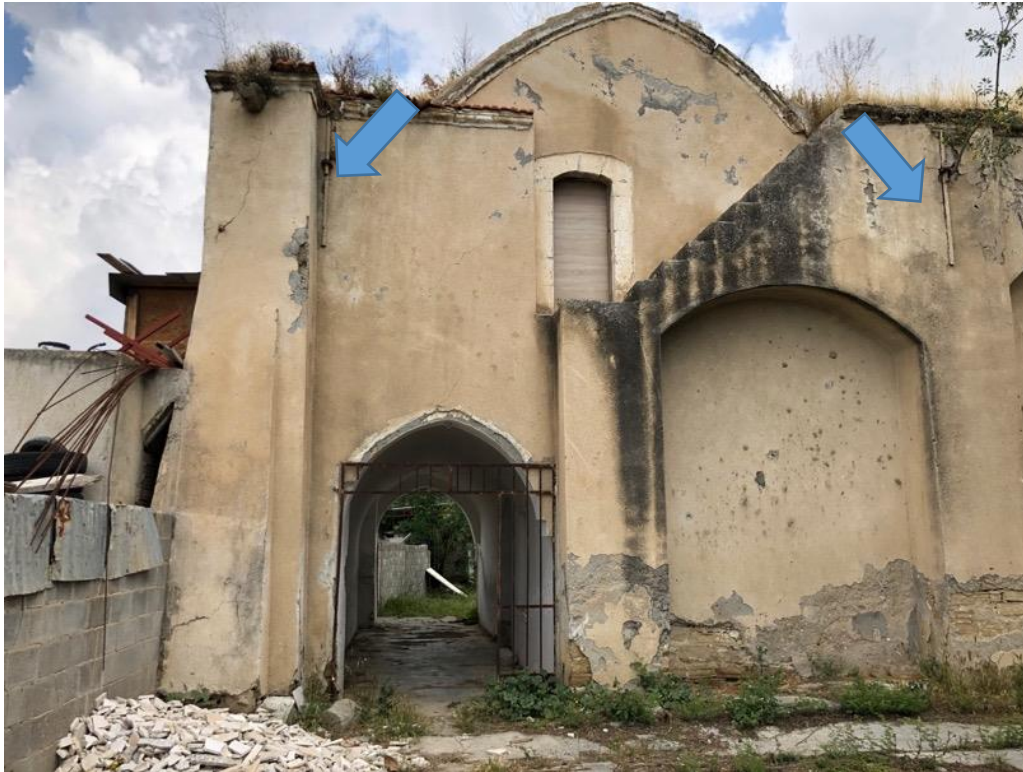
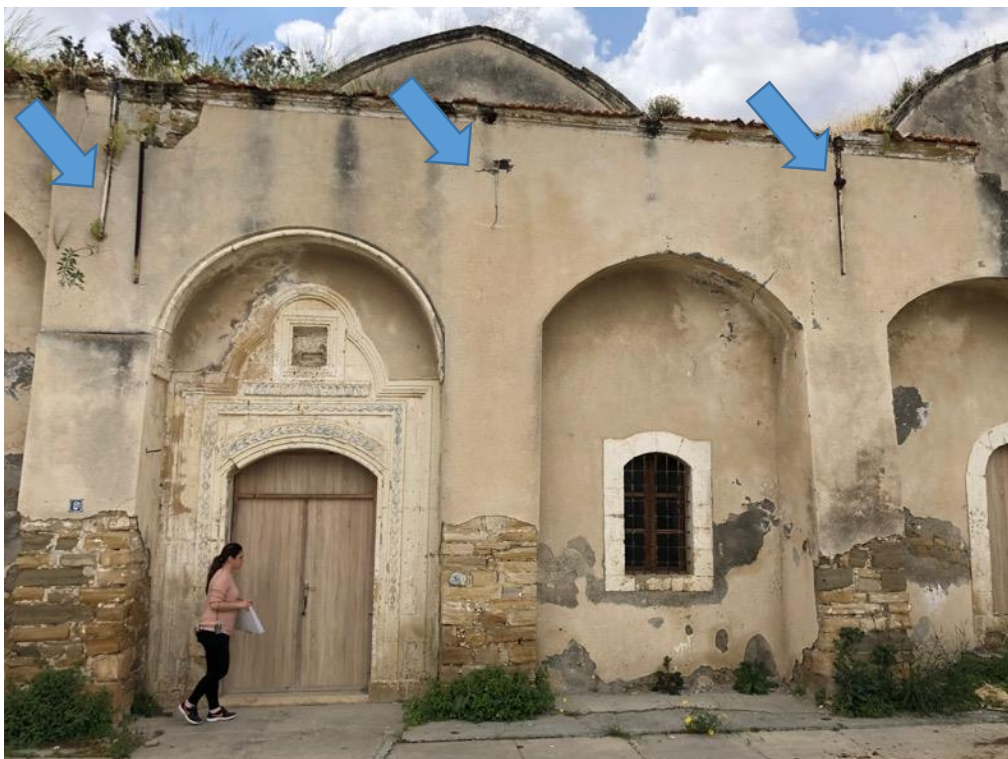
- **Metal tie rods** previously installed for the structural support of the church are present extensive rusting.
- The **timber iconostasis** presents severe deterioration and loss of material.
- The timber elements of the **women's gallery** (ceiling and floor) present severe deterioration created also by insect's infestation. The concrete elements of the women's gallery are also in poor condition.
- **Doors and windows** are broken and/or have missing parts. Metal elements of doors and windows are rusted.
- Structural cracks are observed on **wall and roof masonry**.

Photos 43 and 44: Metal tie rods / All metal elements should be treated.

1.10 Treatment of existing metal rods
