Schedule of Requirement

Specifications for Immediate Works for Erase the Possibility of Further Damage the Church of Ayios Charalambos in Neochorio Kythreas

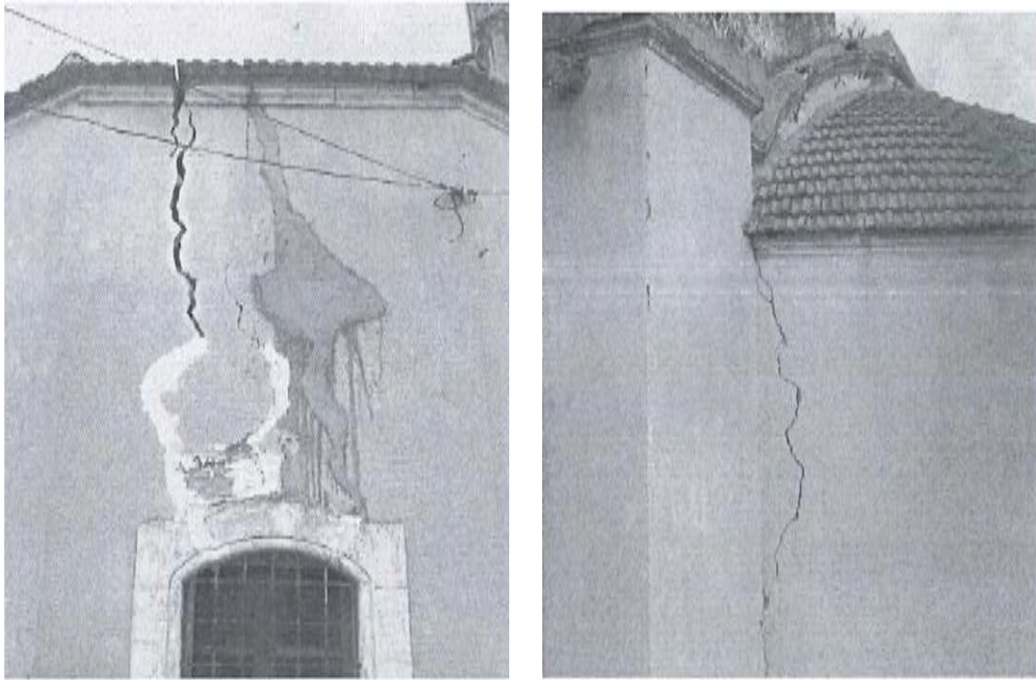
1.4.2 Repairing of the big cracks on the east wall of the church.

In order to repair these huge cracks on the wall that exists on the east wall, the contractor, after the cleaning of the plaster and with the guidance of the engineer of the work, will have to carefully start taking off the stones next to the crack in order to rebuild them in such a way that in every other row of the stone built a tie stone has to cross the crack for a proper stitching of the wall using tie-stones.

- The crack is carefully widened and cleaned by brushing and washing using low abrasive tools and water. It is recommended that a brush and sand paper be used, while high pressure sand blasting and extreme mechanical cleaning must be avoided in order to prevent damage to the stone.

- Stones are removed from the edges of the crack every 0.50m along its length after careful cleaning and tie-stones are built-in at these positions.
- Pointing is removed along the length of the crack at 0.30m on both its sides. Pointing is retained if it is very well preserved.

- After the tie-stones are in place, gallets and/or pointing takes place using lime mortar. Pointing should be recessed at about 0.5-1.0 cm from the exterior face of the stones and be placed neither deeper than the exterior surface of the wall nor protruding from it. During these processes care should be taken in order to maintain the exterior surface of the stones clean.
