Terms of Reference – Emergency conservation works at the church of Agios Charalambos

I. Brief description and Condition assessment**Name:** Agios Charalambos church**Building Period:** Estimated 1830s**Church Typology:** single-story with women's gallery towards the west, single-nave with a cross-vaulted roof system and semi-open narthex towards the west.**Construction Materials:**

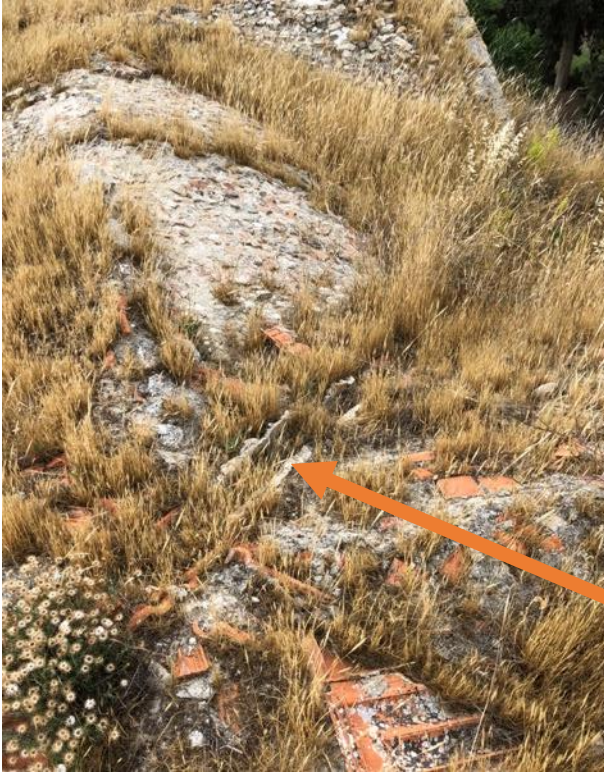
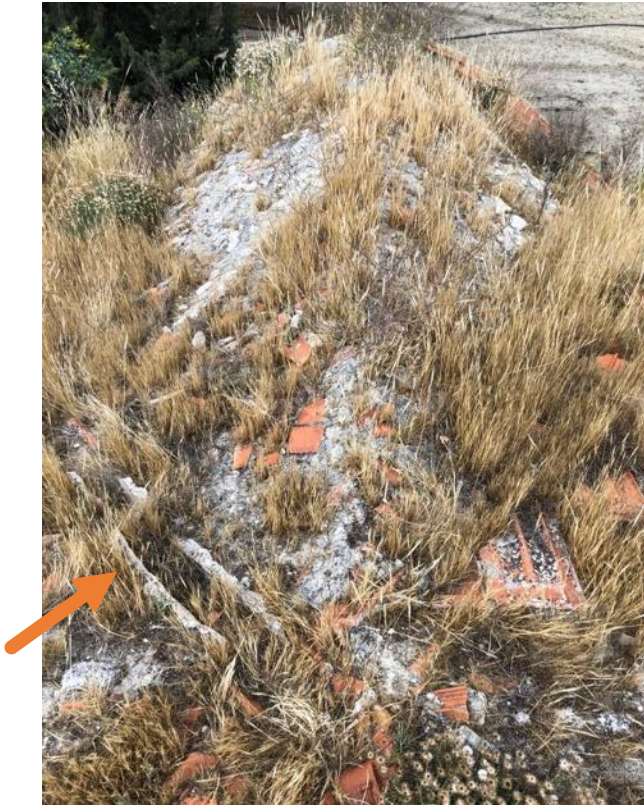
Photos 7 and 8: Roof photos existing drainage system channels are indicated

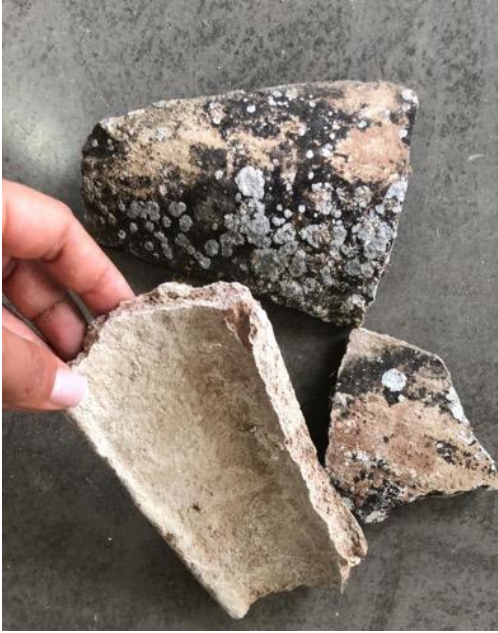
Photo 9: Original 'Byzantine Style' tiles of the roof identified on site

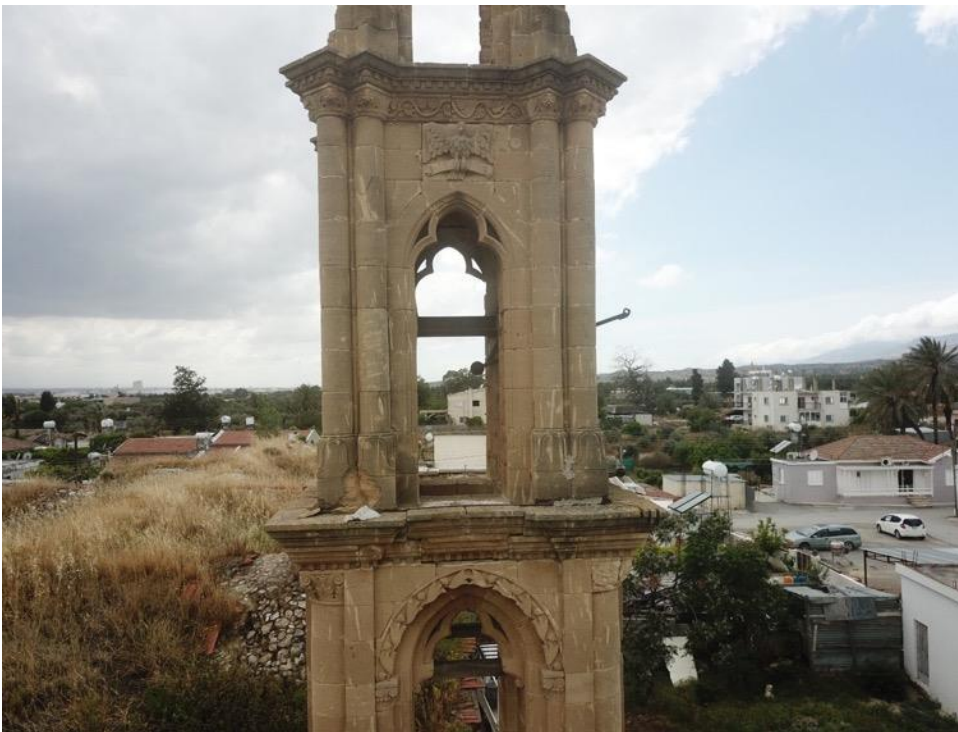
Photos 25 and 26 Bell tower: suffering from vegetation, deterioration and loss of materials, erosion of metal elements and inappropriate repairs.

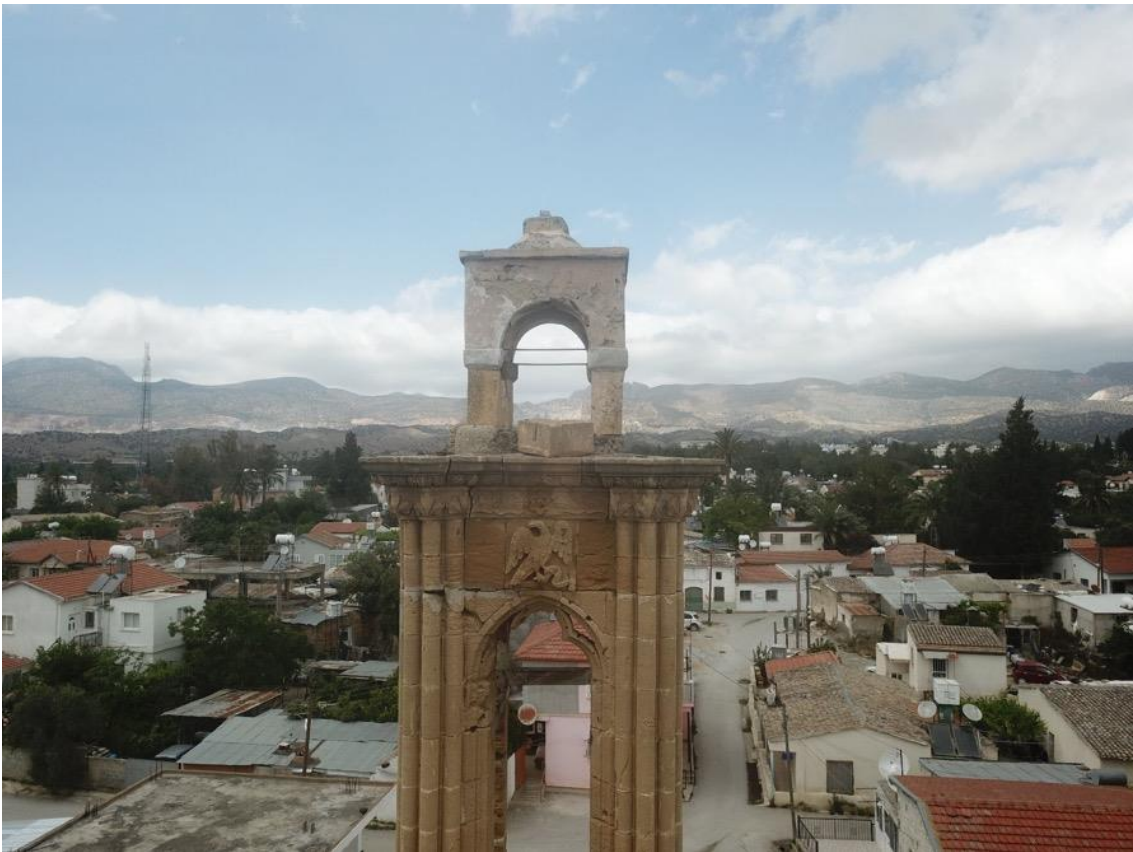
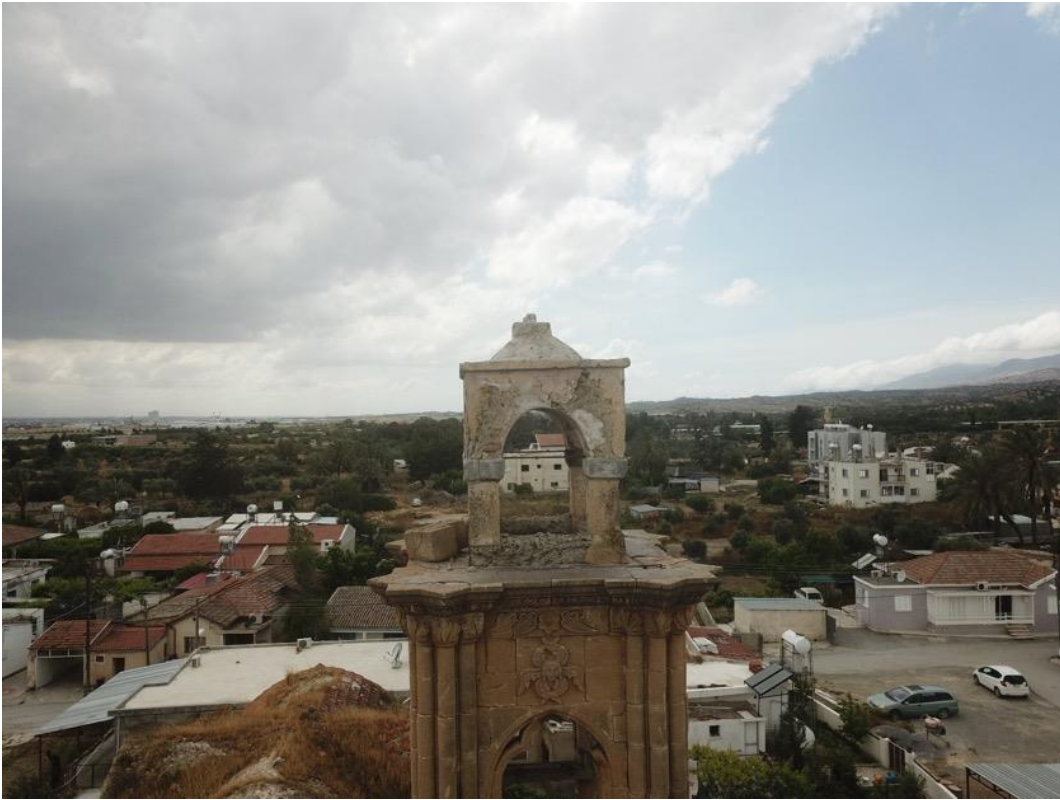
Photos 30,31,32 and 33 Bell tower: suffering from vegetation, deterioration and loss of materials, erosion of metal elements and inappropriate repairs.

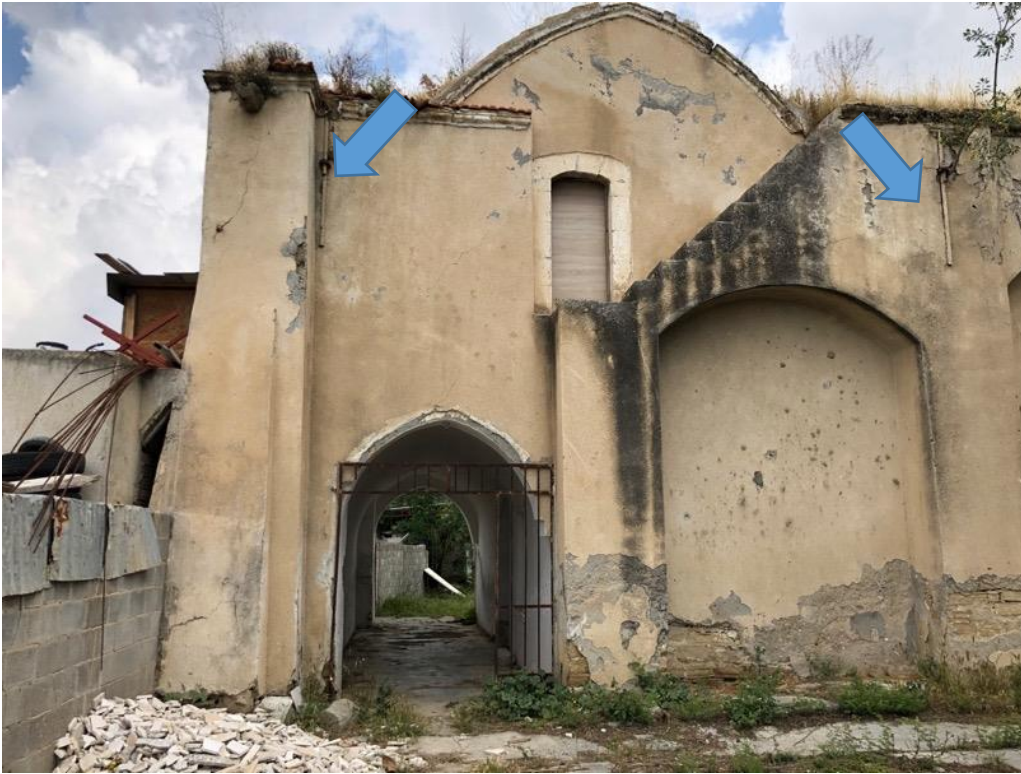
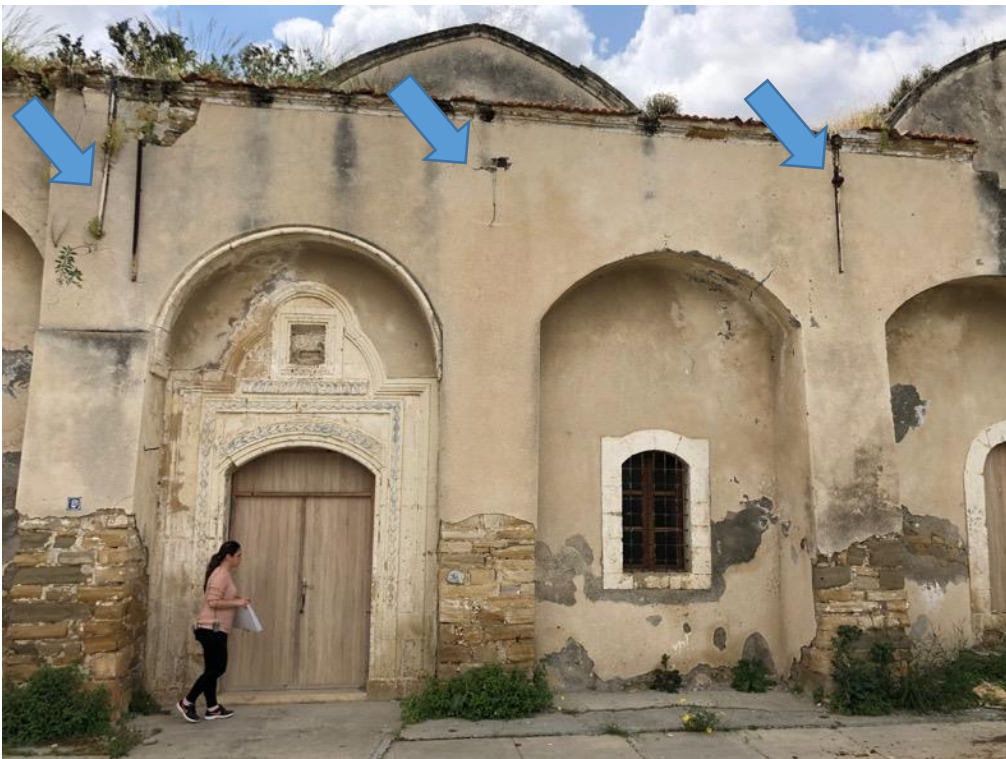
Photos 43 and 44: Metal tie rods / All metal elements should be treated.

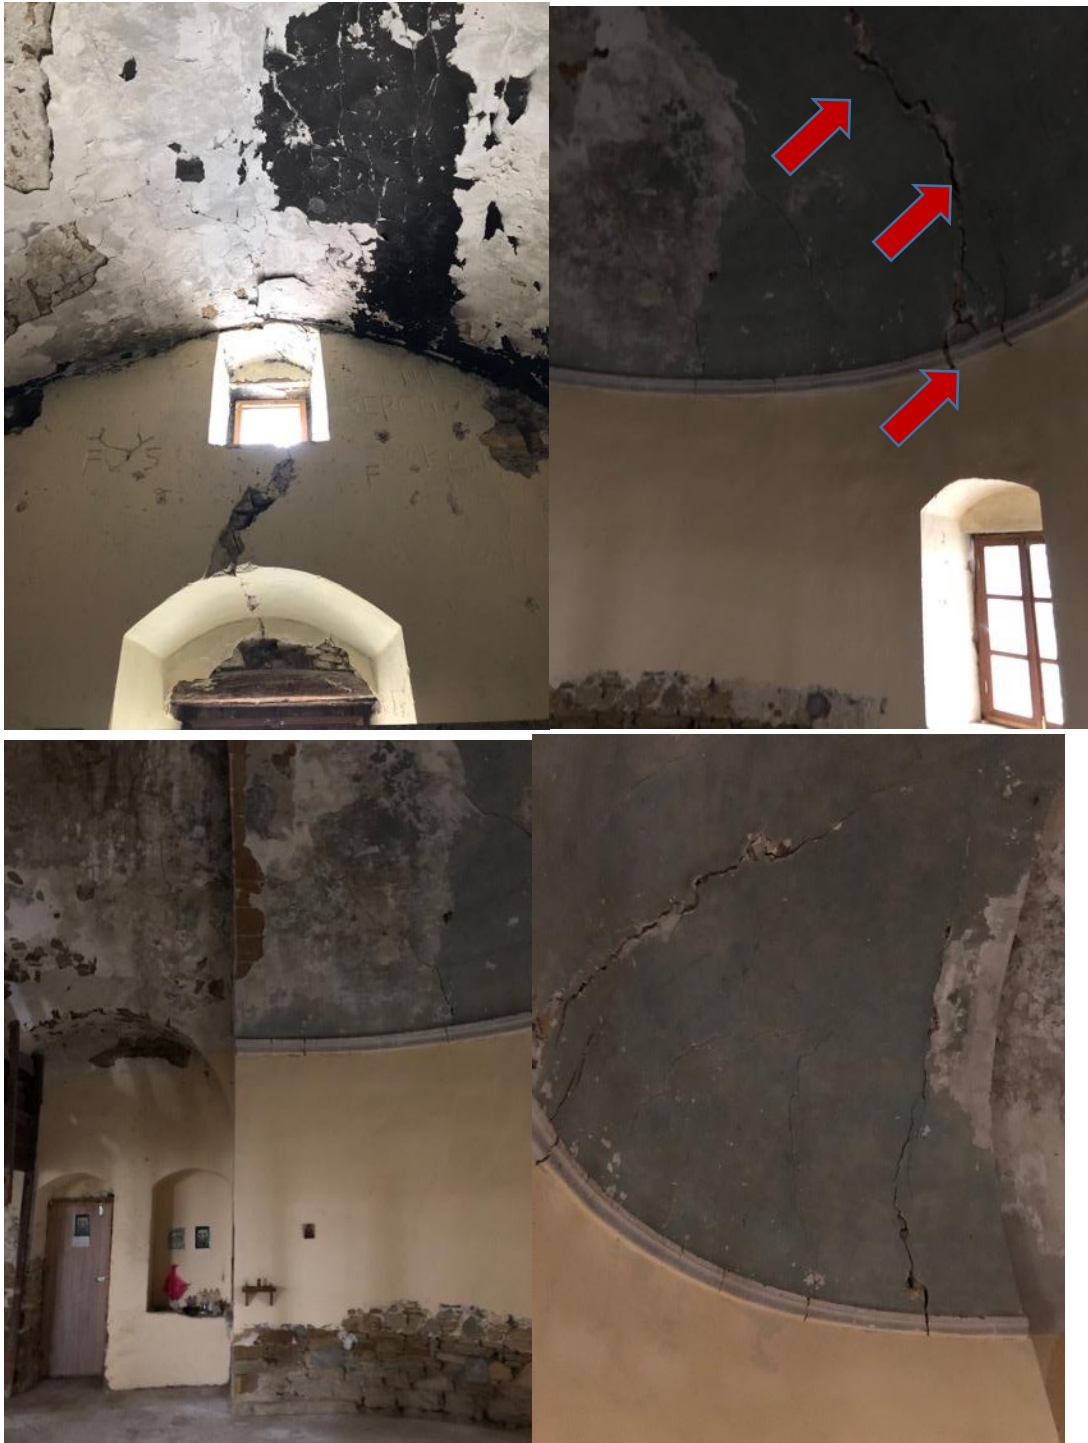
Photo 56.5,56.6, 56.7, 56.8: Cracks / indoor
