Specifications for Immediate Works for Erase the Possibility of Further Damage the Church of Ayios Charalambos in Neochorio Kythreas

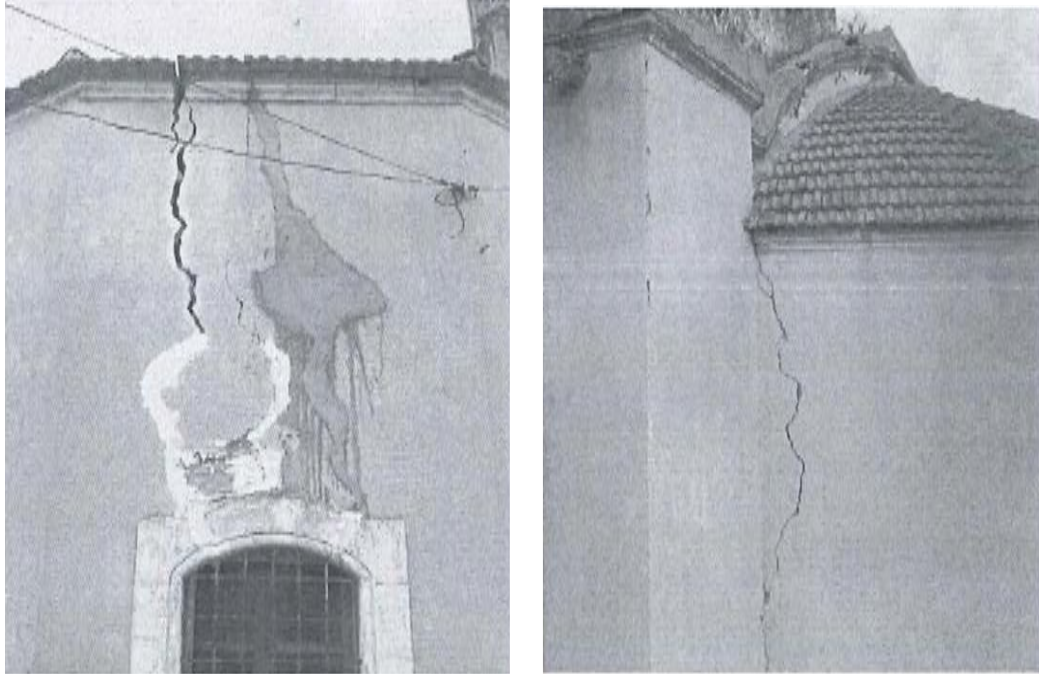
1.4.2 Repairing of the big cracks on the east wall of the church.

In order to repair these huge cracks on the wall that exists on the east wall, the contractor, ~~after the cleaning of the plaster and~~ with the guidance of the engineer of the work, will have to carefully start taking off the stones next to the crack in order to rebuild them in such a way that in every other row of the stone built a tie stone has to cross the crack for a proper stitching of the wall using tie-stones.

- The crack is carefully widened and cleaned by brushing and washing using low abrasive tools and water. It is recommended that a brush and sand paper be used, while high pressure sand blasting and extreme mechanical cleaning must be avoided in order to prevent damage to the stone.

- Stones are removed from the edges of the crack every 0.50m along its length after careful cleaning and tie-stones are built-in at these positions.
- Pointing is removed along the length of the crack at 0.30m on both its sides. Pointing is retained if it is very well preserved.

- After the tie-stones are in place, gallets and/or pointing takes place using lime mortar. Pointing should be recessed at about 0.5-1.0 cm from the exterior face of the stones and be placed neither deeper than the exterior surface of the wall nor protruding from it. During these processes care should be taken in order to maintain the exterior surface of the stones clean.
