<u>Specifications for Immediate Works for Erase the Possibility of Further Damage the Church of Ayios</u> Charalambos in Neochorio Kythreas

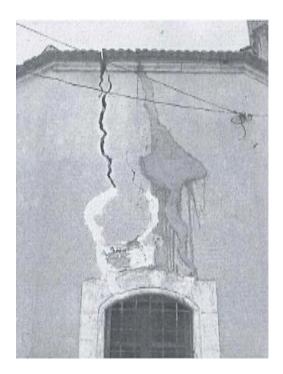
## 1.4.2 Repairing of the big cracks on the east wall of the church.

In order to repair these huge cracks on the wall that exists on the east wall, the contractor, after the cleaning of the plaster and with the guidance of the engineer of the work, will have to carefully start taking off the stones next to the crack in order to rebuild them in such a way that in every other row of the stone built a tie stone has to cross the crack for a proper stitching of the wall using tie-stones.

- Stones are removed from the edges of the crack every 0.50m along its length after careful cleaning and tie-stones are built-in at these positions.
- Pointing is removed along the length of the crack at 0.30m on both its sides. Pointing is retained if it is very well preserved.

- After the tie-stones are in place, gallets and/or pointing takes place using lime mortar.
  Pointing should be recessed at about 0.5-1.0 cm from the exterior face of the stones and be placed neither deeper than the exterior surface of the wall nor protruding from it. During these processes care should be taken in order to maintain the exterior surface of the stones clean.
