Terms of Reference – Emergency conservation works at the church of Agios Charalambos

I. Brief description and Condition assessment**Name:** Agios Charalambos church**Building Period:** Estimated 1830s**Church Typology:** single-story with women's gallery towards the west, single-nave with a cross-vaulted roof system and semi-open narthex towards the west.**Construction Materials:**

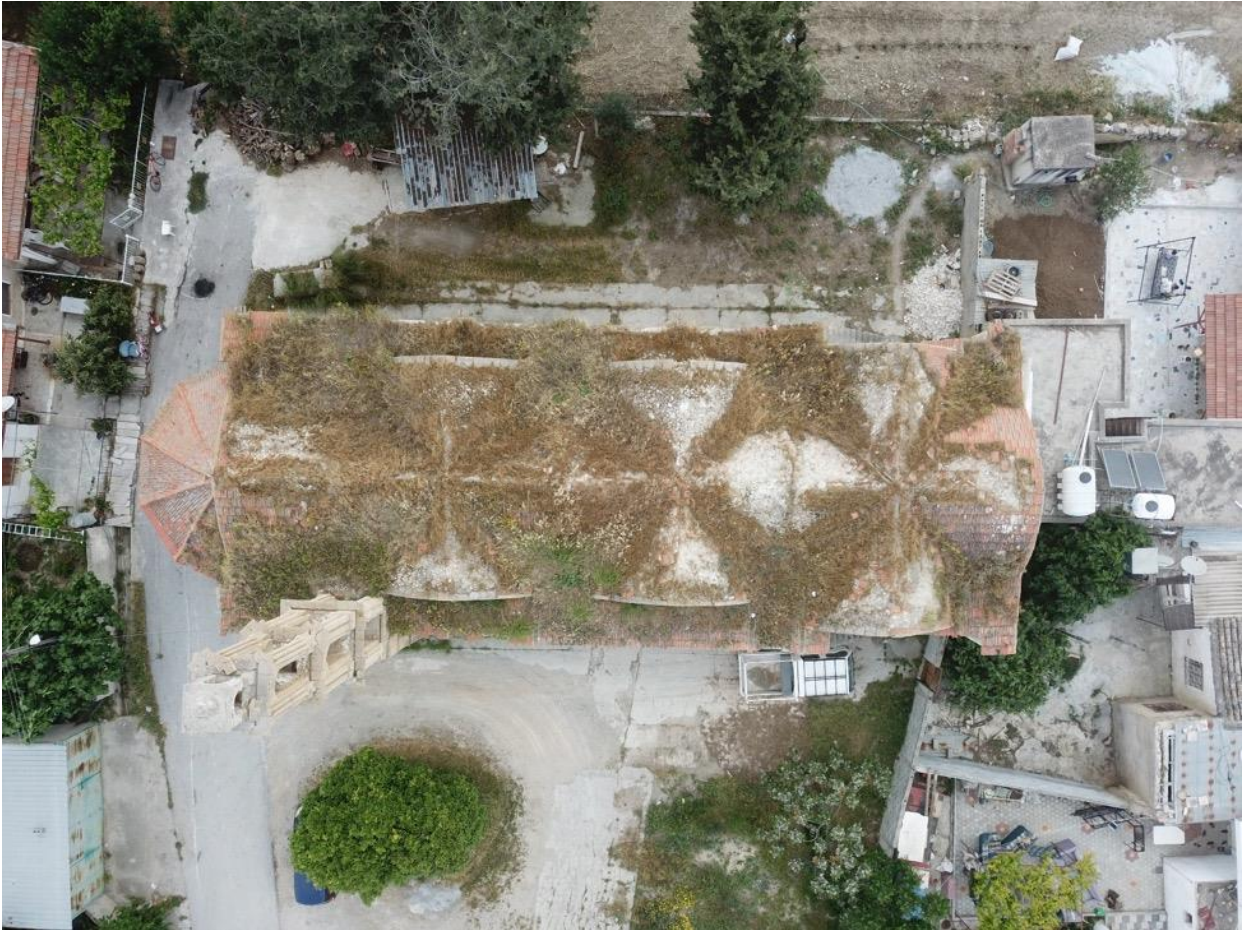
Photo 1: Roof photo: Extensive vegetation, deterioration of the roof mortar and loss of tiles is visible.

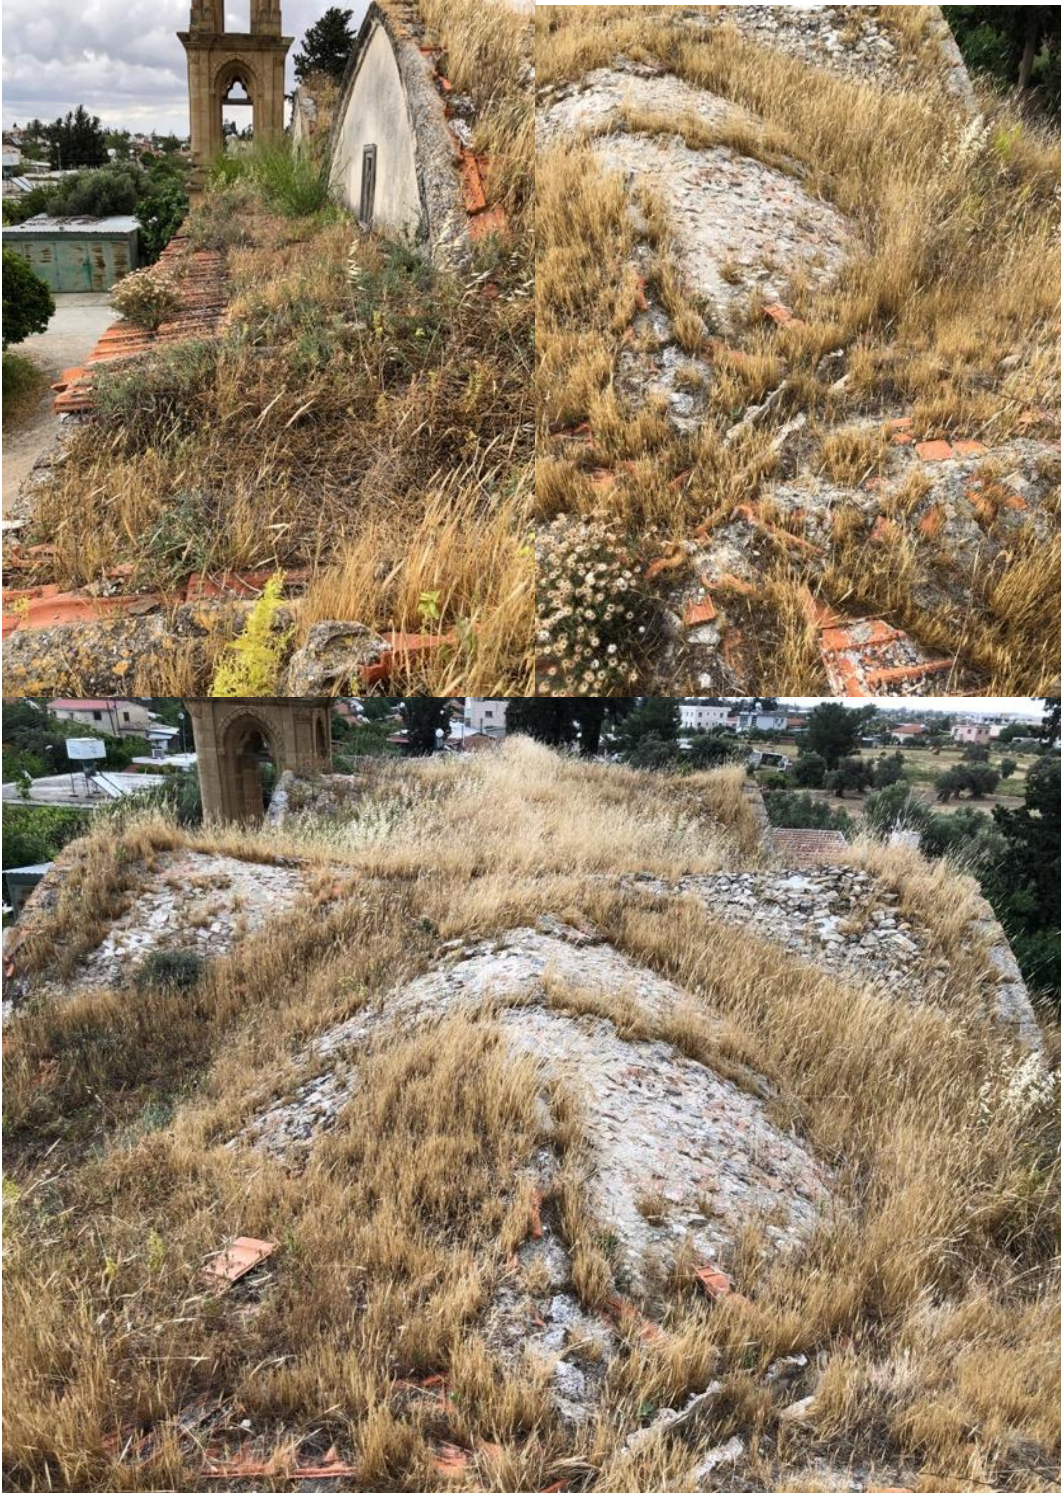
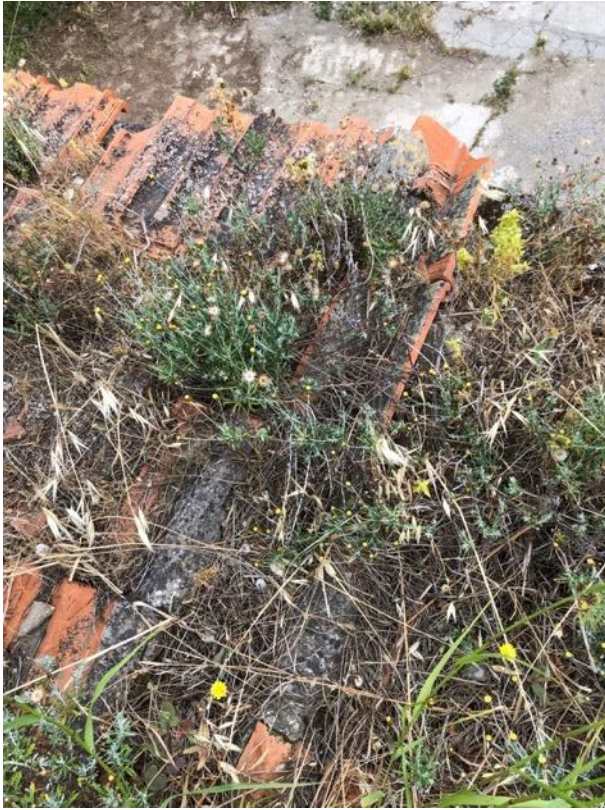
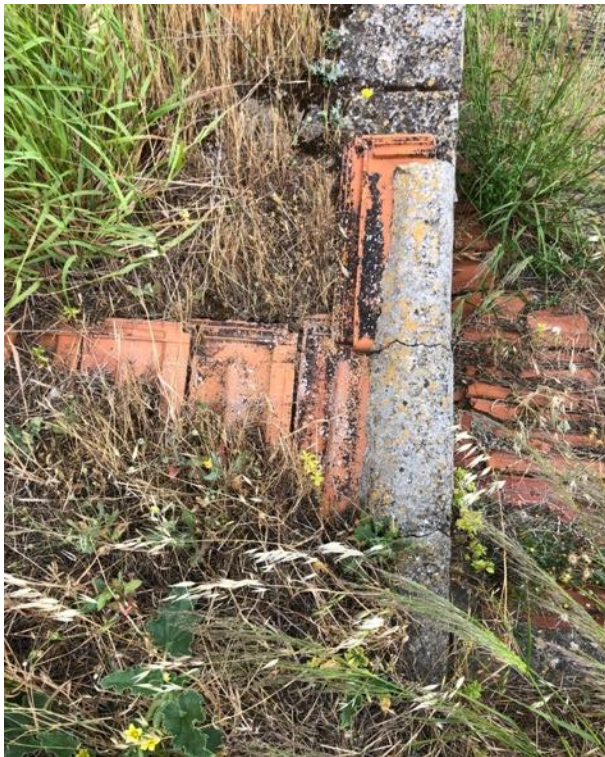
Photos 2, 3 and 4: Roof photos: Extensive vegetation, deterioration of the roof mortar and loss of tiles.

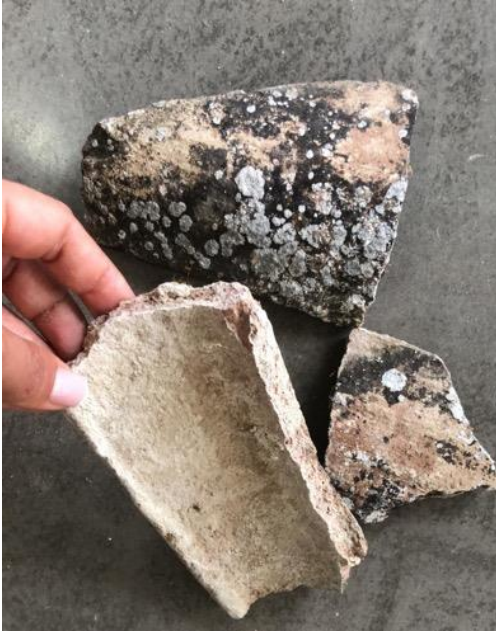
Photo 9: Original 'Byzantine Style' tiles of the roof identified on site

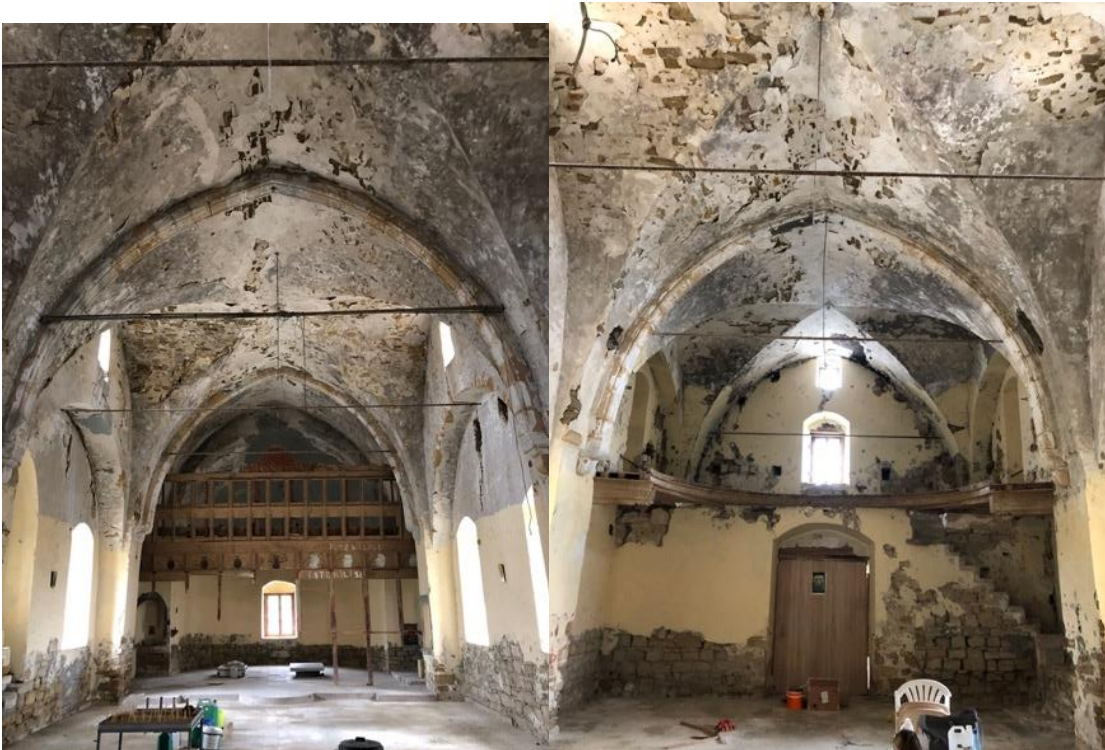
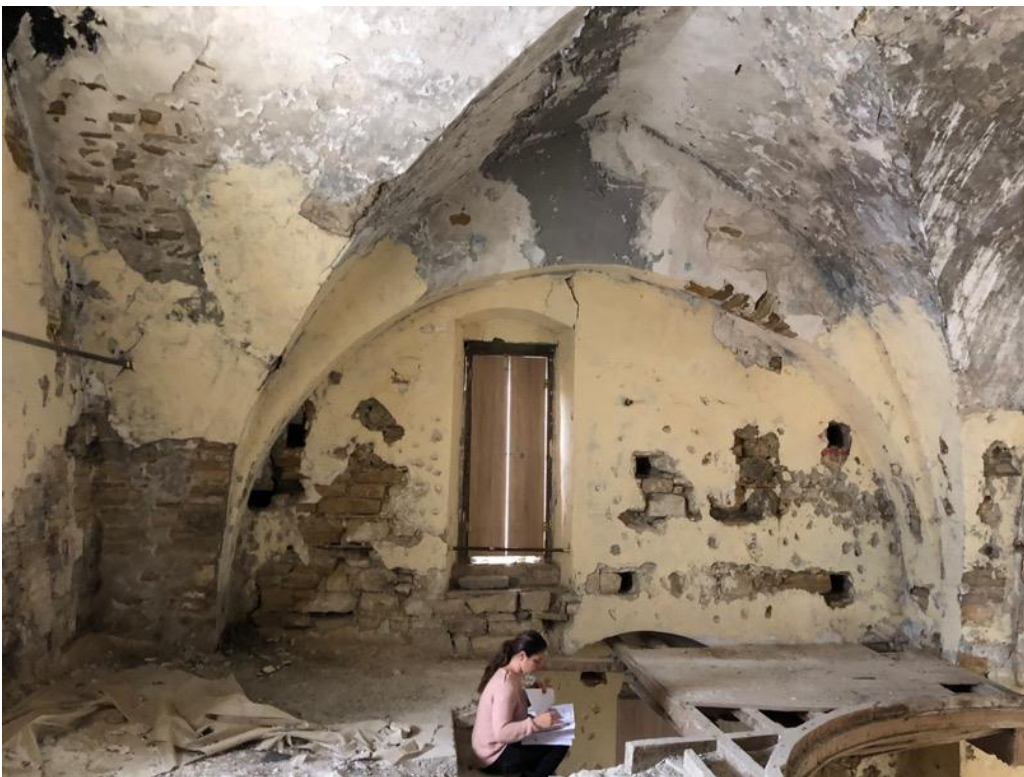
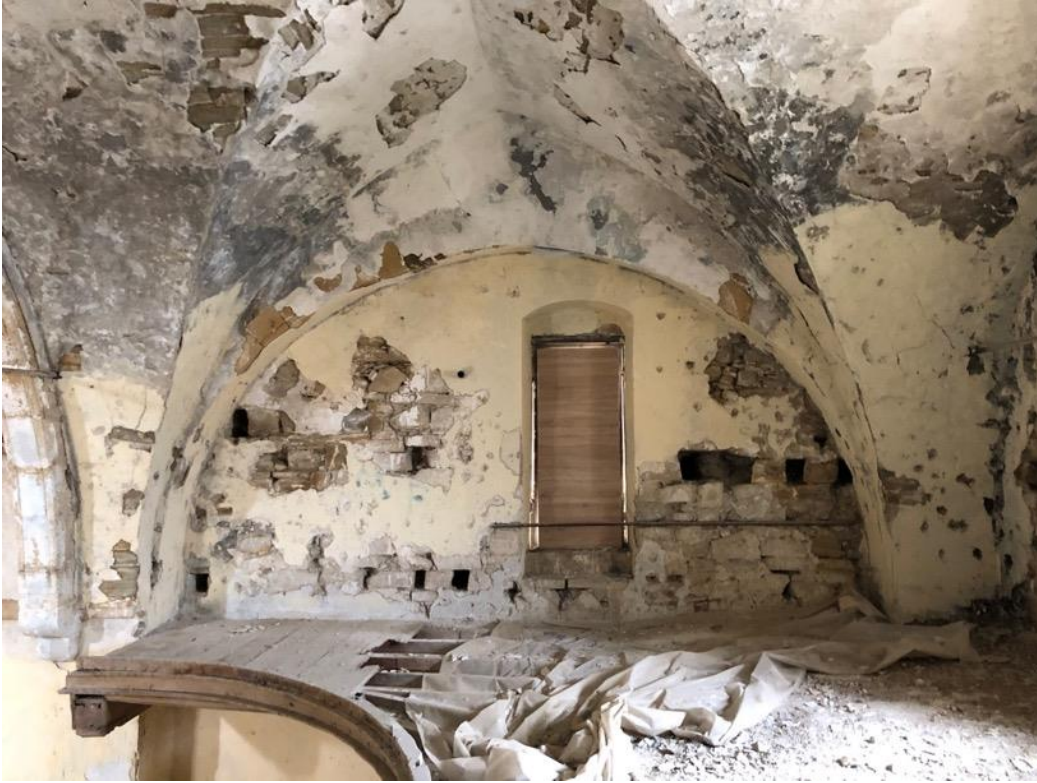
Photos 13 and 14: Roof ceiling: water ingress due to the issues of the roof

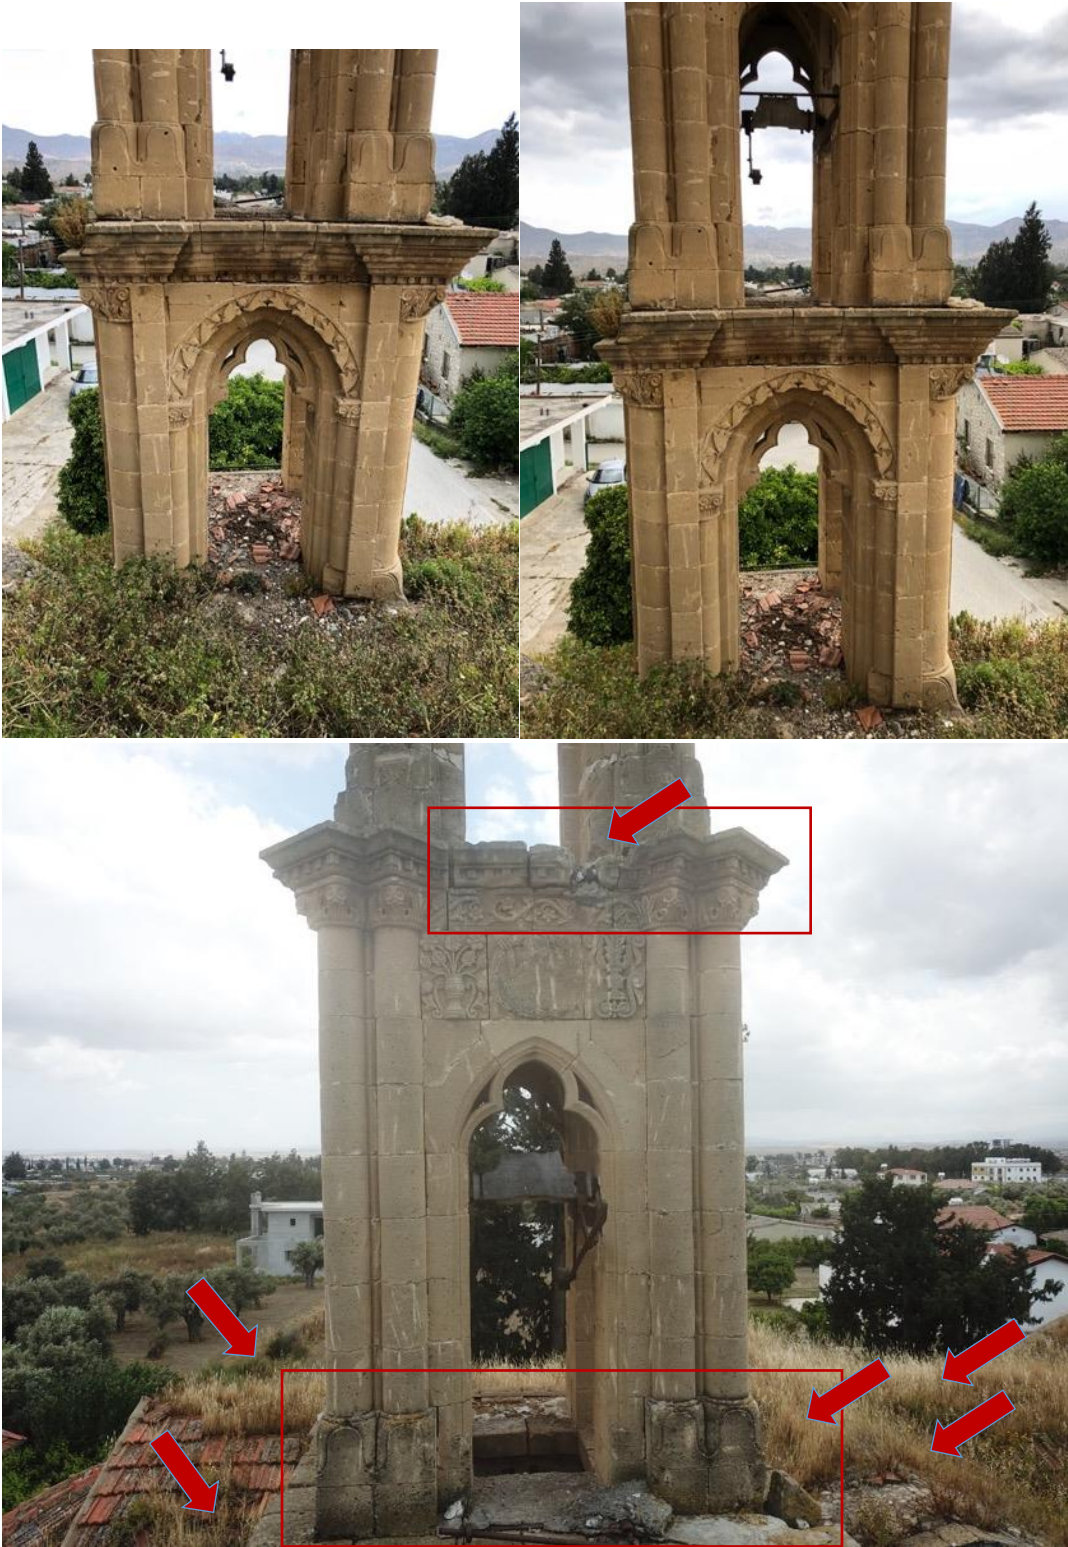
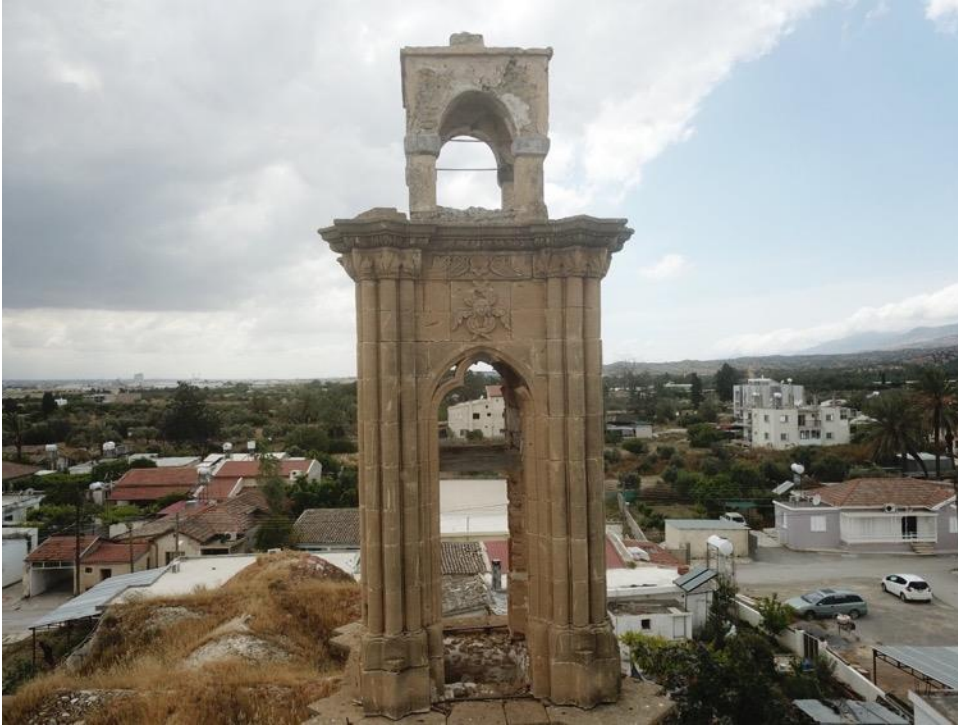
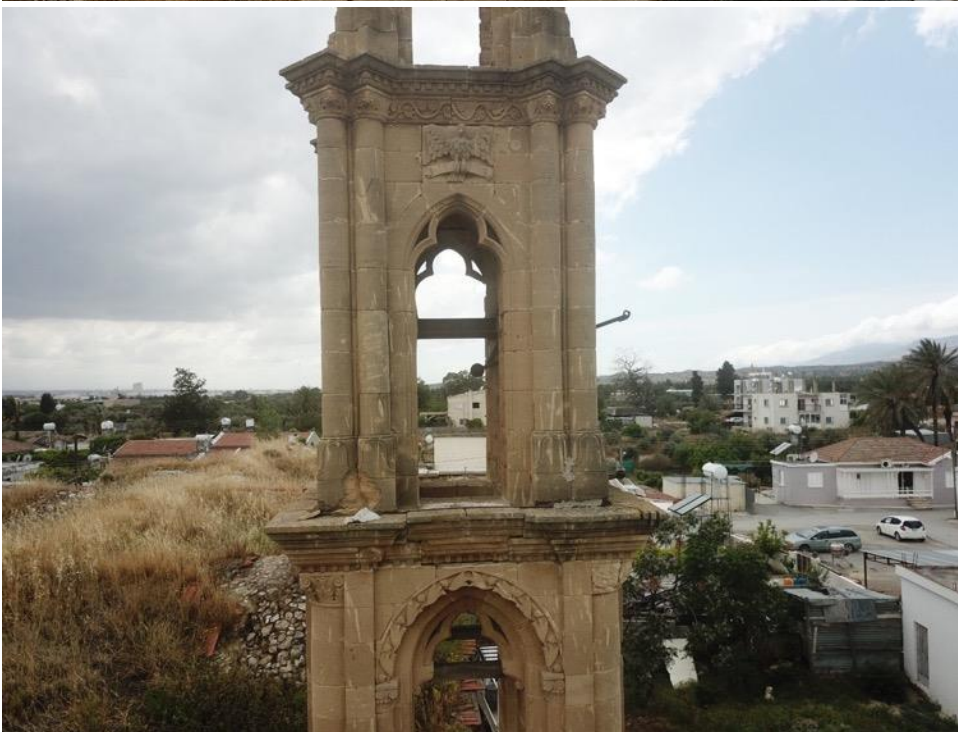
Photos 22,23 and 24 Bell tower: suffering from vegetation, deterioration and loss of materials, erosion of metal elements and inappropriate repairs.

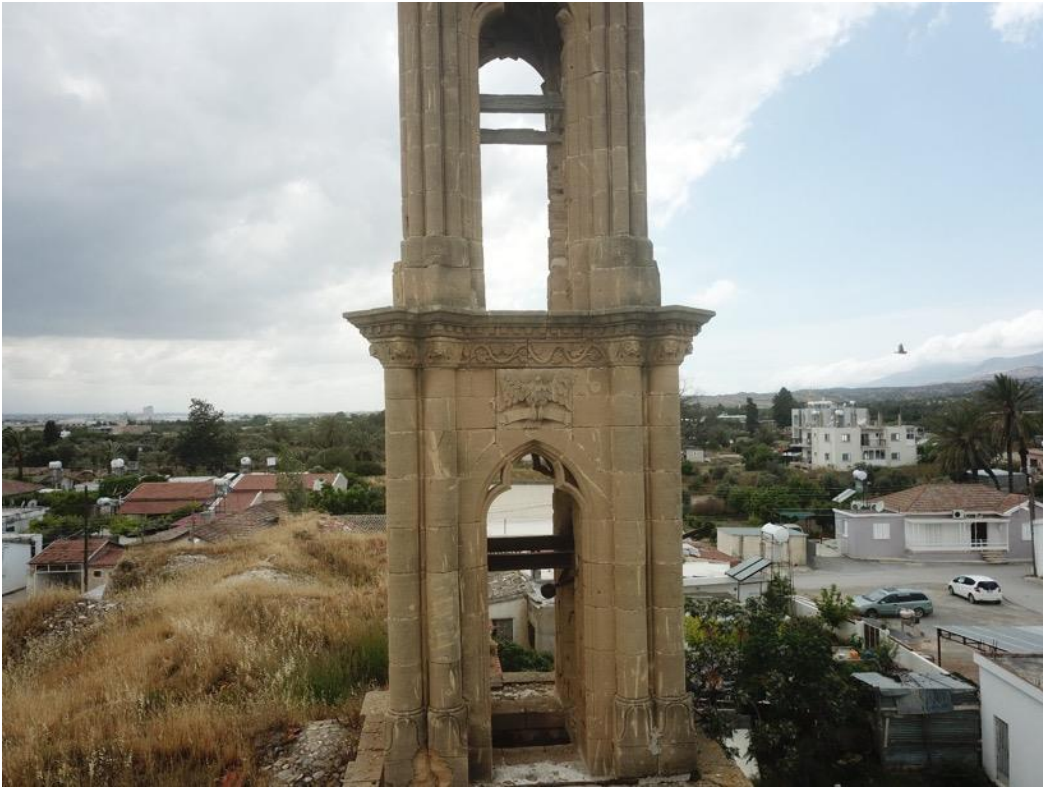
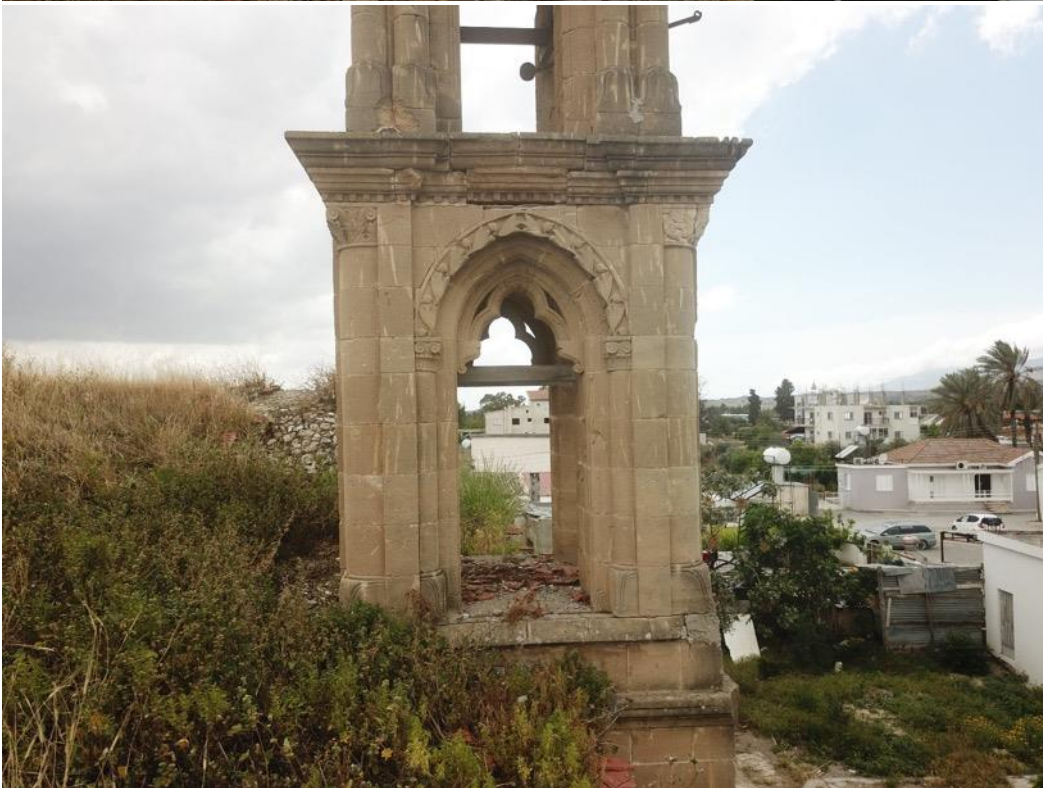
Photos 25 and 26 Bell tower: suffering from vegetation, deterioration and loss of materials, erosion of metal elements and inappropriate repairs.

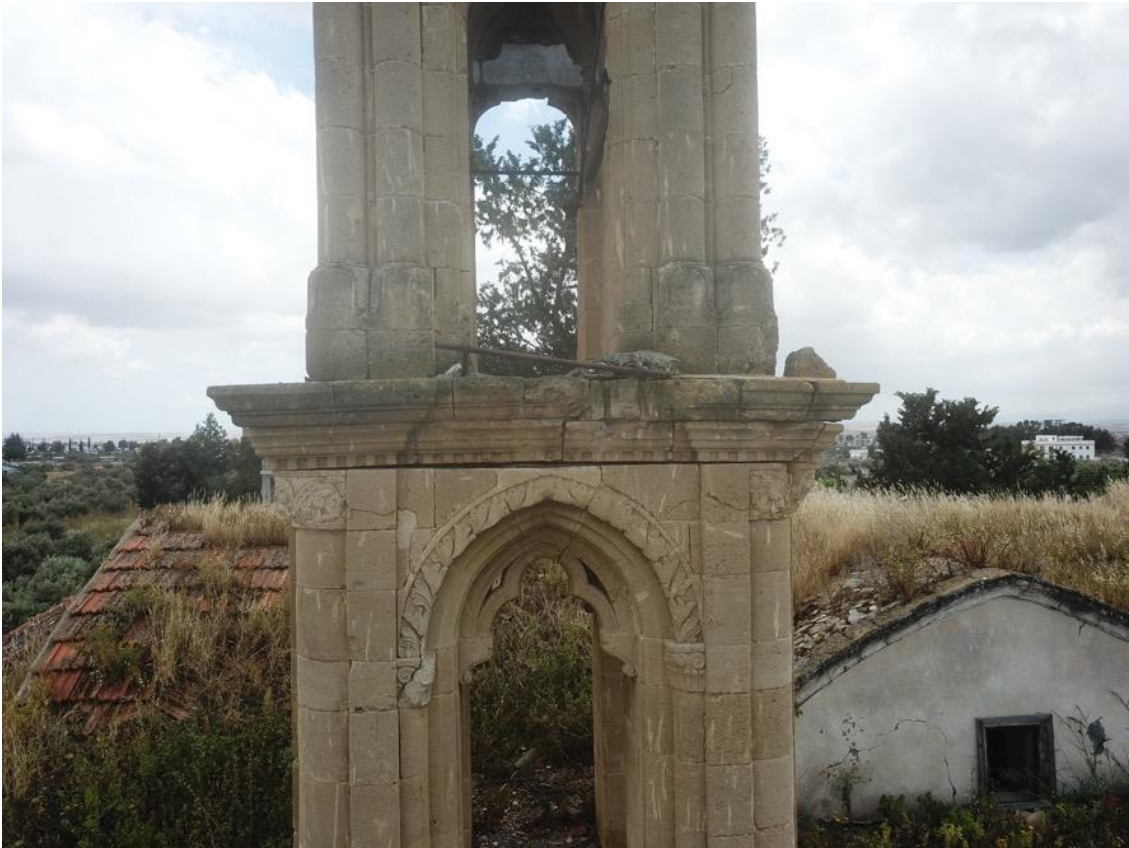
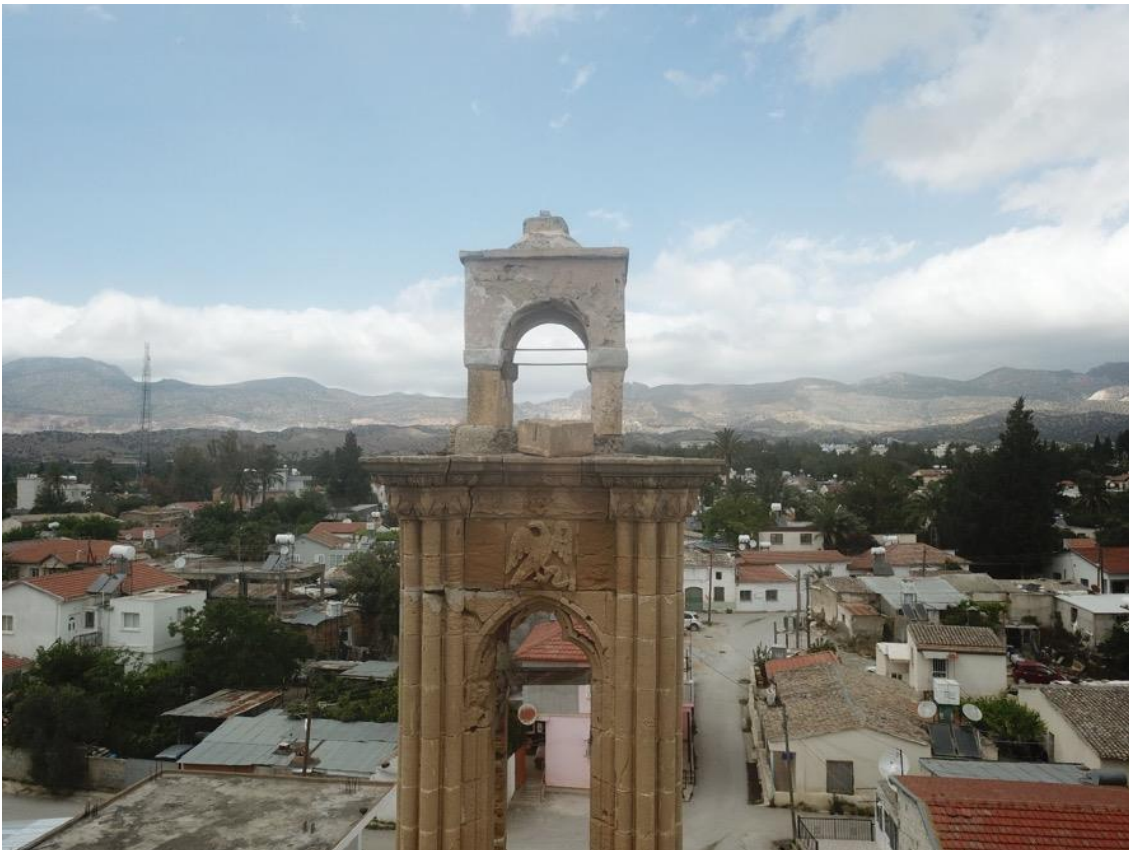
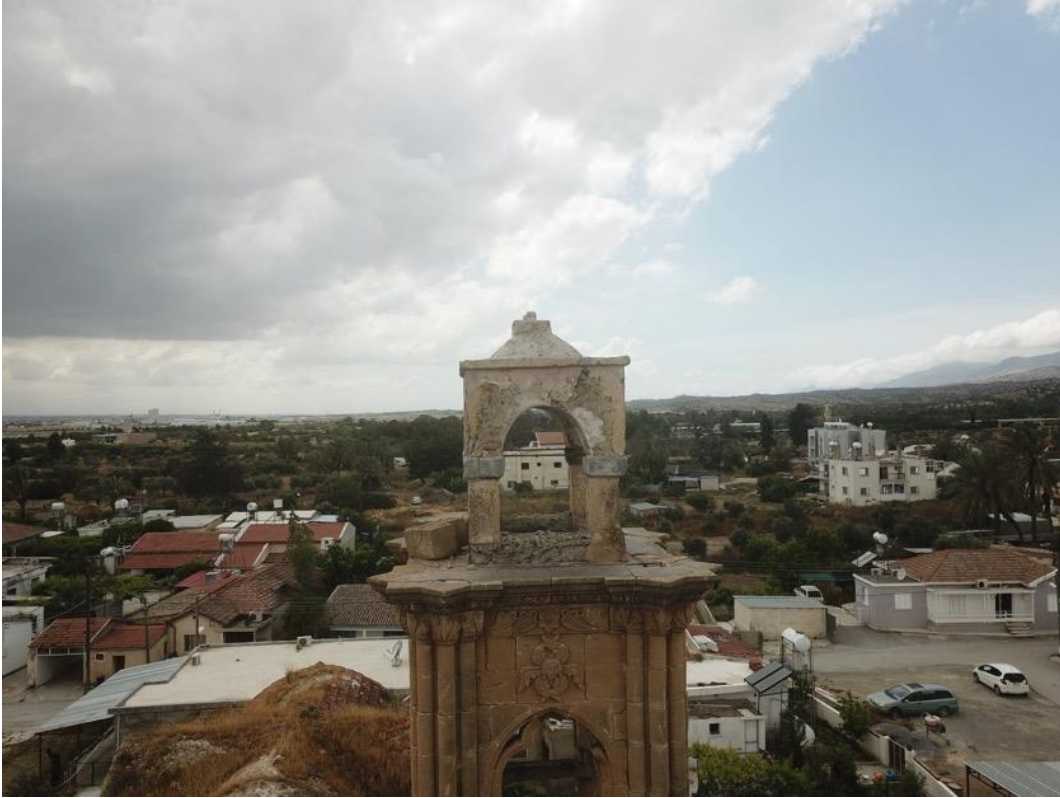
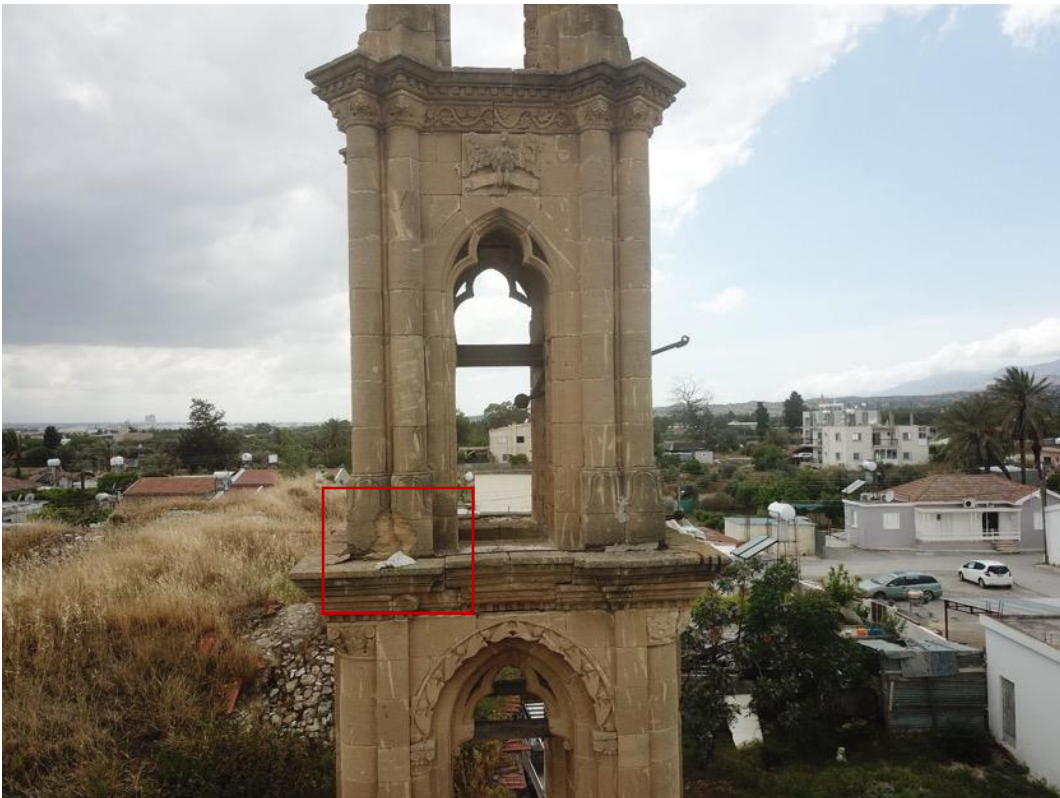
Photos 30,31,32 and 33 Bell tower: suffering from vegetation, deterioration and loss of materials, erosion of metal elements and inappropriate repairs.

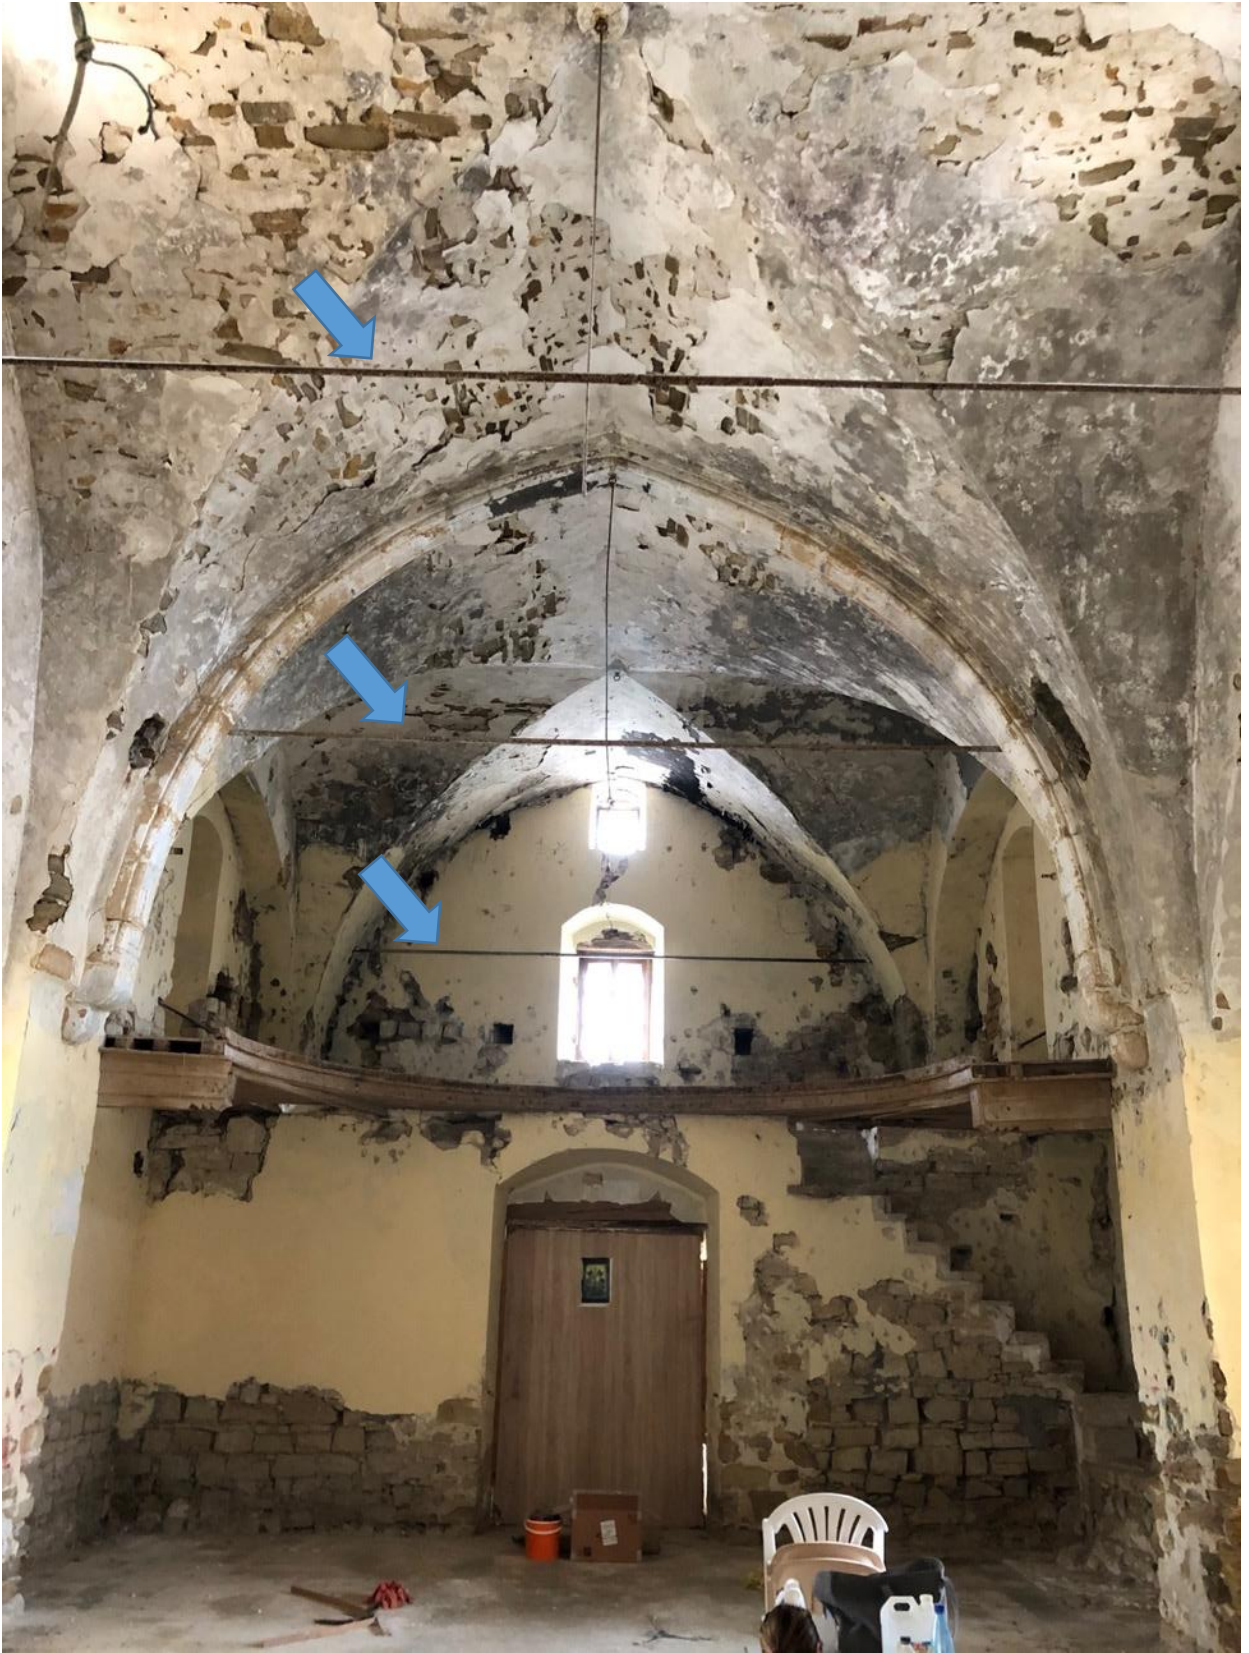
Photo 39: Metal tie rods / All metal elements should be treated.

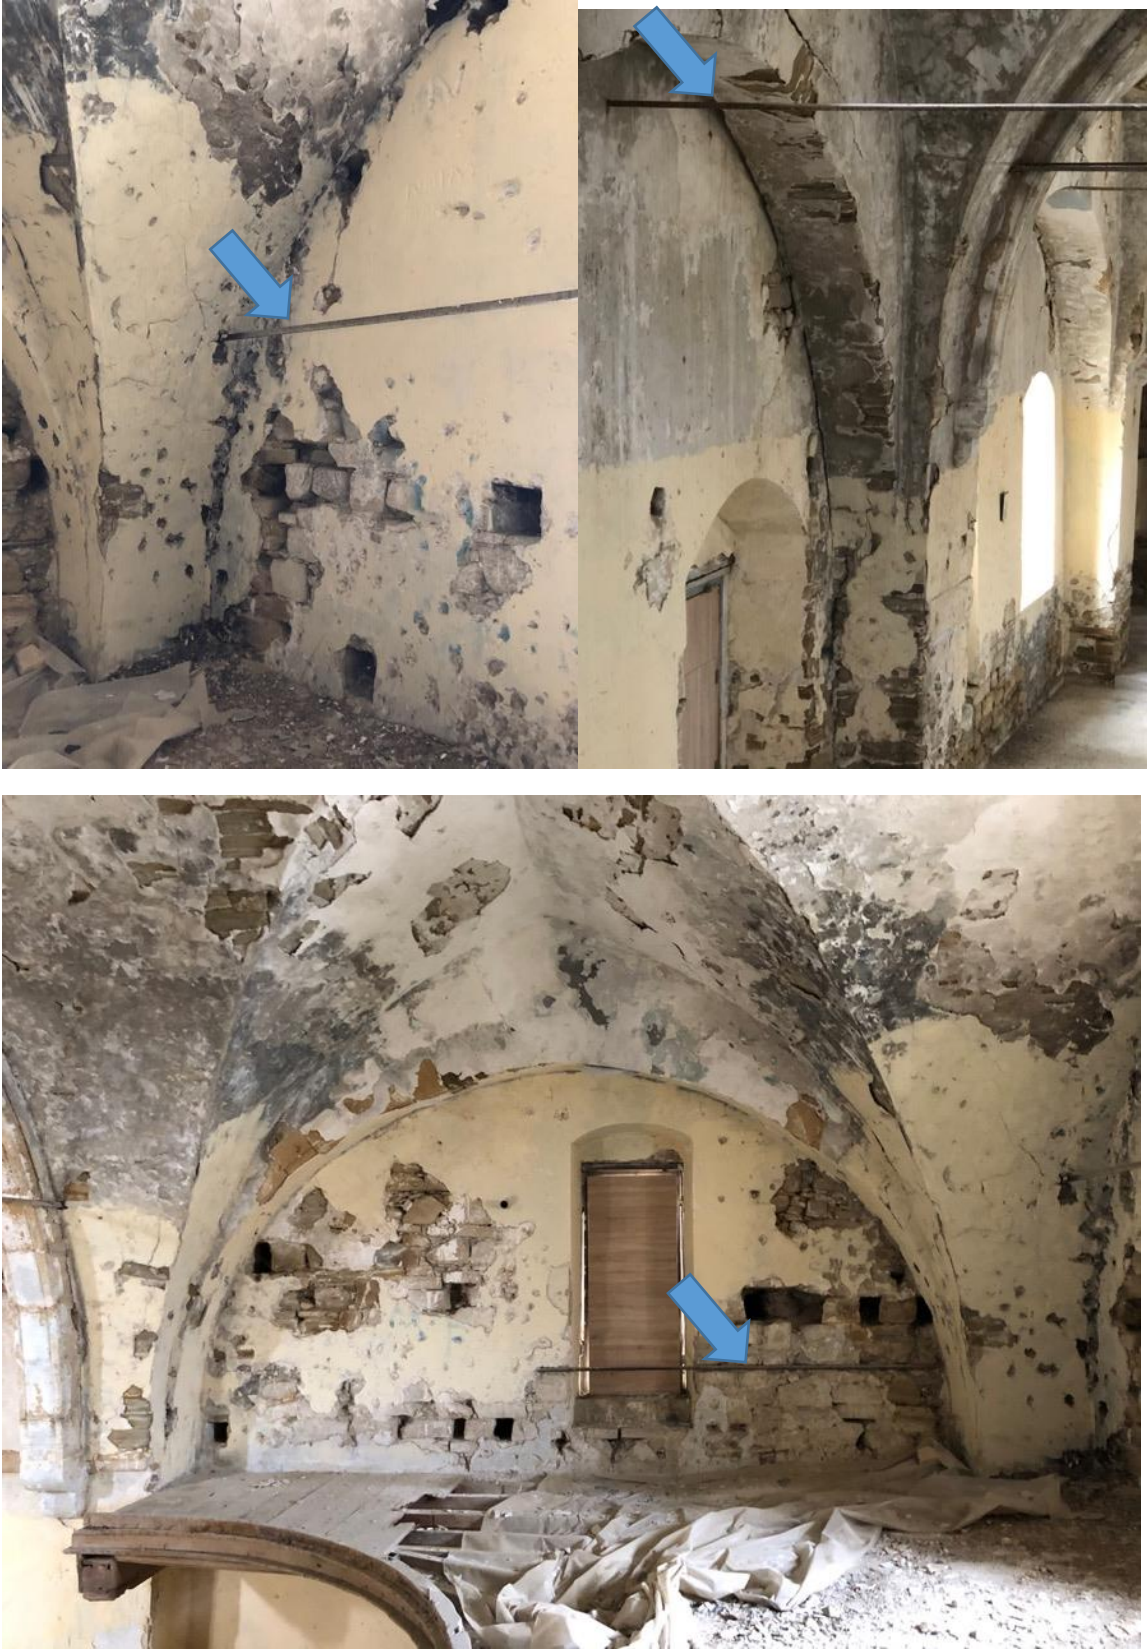
Photos 40,41 and 42: Metal tie rods / All metal elements should be treated.

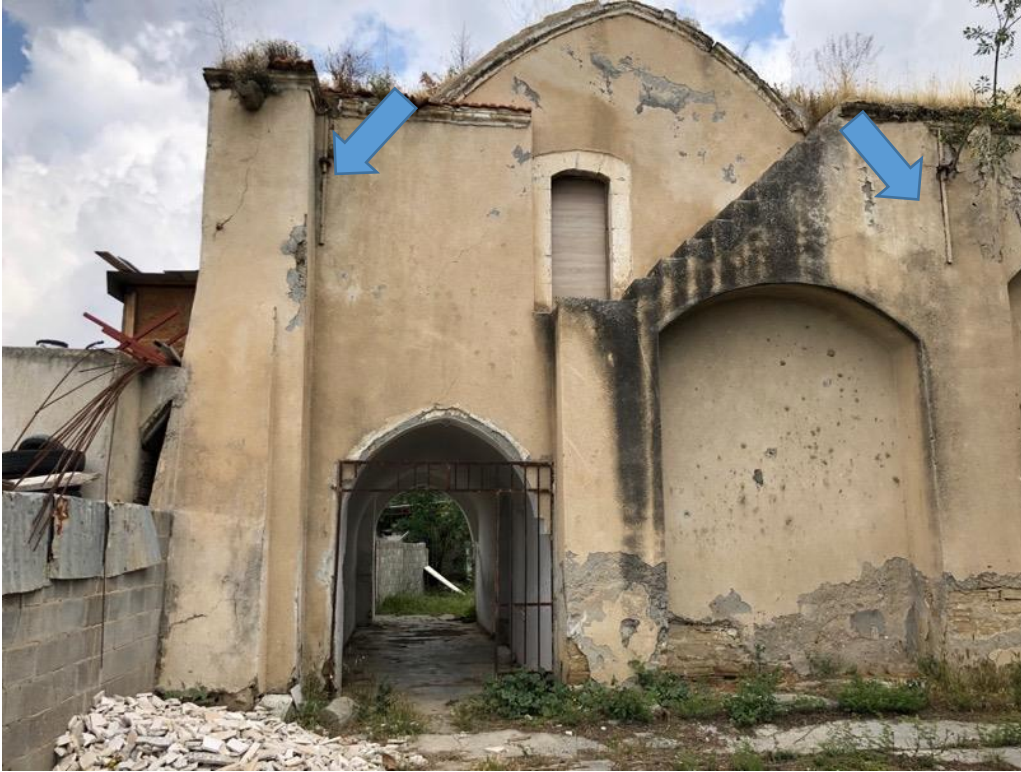
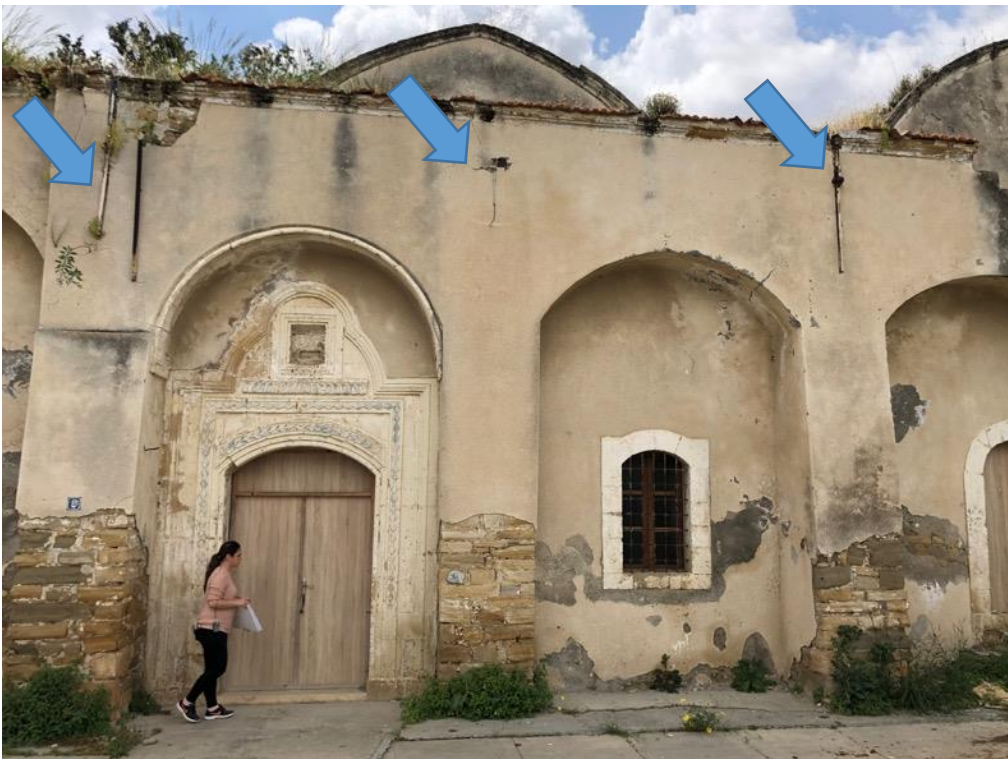
Photos 43 and 44: Metal tie rods / All metal elements should be treated.

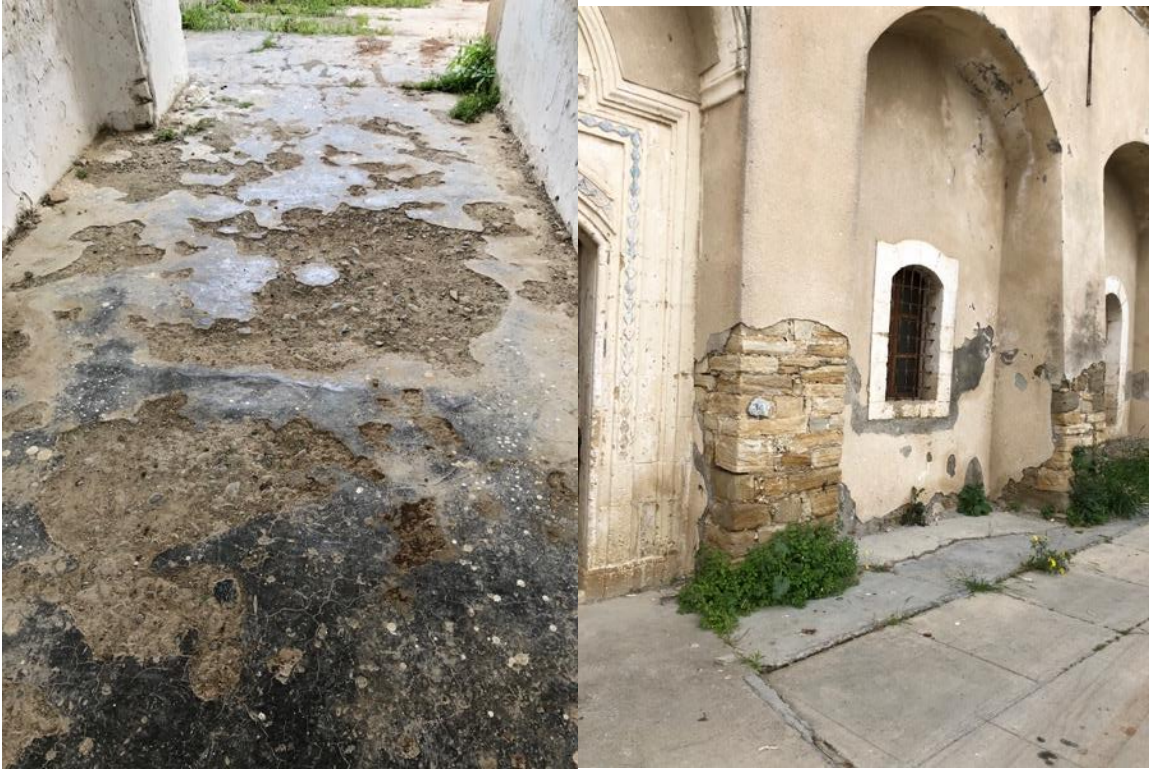
Photo 46 and 47: External concrete floors to be repaired: Narthex area flooring is made of gravel and very thin cement layer on top. Rest of the courtyard is concrete

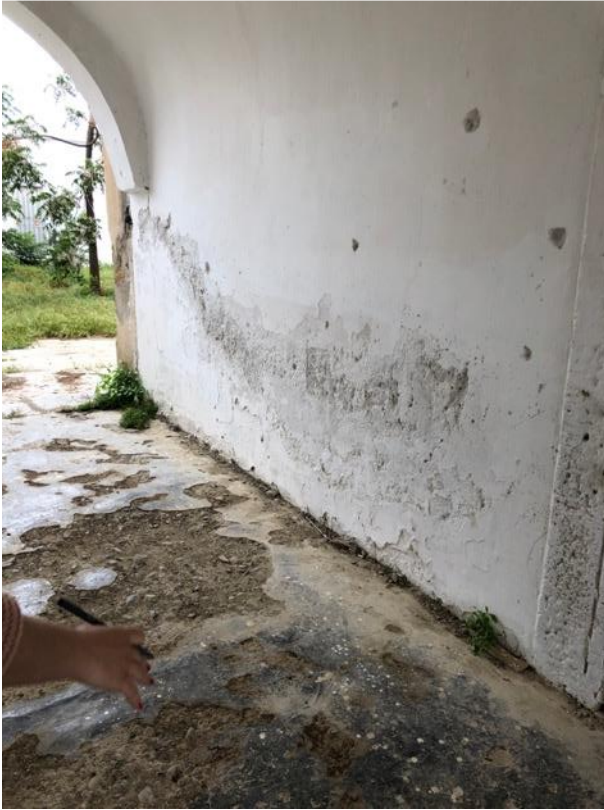
Photo 50: The floor condition of the semi open space area.
