Terms of Reference – Emergency conservation works at the church of Agios Charalambos

I. Brief description and Condition assessment**Name:** Agios Charalambos church**Building Period:** Estimated 1830s**Church Typology:** single-story with women's gallery towards the west, single-nave with a cross-vaulted roof system and semi-open narthex towards the west.**Construction Materials:**

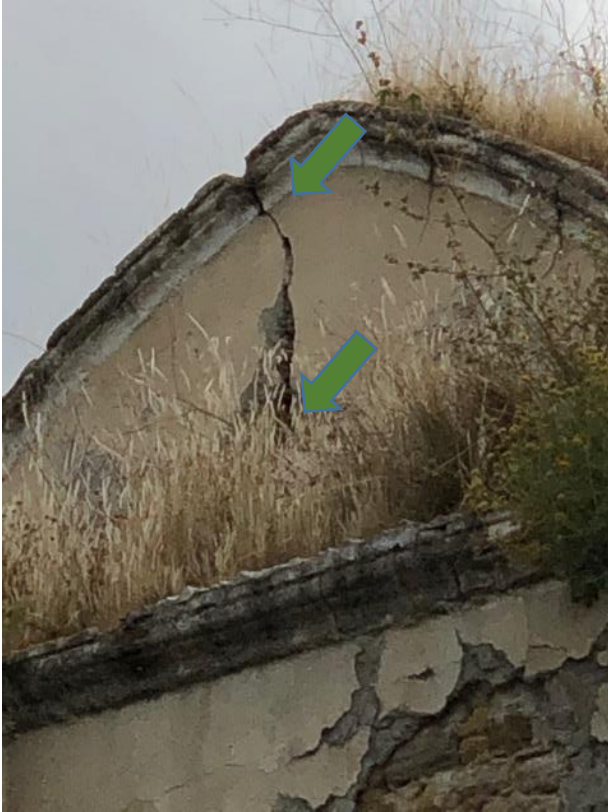
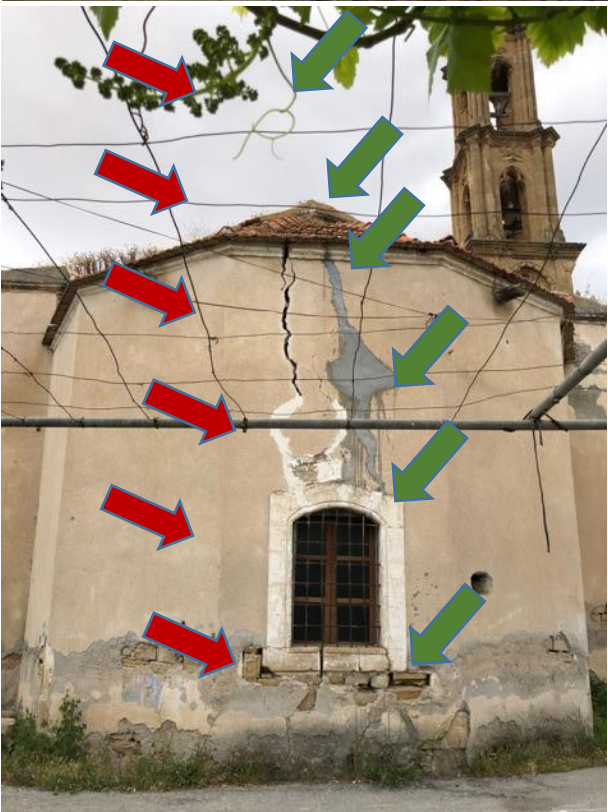
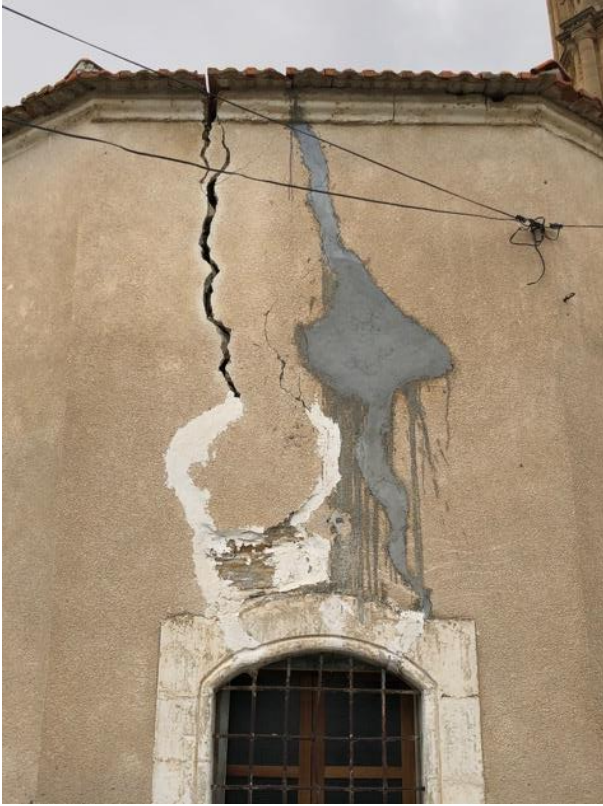
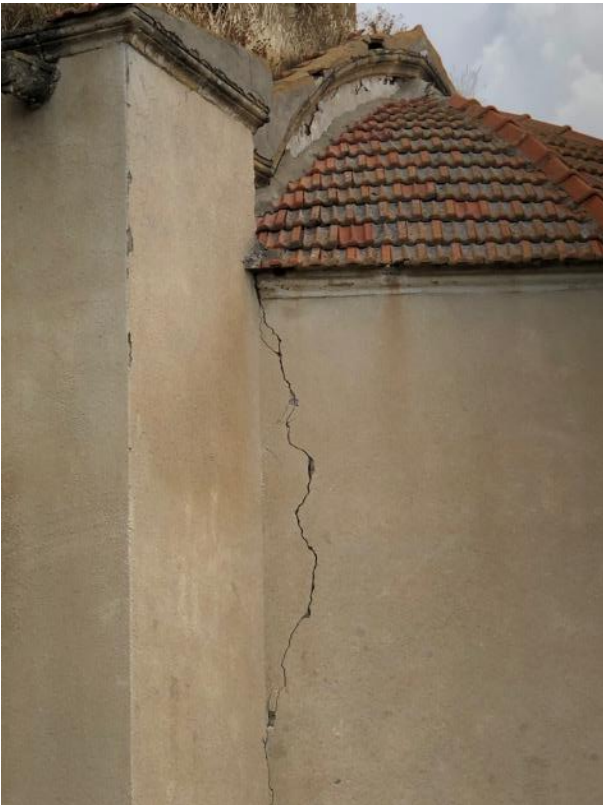
Photo 56.1, 56.2, 56.3, 56.4: Structural cracks to be treated

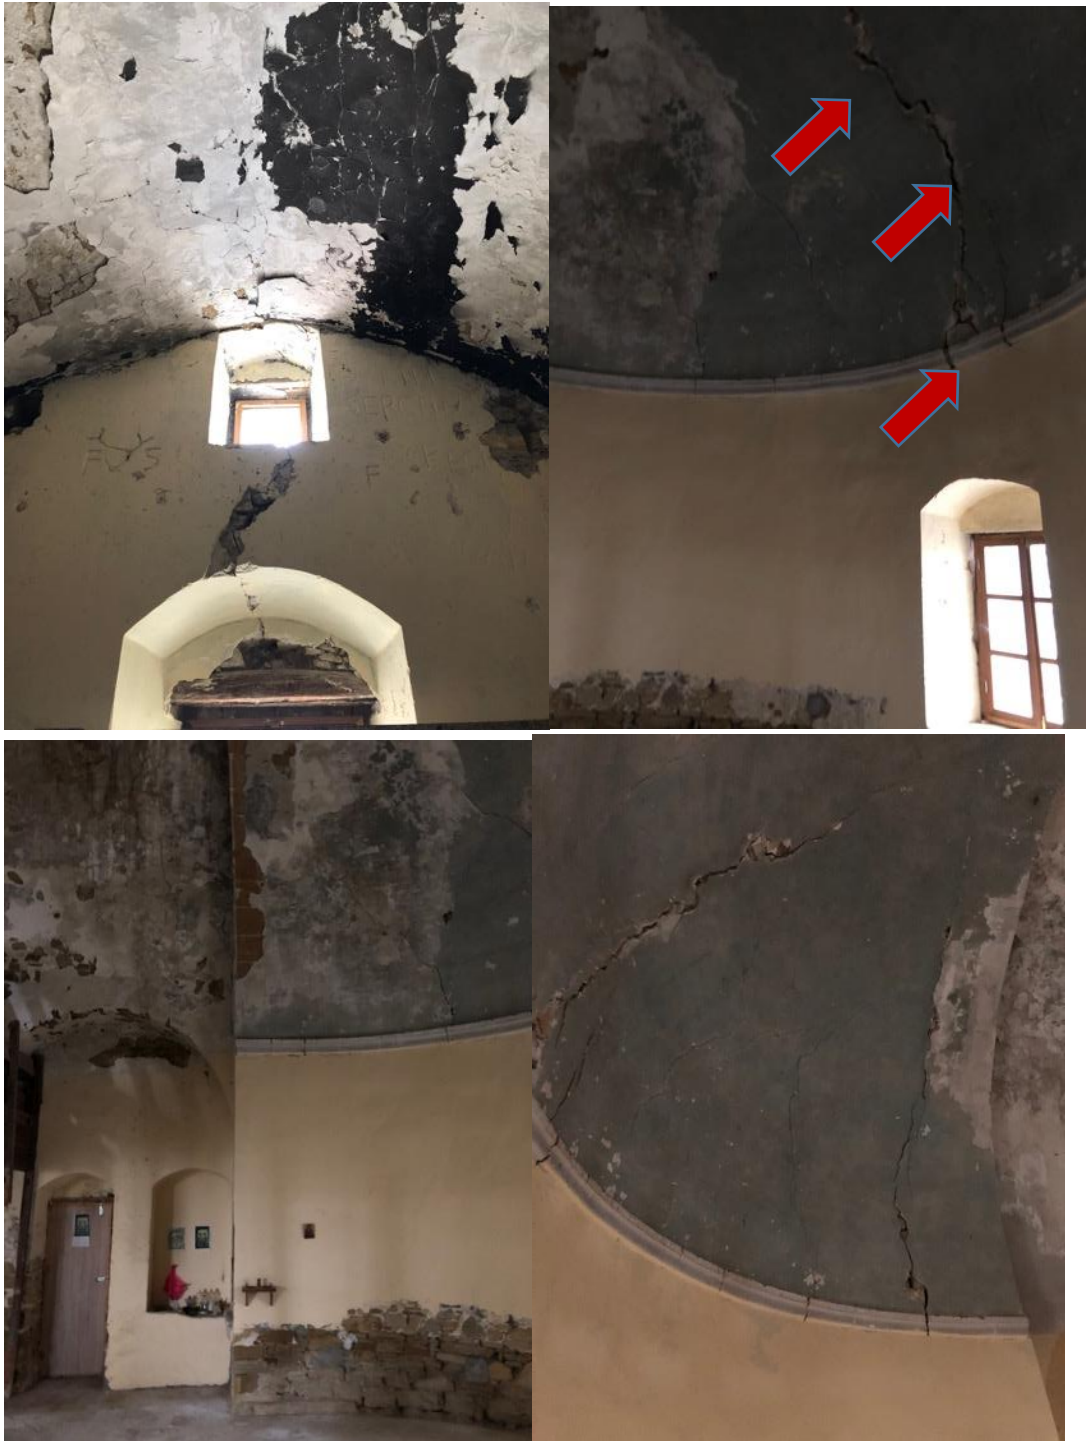
Photo 56.5,56.6, 56.7, 56.8: Cracks / indoor

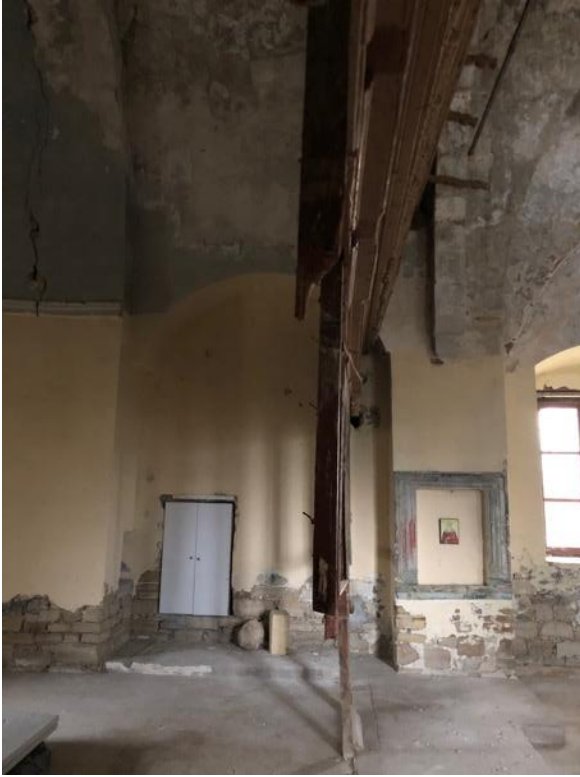
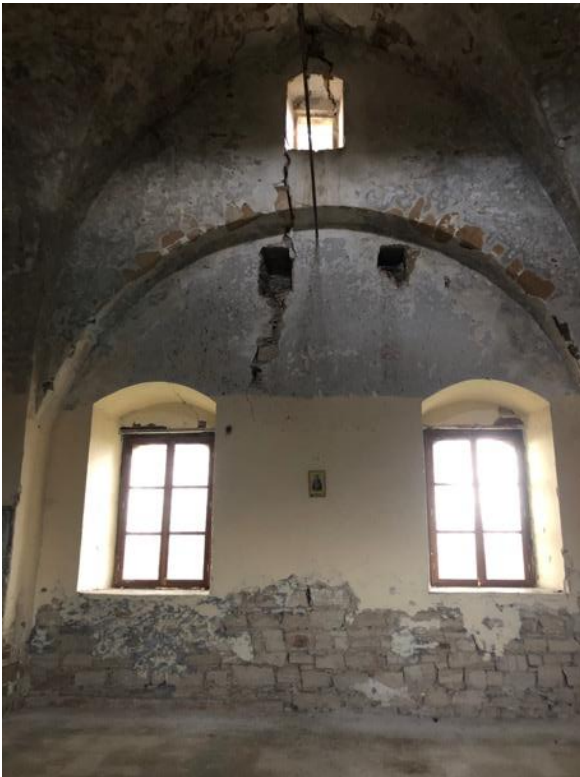
Photo 56.7 and 56.8: Cracks / Indoor
