Scope of work

Rehabilitation of the coast guard Building.

Coast guard Building located in the residential area number One with coordinates (31°12'38.1"N 16°35'12.2"E).

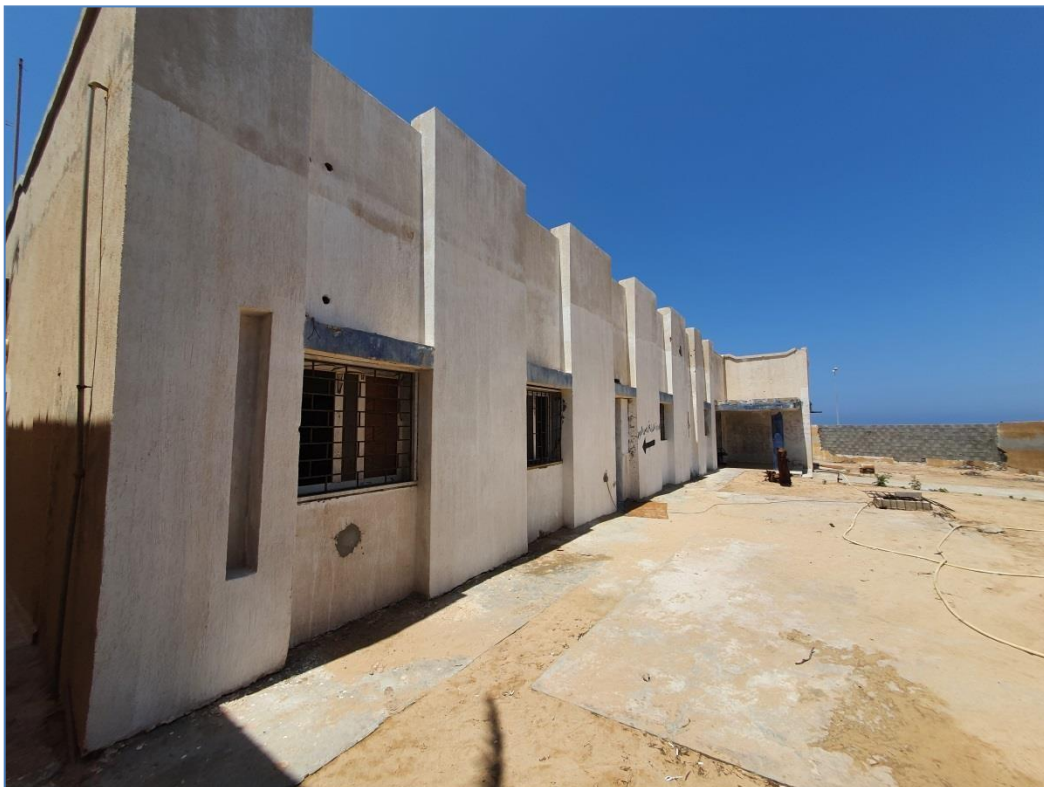
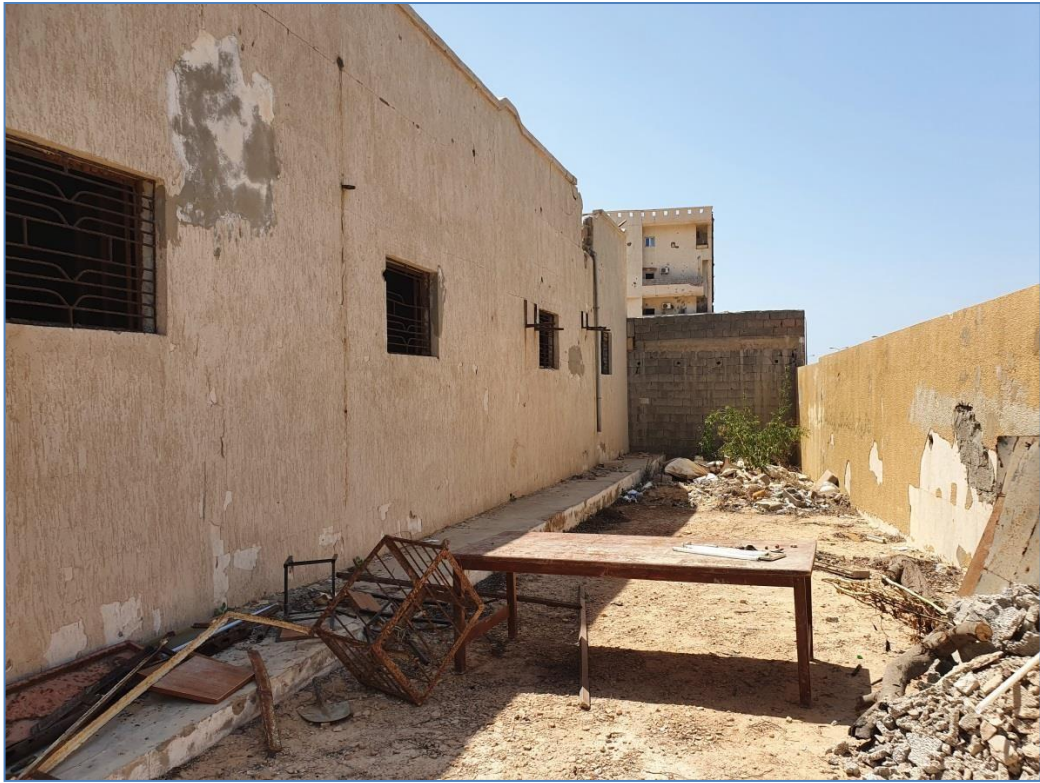
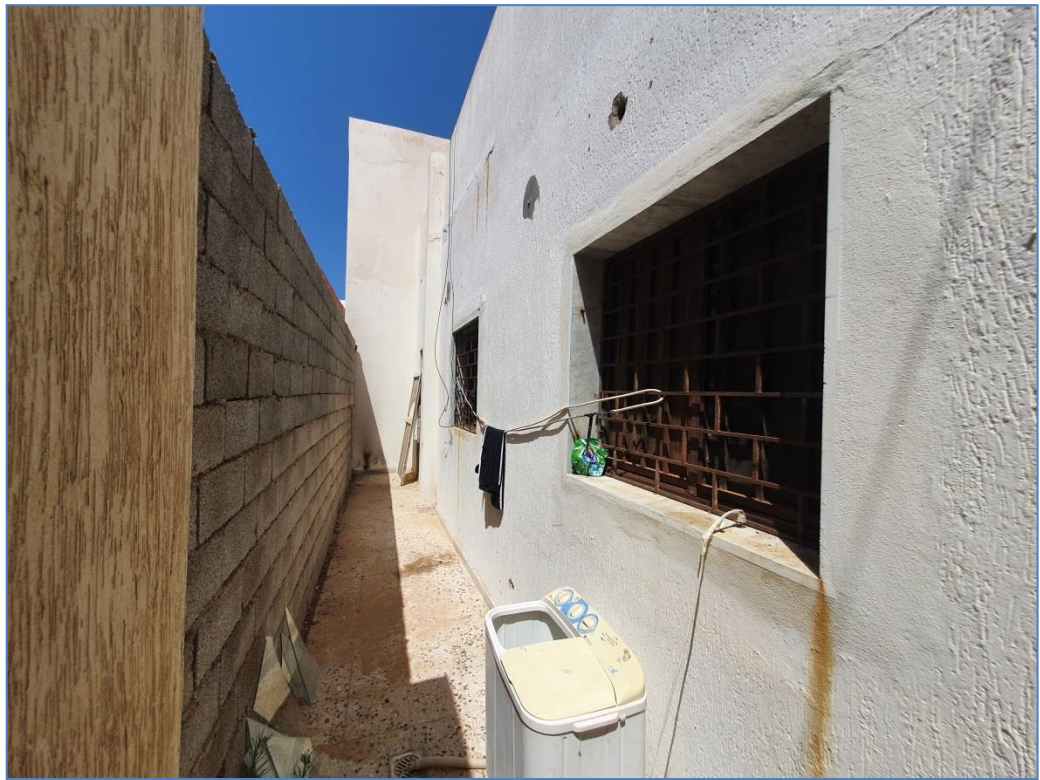
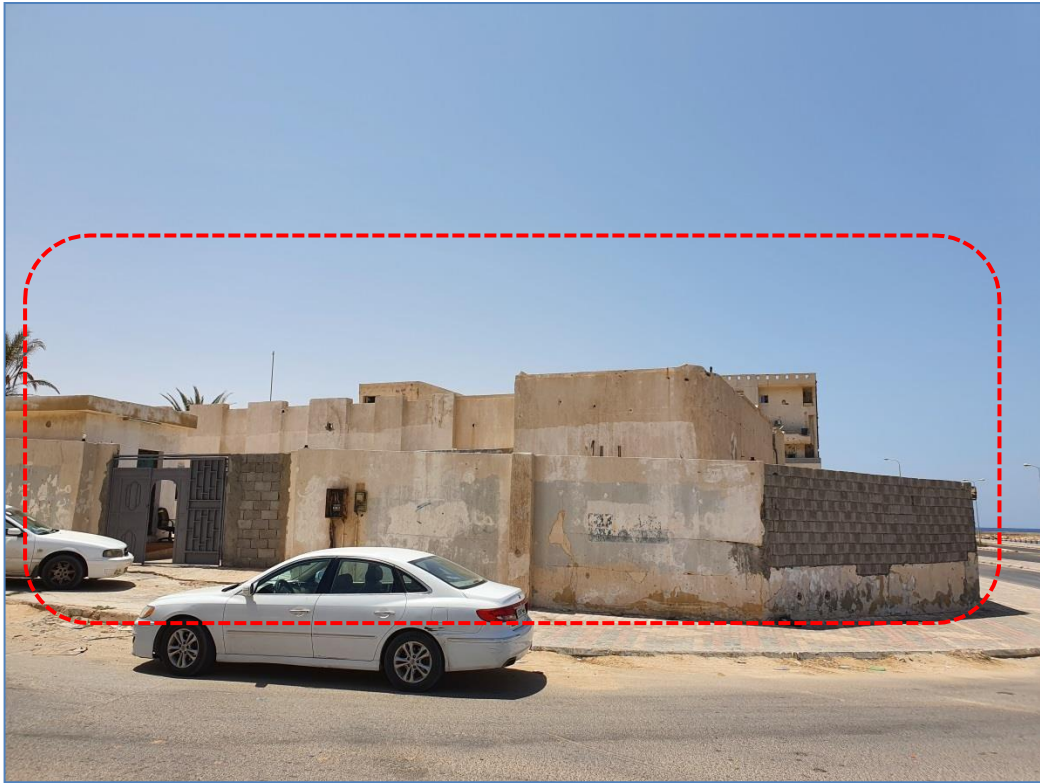
As shown in the photos, the facades of the building need new colored weather shield paint, as well as removing of the deteriorated cement sand plaster if necessary, as detailed in the BOQ.

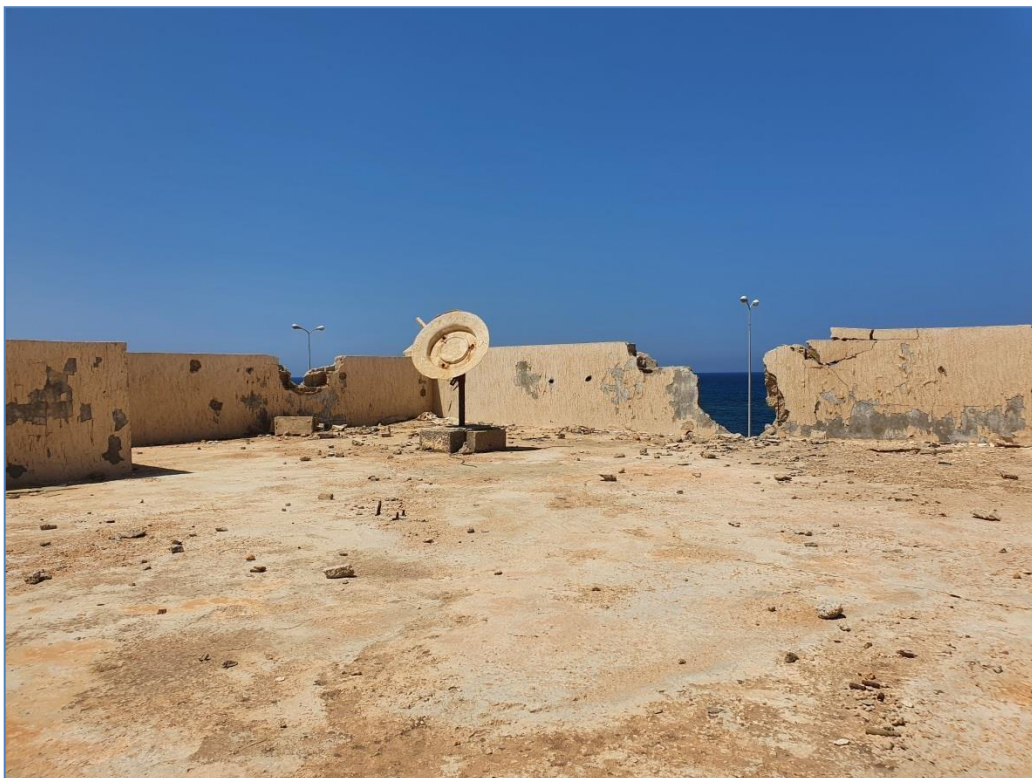
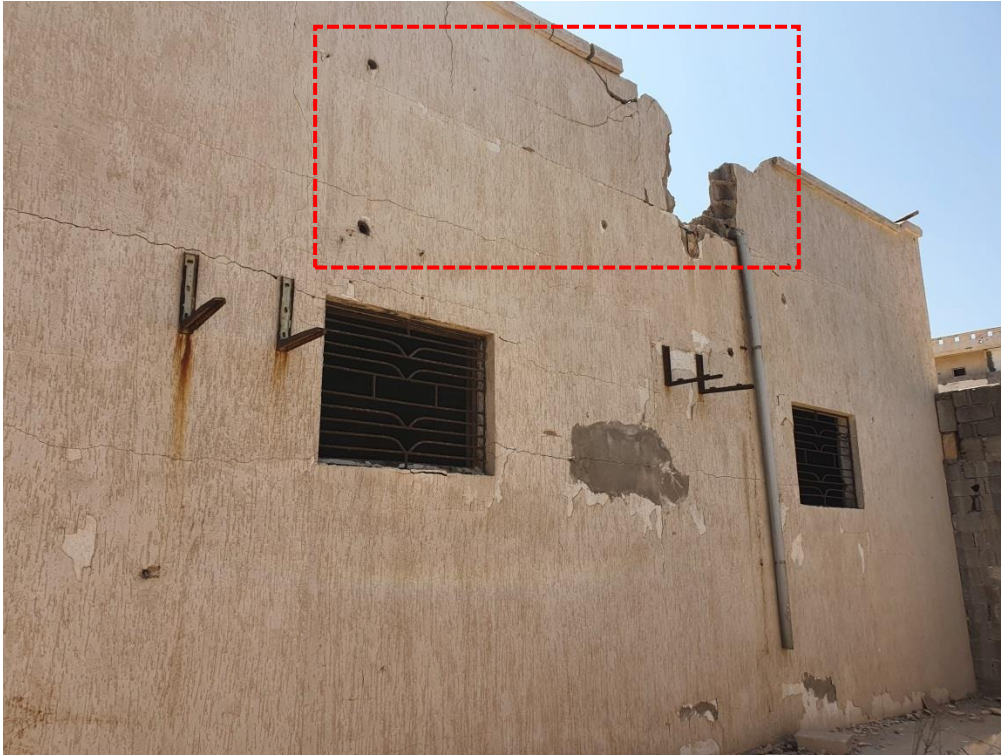
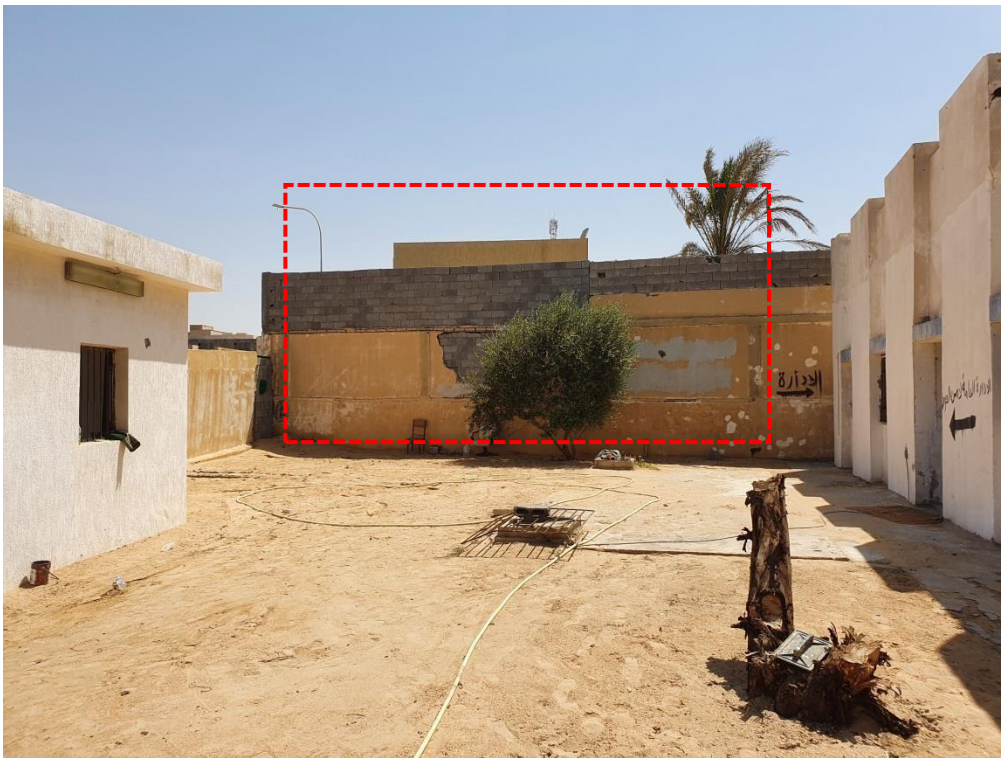
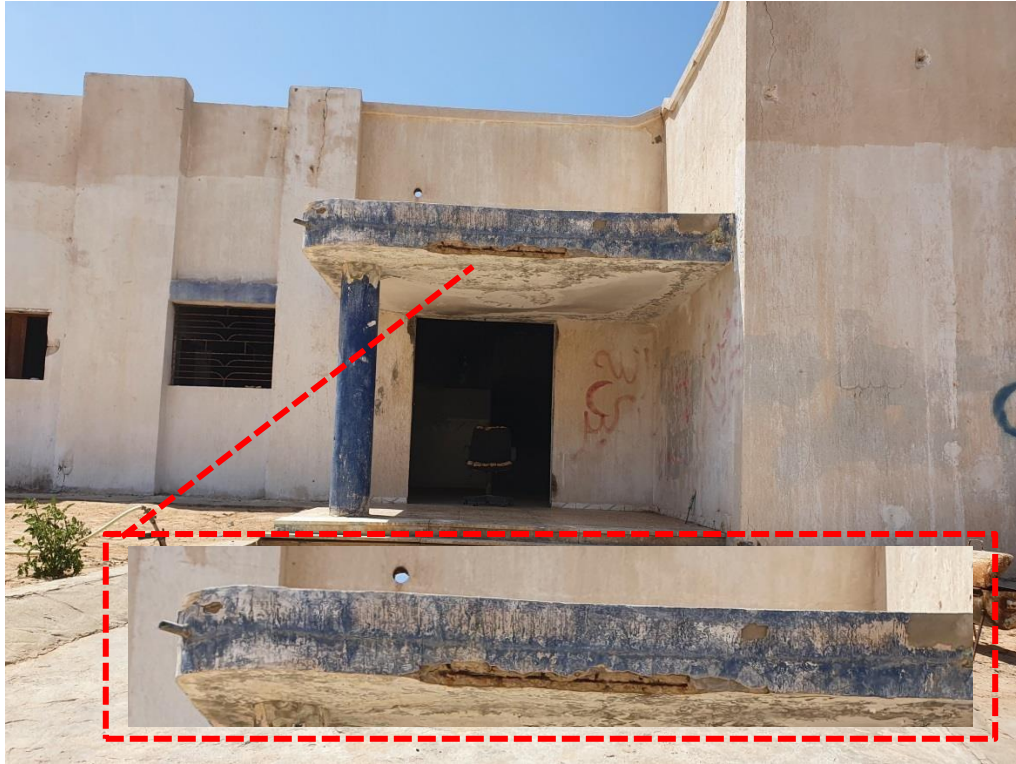
Also, some external walls, parapet and structural elements has suffered many deterioration which needs to be rebuild and rehabilitate similar to the existing as shown in the photos and the BOQ.

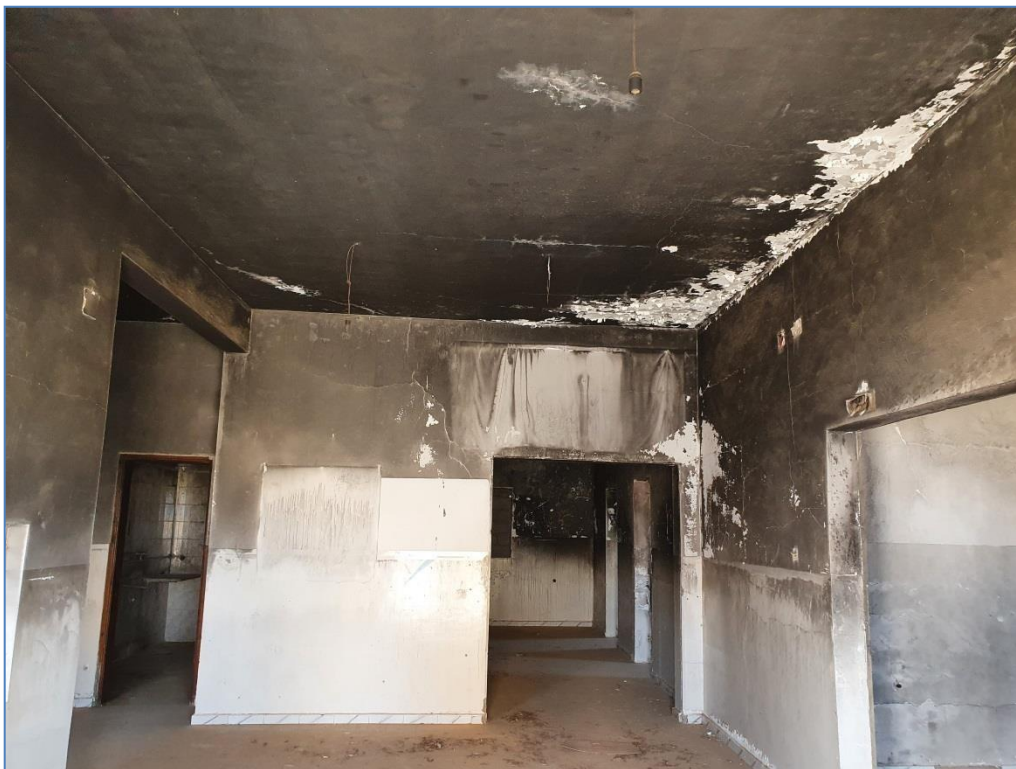
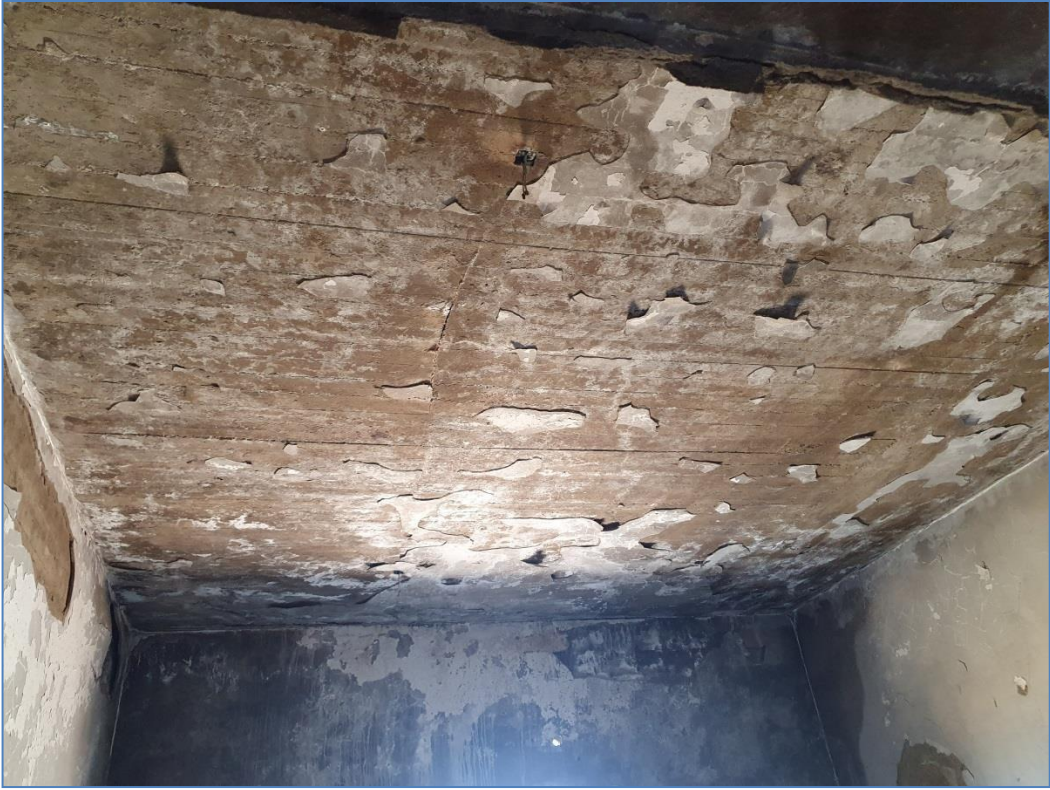
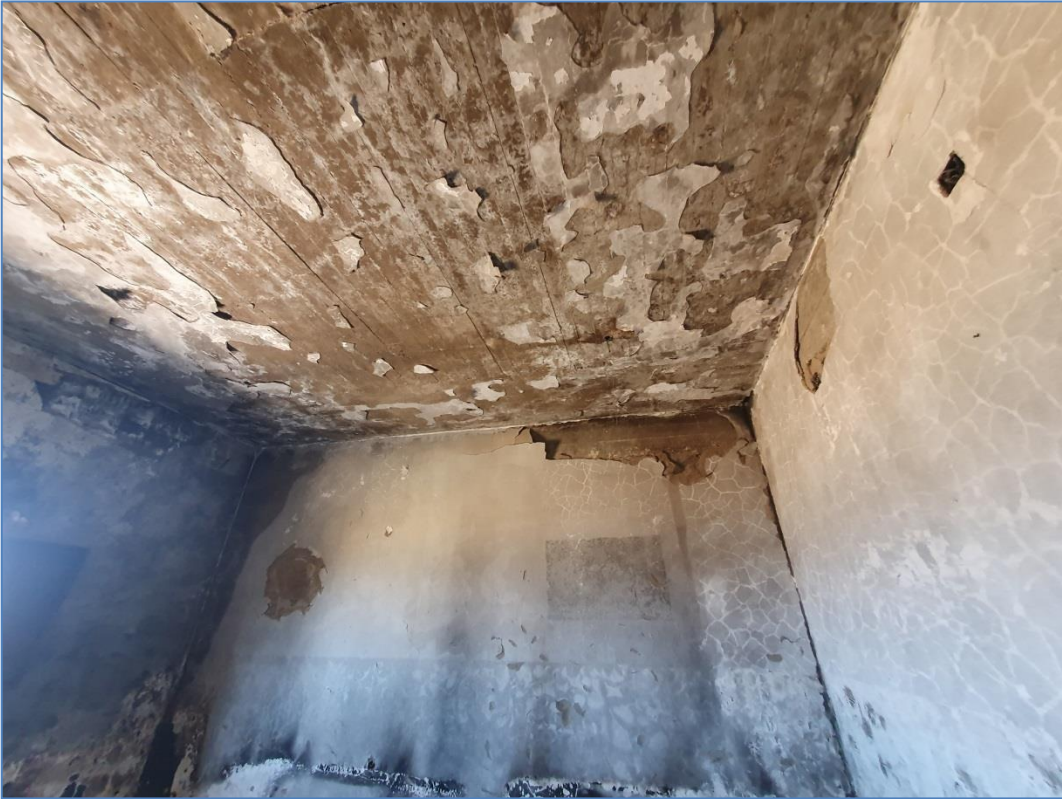
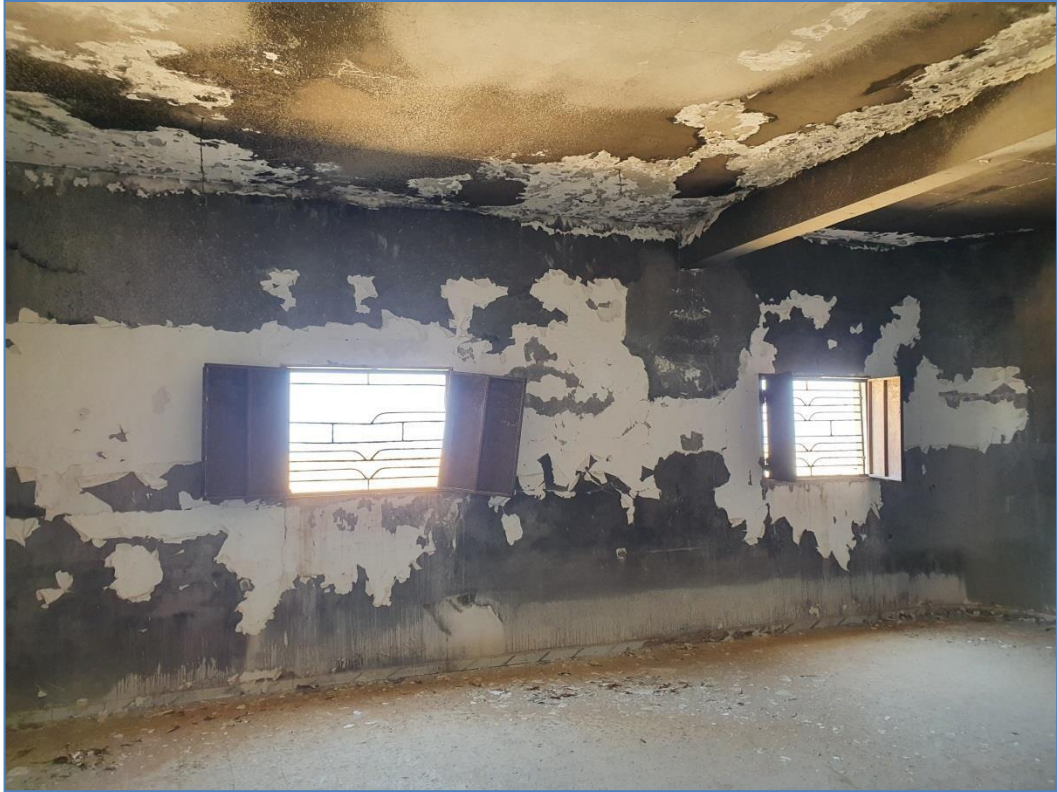
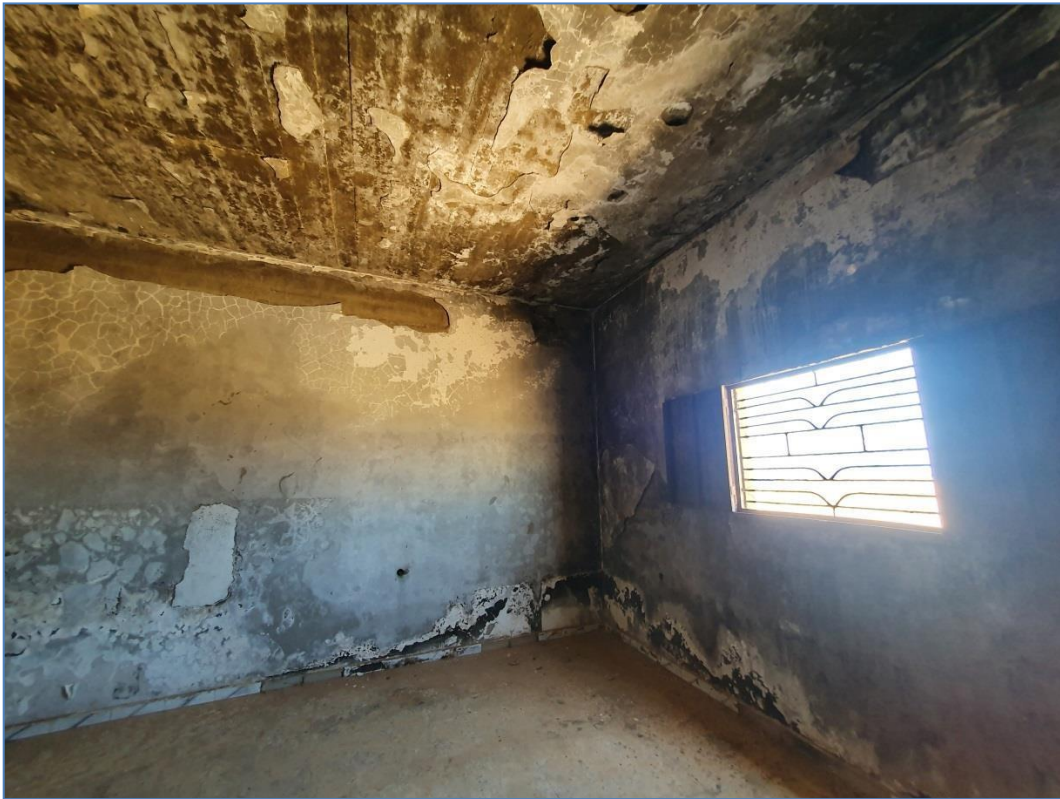
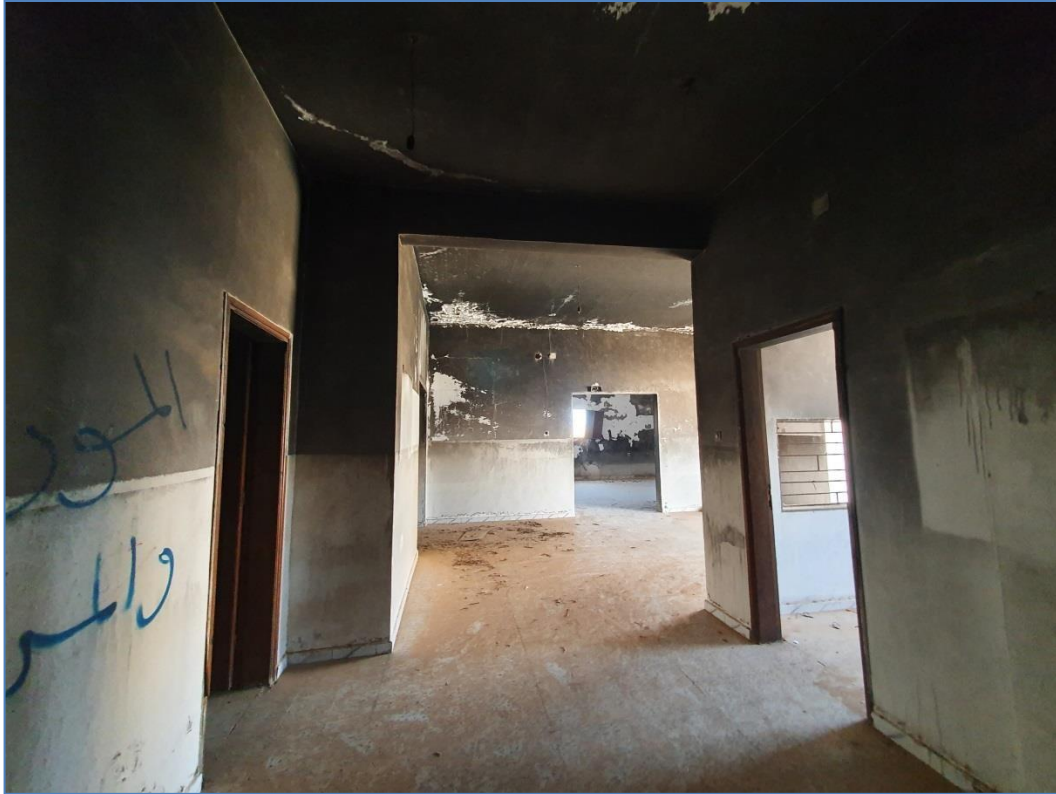
Because of the fire, which led to excessive damage to the plastering layer, it is necessary to remove the old layer and make another new layer and the subsequent paint work, as shown in photos and detailed in BOQ.

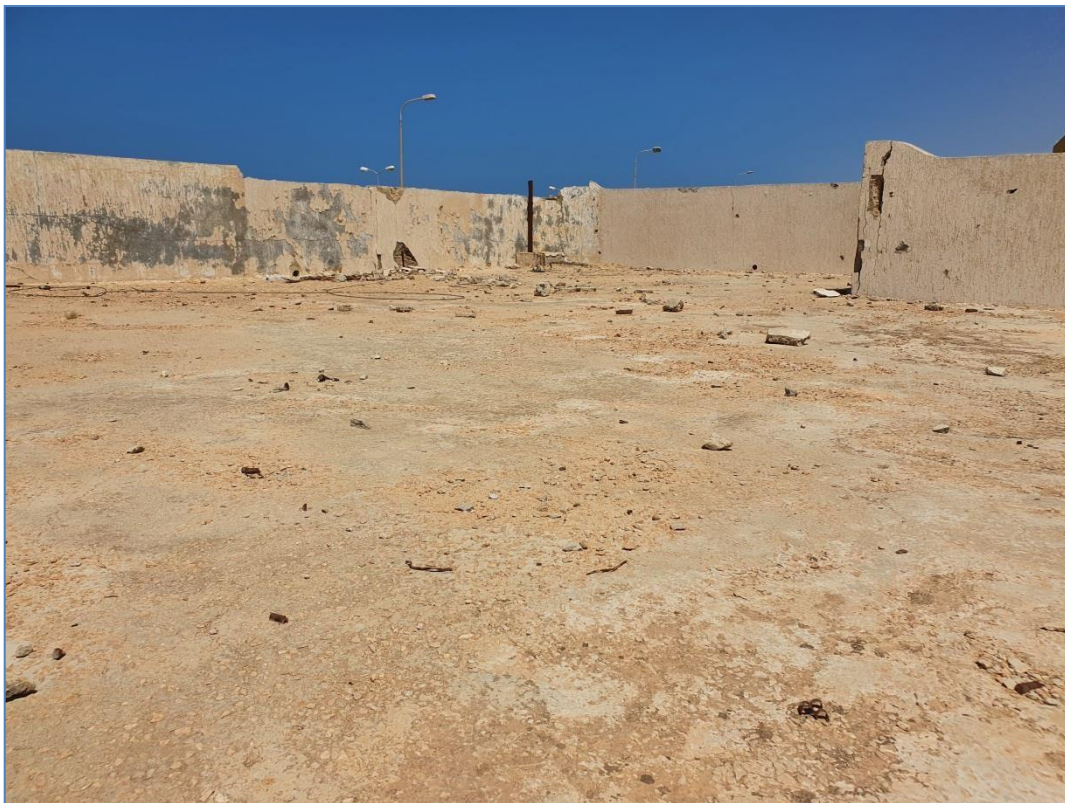
Due to defects in the roof screeding, it is required supplying and laying a bitumen roofing membrane to protect the roof from deteriorating over the time. as detailed in the draft BOQ.

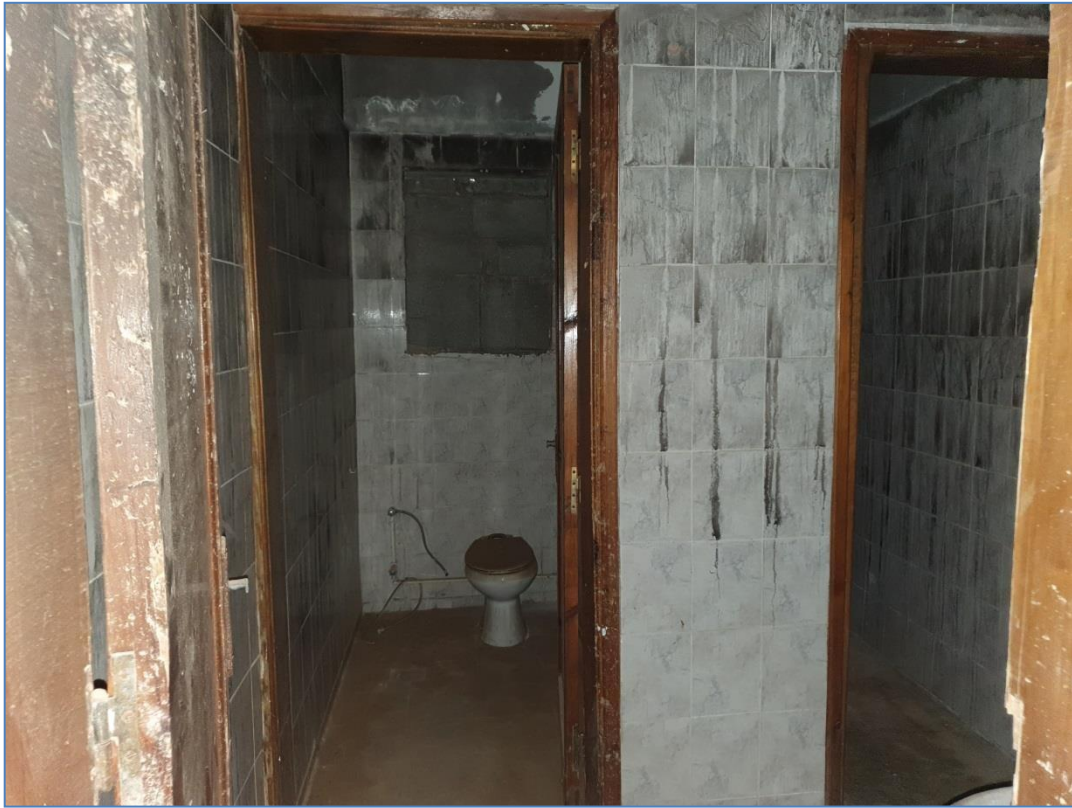
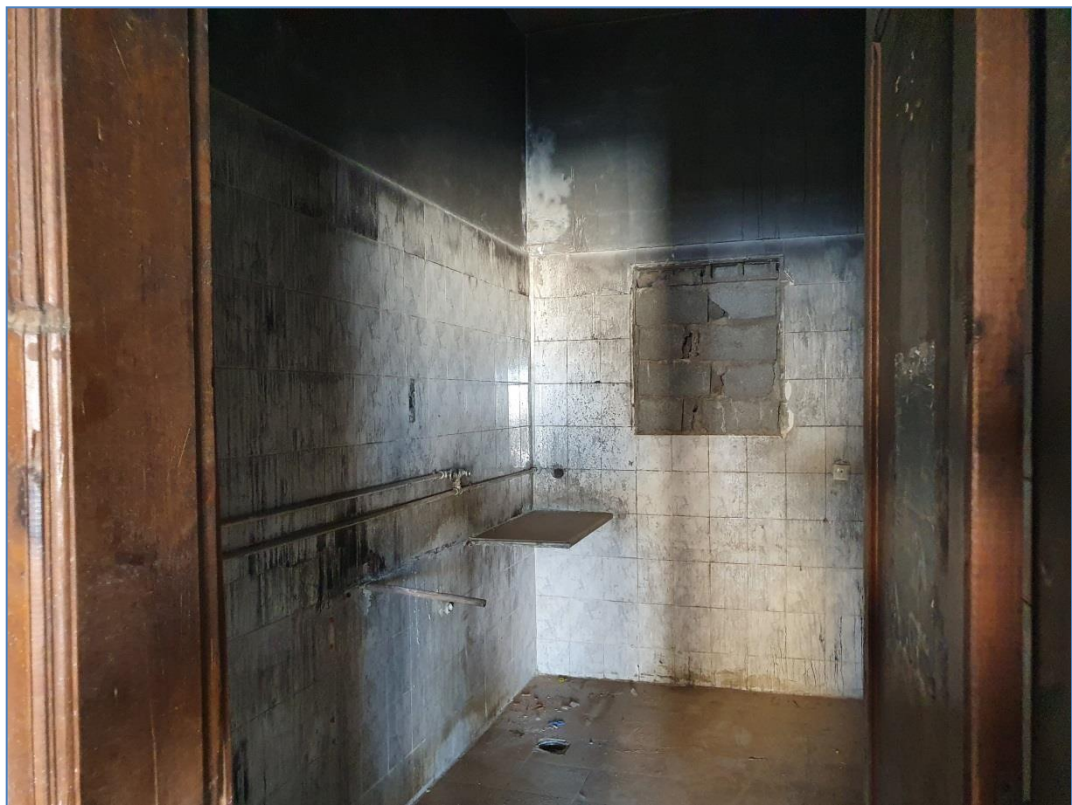
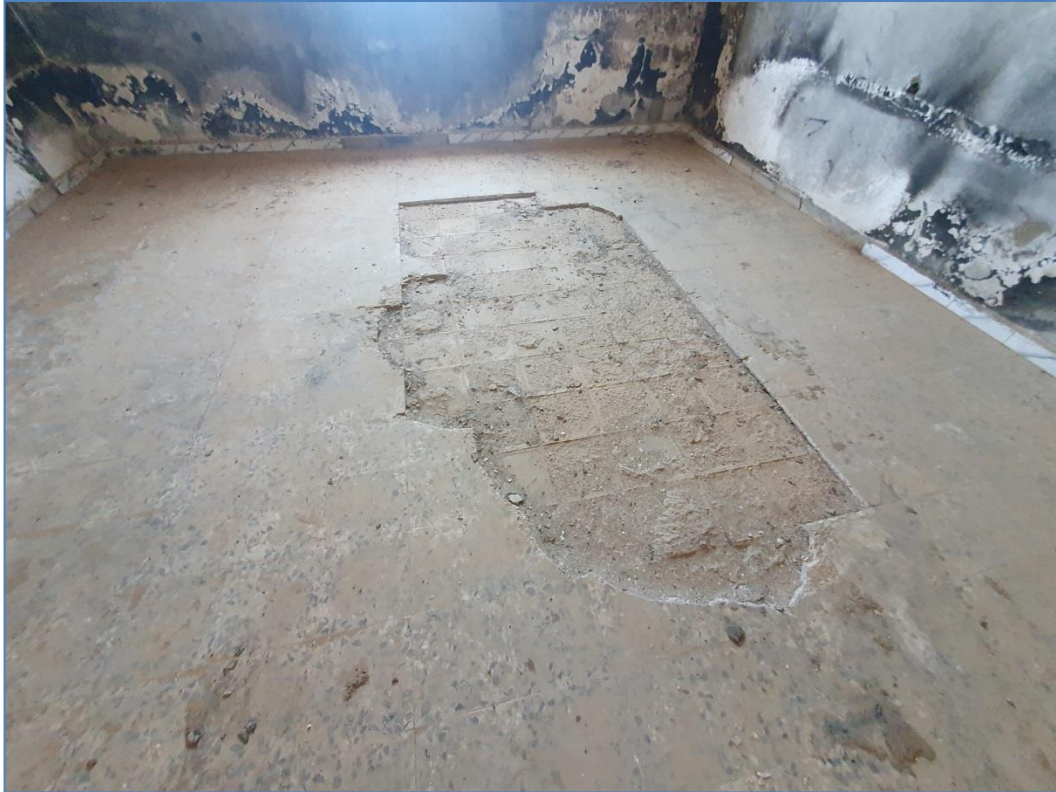
toilets and kitchen require a new ceramic floor and wall, the same with mosaic tiles as shown in photos and detailed in BOQ.

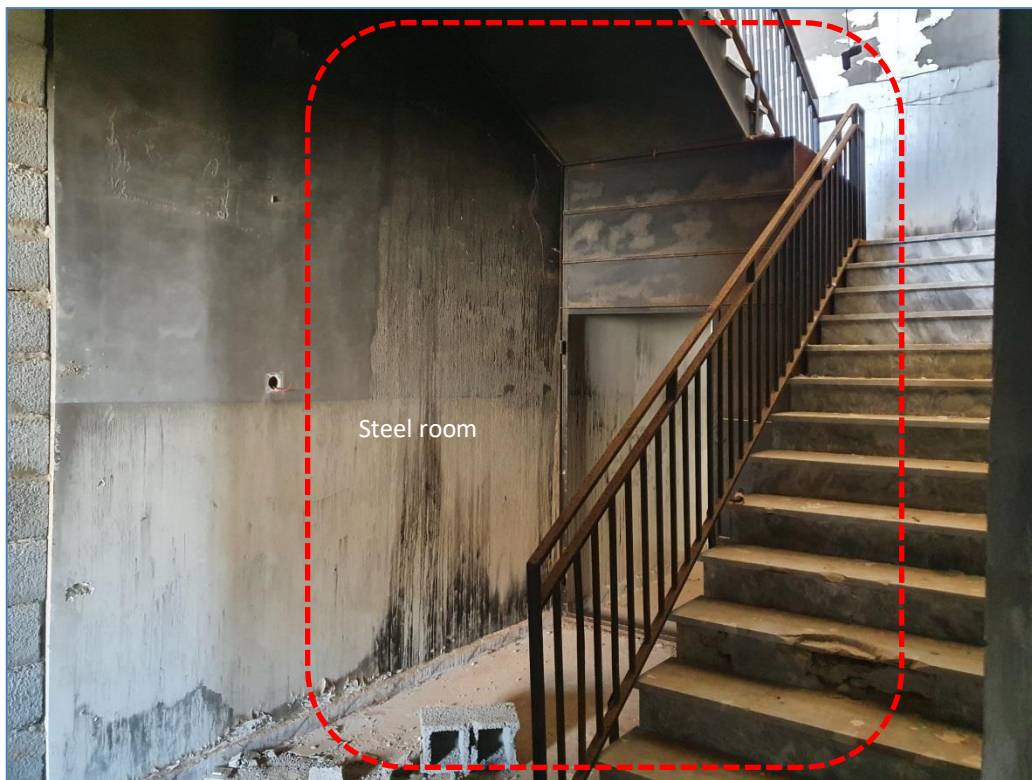
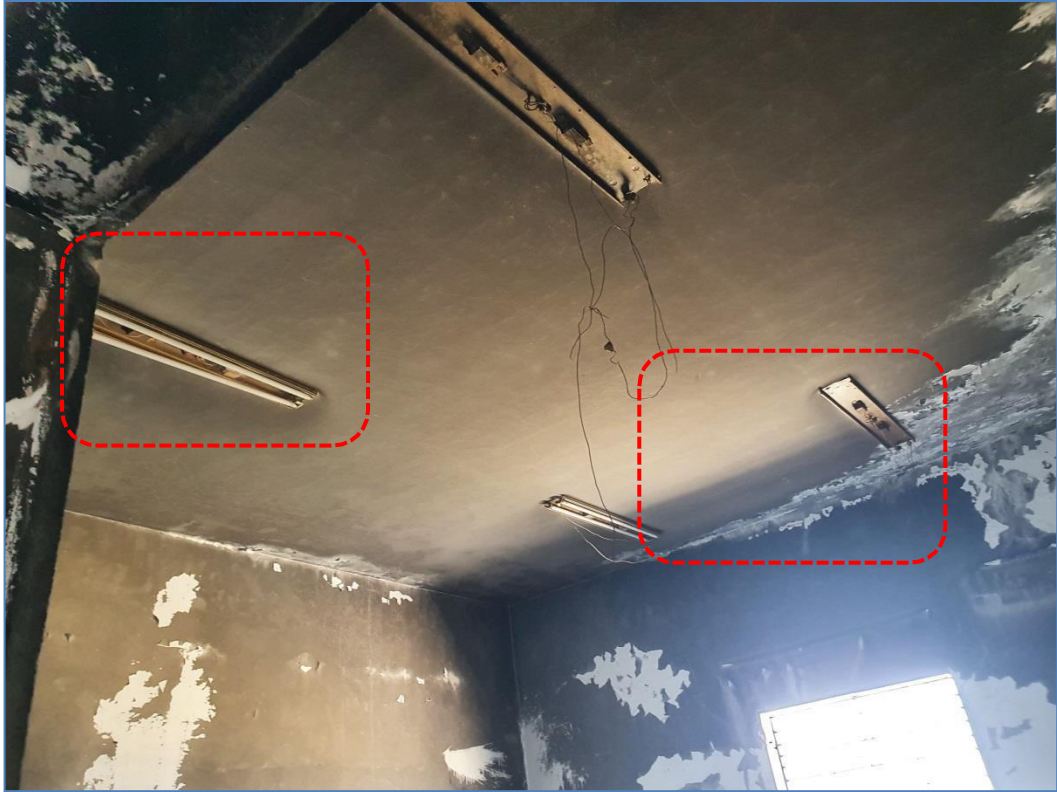
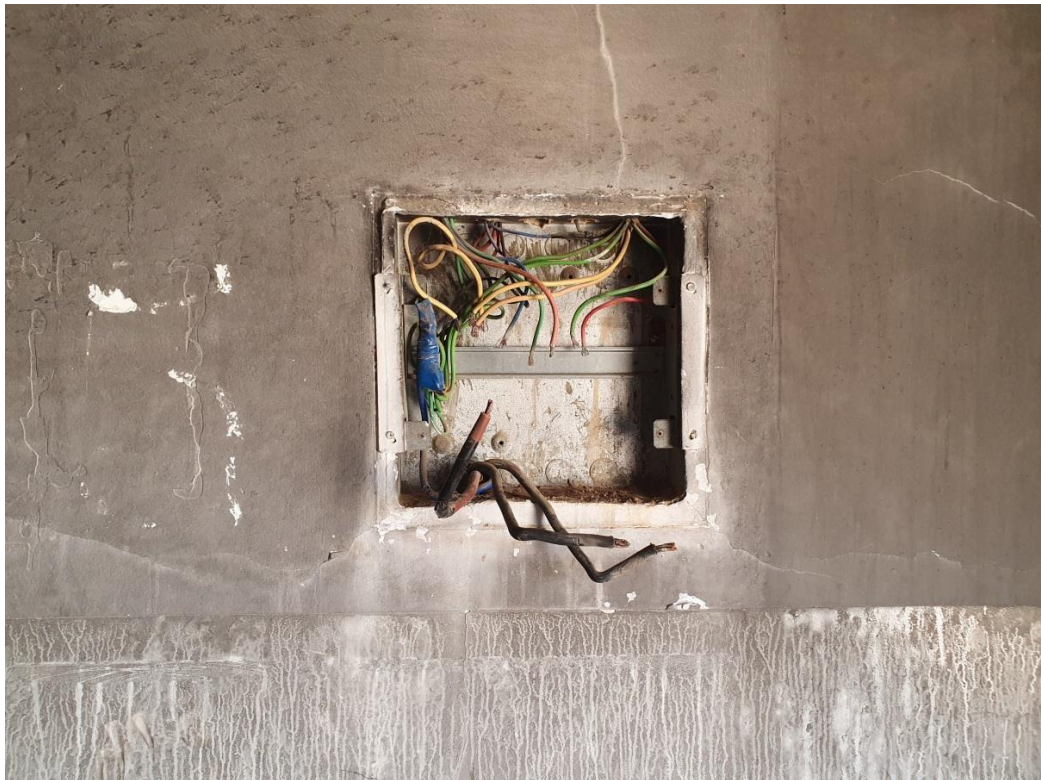
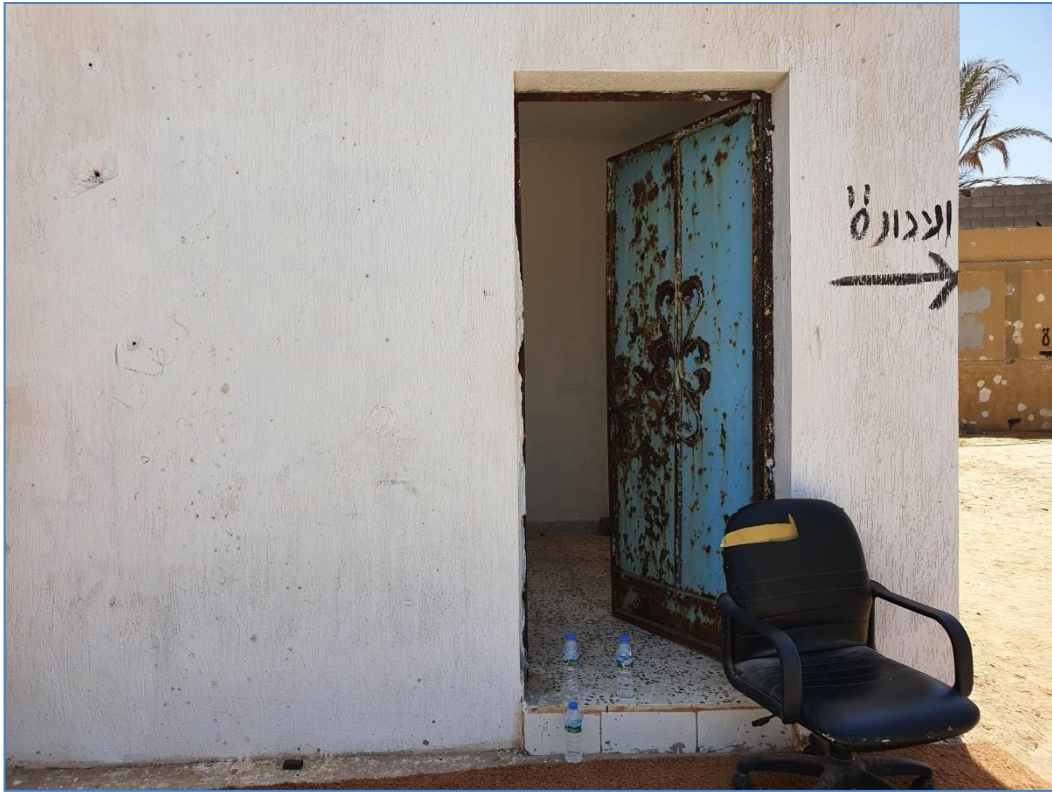
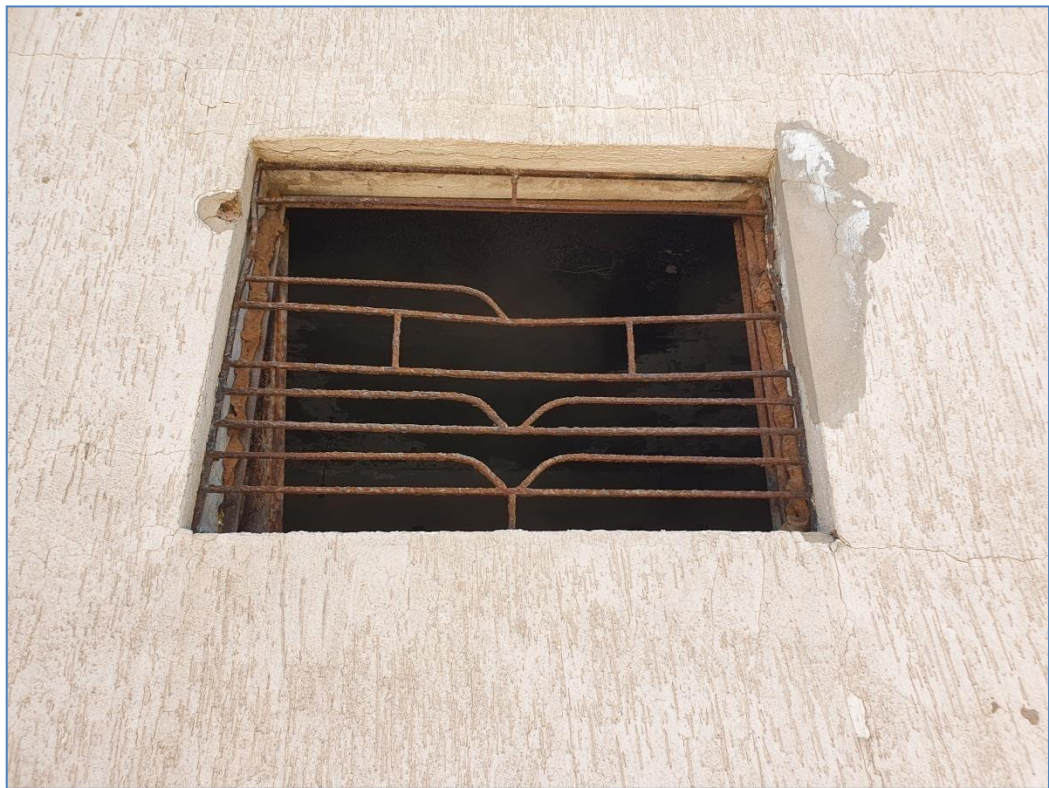
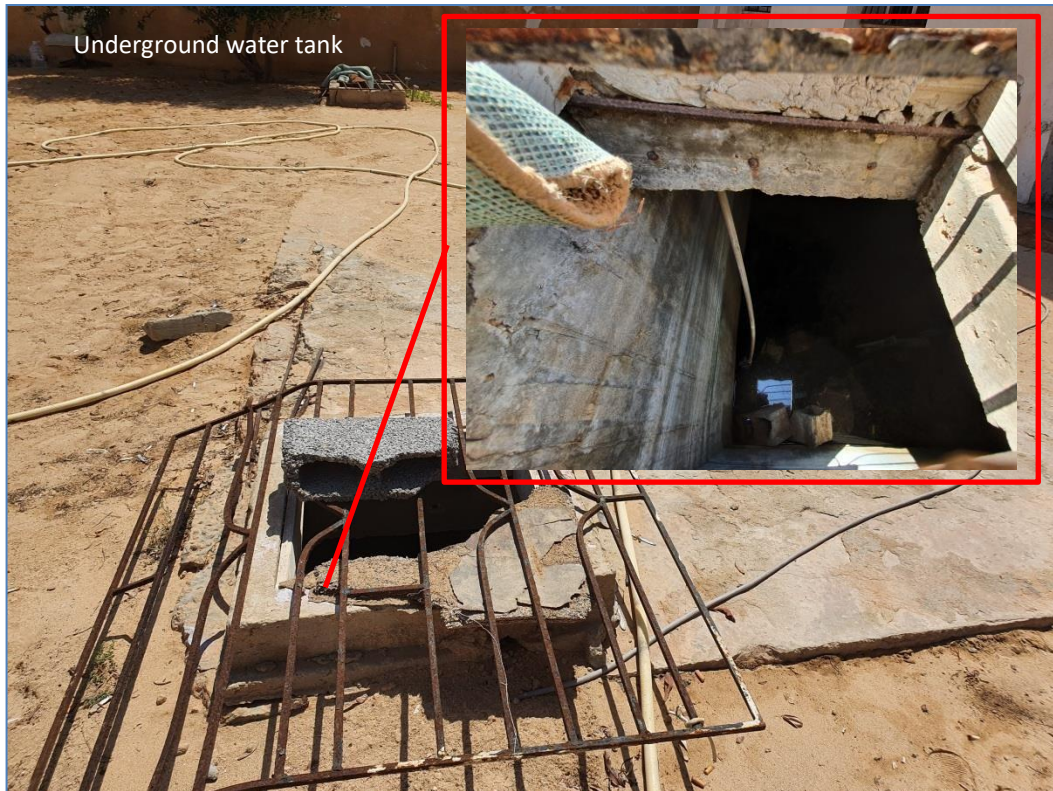
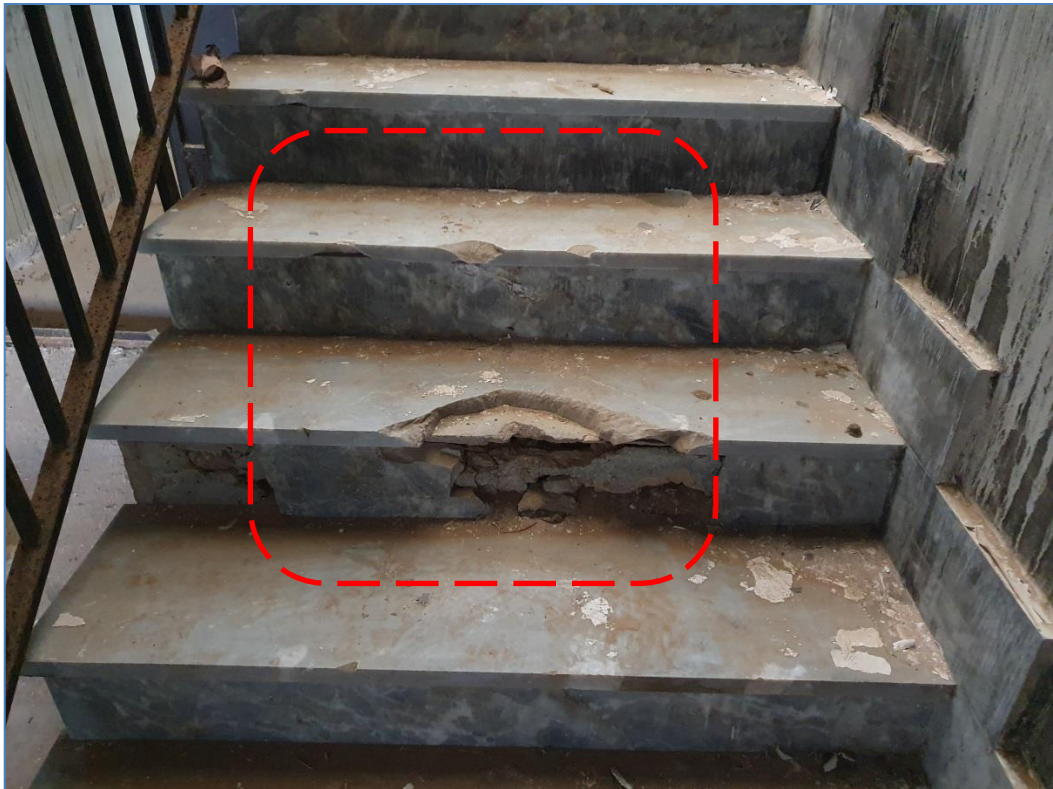
The building requires rehabilitation in many items including repair and supply steel ,wooden and PS doors, as well as the repairing steel protection grill and supply a new PS windows instead of defected windows ,moreover plumbing and electrical works as detailed in the draft BOQ and the shown pictures.
