RESEARCH PROGRAMM FOR THE
RESTORATION AND REHABILITATION
OF THE HISTORIC BUILDING COMPLEX
AND RECONFIGURATION OF THE
ENVIRONMENT OF THE MONASTERY

**PROJECT PHASE B :
IMPLEMENTATION
GUEST HOUSE BUILDING (1919)(GH)**

Title: EXISTING
BASEMENT & GROUND FLOOR PLAN
Scale: 1:50
Date: April 2006
Plate number: **GHE01**

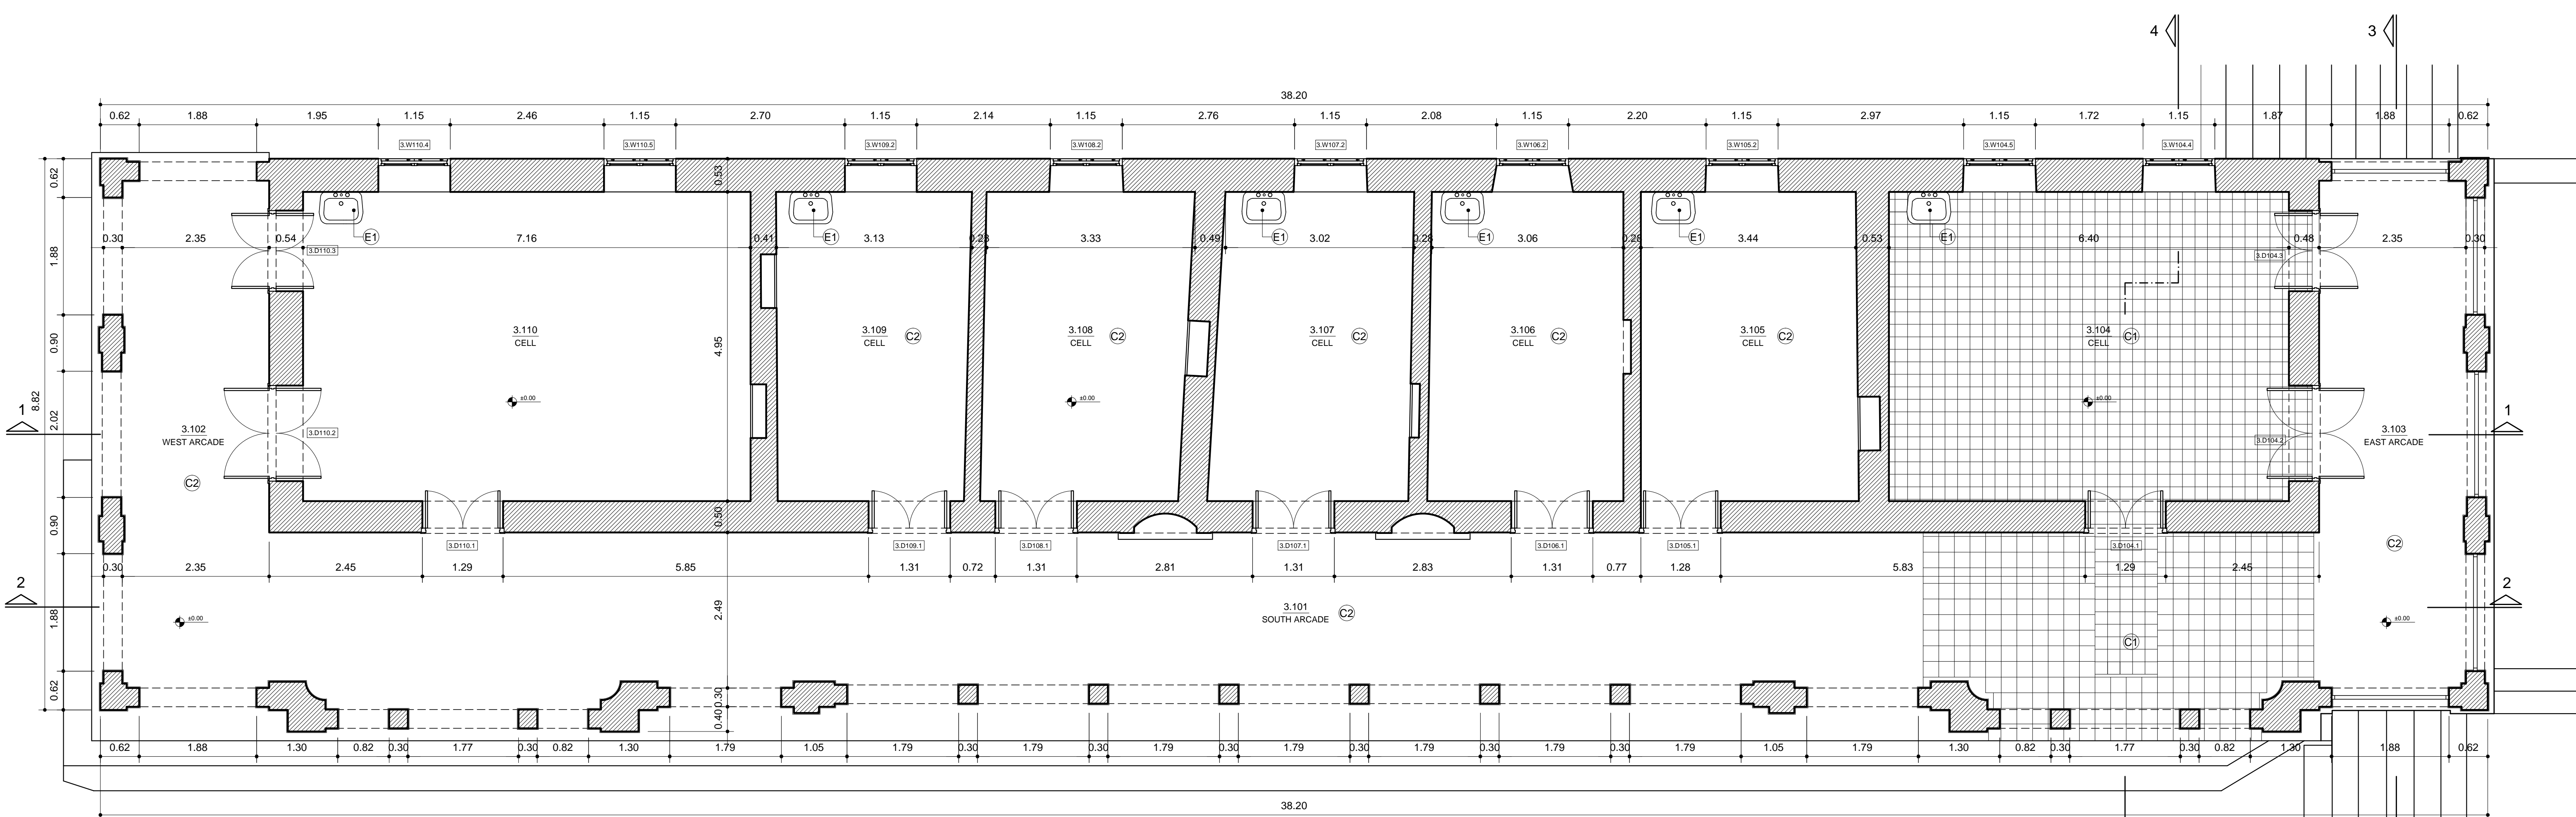
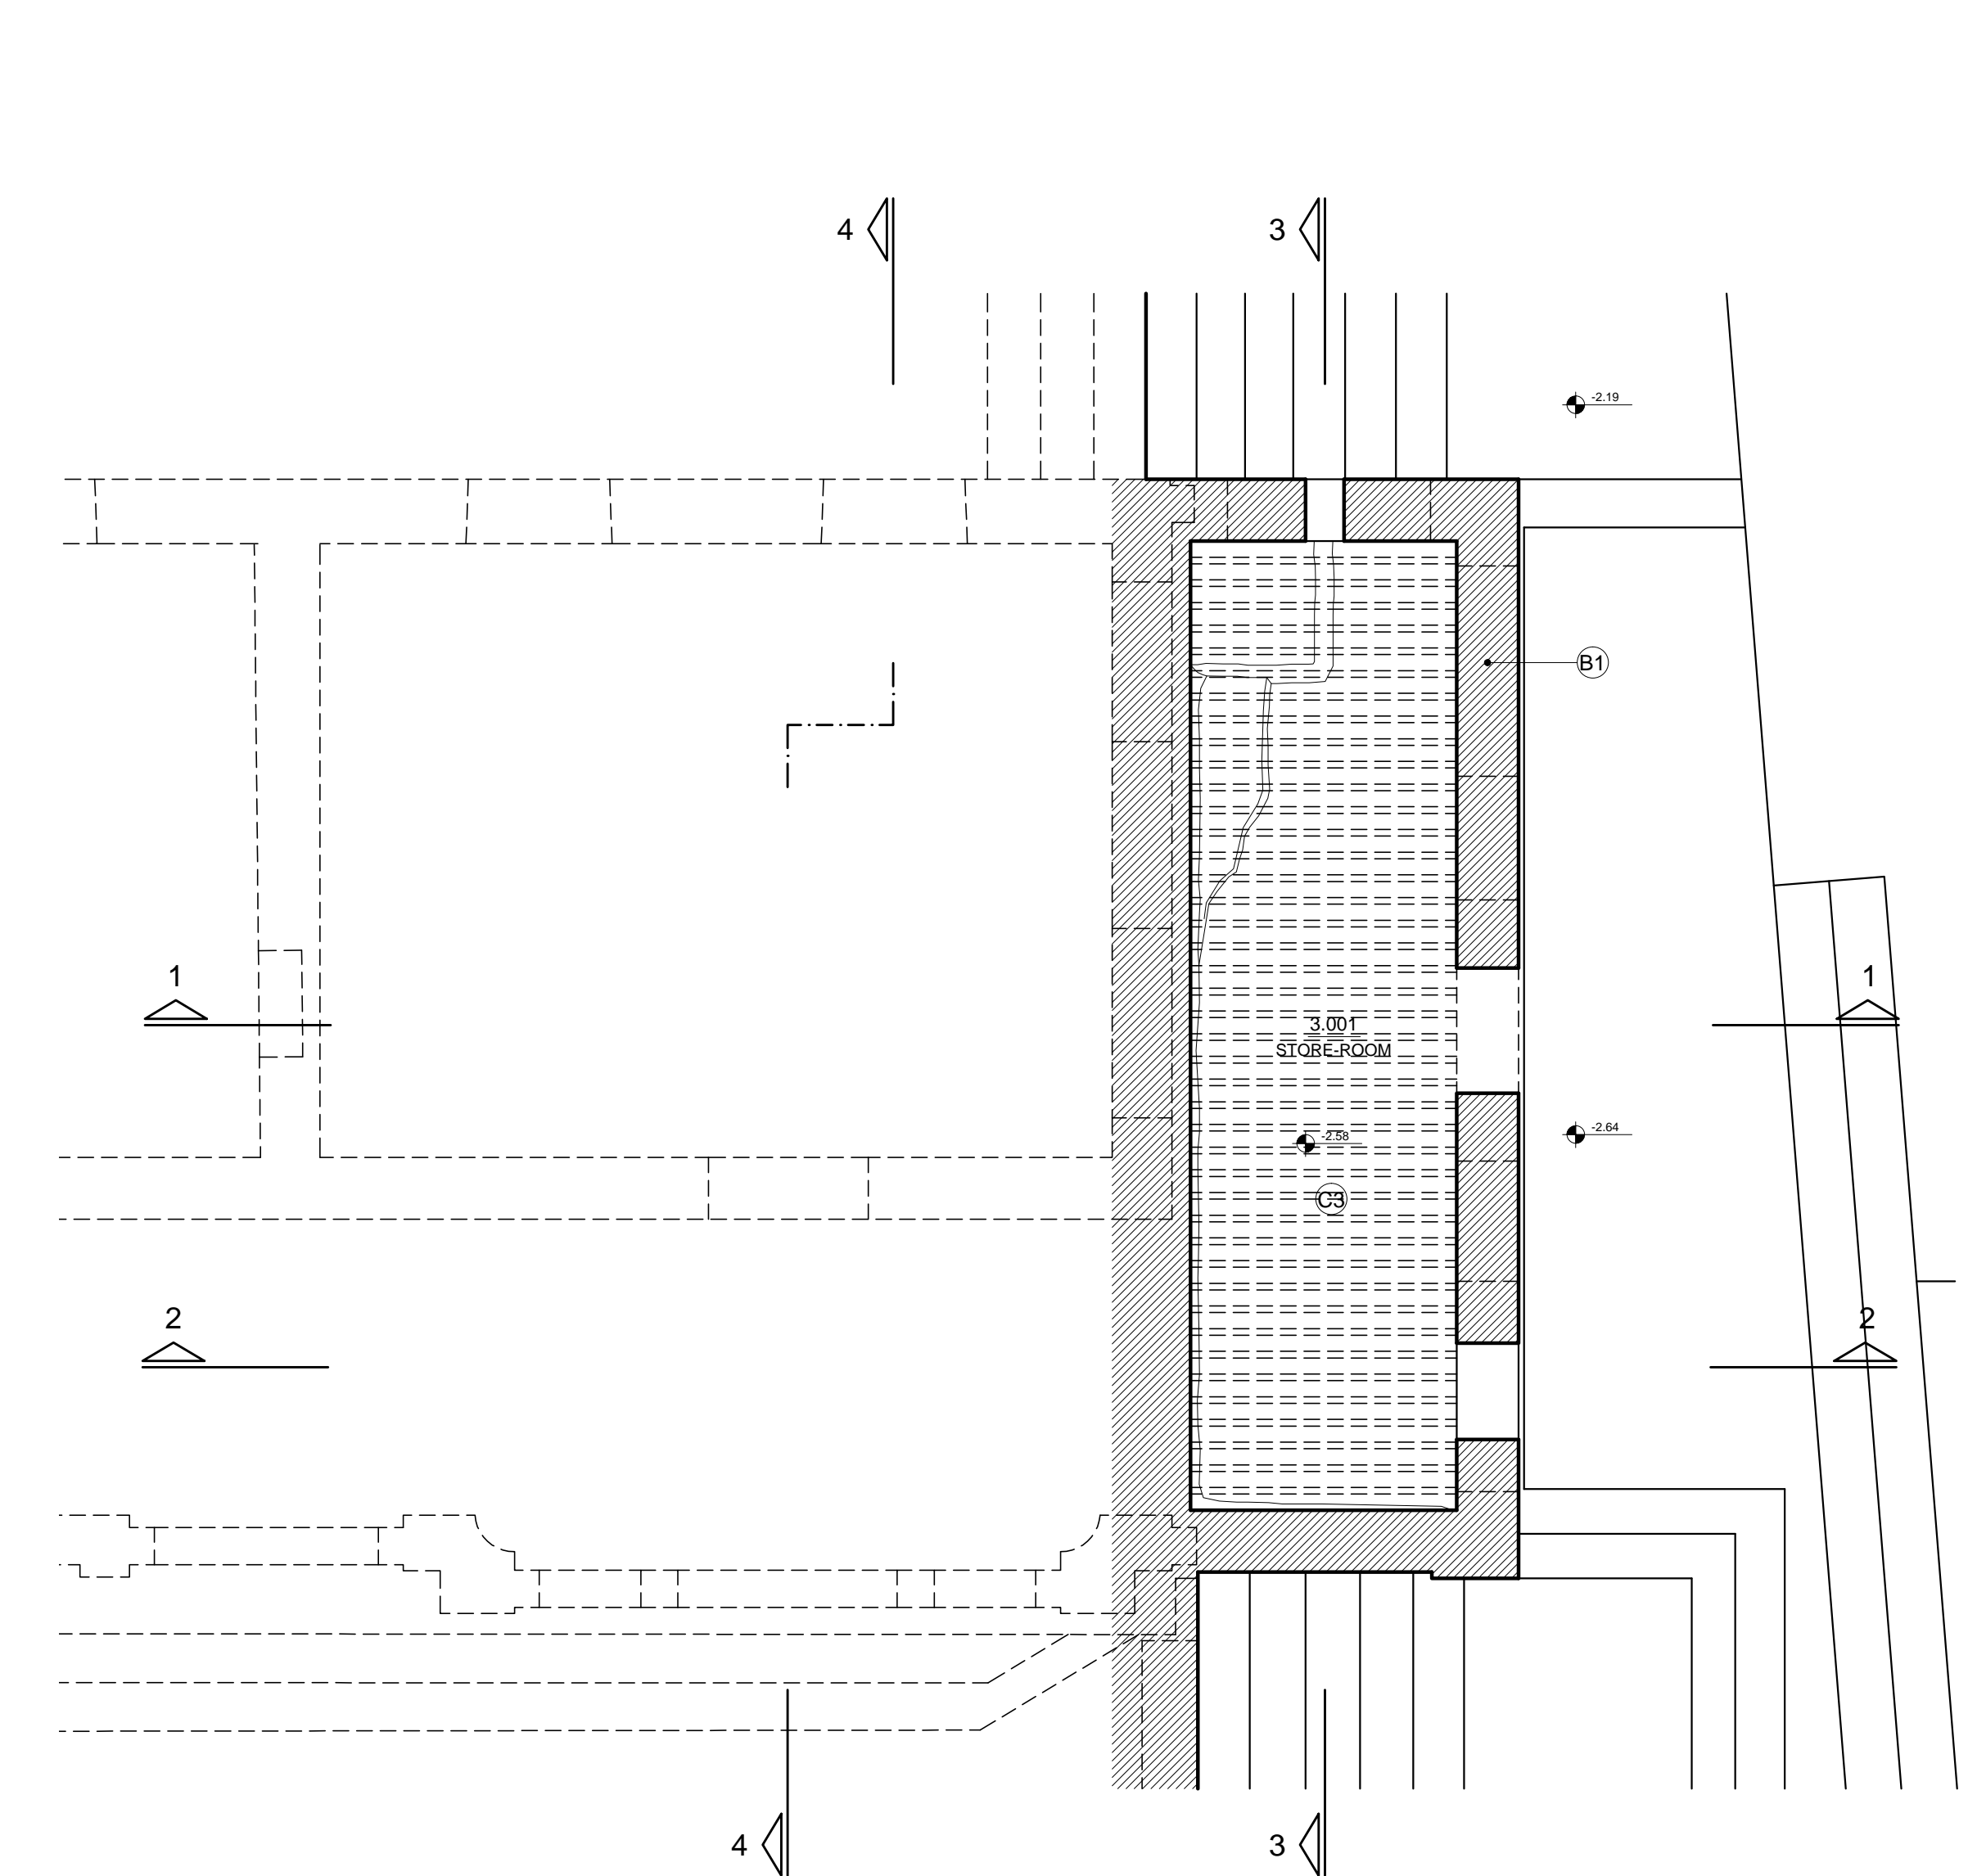
- Extensive erosion of stone
 - Loss of stone
 - Crack
- Structural problems**
- A1 Intense masonry crack
 - A2 Timber bearing structure of the roof with problems of oxidation of the supporting iron straps and looseness of some of the joints

- Construction works**
- B1 Blocked window
 - B2 Extempore coverage of the building with asbestos-cement sheets
 - B3 Problems of preservation and aesthetical downgrading as a result of modern repairs (see key)

- B4 Extempore coverage with ceramic tiles
 - B5 Extempore cement mortar which covers ashlar masonry
- Floors**
- C1 Existing floor of decorative cement tiles

- C2 Extempore ground concrete layer
 - C3 Earthen floor with problems of pollution
- Joinery - Doors & windows**
- D1 Extempore blocking of window
 - D2 Window which needs urgent consolidation

- D3 Door/window which needs conservation
 - D4 Ceiling which needs conservation
 - D5 Part of the ceiling that has collapsed
- Installations**
- E1 Extempore installations of electrical-mechanical systems
