# Field Report Presentation

at MoWT Boardroom, Kampala

Consulting Services: Technical Assistance to the District Local Governments of Abim, Adjumani, Amudat and Moyo to carry out Rehabilitation of District and Community Access Roads

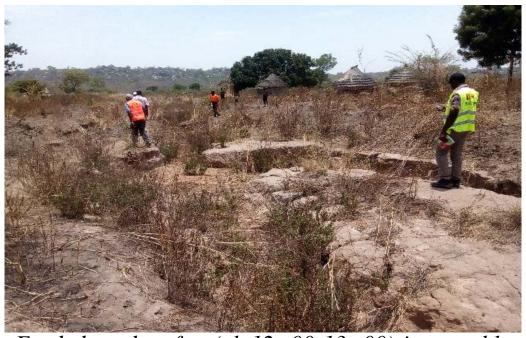
- Rock out-crop sections (ch3+00-6+00), ch7+200-8+100, 9+00-9+200, along the road corridor
- No drainage structures at most catch basins
- Gulley erosion along the road surface(ch12+00-13+00)

Eroded road surface(ch 12+00-13+00);impassable road section

- Rock blasting
- Design for drainage structures
- Drainage improvement

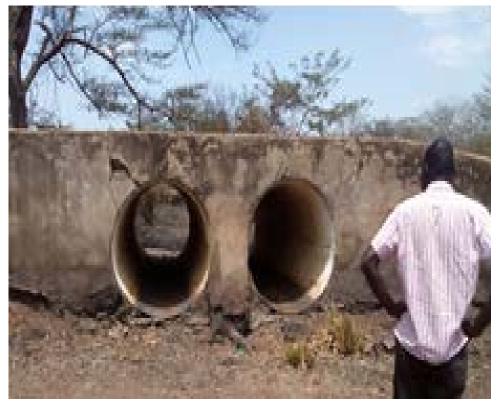
- Rock out-crops(ch 0+200,7+800-7+900) all along the road corridor;
- Broken and silted culverts;
- Low lying section (ch 14+00-20+900);flood prone along river Nile banks;
- Under-designed Culvert crossings (ch 14+00-23+00); and
- Poor condition head and wing walls.

Narrow Stream crossing(ch 4+500); no head walls

- Rock blasting;
- Redesign drainage structures;
- Raise road profile at low lying sections;
- Provide catch water drains; and
- River training.

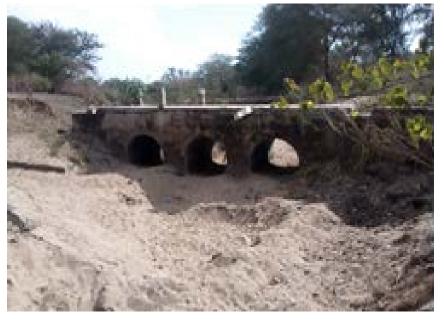
- Flood zone (ch 7+050-7+150); and
- Damaged stream crossing(4x900) at Robibire stream(ch 3+100).

Damaged stream crossing(ch 3+100)

- Raise road surface;
- Provide catch water drains;
- Consider shifting alignment;
- Design for drainage structures; and
- River training.

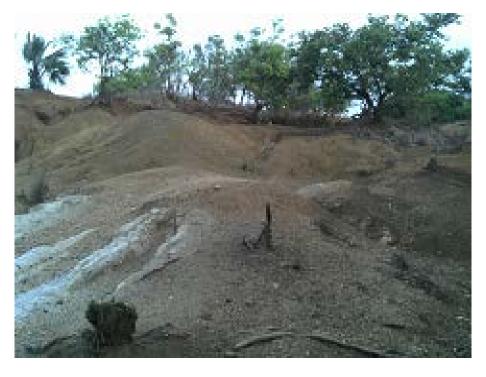
- Narrow road section(1-2.5m width) at (ch 2+00-4+500);
- Heavily eroded stream approach;
- Horizontal curve towards stream;
- Stream without a drainage structure at ch 4+600; and
- Impassable road section at ch 4+600.

Eroded stream approach(ch 4+600)

- Design for drainage structures;
- River training; and
- Alignment diversion upstream.

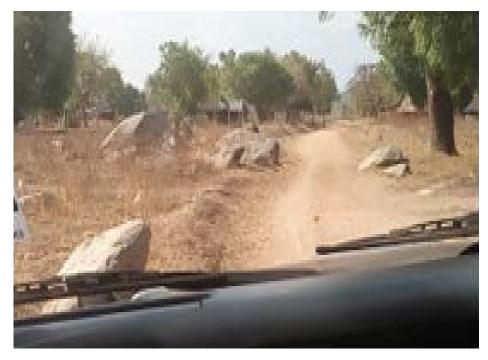
• Rock out-crop sections within the road corridor (ch1+600-2+400, 3+300, 3+700, 7+300,7+600 & 9+700.

Rock along road corridor(ch 1+600-2+400)

Rock blasting.

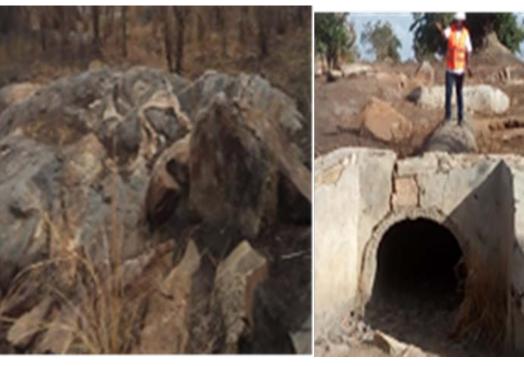
- Rock out-crop (ch 0+800, 3+600, and 7+500).
- 300m long swamp (towards river Nile).
- Broken culverts.

rock and broken culverts(ch 3+600)

- Rock blasting
- Raise road profile during geometric design
- Redesign for drainage structures

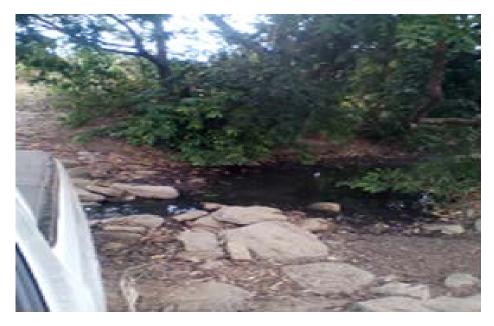
- Streams at ch 0+480,0+600, 1+600, 2+100, & 2+300 without drainage structures; and
- Rock out-crops at ch 2+350.

Ebihwa stream(ch 0+480); no drainage structure

- Design for drainage structures;
- Rock blasting; and
- River training.

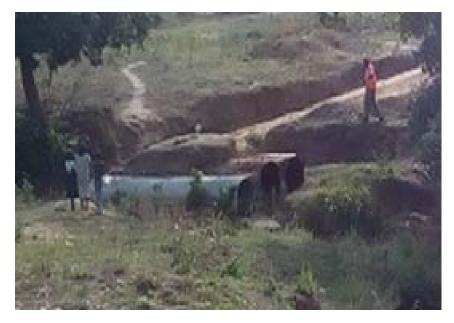
- Streams at ch 1+200 and 1+500; No drainage structure; and
- Stream at ch 1+800 (8m wide).3\*1200mm metallic culverts, structure damaged.

Damaged stream drainage structure(ch 1+800)

- Re-design for drainage structure
- River training

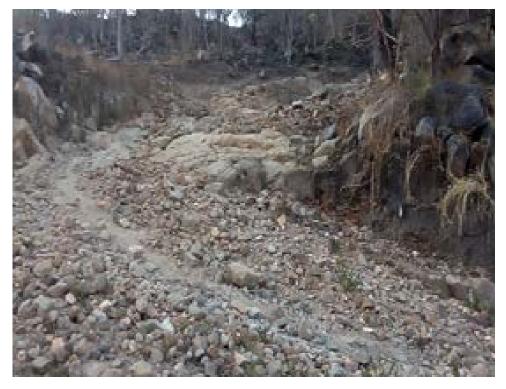
- Seasonal Stream (ch 7+300); 4\*900 metallic culverts, exposed and not functioning;
- Seasonal Stream (ch 9+200); 2\*900mm metallic culverts, damaged;
- Rocky surfaces along and within the road corridor (ch 8+500-9+300, 9+500-11+100); and
- Abnormally steep slopes (10%-30%); section (ch 9+500-11.100).

Rocky surface and steep slope (27%)-ch 9+500-11+100;

- Re-design drainage structures;
- Rock blasting; and
- Alignment diversion.

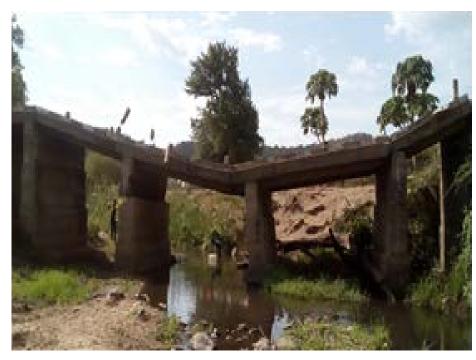
- Seasonal Stream(ch 1+900), no drainage structure;
- Seasonal stream (ch 2+400), 5\*1200 cp culverts, damaged;
- Structurally failed Amua bridge(ch 5+00); and
- Rocky surface(ch 9+700-10+200).

Failed Amua bridge (ch 5+00)

- Design and re-design of drainage structures; and
- Rock blasting.

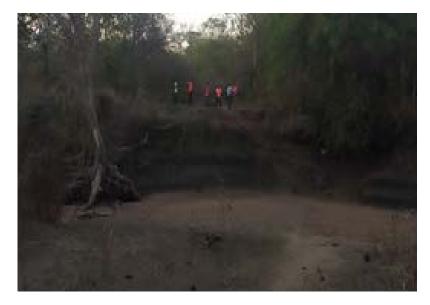
- No drainage structures at the last 2km(8+00-10+00); and
- Kochi stream(10+00), no drainage structure.

*Kochi stream (ch 10+00)without drainage structure*

• Design of drainage structures.

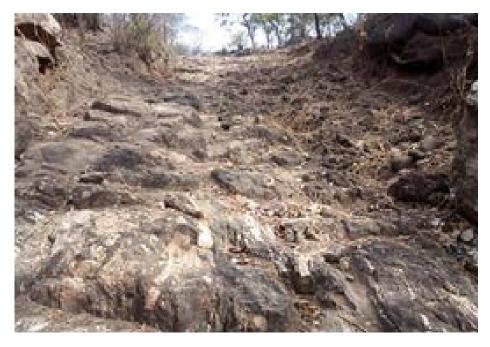
- Rock out-crop(ch 4+100, 4+300, 8+400-8+700, 9+300-11+500, 12+100);
- Rocky surface(ch 6+800-7+400,12+500-14+800);
- steep slopes(10%-23%); and
- Seasonal streams(ch 12+900 &13+900) without drainage structures.

Rocky surface and steep gradient (10%-23%) at ch 13+500

- Rock blasting;
- Design of drainage structures; and
- Alignment diversion from ch 13+500.

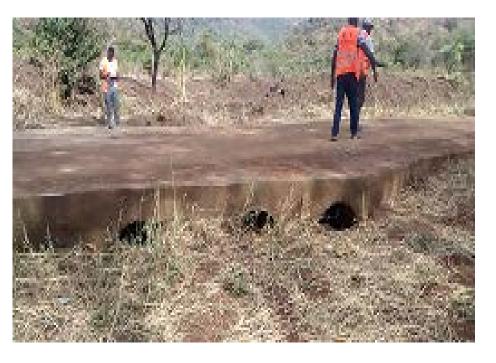
- Vented drift(ch 3+600), fairly functioning;
- Ch 7+100; Road section edges a valley dam embankment;
- Seasonal stream(11+000), 1\*600mm cp crossing, silted and inadequate; and
- Rocky surfaces along the road corridor (ch 11+500,18+400-18+500, 24+400, and 33+400).

*Silted vented drift(ch3+600)*

- Re-design for drainage structures;
- Alignment diversion;
- Align rocky surfaces with concrete.

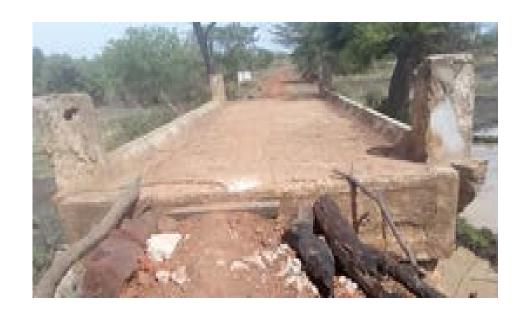
- Seasonal streams (ch 3+300, 7+300, 15+500), No adequate drainage structures;
- Seasonal swamps (ch 7+800-8+200,15+200-15+450, 15+900-16+300);
- Section from ch 12+800-16+130, Road impassable due to heavy gulley erosion; and
- Ch 16+100; 11m long Structurally failed RC bridge.

Structurally failed bridge (ch 16+100)

- Re-design for drainage structures; and
- Raise road surface during geometric design.

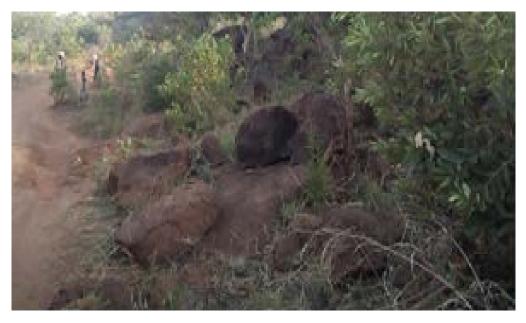
- Rocky surface (ch 1+100 and 1+800), rock out-crops(ch 1+400, 1+800, 2+300-2+500;
- Seasonal stream(ch 1+600), no drain facility; and
- No culvert crossings through entire road section.

Rock along road corridor(ch 2+300-2+500)

- Rock blasting and aligning rocky surfaces with concrete;
   and
- Design for drainage structures.

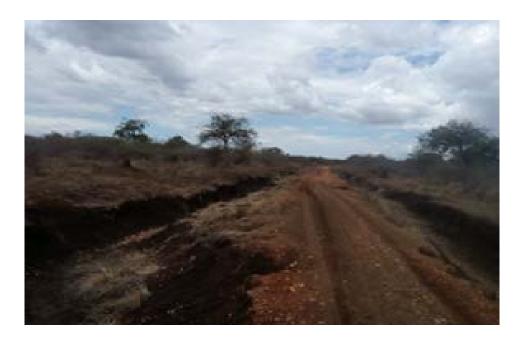
- Rock out-crop (ch 0+900), rocky surface(ch3+100, 3+900-4+00);
- Gulley erosion (ch 2+200-2+300,3+500-3+800,5+100-6+200);
- Lomeripus swamp (ch 7+200-7+400); and
- Lomeripus seasonal stream (ch 7+300), vented drift ;operational.
- **Proposed solutions**
- Rock Blasting and align rocky surfaces with concrete.
- Raise road surface at swampy sections
- Design for adequate drainage structures

*Gulley erosion along road surface(ch 3+500-*3+800)

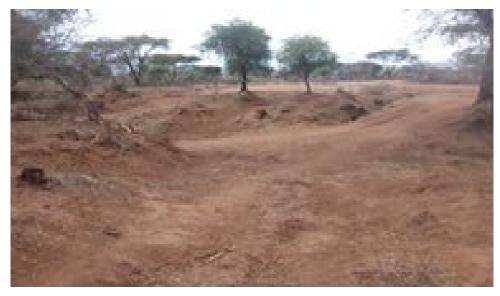
- Gulley erosion along the road surface (ch 0+900-1+00, 2+300-3+200); and
- Lopedot seasonal stream (ch 4+400), Lokokor twin seasonal stream(ch 6+400) and minor stream(ch 5+400), all without drainage structures.

Lokokor twin seasonal stream (ch 6+400 and 6+500); No drainage structures

• Design for drainage structures.

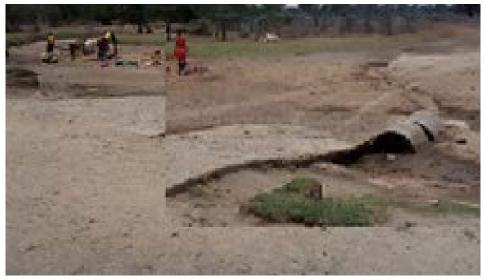
- Drift(ch 0+100), operational;
- Rock out-crops (ch 1+600 and 2+500); and
- Chepenyiny seasonal stream, damaged vented drift.

Chepenyiny seasonal river crossing(ch 12+300)

- Rock blasting; and
- Design for adequate drainage structures.
