**Site Assessment and Feasibility  
Study of the Nubarashen Burial  
Site of Obsolete and Banned  
Pesticides in Nubarashen, Armenia**

***Contract № ARM/01/2013***

**Phase 1 and 2 investigation report**

**Draft, 28 June 2013**

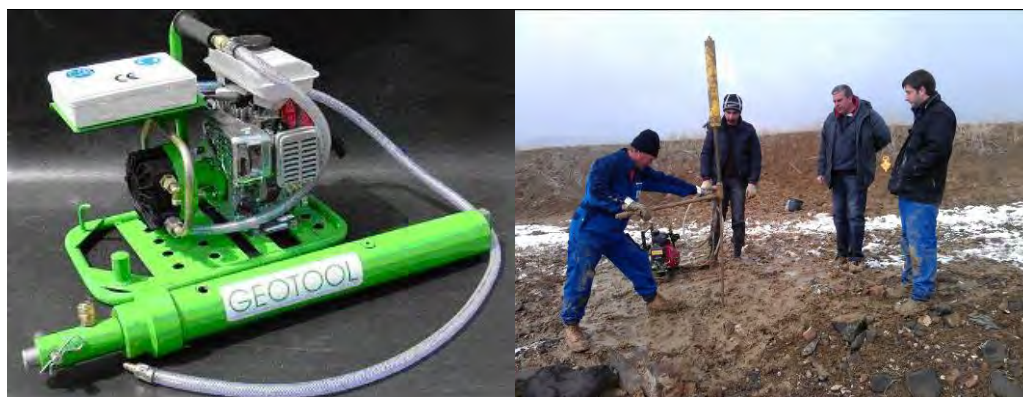
Figure 2.2 A Left the DCPT Geotool and right a DCPT measurement

17 DCPTs were carried out in one longitudinal and three cross sections to establish the surrounding soil structure of the landfill body. Figure 2.2 gives a field setup of a DCPT and the locations of the DCPTs are given in figure 2.3. The DCPTs are performed using a standard 60 degree apex cone connected to 'A size' drill rods with the same standard fall height and weight as the Standard Penetration Test. The DCPTs are not performed in the landfill body because the cone can easily penetrate a drum or container with liquids without knowing. If a drum or container is perforated the soil will be contaminated. The risk of causing soil contamination by the DCPTs is seen as unacceptable and therefore not taken.

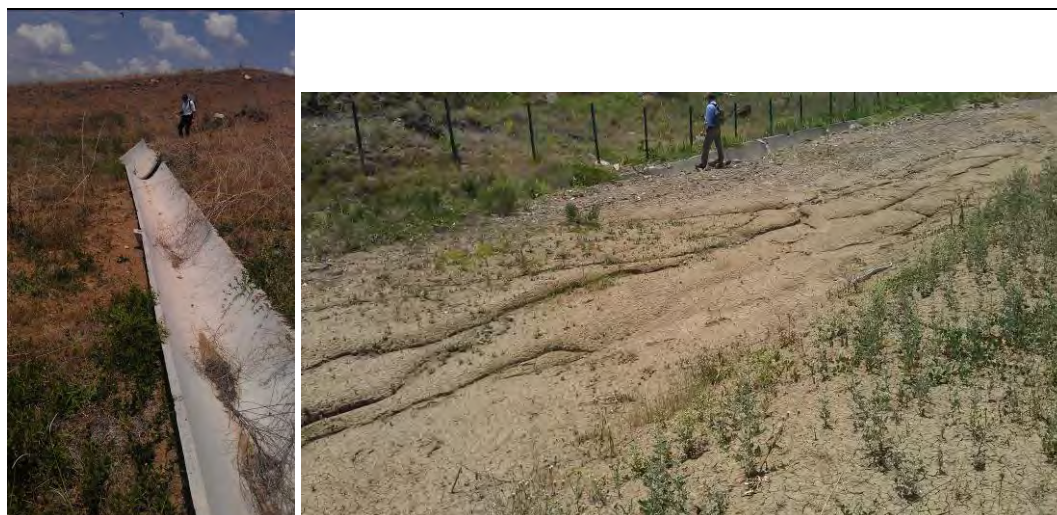
**Figure 2.7 Left: Dislocated drainage element. Right: Eroded topcover landfill body**

The landfill body itself is a hillock of approximately 1.25 m high uphill, 2 m high in the middle and 1.50 m high at the down hill part with respect of the surrounding surface level of the enclosed area. The hillock is 104 m long and 12 m wide uphill, 10 m wide in the middle and 18 m wide at the down hill part. The total area of the hillock is around 1.640 m<sup>2</sup>. The topsoil of this hillock covering the dumped pesticides is clayish and traces of pesticides and remains of packaging are observed at the surface. The top cover of the landfill body is getting eroded and at a few places the top cover has cracks (see figure 2.7).

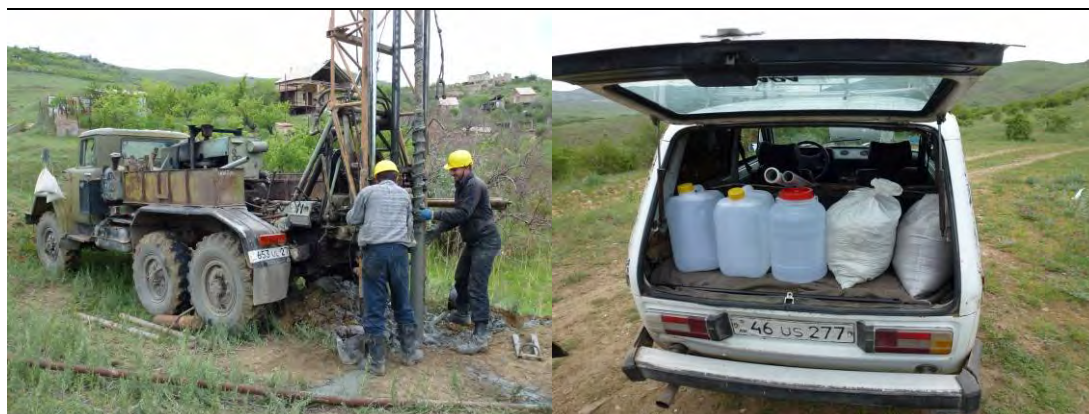
**Figure 4.1 Left: The Zil mechanical drill rig in action. Right: Well tubing, clean water, filter gravel and bentonite were transported to the site from Yerevan**

The Phase 2 fieldwork was conducted from 6 to 18 May, 2013. The shallow boreholes and the boreholes at the difficultly accessible reed ponds were performed by manual augering. The deep boreholes were performed by a mechanical rotary core Zil drilling rig, from the Armenian company 'Engineer-geologist' Ltd (see figure 4.1). A total of nine monitoring wells have been installed. The monitoring wells consist of HDPE filter pipes with filter screen (equipped with water traps and filter gauze) and PVC risers. Each monitoring well is labeled and finished with a plastic cap or metal well head and a weatherproof label providing technical details (see figure 4.2).

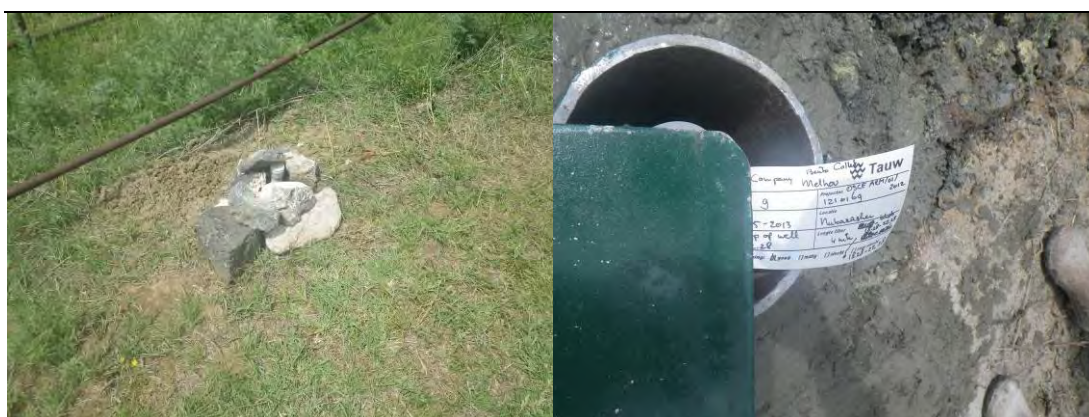
**Figure 4.2 Left: Monitoring well 8, protected by rocks. Right: Monitoring well 9, protected with steel well head. All monitoring wells are equipped with weather proof labels providing details on the monitoring wells**

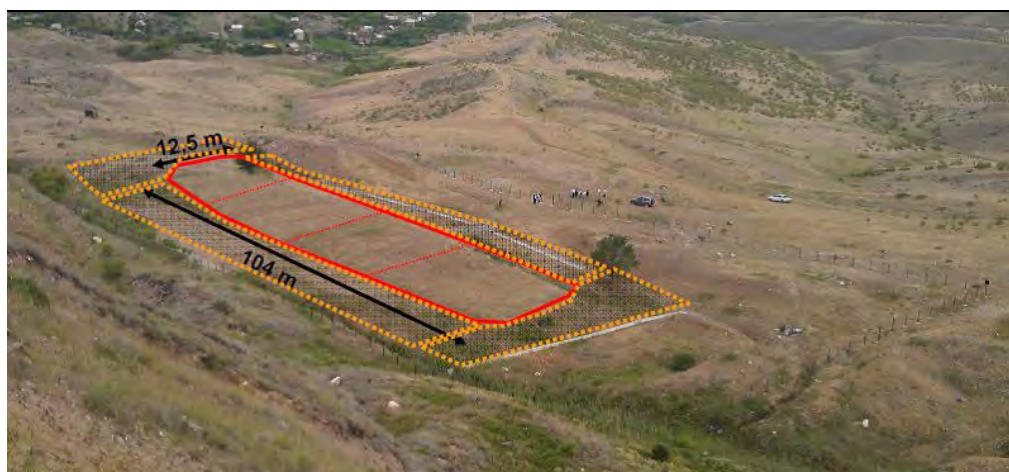
**Figure 4.3 Composite soil samples topsoil dumpsite are presented in red (from right - east- to left - west - 201 to 204. The areas in the orange coloured section are discussed in section 4.3.3**

Below table 4.2 lists the samples taken from the top cover of the landfill body (see figures 4.3 and 4.4). The motivation for taking these samples is to assess the soil quality, as well as the erodability and soil texture (reported in section 5). Appendix 2 presents maps with the sample locations. The analytical results are given in the tables 4.3.

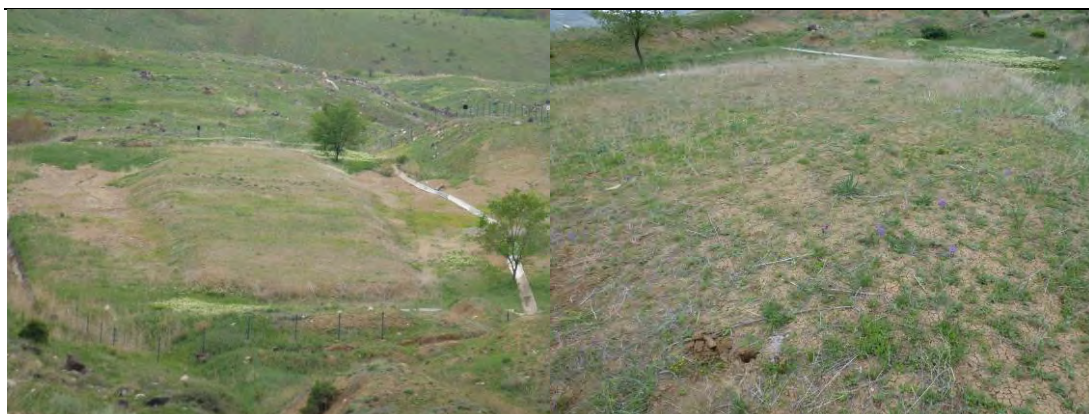
**Figure 4.4 Left: the landfill body seen in a westerly direction. Right: drilling point on topcover**

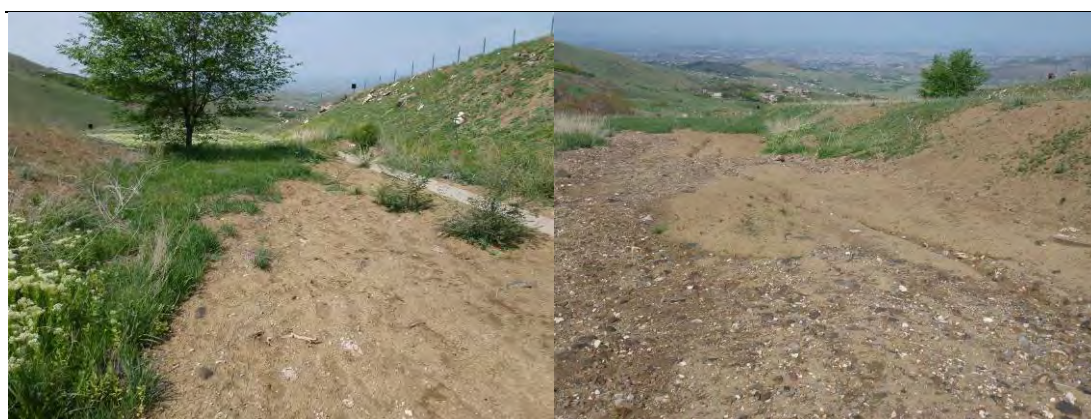
**Figure 4.5 Surface areas with - and without - plant cover, within the fence, next to the landfill body**

Some of the analysed samples from the top soil were collected from areas with plant cover (CSS 102, 104, 106), and some from areas with bare soil (CSS 103, 105 and 107). This is illustrated in figure 4.5. Appendix 7 presents maps with the sample locations. The analytical results are given in the tables 4.5 and 4.6.

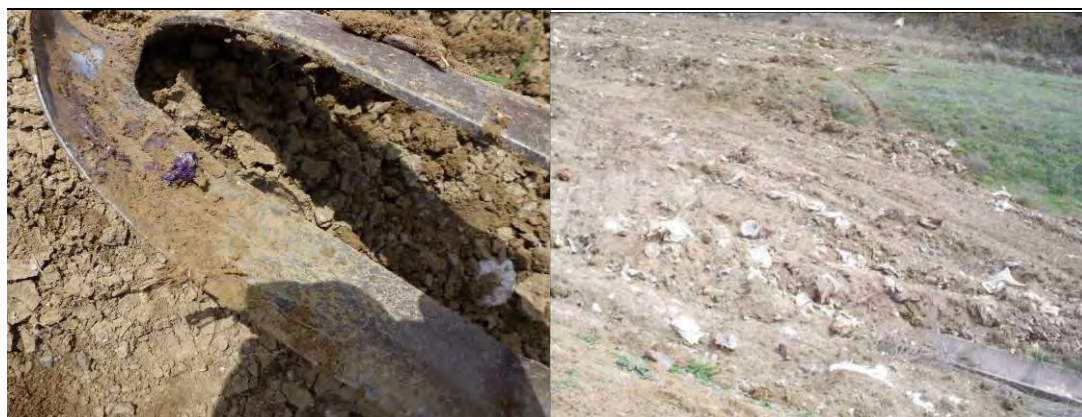
**Figure 4.6 Left: pure product particle on auger head (likely Granosan) Right: The situation (April 2010) before closing of the landfill, with pesticide waste scattered around the current landfill body**

The presence of pure product outside of the landfill body is explained by the photos taken in April 2010 (Appendix 4 of the ToR) before the top cover was (re)-installed, that clearly show pure product was laying scattered around the current landfill body perimeter (see figure 4.6). Another observation is the presence -or absence- of plant cover. Some of the analysed samples from the topsoil were collected from areas with plant cover (CSS 102, 104, 106), and some from areas with bare soil (CSS 103, 105 and 107). The analytical results indicate much higher contaminant levels in the 'bare soil' composite soil samples as compared to the 'plant cover' composite soil samples. Although the absence of plant cover may not necessarily be related to only POPs pesticides, it does relate to the presence of some of the substances buried in the landfill such as herbicides.

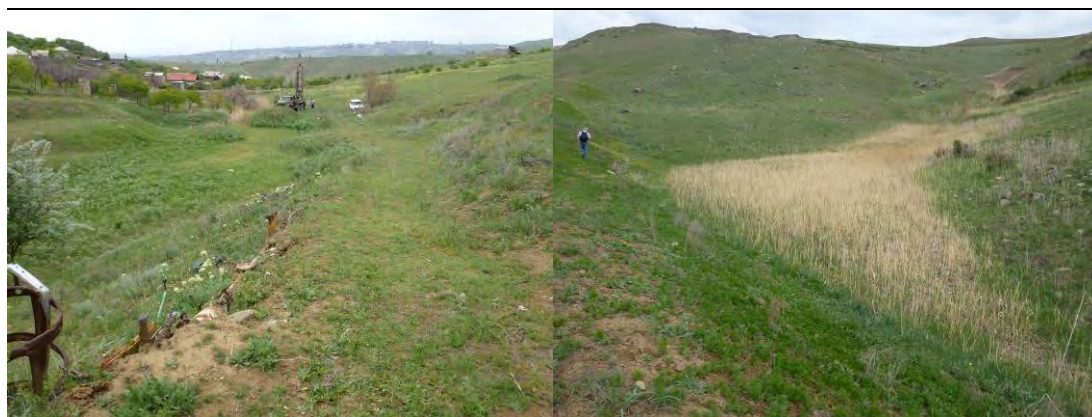
**Figure 4.4** Left: Reed pond 8/9 with the drilling rig installing monitoring well 9. Right: Reed pond 6. This photo indicates that the gully is likely not connected to the landfill run-off. The landfill is located up-gradient, to the left, from the Tauw colleague walking in the top left of the picture, whereas the water feeding the gully appears to come from the top right of the picture

Based on visual inspection in the field, Ponds 6 and 7 (and possibly 8/9) appear not to be directly connected to the potential surface run-off from the landfill area (see figure 4.4). Concentrations of DDT, range from detectable (below the 'slightly contaminated' limit value) in pond 7, to slightly contaminated in pond 6. The sediments in pond 8/9 were measured to contain the highest levels of DDT of the five ponds. The second gully meets the first gully (with ponds 6 and 7) at pond 8/9. The second gully (the left one in figure 4.3) also does not appear to be directly connected to the potential surface run-off from the landfill area, based on visual inspection of the terrain topography (see figure 4.3). It does however drain the upper part of the valley close to the landfill. Although the gullies appear to not be directly connected to the runoff water from the landfill, it cannot be excluded that one or both gullies are (also) fed with water that has infiltrated into the landslide area.

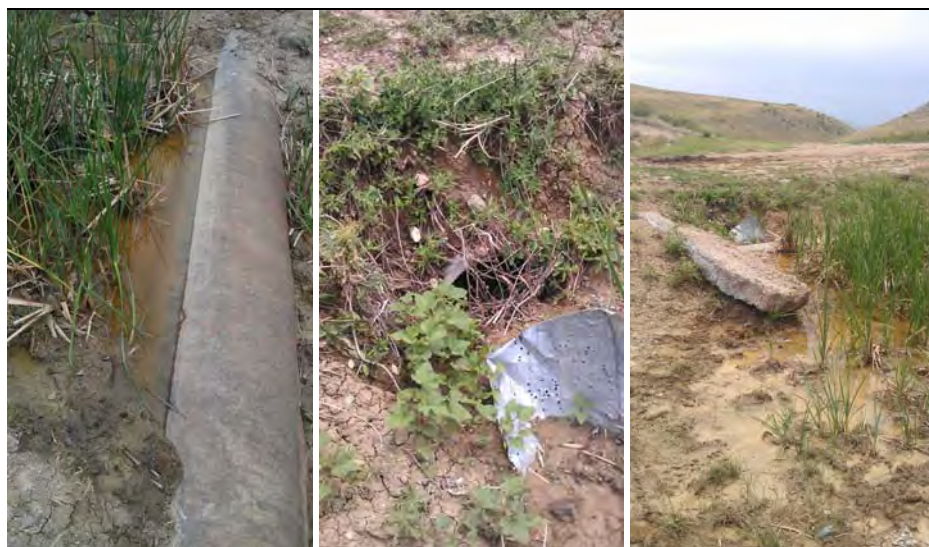
**Figure 5.1 Left: The water main preventing the water to flow to the culvert Middle: The blocked culvert Right: Pond 1, the water main, the blocked culvert and the dirt road**

Upstream just across the watershed is Pool 1 (see figure 4.3) This pool has for a large part of the year standing water because the water main is forming a barrier for pool to drain completely. If the water level in the pool is higher than the top of the water main (see figure 5.1), the water flows towards the culvert under the road passing 300 - 400 meter upstream the landfill. This culvert is half blocked with sediments and prevents rapid drainage of the standing runoff water.

Observations in the field and the site assessment results as described above indicate that the landfill area is located on an unstable landside. The landfill site itself (fenced area) is relatively flat but is surrounded by steeper terrain. Especially upstream of the landfill site, the terrain is steep and shows signs of previous landslides in the form of terraces (see Figure 5.3). It is assumed that the driving force of the lateral mass movement in the flatter terrain is the slope instabilities upstream. The slope stabilities upstream appear to be activated by the inflow of water from the small (man-made) pool 1 (see figures 4.3 and 5.1) at the top of the slope.

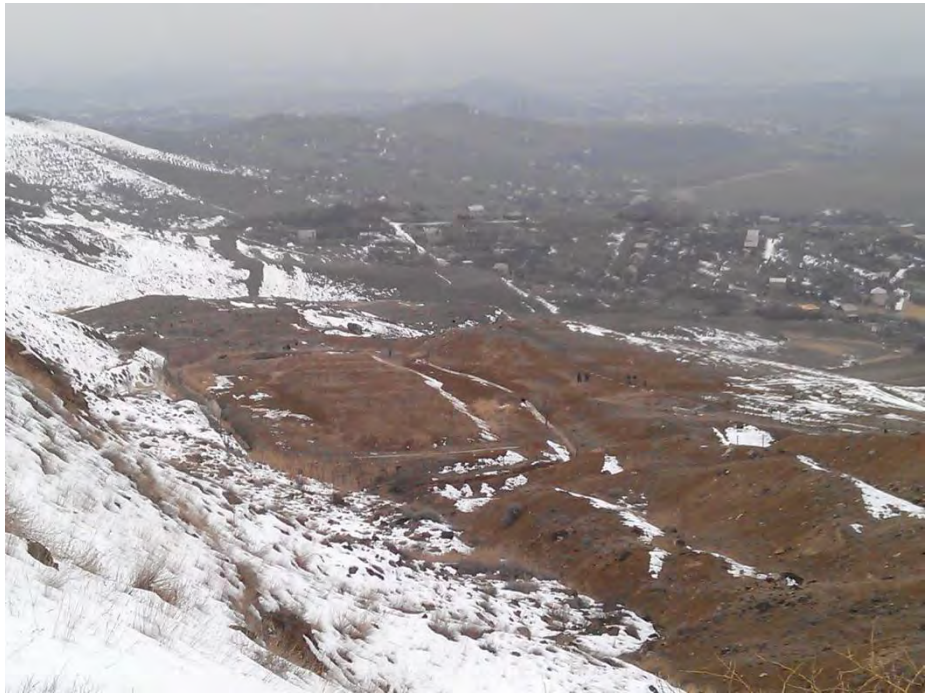
**Figure 3: the landfill seen from above**

The execution of the fieldwork was difficult. The soil at the site formed a large obstacle in conducting the fieldwork. The soil consists of a type of silt or clay that stuck to the equipment. Depending on the time of day, it changed in substance and went from solid after frost in the morning, tough and sticky when cold and wet, to soft and sticky after warming up during the day. It caused the wheels of the surveycart to jam. The wheels became larger and heavier after each turn of the wheels so they had to be scraped clean almost continuously. Also, and more important, the surveywheel needed constant attention. For an accurate position is very important that the survey wheel keeps turning, and turning at the right speed. When the diameter of the surveywheel changes due to the clay sticking to it, it doesn't measure the correct distance. Therefore it had to be checked and cleaned many times during the execution of the fieldwork. Due to this not all physical contact with the soil could be avoided and it took some effort to get the critical parts like connectors and surveywheel parts cleaned at night.

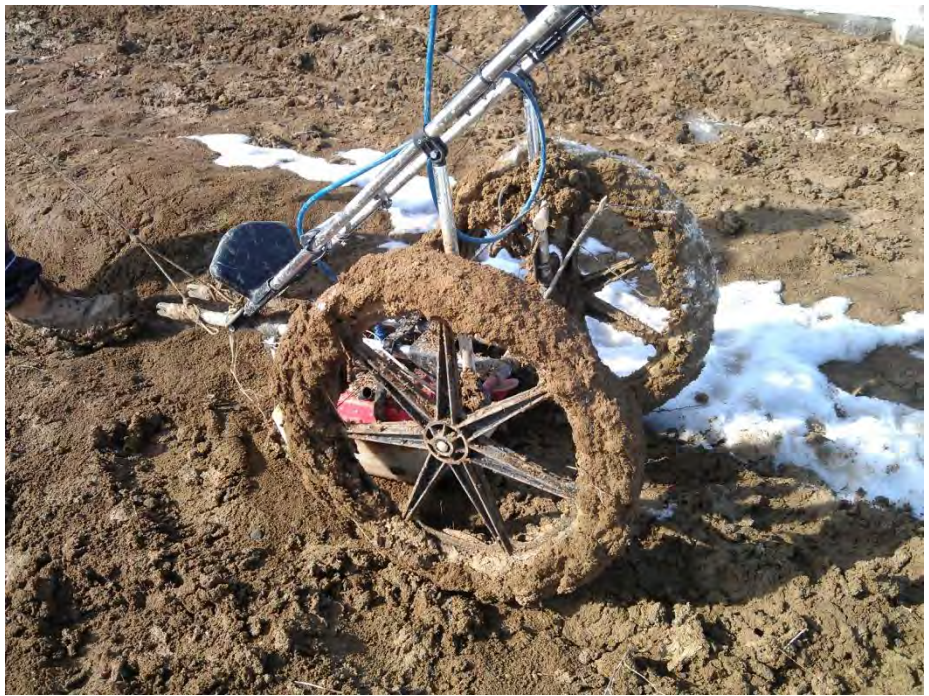
**Figure 4: clay sticking to the equipment**

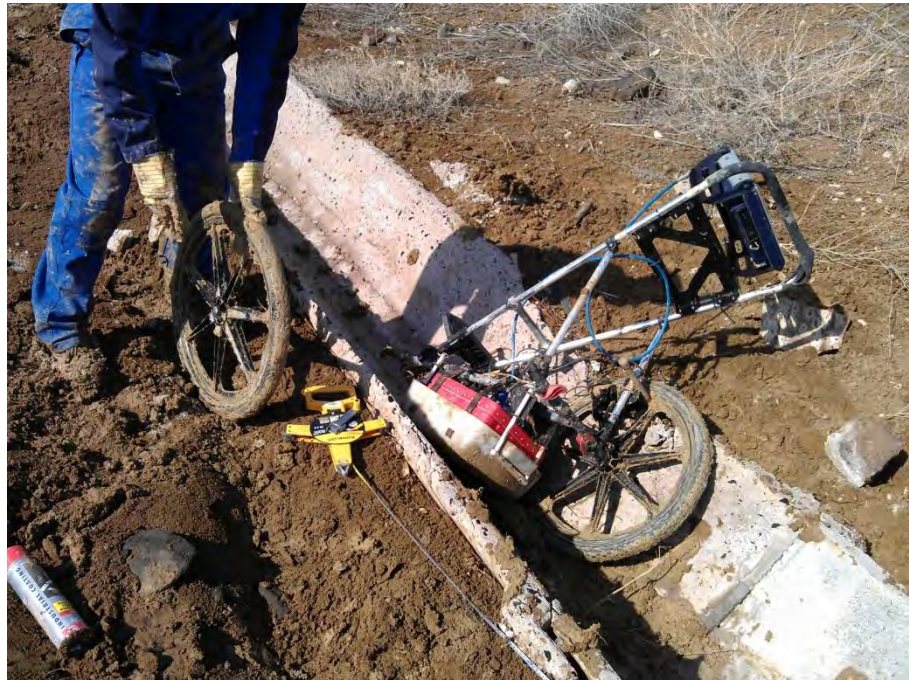
**Figure 5: cleaning the equipment**

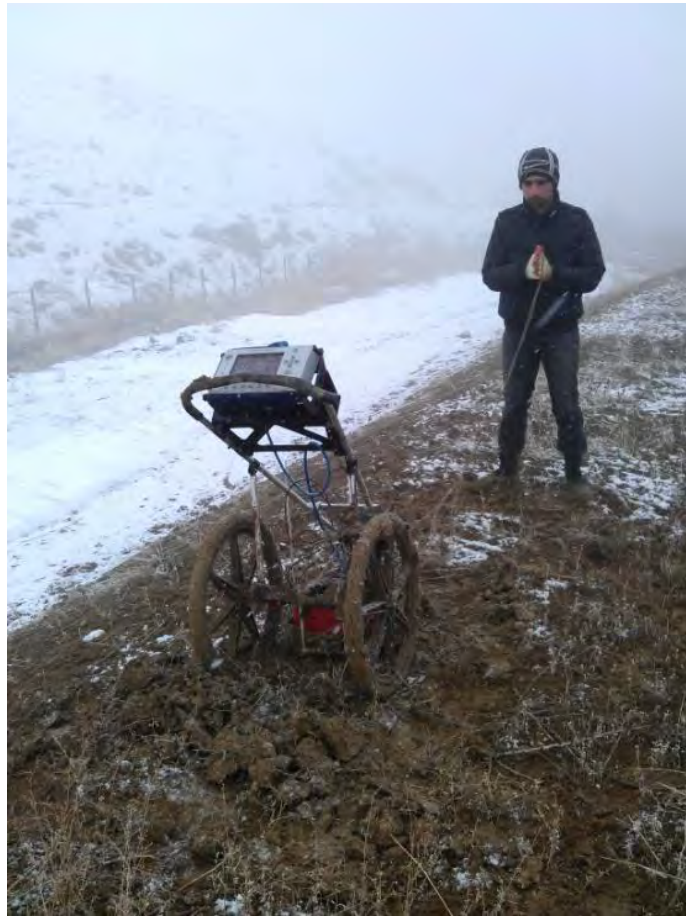
**Figure 9: the 400Mhz antenna in Armenia**

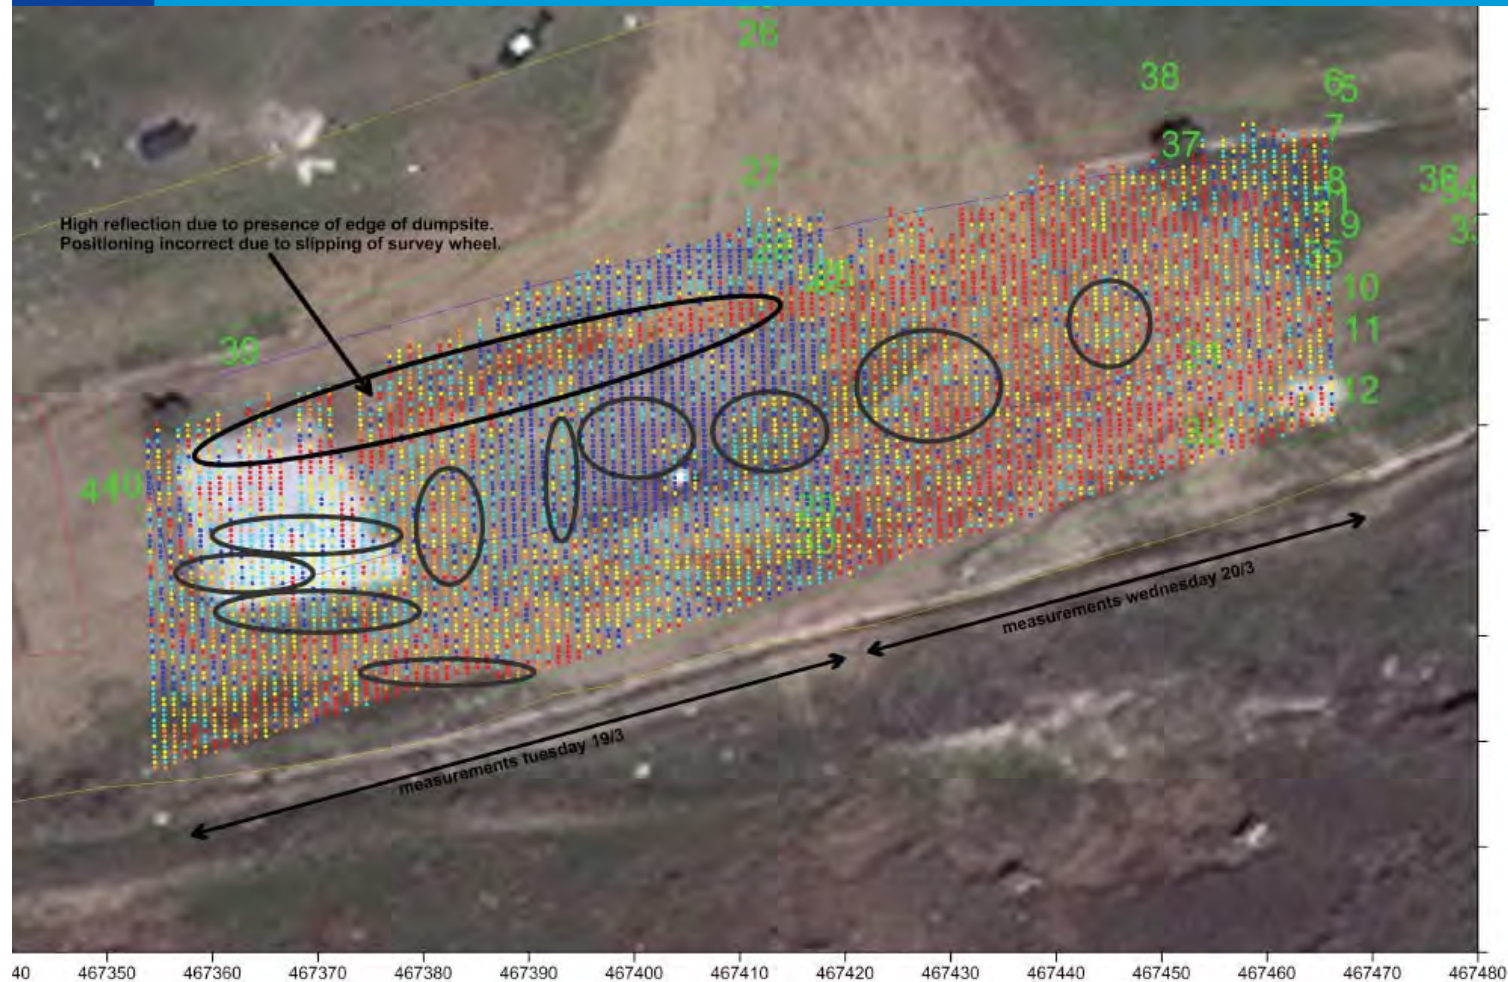
# Results GPR

Relative amount of reflection  
in the top layer (max 50 cm deep).

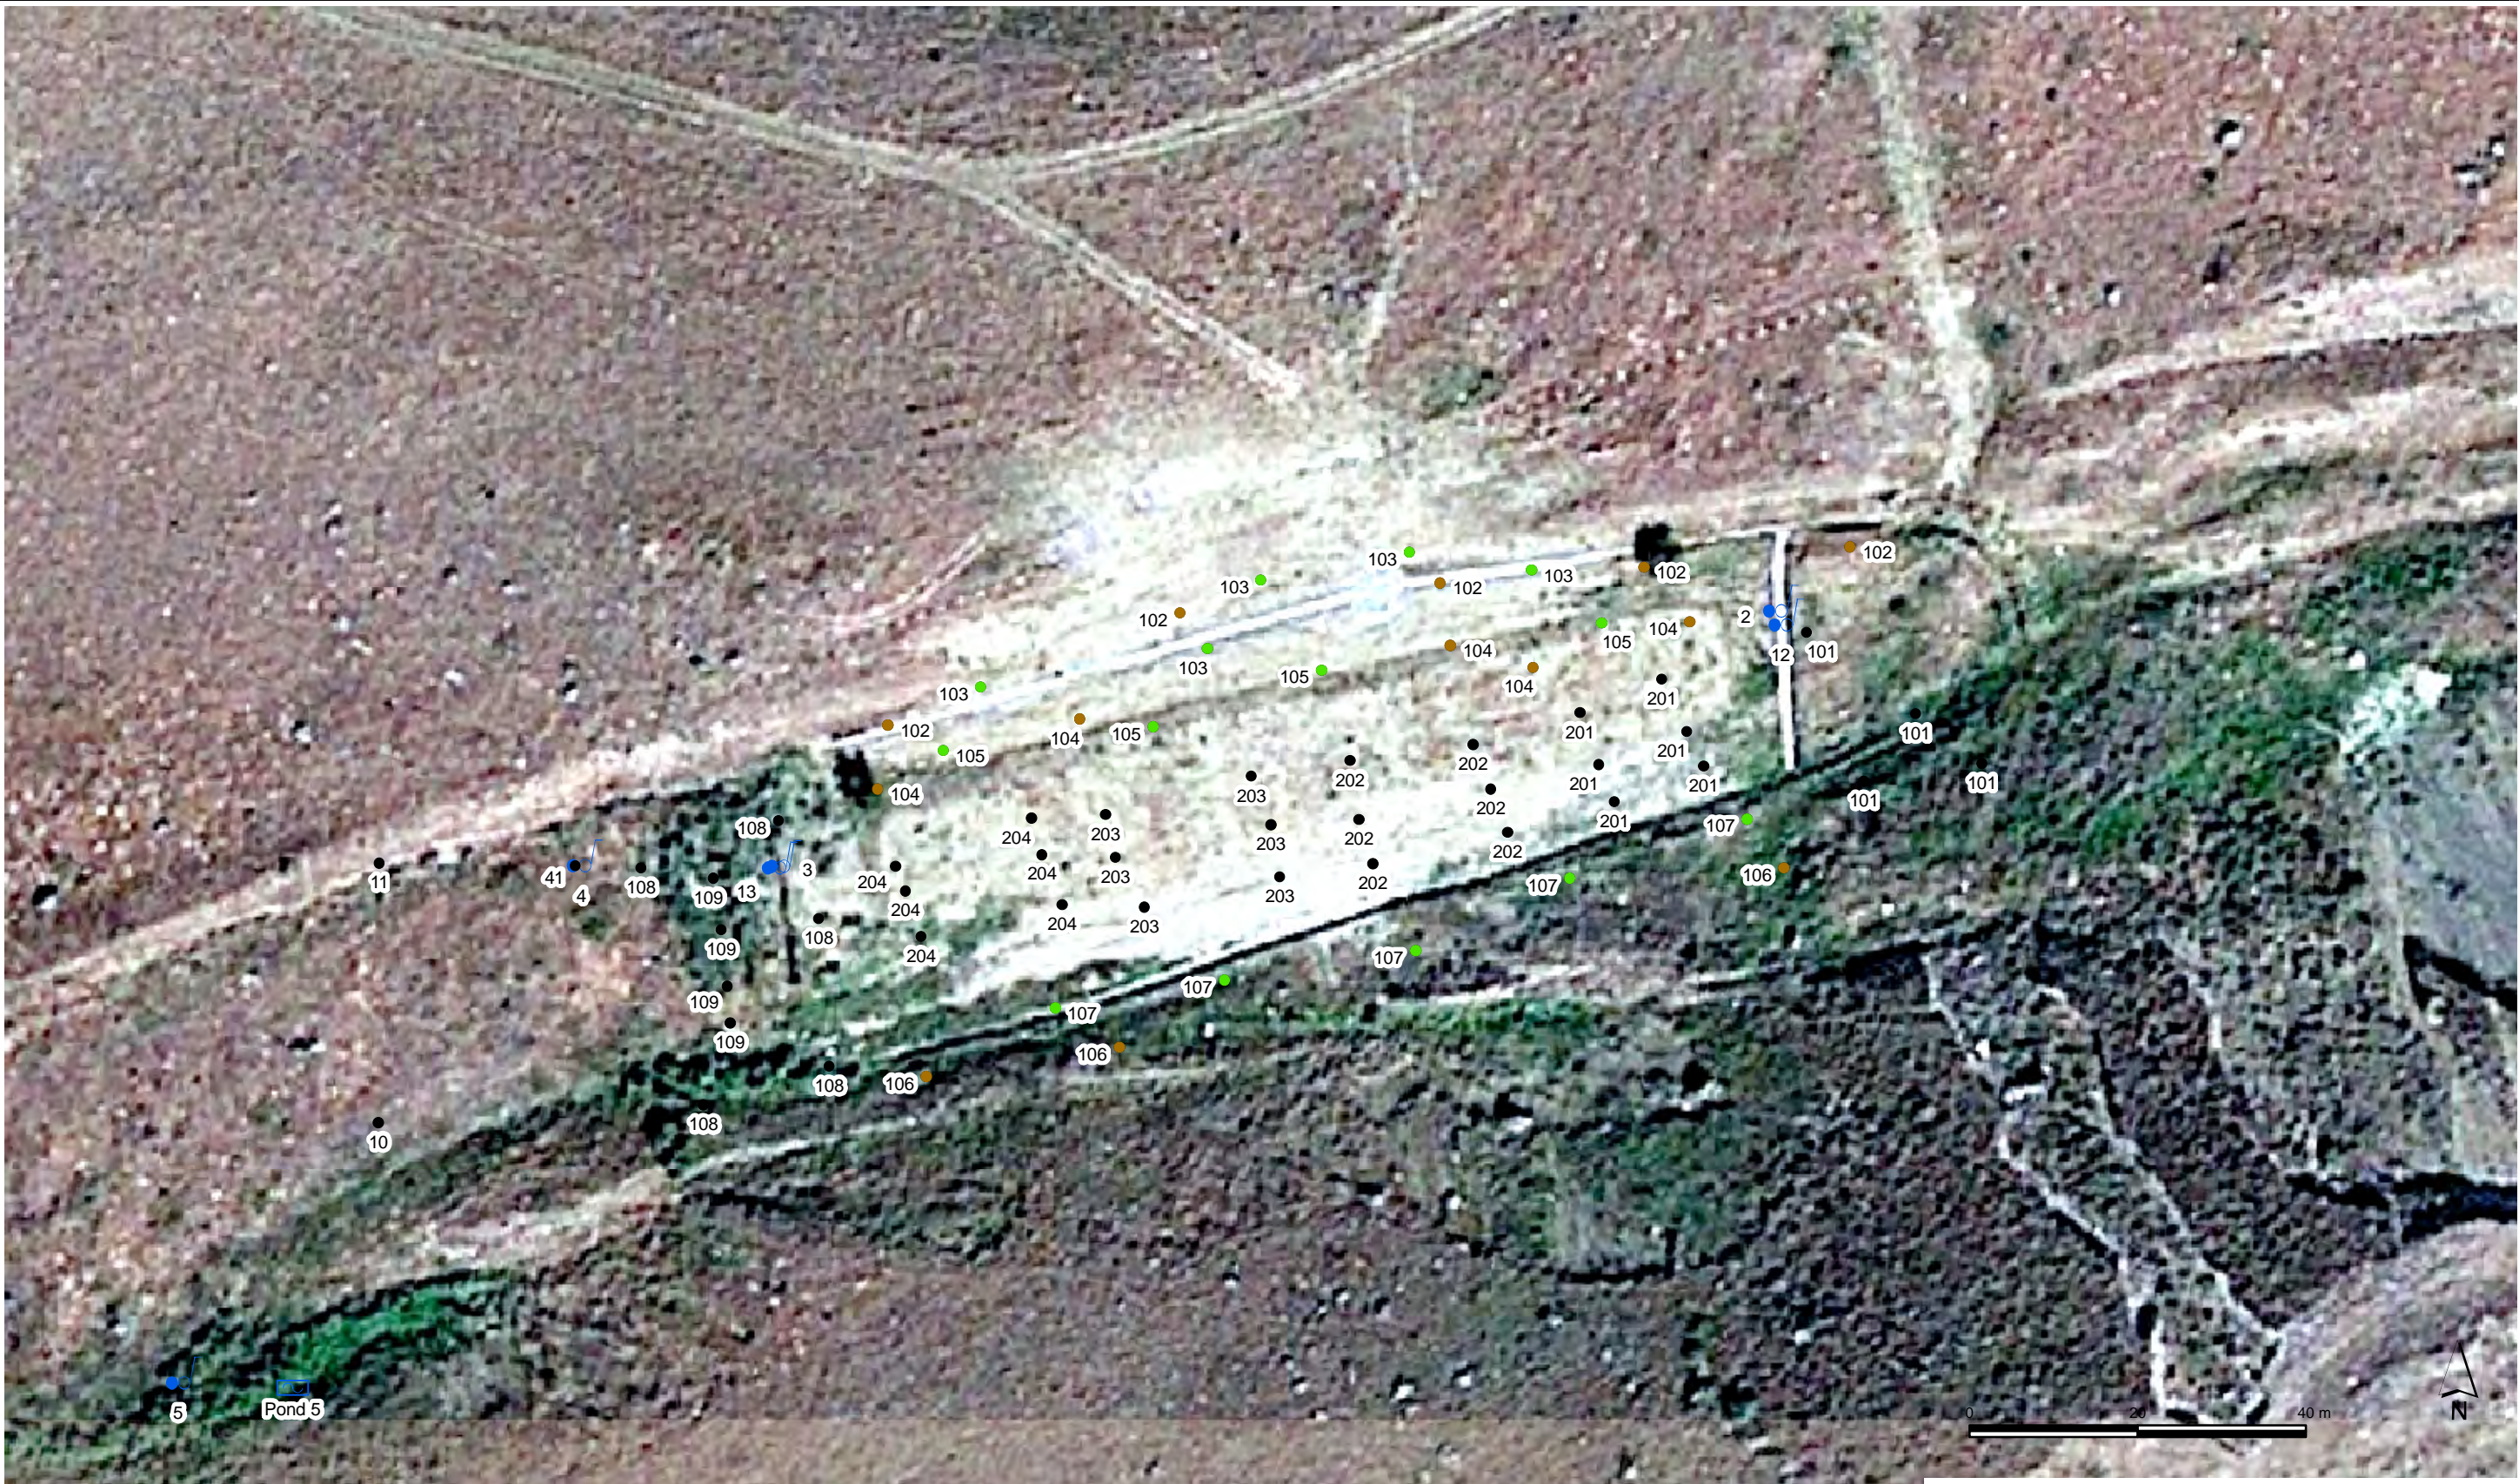
- Monitoring well
- Pond
- Borehole
- Topsoil sample from areas with plant cover
- Topsoil sample from areas with bare soil
