Nicosia walled city public fountains

Description of Services and Works: Fountain 1

Original Use: Drinking fountain

Historical Period(s)/Chronology: Colonial period, 1950s decade

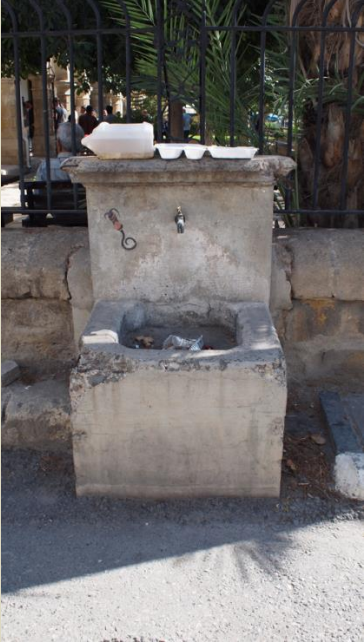
<p>Photo 1. The façade of the fountain towards the street (Mahmut Pasa sokak) (northwest orientation) @ UNDP, November 2018</p>

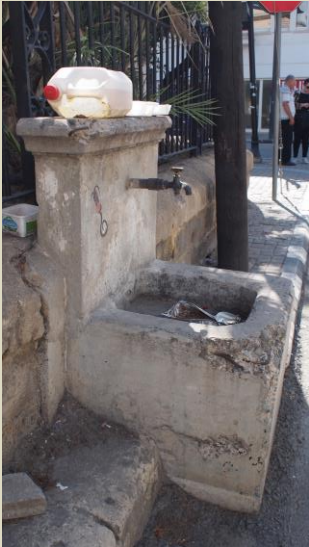
<p>Photo 2. The northern façade of the fountain @ UNDP, November 2018</p>

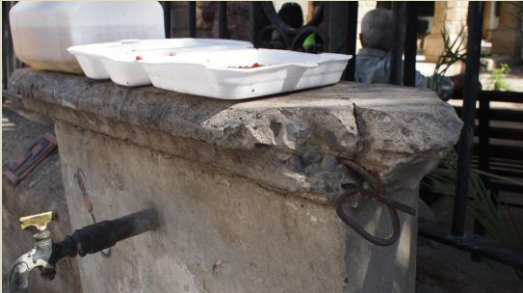
<p>Photo 3. Deterioration of the upper southern corner of the fountain @ UNDP, November 2018</p>	<ul style="list-style-type: none"> - General cleaning of the fountain and around it (removal of waste). - Assessment of the degree of corrosion of the reinforcement steel (exposed parts and further). Treatment of the corroded steel reinforcement elements according to the assessment. If needed part of the elements should be replaced. - Patch repair of the concrete body of the fountain in order to restore it to its original form. - Cleaning of the fountain's tap. - All traces of plaster/paint should be removed from the fountain's concrete body. - Cleaning of the fountain surface with low impact sandblasting and surface finishing. <p>DESCRIPTION OF WORKS</p> <p>Concrete repairs;</p> <ul style="list-style-type: none"> - Check reinforced concrete for any loose and rotten parts. - Break and remove all rotten and loose part off the fountain. - Clean all rust, with a metal brush off the existing reinforcement bars - Provide and apply special protective anti-corrosion paint on the exposed reinforcement bars – at least 2 coats - After the paint has matured apply ready mix reinforcement repair mortar. The finish of the new mortar must have the same shape and finish details as the original finish. Contractor should provide sample of the concrete patch repair in a small area for approval before proceeding with the repair of all deteriorated parts. <p>The contractor is responsible to protect all the elements of the fountain and of surrounding structures while providing the services.</p> <p>Following the completion of the works UNDP will provide a plaque to the contractor for installation by the fountain; position of the plaque will be indicated</p>
