## Description of Services and Works: Fountain 2

RFQ 107/2019 Conservation of 3 fountains in Nicosia walled city - Annex 1.2-Terms of Reference for Fountain 2

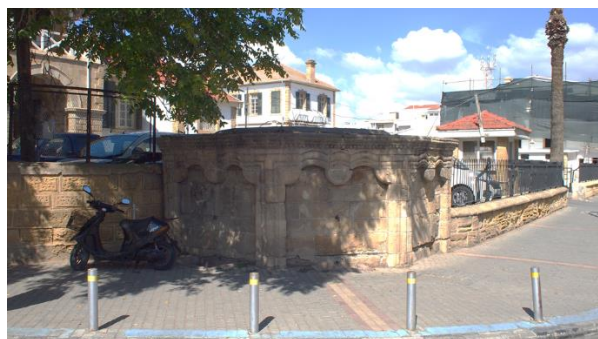
Photo 1. The façade of the fountain towards the street (southeast facade) @ UNDP, November 2018

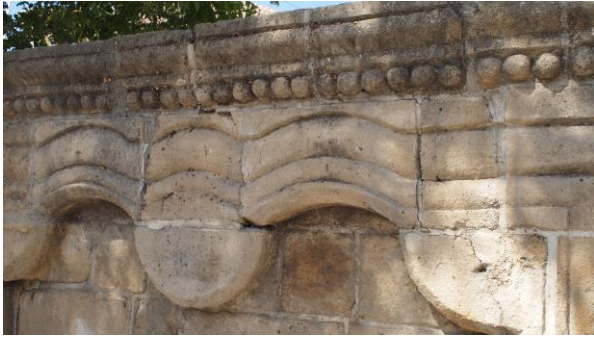
Photo 2. Details of the deterioration of the upper decorative band of the fountain @ UNDP, November 2018

- Removal of loose and deteriorated mortar used for patch repairs on the stone
- Removal of non-compatible plasters and mortars (concrete)
- Consolidation of stone where needed. Stone with severe damage and/or deterioration should be replaced with compatible stone of the same size and type -carved profile should be reproduced. It is critical for the color of any additions to be compatible with the original stone body of the fountain

- Removal of loose and deteriorated mortar used for patch repairs on the stone using hand tools. Only if absolutely necessary and after approval by UNDP sand blasting at low pressure will be used with care so as not to damage the stone. Any inappropriate intervention/additions such as patch repairs with cementitious based materials should also be removed.

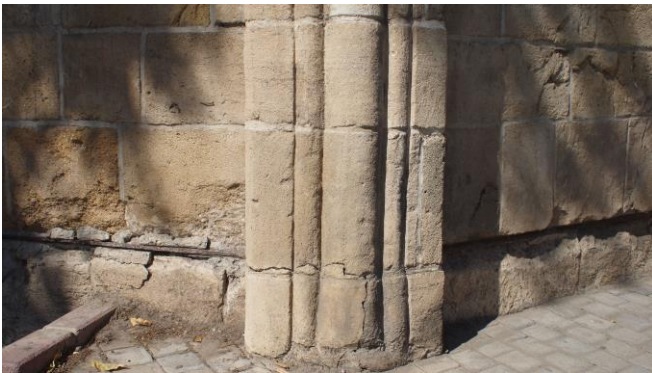
Photo 3. Deterioration on the lower areas of the fountain @ UNDP, November 2018

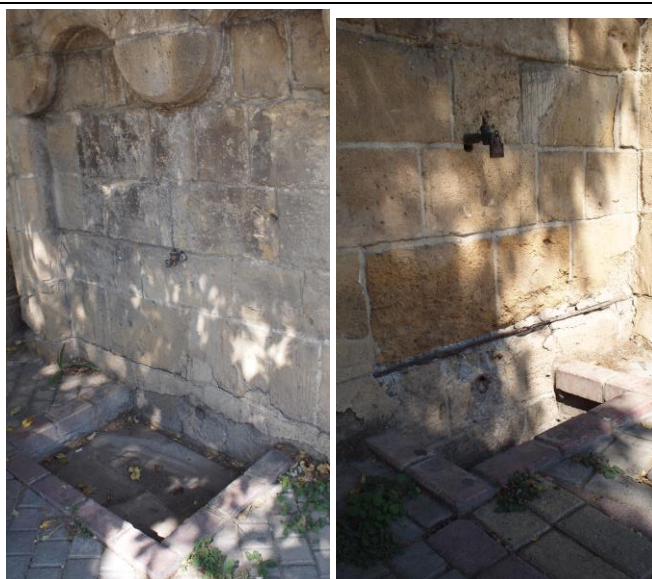
Photo 4 & 5. The basins of the fountain (embedded on the pavement) @ UNDP, November 2018

- **Cleaning and treatment of the basins of the fountain**

**Concrete basin at the fountains;** existing drainage basins in front of the fountains are concrete. All concrete members of the basin to be repaired strengthened with appropriate materials to upgrade the condition of the concrete basins. Drainage system to be checked in detail and bring the existing drainage system to a good and working condition. Apply liquid insulation in the basin.
