RESEARCH PROGRAMME FOR THE **RESTORATION AND REHABILITATION** OF THE HISTORIC BUILDING COMPLEX AND RECONFIGURATION OF THE ENVIRONMENT OF THE MONASTERY

PROJECT PHASE B: IMPLEMENTATION MEDIEVAL CHAPEL (MC)

ADMINISTRATIVE COMMITEE OF THE HOLY MONASTERY OF APOSTOLOS ANDREAS RIZOKARPASSO, CYPRUS

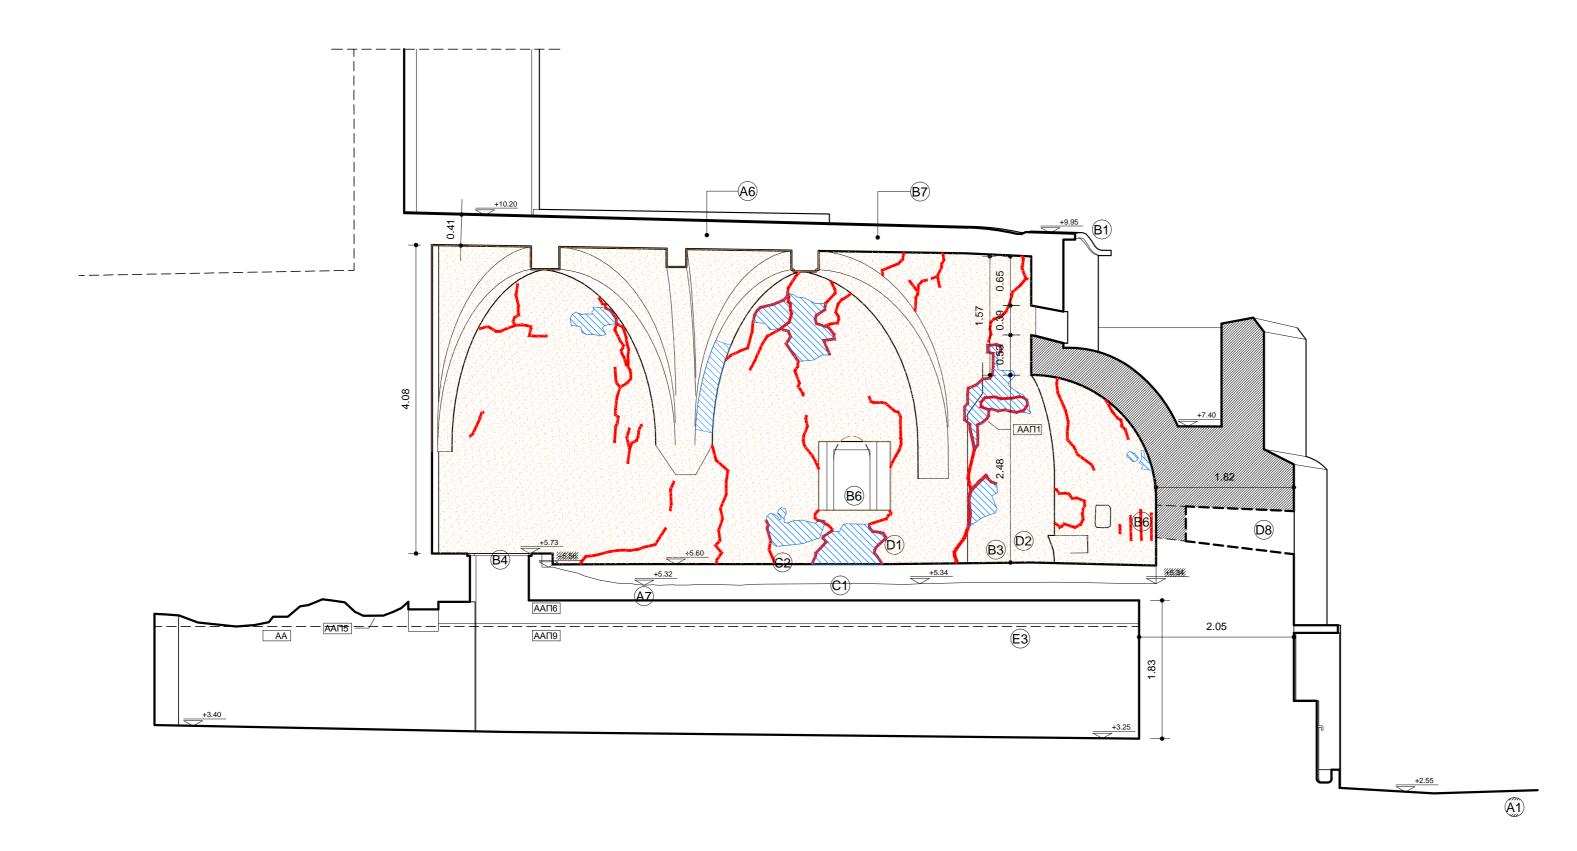
Plate number: MCE03

Whitish plaster Render of cement mortar Partial sealing with cement mortar Floors Paint C1 Area below the recent floor which needs excavational research Loss-erosion C2 Recent floor of cement tiles which was laid 10-15cm Construction works of render higher than the original one **C3** Problems of rising dampness B1 Poorly constructed cornice of cement mortar Loss of pointing Structural problems B2 Area with problems in draining rainwater A1 Area with problems of substratum differential B3 Absence of Altar C4 Recent floor of cement tiles which needs replacement settlement B4 Poorly constructed cover plate of the well which leads C5 Poorly constructed floor of cement mortar Erosion of stone to the underground galleries of the Agiasma **B5** Spring of the Agiasma showing traces of form C6 Stone floor in a bad preservation state and with poor (see structural study) A2 Differential settlement of foundation concrete repairs Extensive erosion of stone (see structural study) alterations B6 Blocked window A3 Area of the masonry showing cracks A4 Area of the masonry which needs solidification B7 Surface of the masonry which needs conservation Joinery - doors & windows Loss of stone A5 Area of the masonry which needs conservation **B8** Area where steps need to be constructed in order to D1 Absence of icon screen A6 Area of the extrados of the domes which needs improve the transition from one level to the other Crack consolidation D3 Existing masonry recess B9 Stone steps showing local problems of detachments D4 Timber 19th C doorway A7 Unknown preservation state of the extrados of the and fragmentation of their compartments ААПЗ Test sample D5 Absence of door arcade dome B10 Absence of access to the sea D6, D7, D8 Absence of window A8 Areas of the masonry which need additions B11 Areas of render showing decay

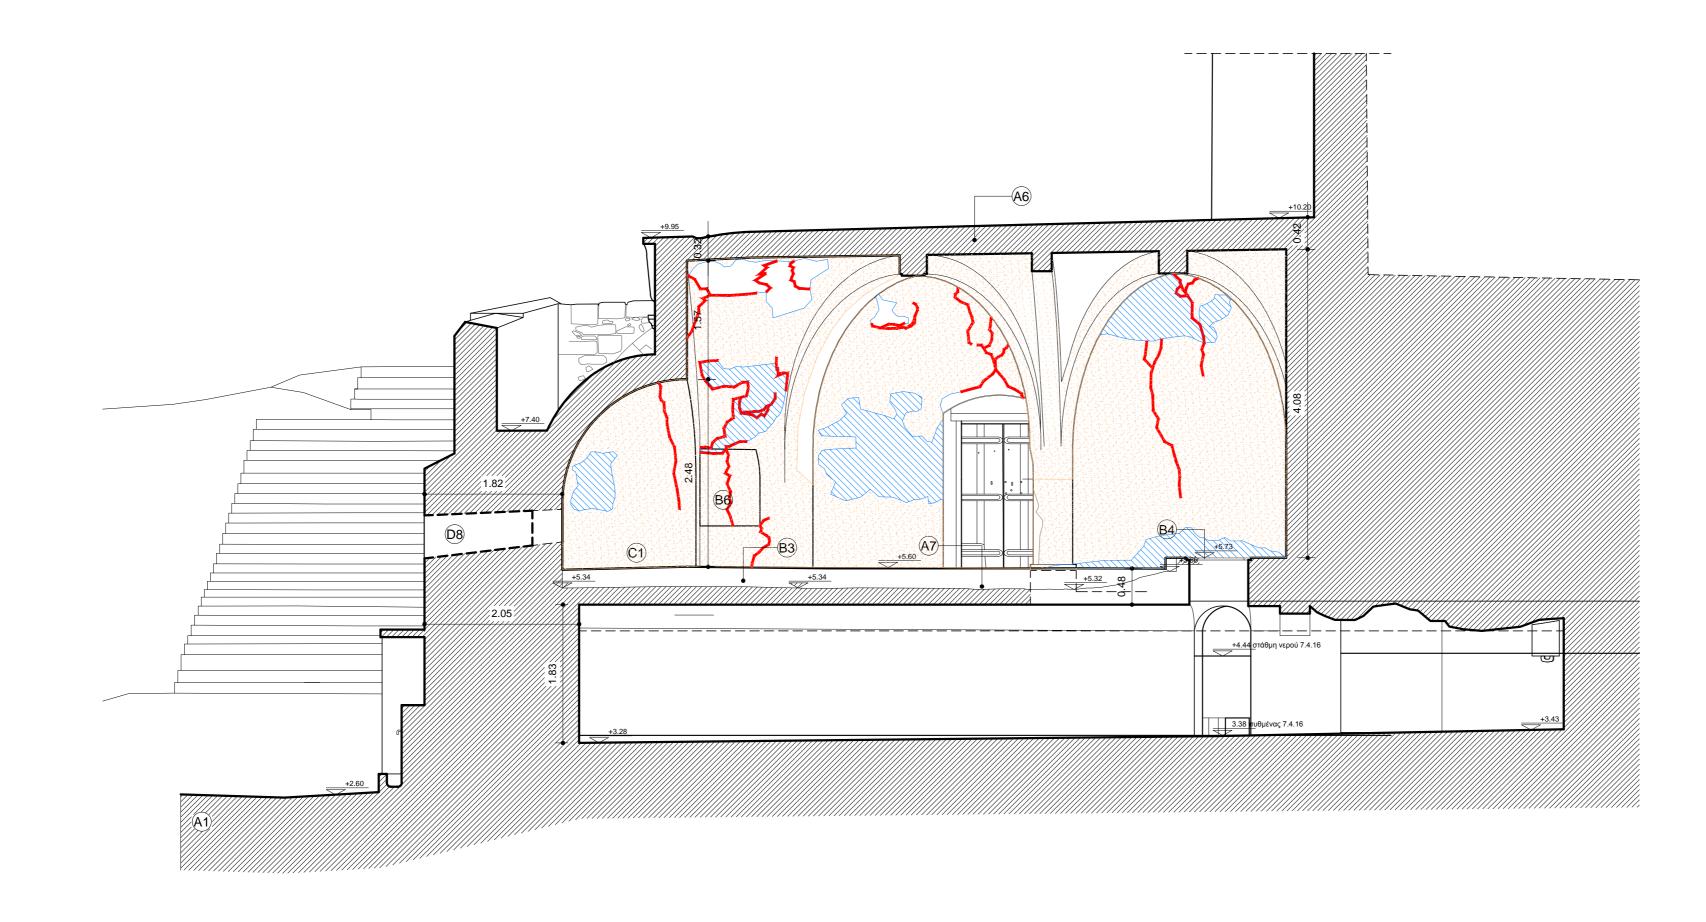
Plate number: MCE04

Whitish plaster Render of cement mortar Partial sealing with cement mortar Floors Paint C1 Area below the recent floor which needs excavational research Loss-erosion C2 Recent floor of cement tiles which was laid 10-15cm Construction works of render higher than the original one **C3** Problems of rising dampness B1 Poorly constructed cornice of cement mortar Loss of pointing Structural problems B2 Area with problems in draining rainwater A1 Area with problems of substratum differential B3 Absence of Altar C4 Recent floor of cement tiles which needs replacement C5 Poorly constructed floor of cement mortar settlement B4 Poorly constructed cover plate of the well which leads Erosion of stone (see structural study) to the underground galleries of the Agiasma **B5** Spring of the Agiasma showing traces of form C6 Stone floor in a bad preservation state and with poor A2 Differential settlement of foundation concrete repairs C7 Poor repair of the steps with cement mortar Extensive erosion of stone (see structural study) alterations B6 Blocked window A3 Area of the masonry showing cracks A4 Area of the masonry which needs solidification B7 Surface of the masonry which needs conservation Joinery - doors & windows Loss of stone A5 Area of the masonry which needs conservation **B8** Area where steps need to be constructed in order to D1 Absence of icon screen A6 Area of the extrados of the domes which needs **D2** Absence of furniture of the Prothesis improve the transition from one level to the other Crack consolidation D3 Existing masonry recess B9 Stone steps showing local problems of detachments D4 Timber 19th C doorway A7 Unknown preservation state of the extrados of the and fragmentation of their compartments ААП3 Test sample D5 Absence of door arcade dome B10 Absence of access to the sea D6, D7, D8 Absence of window A8 Areas of the masonry which need additions B11 Areas of render showing decay

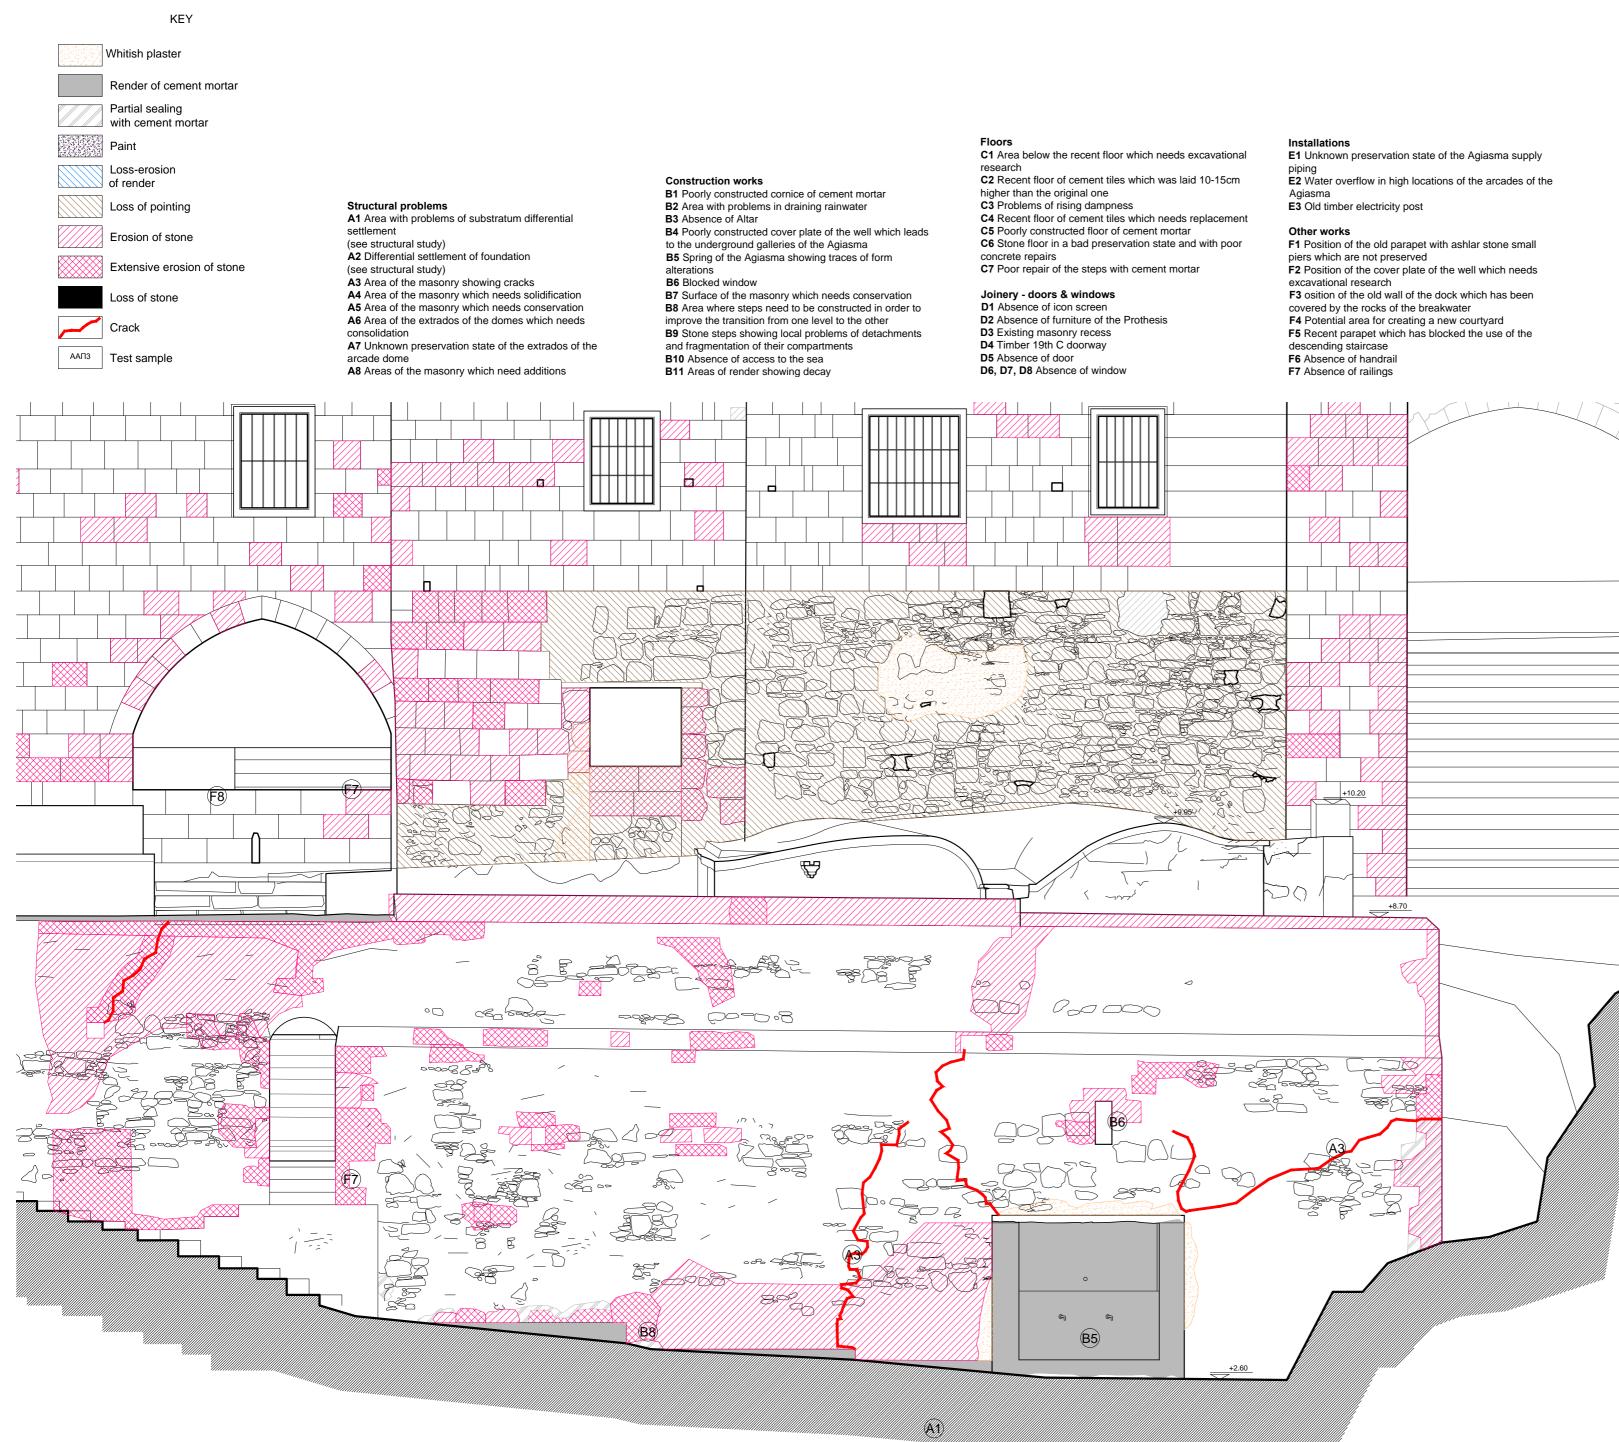
SECTION 9-9 Scale: 1:50 0 1 Date: May 2007 Rev. February 2016 MCE12

Whitish plaster			
Render of cement mortar			
Partial sealing with cement mortar			
Paint			Floors C1 Area below the recent floor which
Loss-erosion of render		Construction works	research C2 Recent floor of cement tiles which higher than the original one
Loss of pointing	 Structural problems A1 Area with problems of substratum differential settlement (see structural study) A2 Differential settlement of foundation (see structural study) A3 Area of the masonry showing cracks 	 B1 Poorly constructed cornice of cement mortar B2 Area with problems in draining rainwater B3 Absence of Altar B4 Poorly constructed cover plate of the well which leads to the underground galleries of the Agiasma B5 Spring of the Agiasma showing traces of form alterations B6 Blocked window 	C3 Problems of rising dampness C4 Recent floor of cement tiles which
Erosion of stone			C5 Poorly constructed floor of cement C6 Stone floor in a bad preservation s

Extensive erosion of stone			concrete repairs C7 Poor repair of the steps with ceme
Loss of stone	A4 Area of the masonry which needs solidification A5 Area of the masonry which needs conservation	B7 Surface of the masonry which needs conservation B8 Area where steps need to be constructed in order to	Joinery - doors & windows D1 Absence of icon screen
Crack	A6 Area of the extrados of the domes which needs consolidation	improve the transition from one level to the other B9 Stone steps showing local problems of detachments	D2 Absence of furniture of the Prothes D3 Existing masonry recess
AAII3 Test sample	 A7 Unknown preservation state of the extrados of the arcade dome A8 Areas of the masonry which need additions 	and fragmentation of their compartments B10 Absence of access to the sea B11 Areas of render showing decay	D4 Timber 19th C doorway D5 Absence of door D6, D7, D8 Absence of window

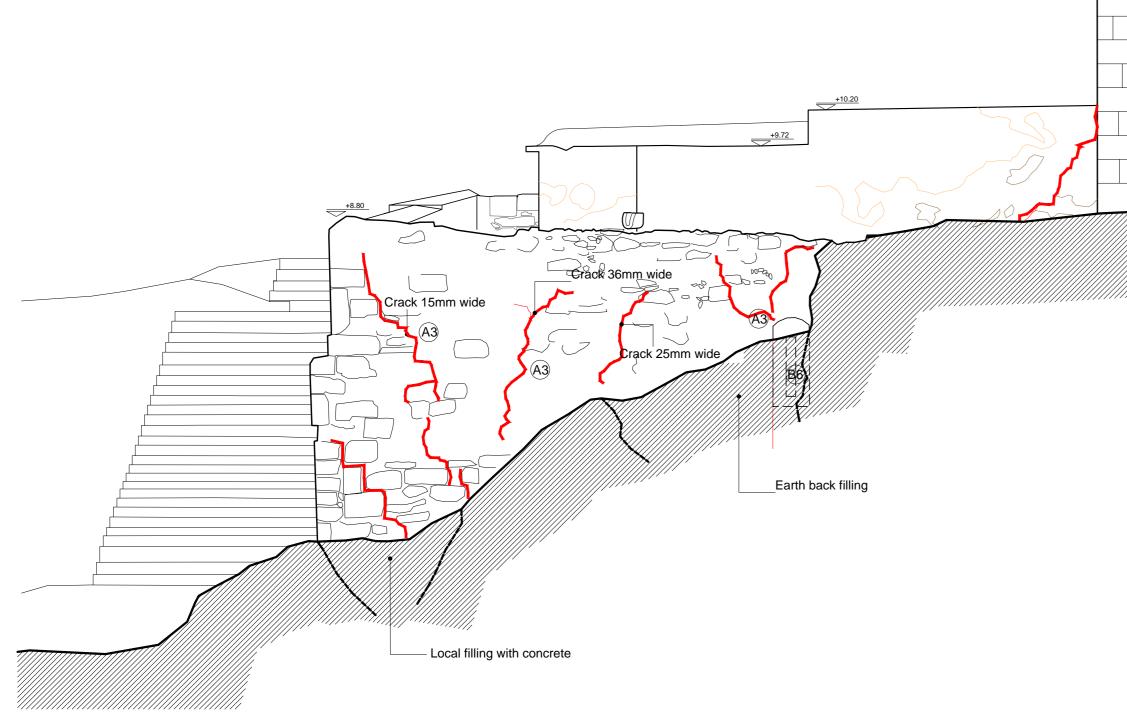
SECTION 10-10 1:50 Scale: May 2007 Rev. February 2016 Date: Plate number: MCE14

Whitish plaster Render of cement mortar Partial sealing with cement mortar Floors Paint C1 Area below the recent floor which needs excavational research Loss-erosion C2 Recent floor of cement tiles which was laid 10-15cm Construction works of render higher than the original one **C3** Problems of rising dampness B1 Poorly constructed cornice of cement mortar Loss of pointing Structural problems B2 Area with problems in draining rainwater A1 Area with problems of substratum differential B3 Absence of Altar C4 Recent floor of cement tiles which needs replacement settlement B4 Poorly constructed cover plate of the well which leads C5 Poorly constructed floor of cement mortar Erosion of stone to the underground galleries of the Agiasma **B5** Spring of the Agiasma showing traces of form (see structural study) C6 Stone floor in a bad preservation state and with poor A2 Differential settlement of foundation concrete repairs Extensive erosion of stone C7 Poor repair of the steps with cement mortar (see structural study) alterations A3 Area of the masonry showing cracks B6 Blocked window A4 Area of the masonry which needs solidification B7 Surface of the masonry which needs conservation Joinery - doors & windows Loss of stone A5 Area of the masonry which needs conservation **B8** Area where steps need to be constructed in order to D1 Absence of icon screen A6 Area of the extrados of the domes which needs **D2** Absence of furniture of the Prothesis improve the transition from one level to the other Crack D3 Existing masonry recess consolidation B9 Stone steps showing local problems of detachments D4 Timber 19th C doorway A7 Unknown preservation state of the extrados of the and fragmentation of their compartments ААПЗ Test sample arcade dome B10 Absence of access to the sea D5 Absence of door D6, D7, D8 Absence of window A8 Areas of the masonry which need additions B11 Areas of render showing decay
