ANNEX 1 - DESCRIPTIONS & SPECIFICATIONS

1-Condition Assessment

Ag. Georgios Church is located in Ardana/Ardahan, Cyprus. The apses area where heavy deteriorations are seen is constructed with two leaved wall system. The internal wall is curved and the external wall is polygonal. Main arch before the half dome is 4 meters in diameter. The half dome is 2.7m meters in diameter and the thickness of the walls vary from 1 meter to 70 cm.

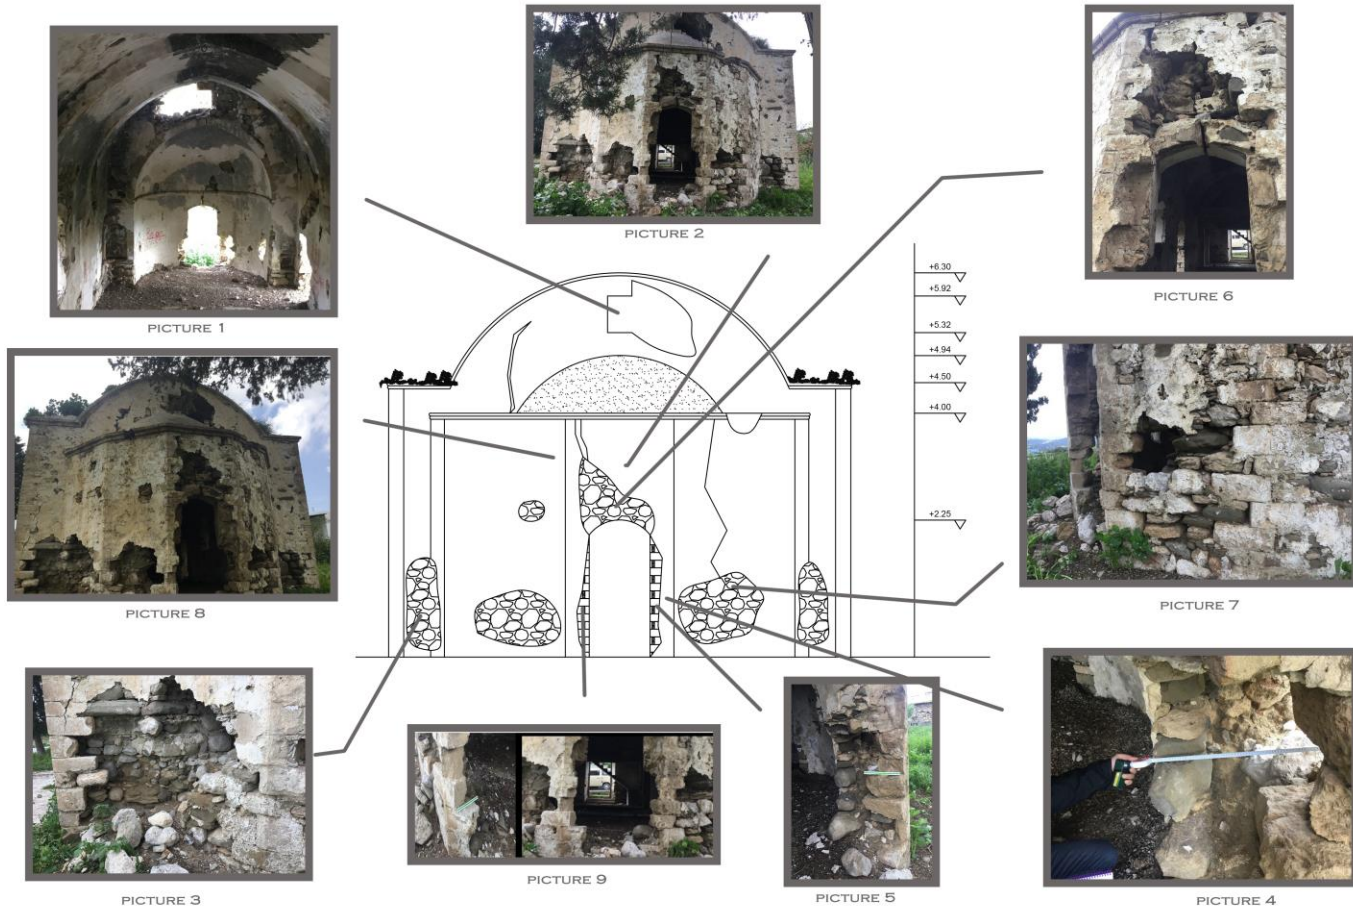
Picture 1

The arch of the apses has a dislocated key stone and deformation in shape especially on the right side of it when looking from west.

There is extensive material loss from the infill material above the arch and the half dome.

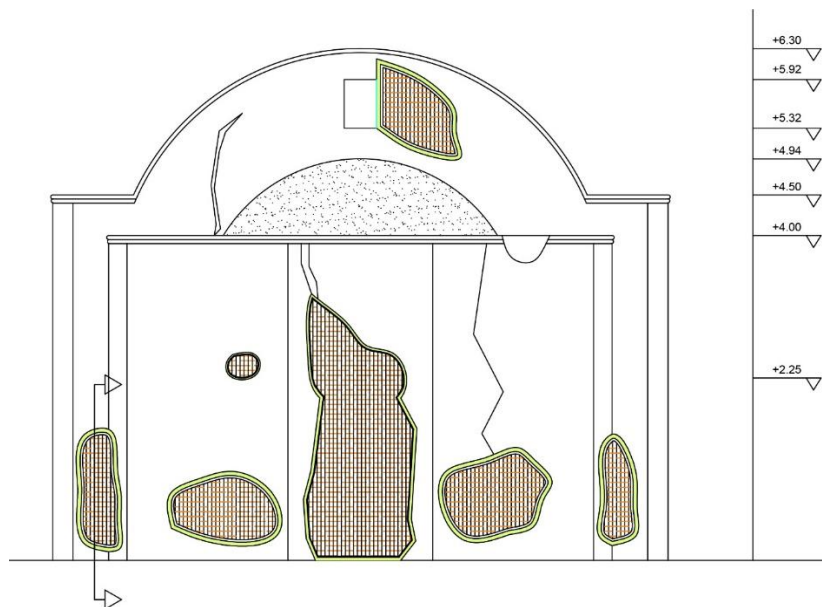
Figure 3 South Elevation with supports and infill work

A support system is proposed for the gap under the arch and under Eastern window. Ring lock scaffold system with supports will be used as indicated in the drawings. For the diagonal supports cuff system complying with standard EN74-1 10BM have to be used. All scaffold set up and materials used have to comply with EN 12811. Connection details of the supports and scaffolds are also provided.

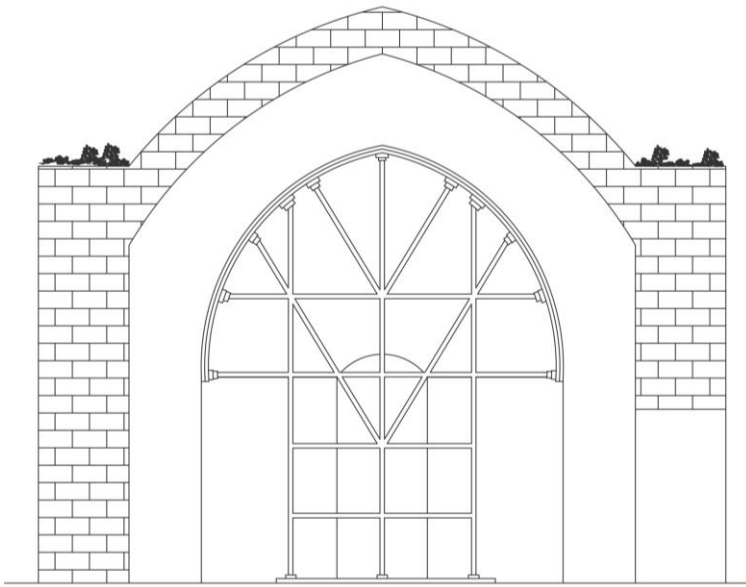
Figure 4 Cross Section looking east-with arch supports
