Structural interventions

UNDP Partnership for the Future		TECHNICAL COMMITTEE OF CULTURAL HERITAGE	DIMITRIOS M. MYLIANTHAKIS ARCHITECT LILIA N. DIMOPOULOU ARCHITECT	NIKOS KALITAKIS CIVIL ENGINEER SECOND REGISTRATION CIVIL ENGINEER EMMA ENPA, CIVIL ENGINEER	CHRISTOS MAURIS, QUANTITY SURVEYOR DORA NICKOLAKI, ARCHAEOLOGIST	PROJECT KARPASSIA LOTIS-AYIOS PHELOS CHURCH & BASILICA PROJECT NAME SURVEY DRAWINGS DRAWING TITLE SECTION B-B	DATE REV. MAR-2016 JAN. 2016 DRAWN BY Paraskevi Spanakidou SCALE 1:50	PROJECT CODE C20115 (AP1) DESIGNED BY E 06
--	--	--	---	--	---	--	---	--	---

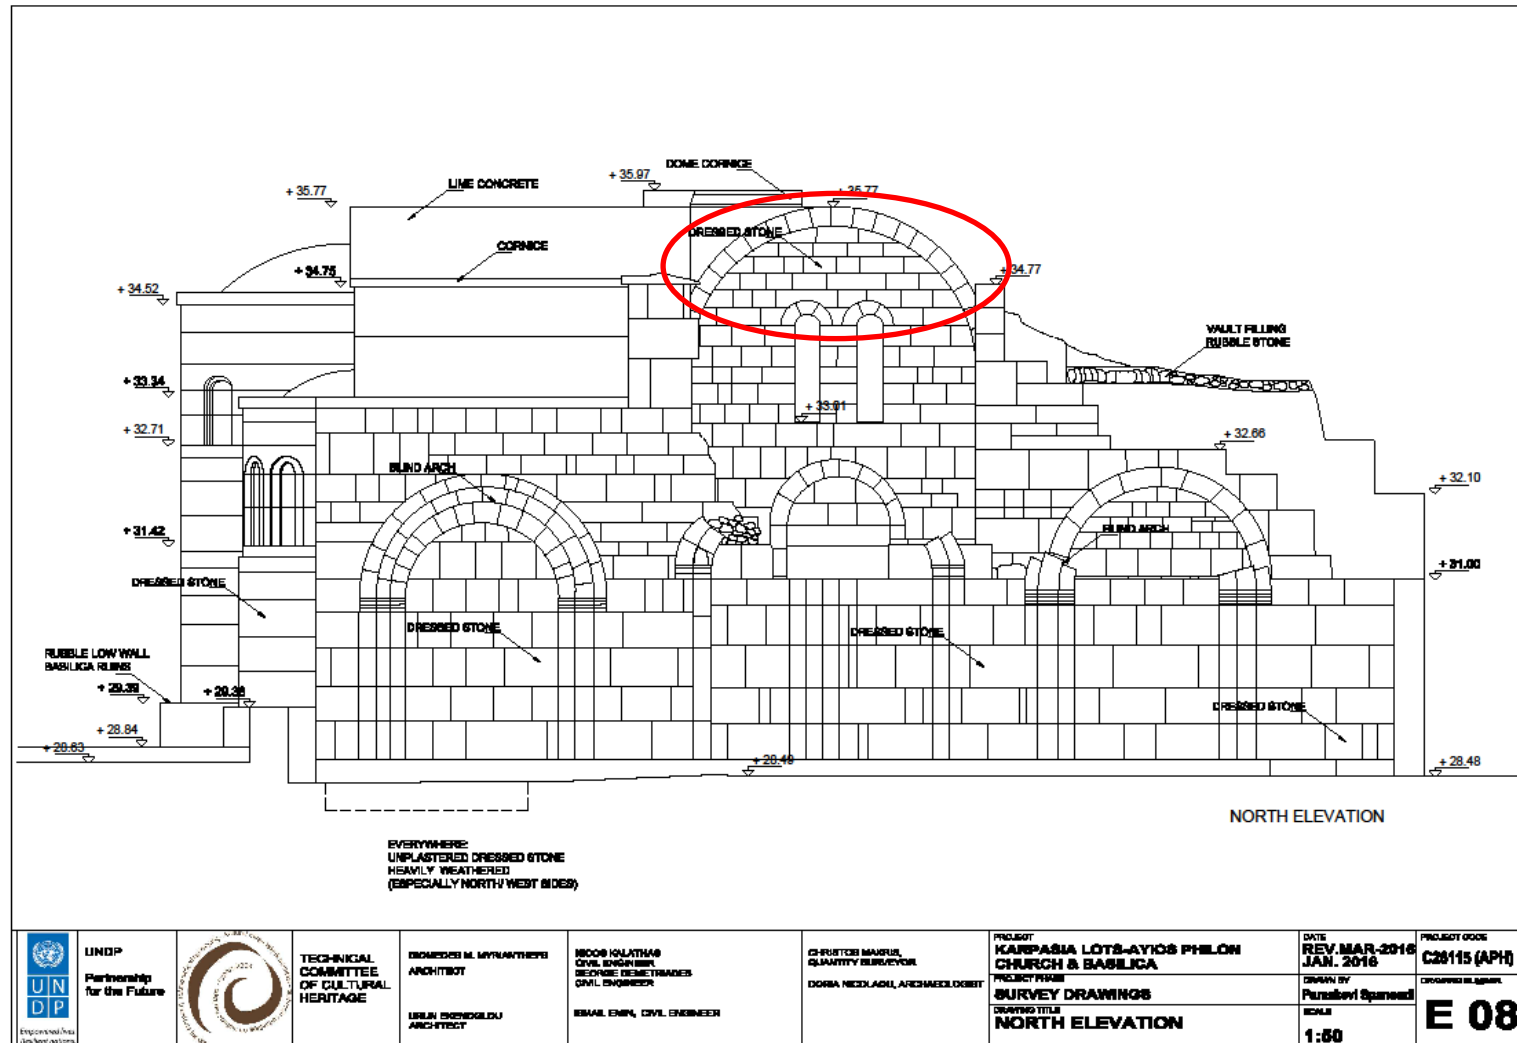
- Repair and consolidate the deteriorated areas of the vaults as shown on the drawing.

- Re-point the areas shown and use lime mortar and same size rubble stones where missing.

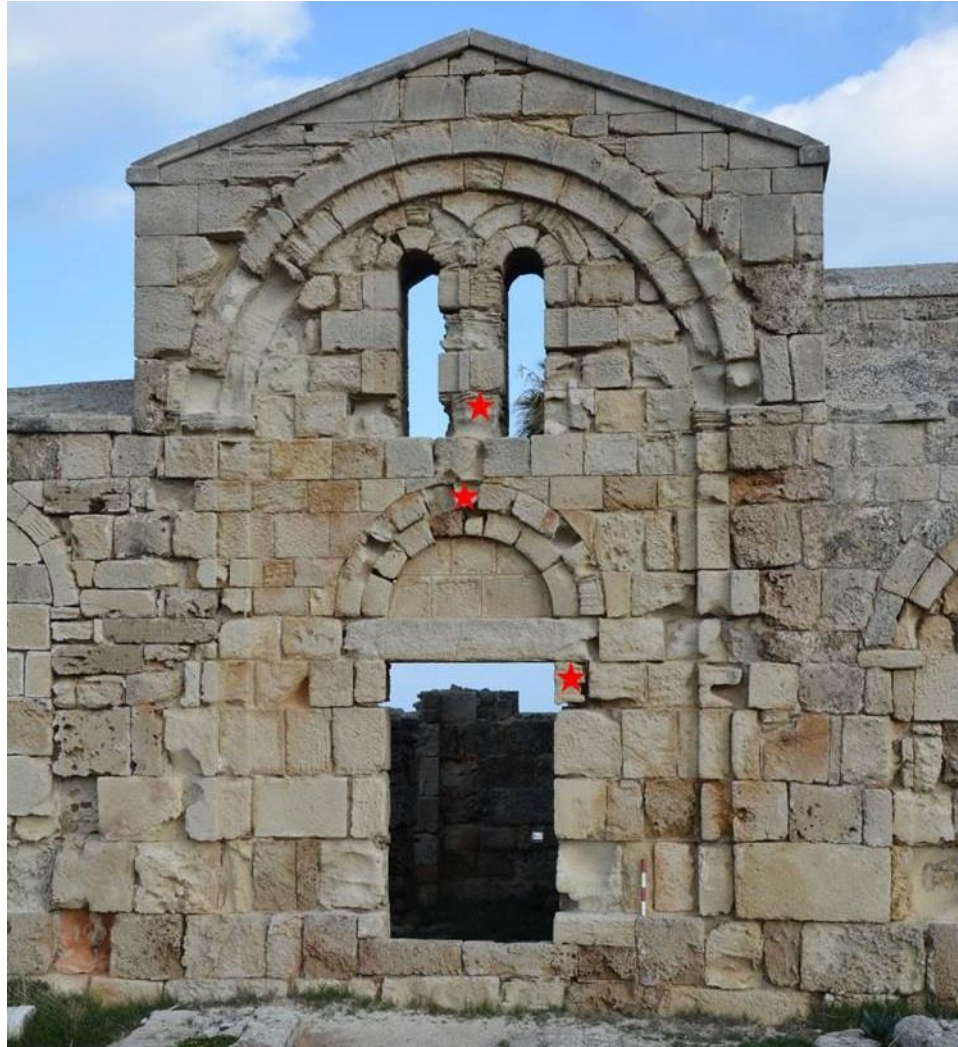
- Stone replacements
 - 5 heavily weathered stones that are posing danger to the structural stability of the building have to be replaced as shown. New stones should be of similar characteristics as the stone to be replaced i.e. similar mechanical and physical properties

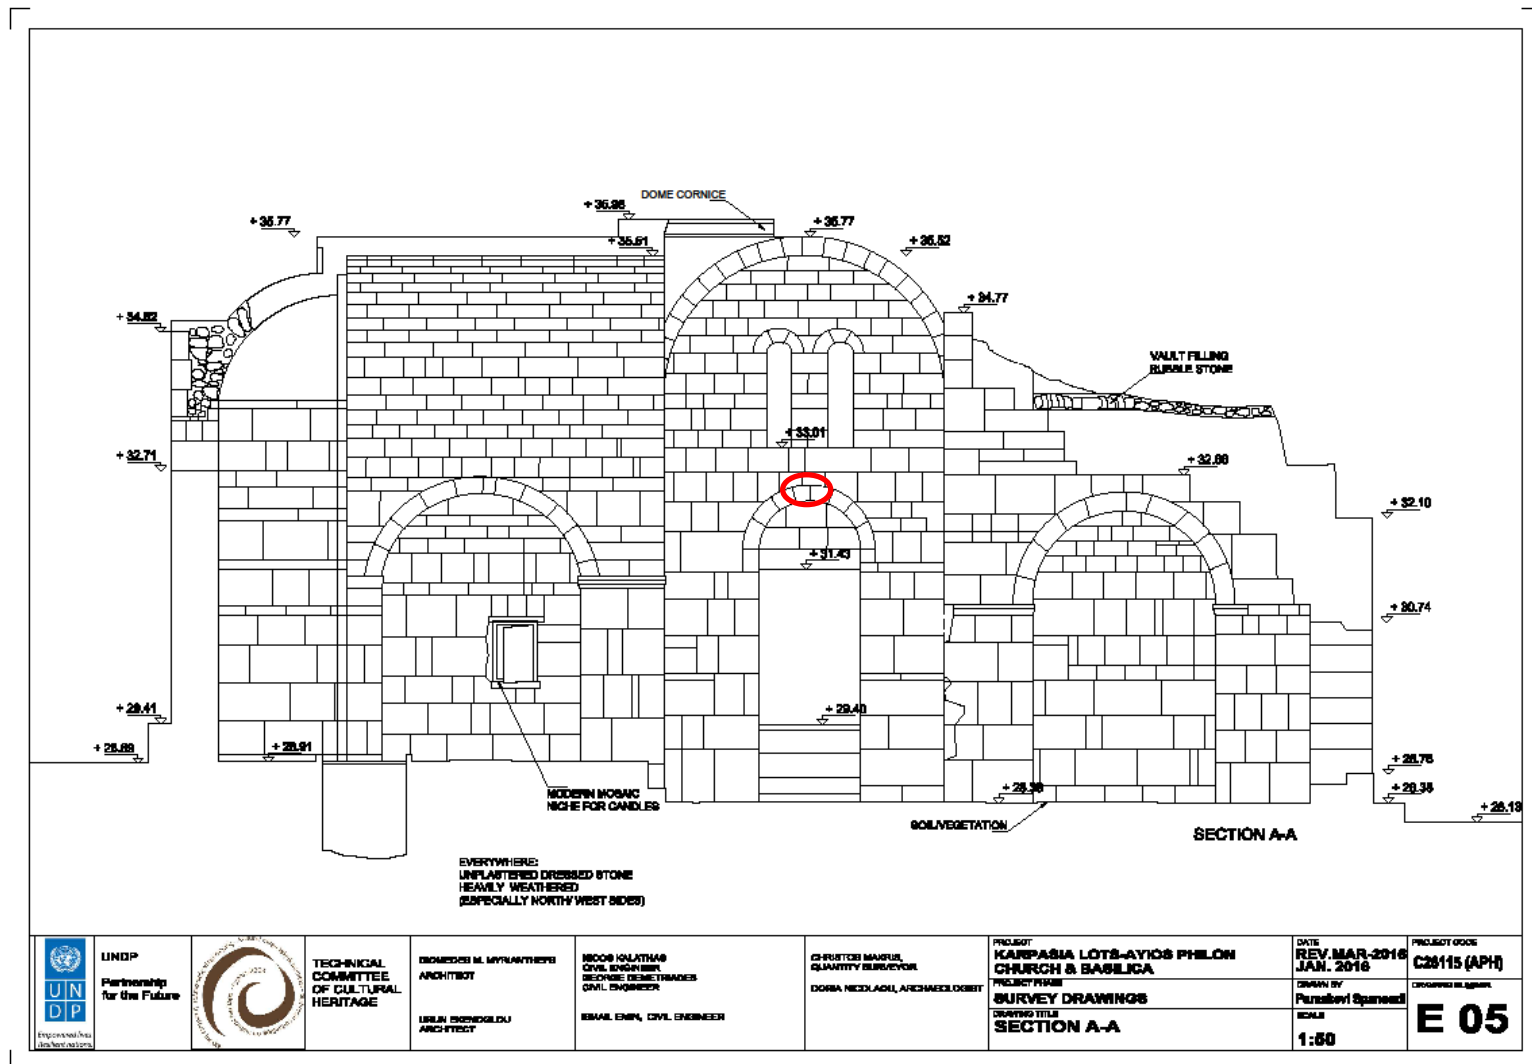
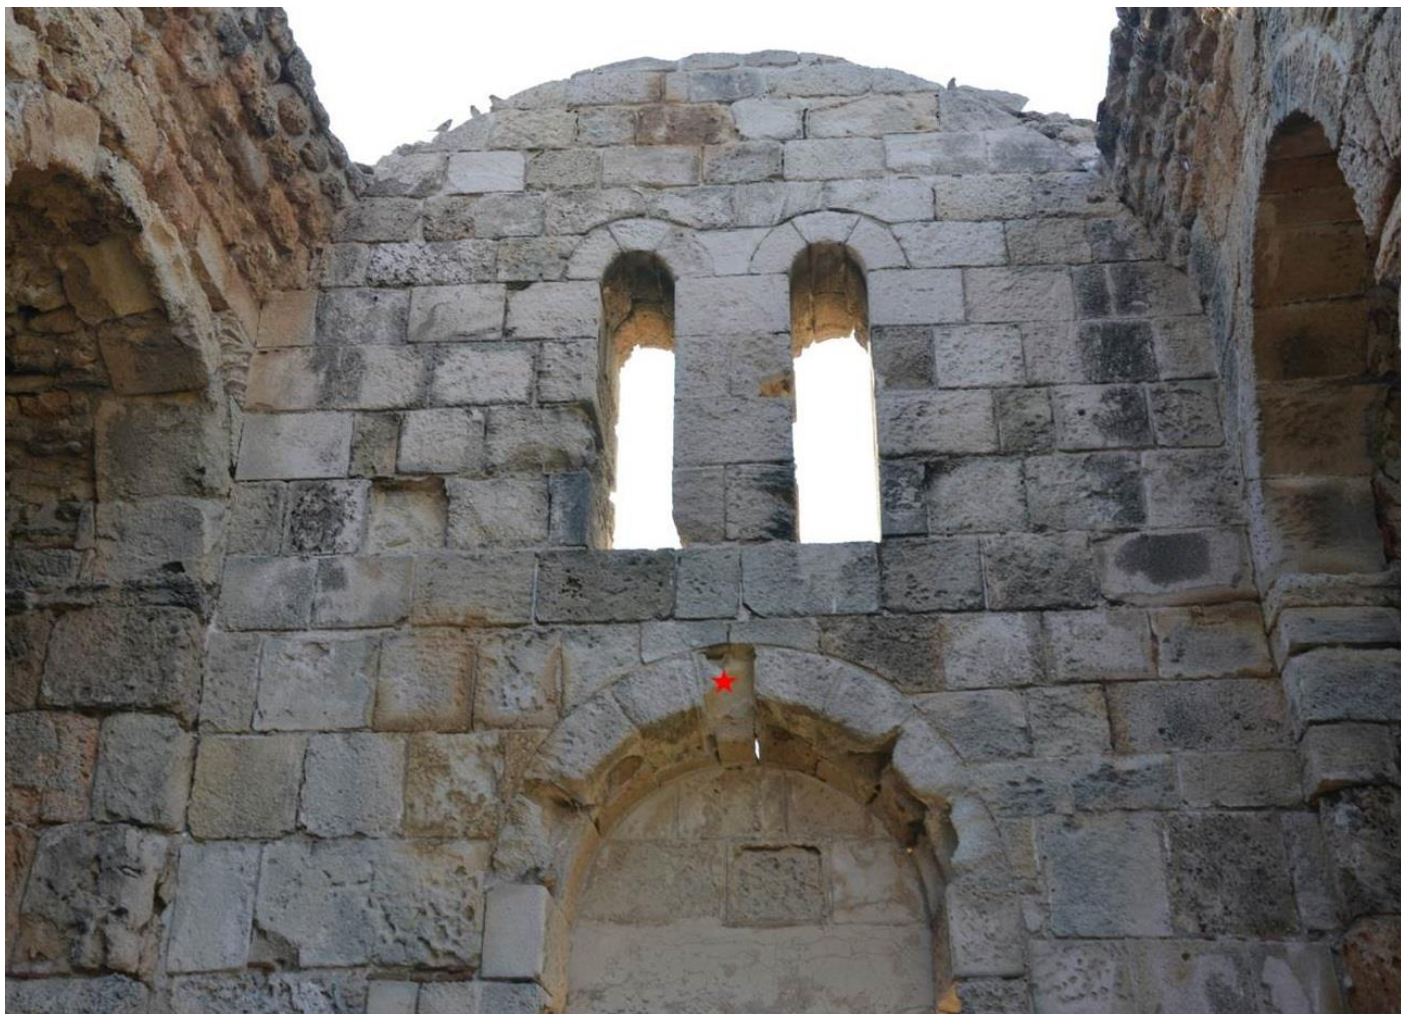
- Fill the crack of the south apse with mortar (internally and externally), to prevent water penetration and erosion.
