## **Terms of Reference – Emergency works at the belfry of Panagia Evangelistria church**

### **I. Brief description and Condition assessment**

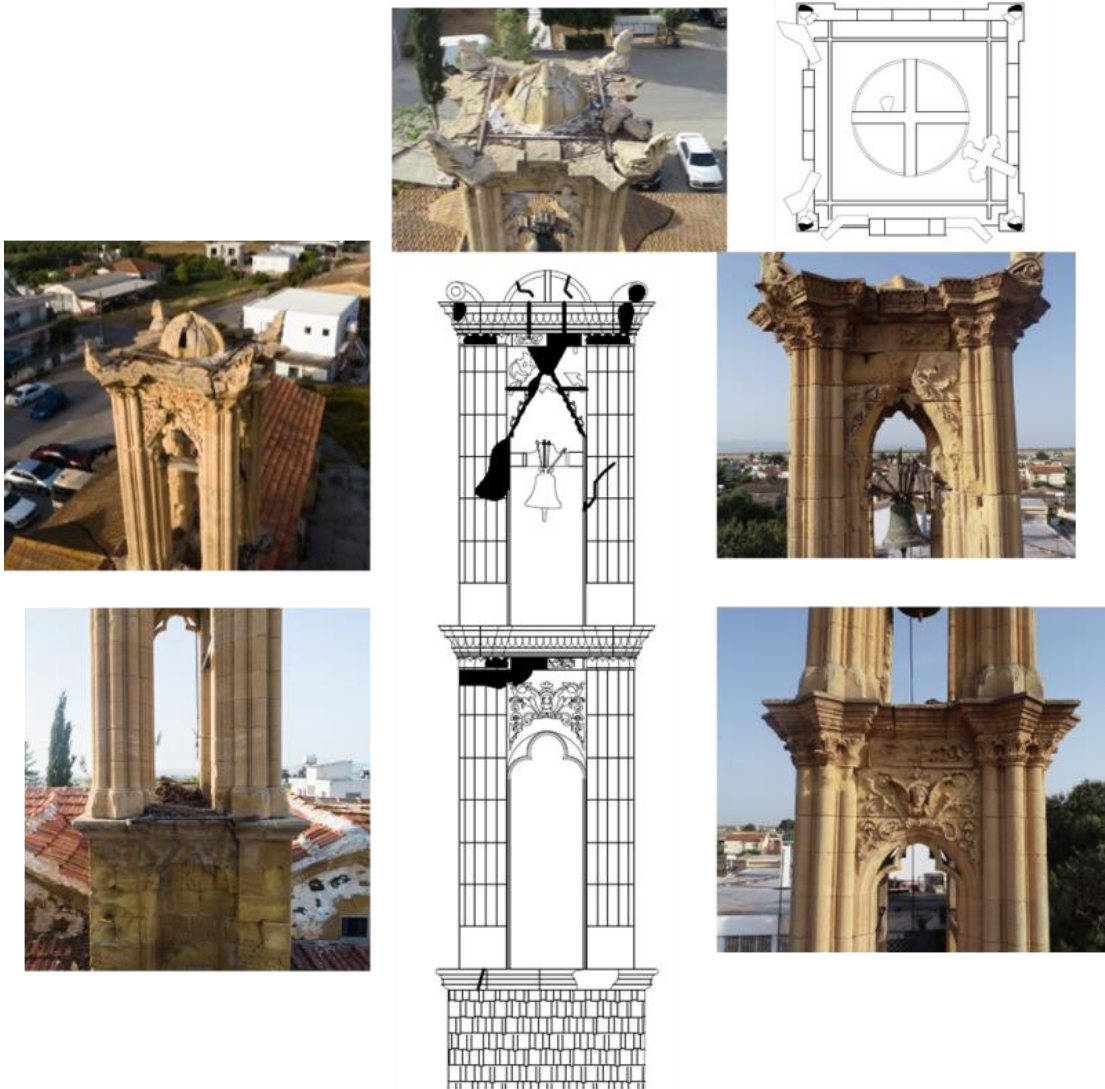
Picture 1

Extensive cracking and dislocation between the stones are seen especially on the uppermost cornice level where the iron structural reinforcement is exposed and corroded.

Original cross is also fallen from its place but still present on the top level

Main Interventions are proposed on the cornice level. i.e replacement of the corroded iron elements with same size iron elements protected with water resistant, anti – corrosive primer such as (sika Armatec 100 master seal 300) or equivalent. After replacement the coated iron will be covered with lime mortar. All the exposed iron elements in the facades and levels will be coated after mechanically removing the superficial rust and then covered with 2 cm thick lime mortar. The existing cross will be placed on the dome and the missing stone on the dome will be replaced. Pointing will be done as specified on the solid base level and until the ground on southern façade of the bell tower. Rusted metal elements on the belltower will be treated for rust. All the wooden and iron mechanisms of the existing bells will be mechanically cleaned and treated against deterioration.

| No. | Work Item | Description |
|---|---|---|
| 4 | Structural Reinforcement Upper Cornice level and | Main Interventions are proposed on the cornice level. i.e replacement of the corroded iron elements with same size iron elements protected with water resistant, anti – corrosive primer |
