Description of works – Emergency works at the belfry of Panagia Evangelistria church

I. Brief description and Condition assessment

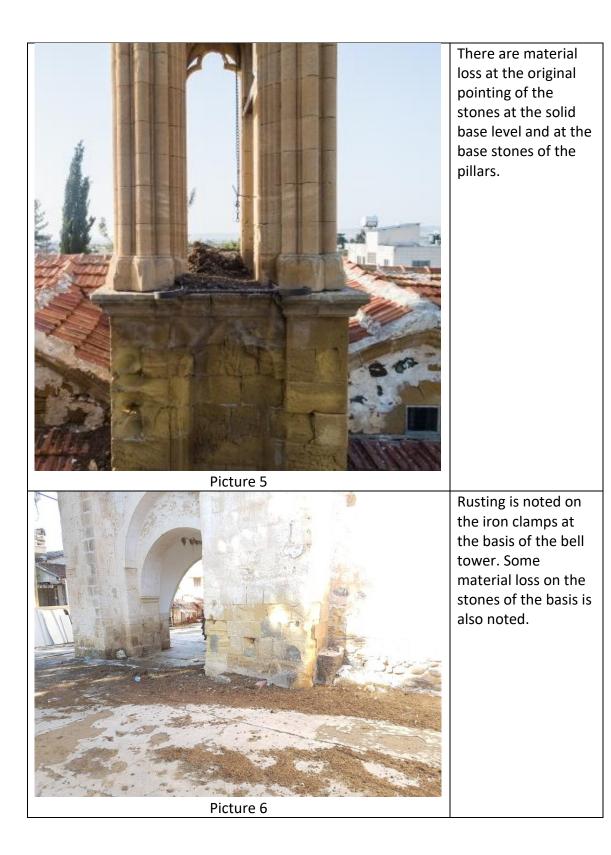
Superficial material deterioration is seen especially on the carved areas of the Bell Tower.

There are iron stone connecting members exposed after these deteriorations.

Superficial material deterioration is seen especially on upper parts of the pillars

Main Interventions are proposed on the cornice level. i.e replacement of the corroded iron elements with same size iron elements protected with water resistant, anti – corrosive primer such as (sika Armatec 100 master seal 300) or equivalent. After replacement the coated iron will be covered with lime mortar. All the exposed iron elements in the facades and levels will be coated after mechanically removing the superficial rust and then covered with 2 cm thick lime mortar. The existing cross will be placed on the dome and the missing stone on the dome will be replaced. Pointing will be done as specified on the solid base level and until the ground on southern façade of the bell tower. Rusted metal elements on the belltower will be treated for rust. All the wooden and iron mechanisms of the existing bells will be mechanically cleaned and treated against deterioration.

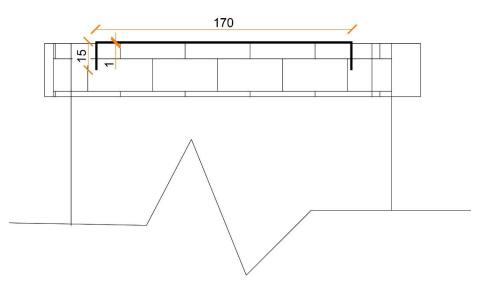
*The dimensions are estimated since access to the top of the belfry was not possible during the design. The contract should take detailed measurements and if needed the dimensions of the proposed elements can be modified after approval by the Engineer.
