All works are described in detail in the Bill of Quantities of rehabilitation works in the cold chain refrigerator in Sirte City.

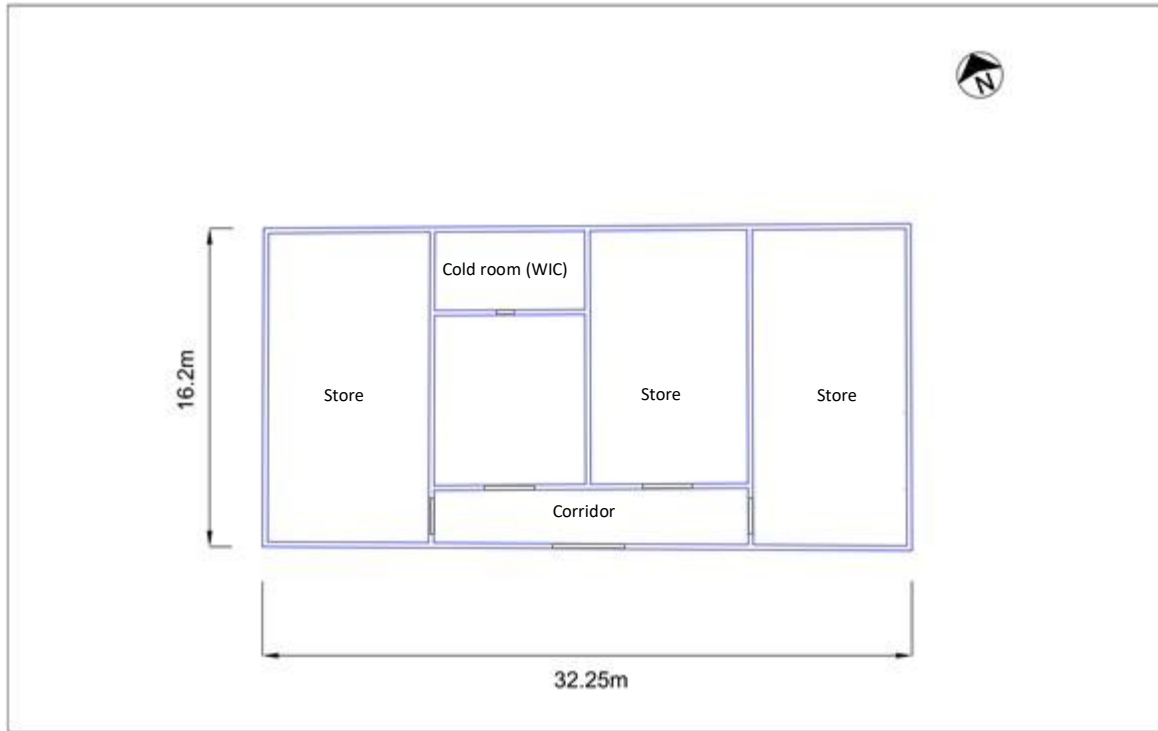
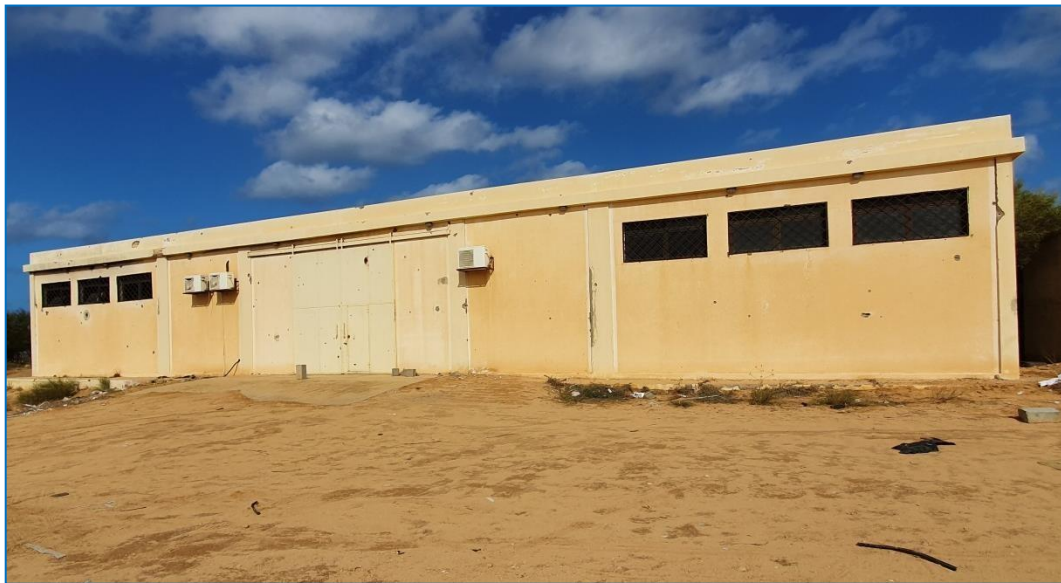
Also, some floorings, parapet and structural elements have suffered many deterioration which needs to be constructed and rehabilitated similar to the existing as shown in the photos and detailed in the BOQ.

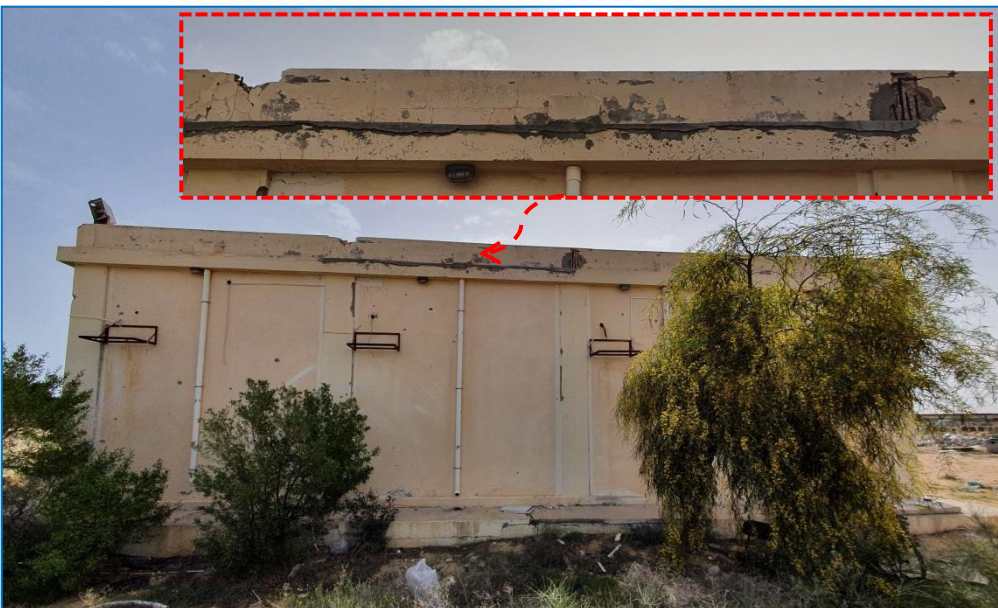
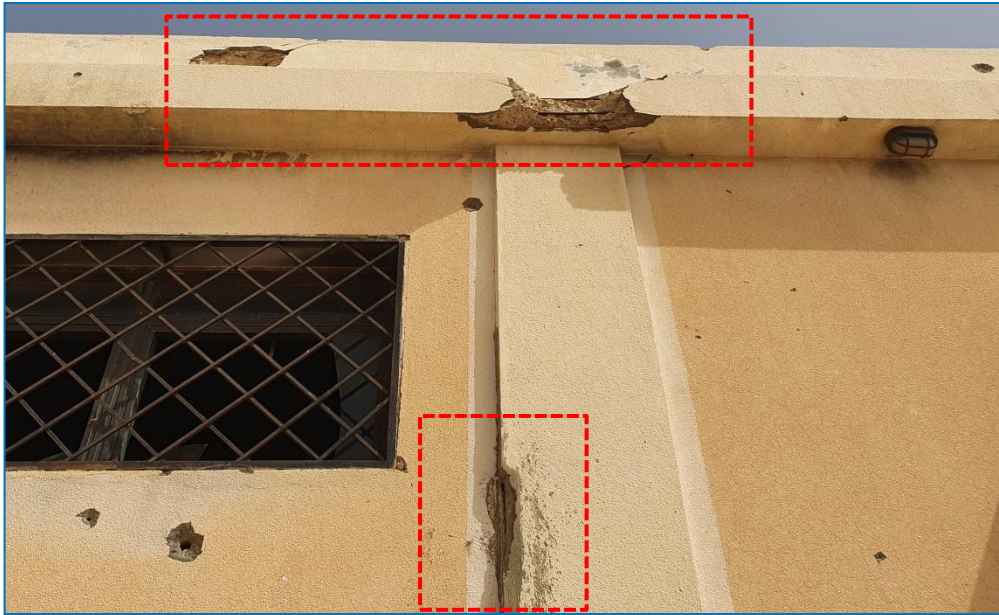
Because of defects in the roof screeding in the building, it will be necessary to supply and laying a bitumen roofing membrane to protect the roof from deteriorating over the time, as detailed in the BOQ.

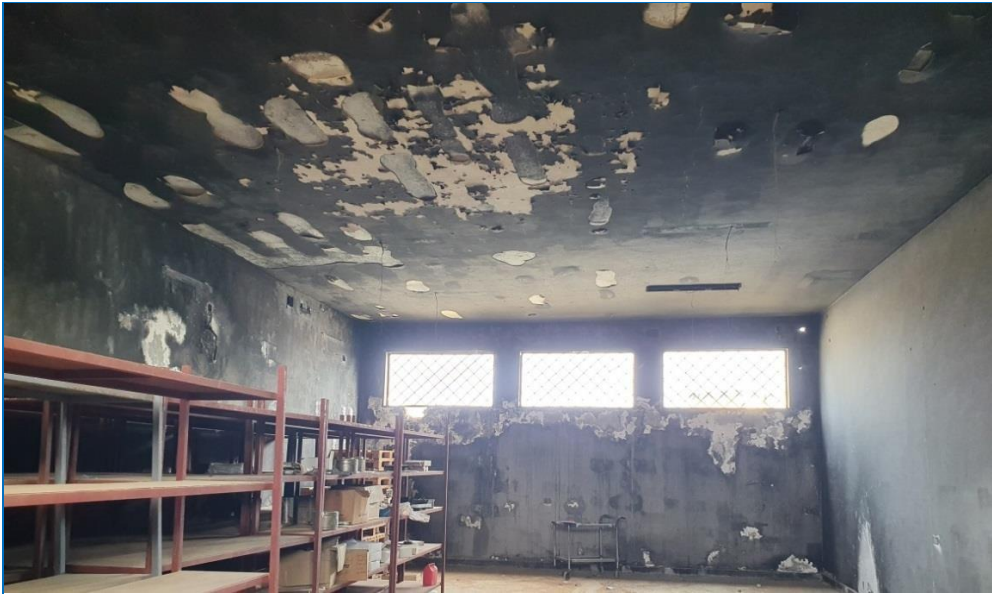
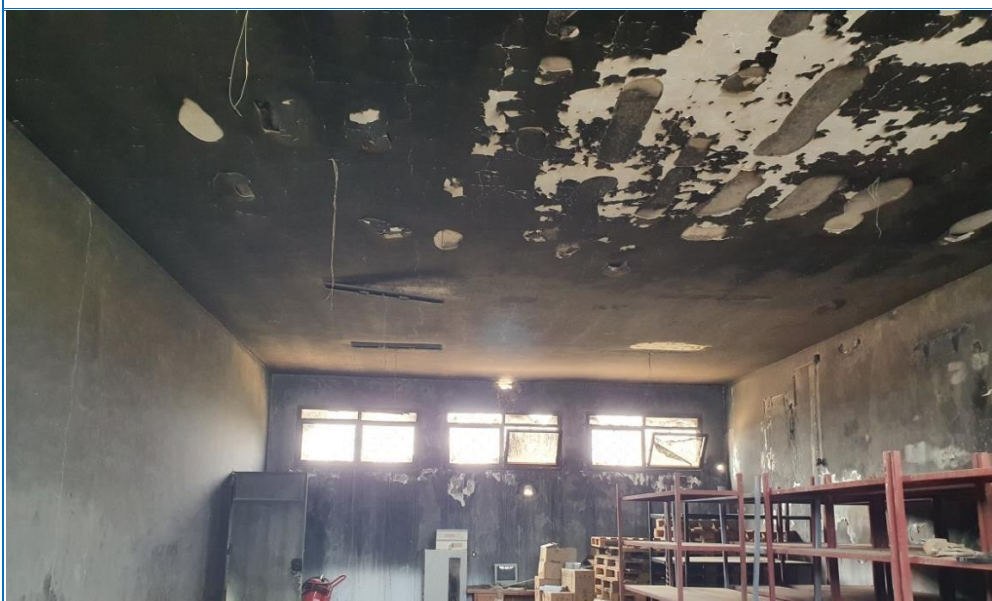
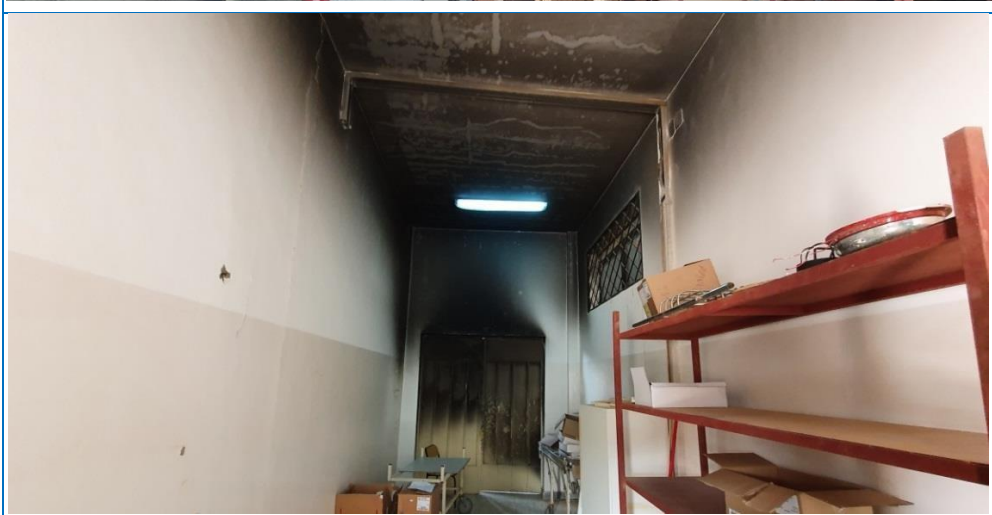
Due to the fire resulting from a direct shell in one of the warehouse halls, which led to excessive damage to the plastering layer, it is necessary to remove the old layer and make another new layer and the subsequent paint work, as shown in photos and detailed in BOQ.

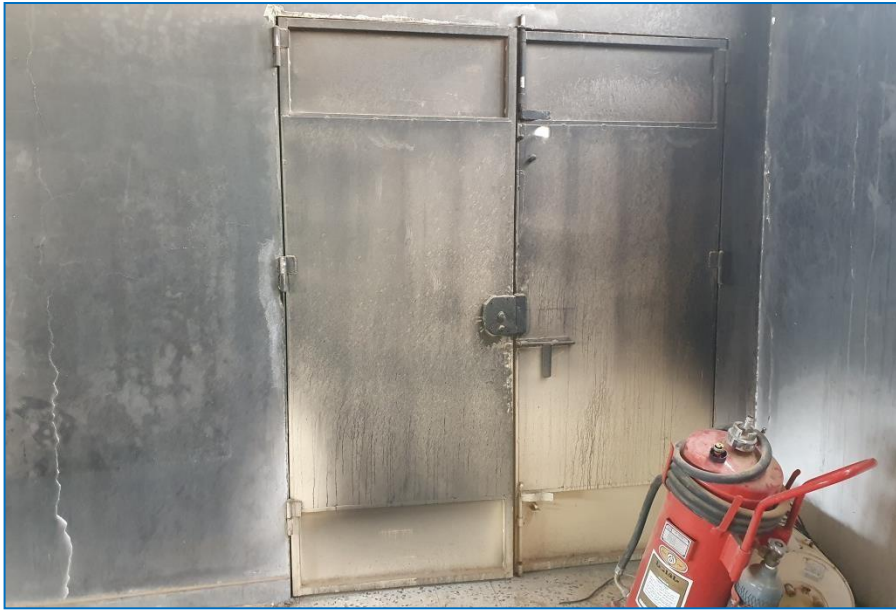
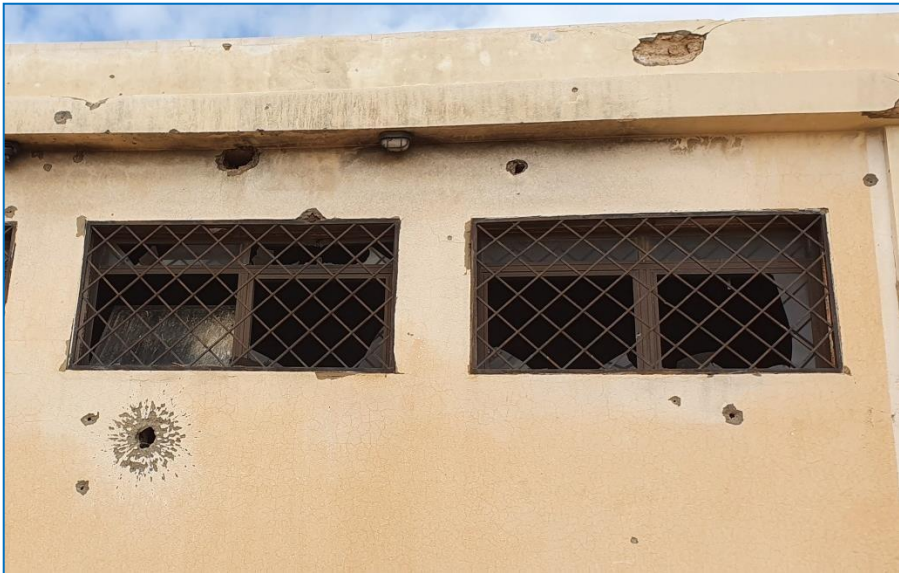
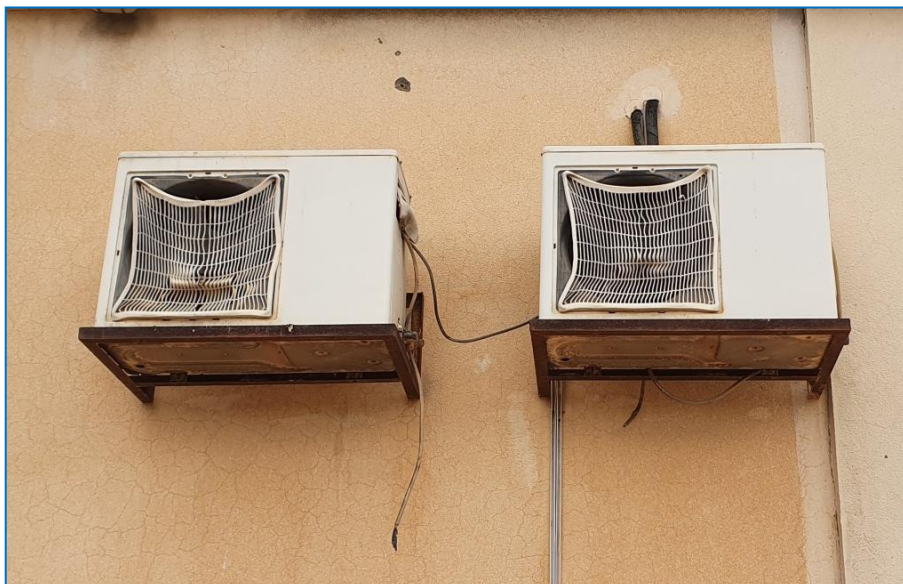
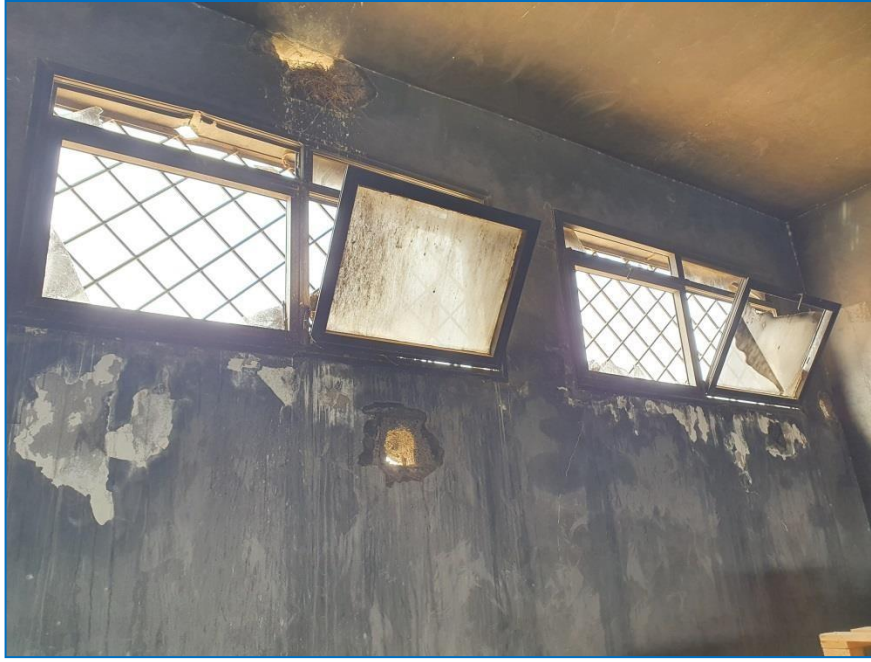
The building requires rehabilitation in many items including repair steel doors and supply PS doors, as well as repairing steel protection grille and supply a new PVC windows instead of defective windows, moreover supplying and installing backup generator, air-condition, and other electrical works as detailed in the BOQ and the shown pictures.
