1919 BUILDING, KITCHEN AND GUEST HOUSE
PARTICULAR SPECIFICATIONS

3.3 Description of Interventions - Particular specifications

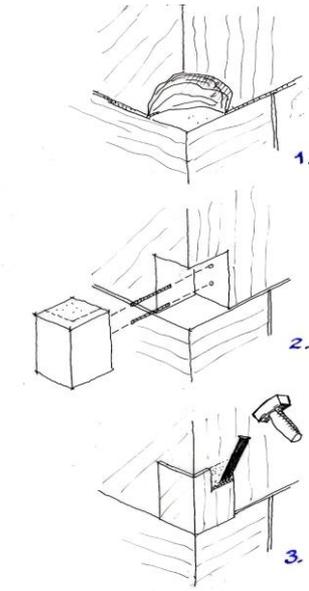
For calculation purpose three different cases must be priced: 1) Corner or arch stones, total replacement-full stone dimensions, 100 pieces, 2) Corner stones, partial replacement of any dimension (as sketch below) 100 pieces, 3) Non-corner stones, full surface (façade) dimensions and 8cm thickness, 60 pieces.

Sequence for repair of damage using natural stone filling

damage to adjacent ones) and new similar stones will be built. The new stones will be built with lime mortar and pointed. The work shall be applied to areas of simple plain stones or carved stones with decorative mouldings, or ashlar stones or stones on arches. The work might include a complete or partial stone replacement. Where needed epoxy coated iron pins must be used for joining stone pieces together.

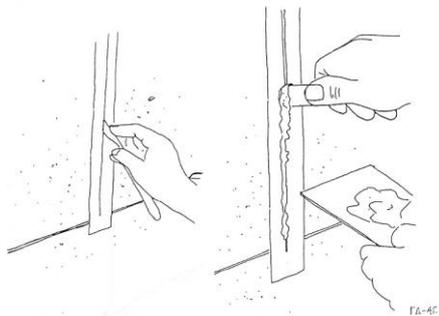
Use of adhesive tape to protect stones during pointing

- cleaning of joints with stone dressing tools with care so that the surrounding stone is not scratched and joints are not widened. All cutting out of mortars should leave a square face in the back of the joint. Cleaning should be done in 5cm depth.
- removal of deteriorated material and loose deposits with soft bristle brushes.
- cleaning of the joints with air and water under pressure.
- mixing of mortar whereby aggregates are mixed dry and the binder is separately mixed with the pigments. All constituents are mixed together and the optimum amount of water is added.
- pointing of the joint by careful packing of the mortar in layers according to original form/profile.
- protection of mortar from rapid drying by covering with PVC membrane or damp cloth. Regular spraying with water in order to keep the mortar humid should take place for a minimum of 15 days.

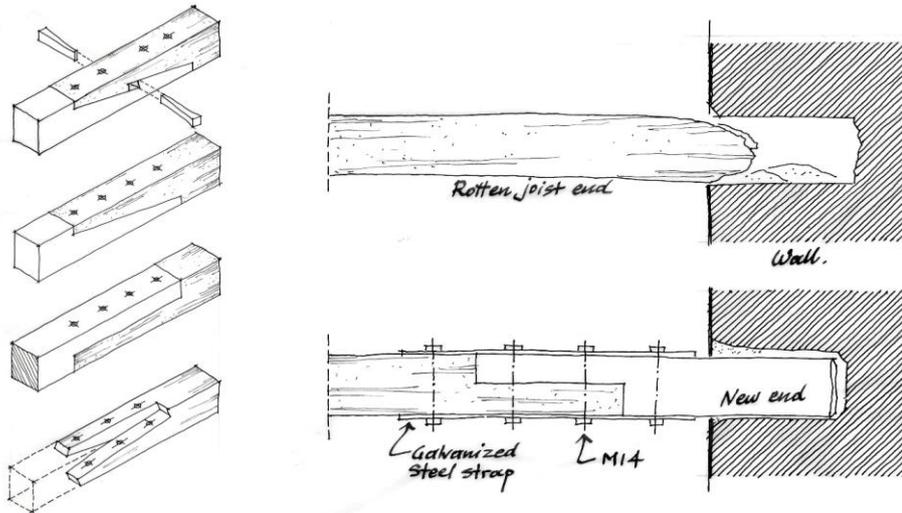
After systematic dusting and cleaning of the timber surface takes place, the rotten timber parts (i.e. joist ends, etc) will be replaced, treatment of wood for fungi and protection using linseed oil and/or special impregnation varnish (preservative) will take place.

Repairs of timber components

All rusty nails and iron plates will be removed from the timber structure. New stainless steel metal plates, straps and bolts will be used for the reinforcement of loose joints.

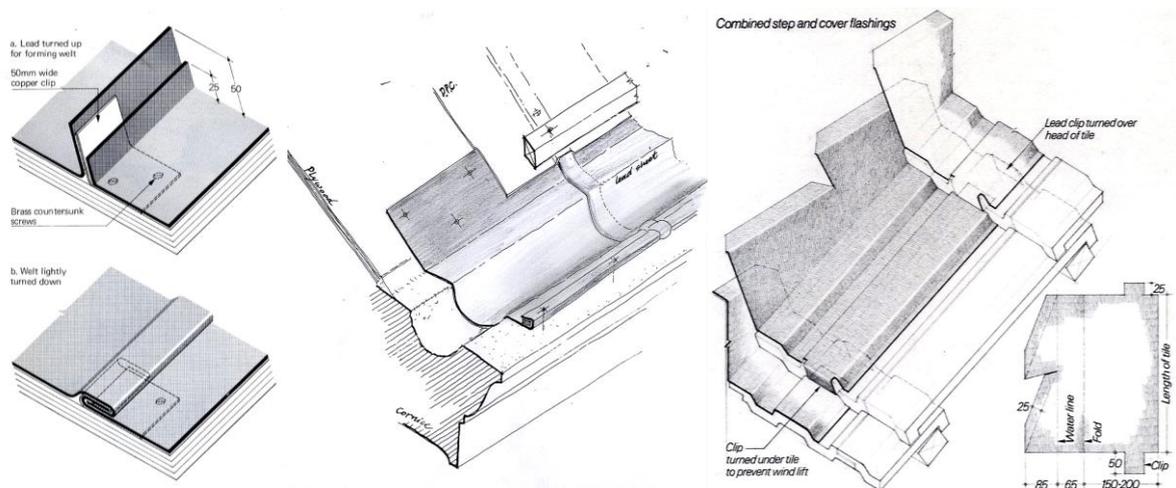
Special attention has to be paid at the joint between the tiles and the stone cornices (horizontal and pediments). As it was documented, the cornice has special grooves for fixing tiles at its rear. However, this was not enough for waterproofing of joint and probably that is why it didn't work, being substituted by asbestos-cement plates. For the improvement of this point, it is suggested a construction of overlapping lead sheets 2 mm thick that will be at least 30cm wide from either sides of the joint. Lead sheets will be placed between tile layers and nailed with the use of bronze screws to the cornice blocks.

Leadwork at the cornice level and roof of the building

Over this timber structure overlapping waterproof sheets of roofing asphalt membrane will be nailed and will drain rainwater to the cornice. The battens of the tiles will be placed vertically to the orientation of the structure below, and spacing will be filled up with thermal insulation boards of expanded polystyrene. French tiles will be fixed to the battens with the use of stainless nails and/or wire. Ridge capping units will be also of French type and will be placed with strong cement mortar, giving extra attention at the pointing of the joints.
