Project Title :
Church of AG. SERGIOS AND BACCHUS
in Ag. Sergios / Yeni bogazici

Drawing name : 2. Proposal
ROOF FLOOR PLAN
(vault level)

Drawing no. :
A-Pr 05

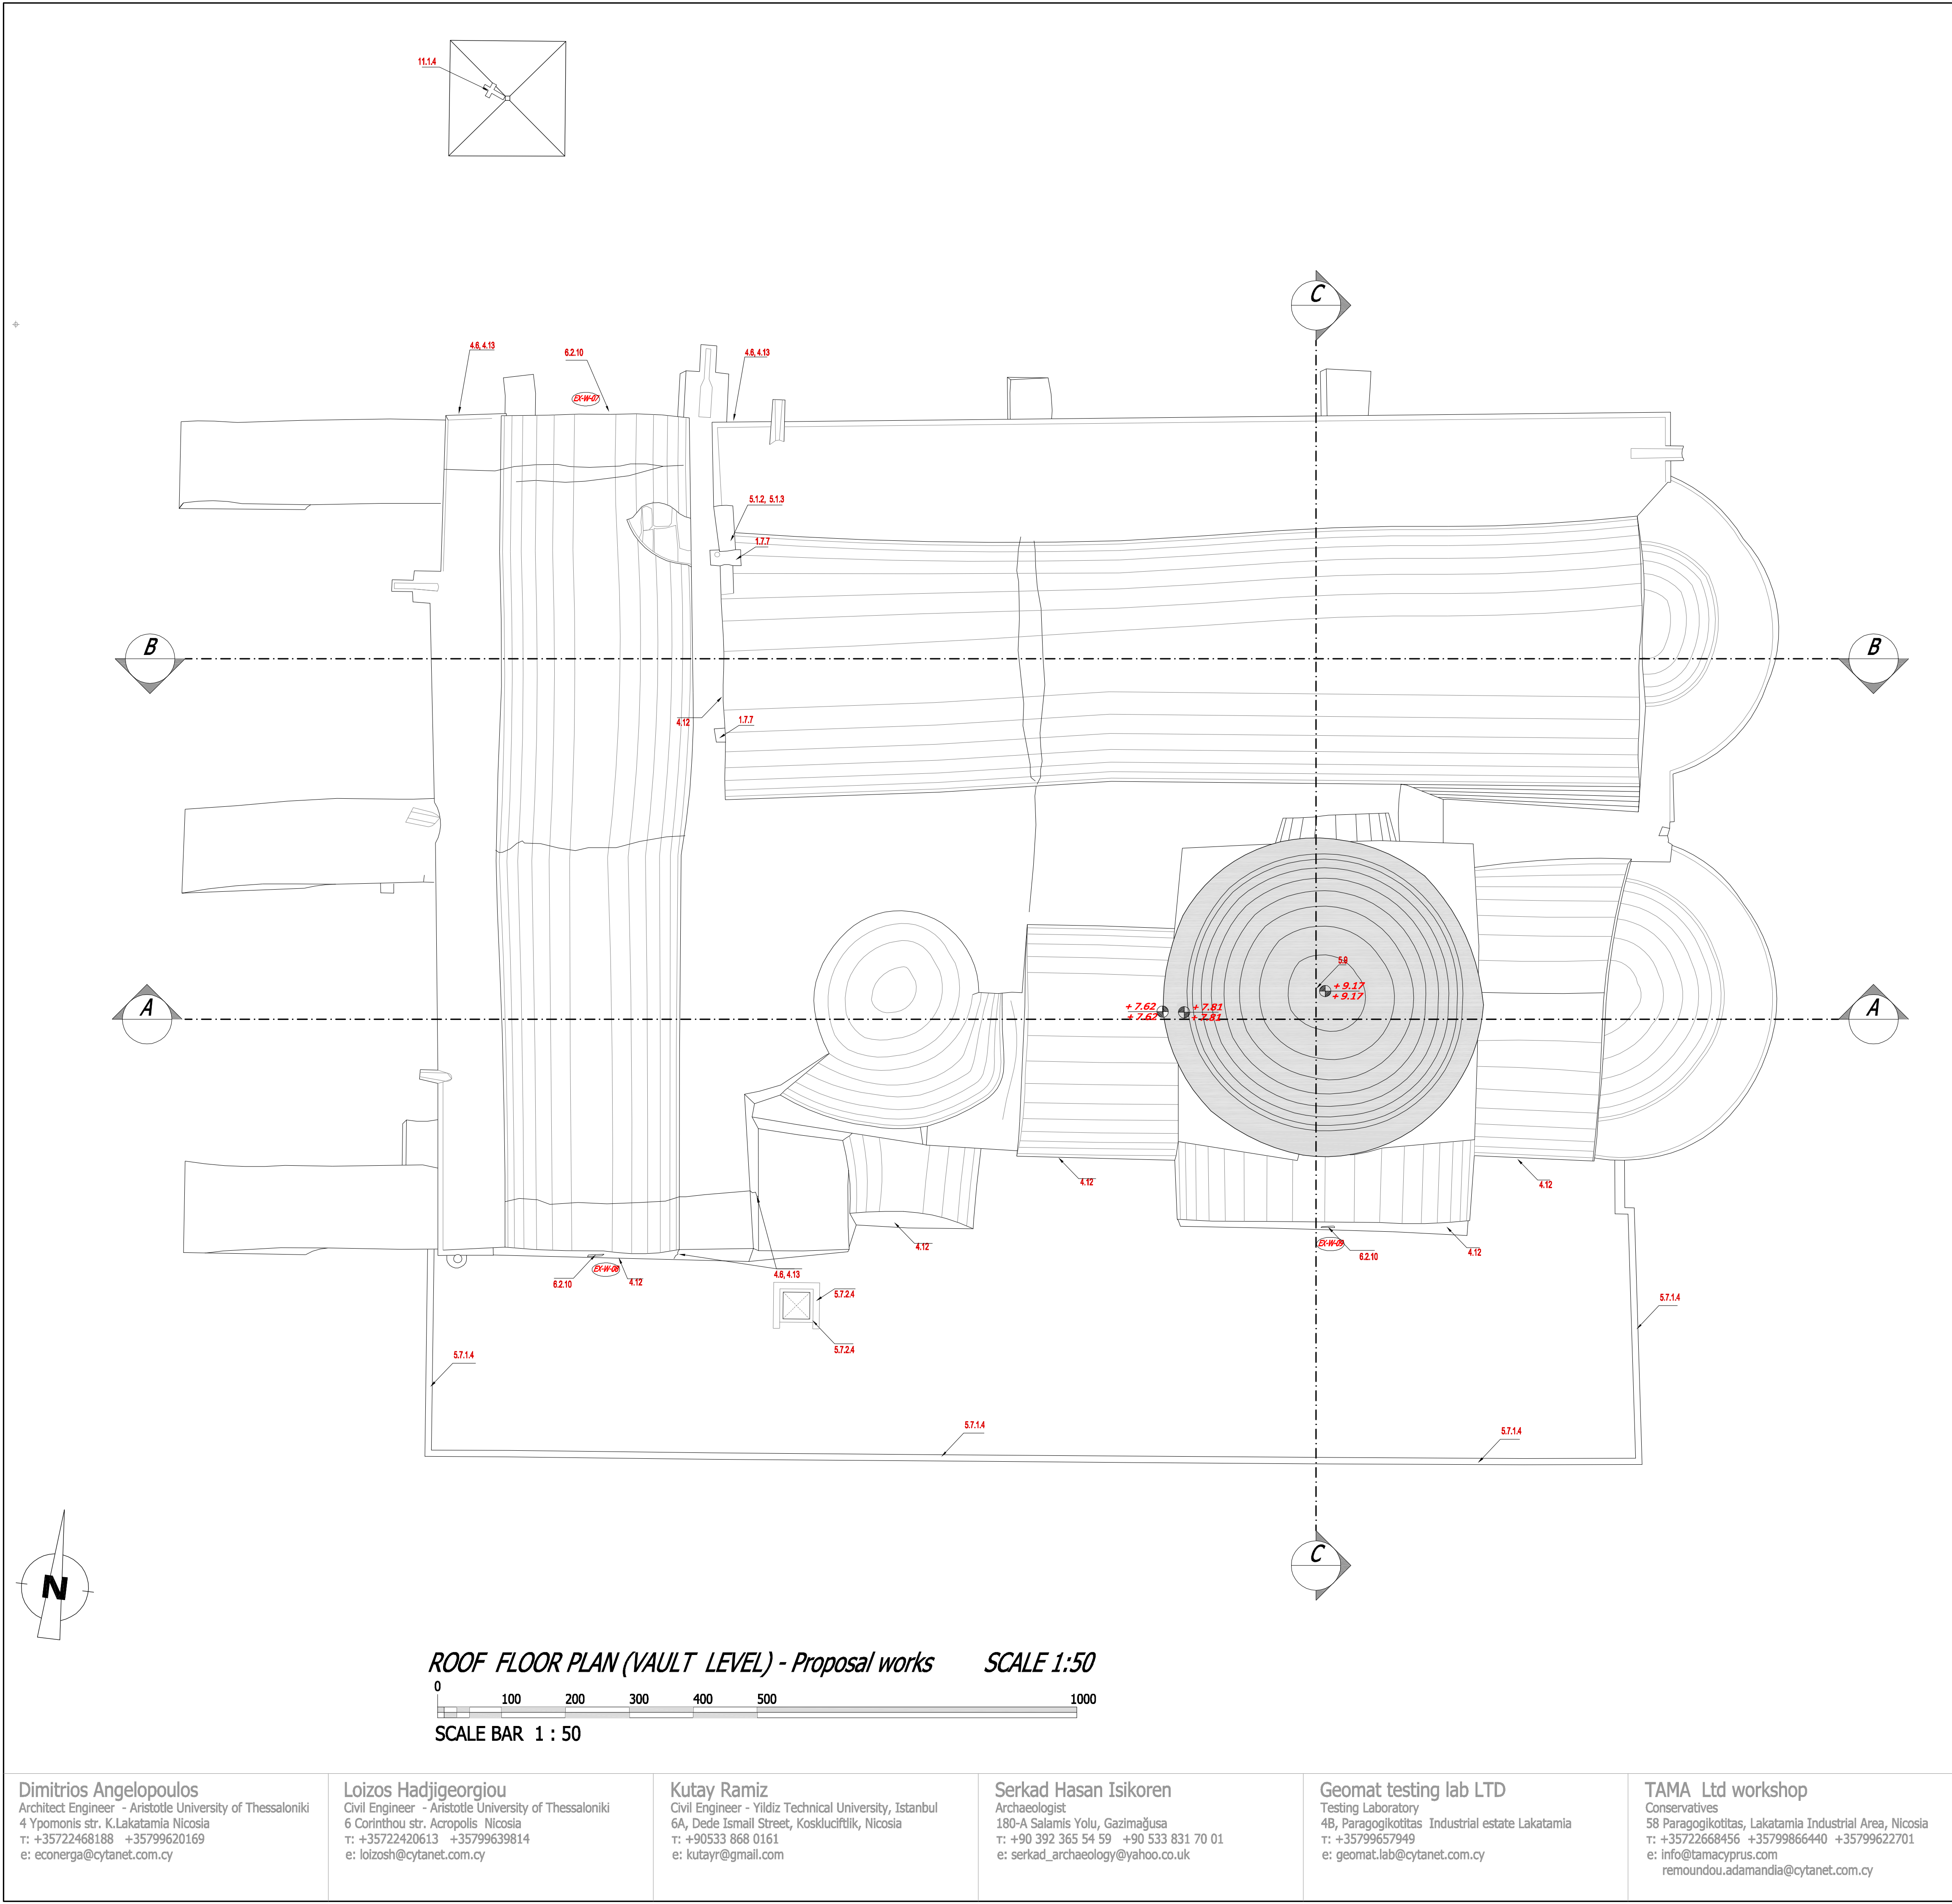
3.1.5 Proposal copper pipe to support for cabling for lighting
3.1.5 Proposal copper pipe to support for cabling
4.2 Remove of deteriorated plaster and repair of wall under conservators and architect supervision

4.2 Remove the plaster only where is structurally deteriorated. Further actions according to findings.
4.2 4.15 Area to be treated exclusively by conservator - plaster removal and / or plaster repair. Further actions according to findings.

4.6 Stone dismantling and rebuilding
4.8 Repair vault (according to civil engineer's study)
4.9 Cleaning and pointing removal and repointing of buttress
4.10 Stone replacement.

4.11.2 Repair plaster (according to civil engineer's study)
4.12 Cleaning and new repointing of wall
4.12 5.6 Areas to clean, maintain and repointing, cover with water insulation

4.13 Grouting
4.14 Grout injections
4.19 Area for consolidation with hydraulic mortar and limestones
5.1, 5.4, 5.6 Area to remove debris and roots, repair stones and cover with fibernet and hydraulic mortar and water insulation

5.3 Cleaning and maintain of cornices
5.9 Replace cross with a new limestone made cross (see drawing A-Pr 11)
6.2 Window conservation (see drawing A-Pr 11)

6.4 Window frame replacement (see drawing A-Pr 11)
7.1 Existing door to conserve-drawing A-Ex 16
9.2 Conservation of iconostasis beam / woodwork exclusively by conservator, (see final conservation guidelines)

11.1.1 Maintain of the bell mechanism
11.1.4 Repair and reposition of the broken cross
12.0 Holly altar conservation exclusively by conservator according to conservation proposals.
