Annex B: Set of Drawings for Diling Integrated Farm Rehabilitation

Hai-Elmak-Diling Locality-South Kordofan State

Dilling Integrated Farm Rehabilitation

Main Plan Drawings

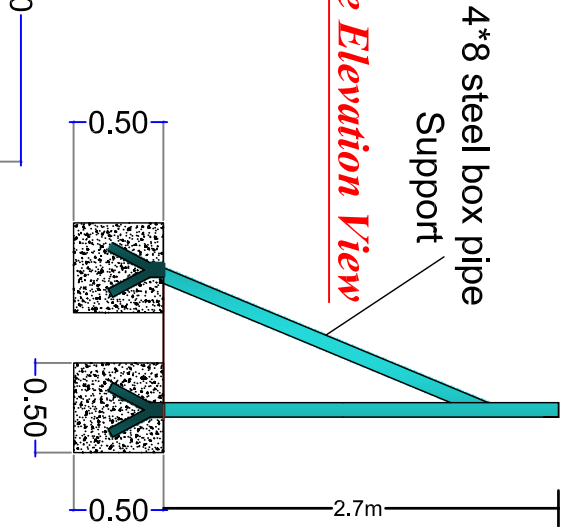
Side Elevation View

- The steel frame and the steel sheet shall be of good quality
- The steel frame and the sheet shall be painted with antirust and final coats
- The the contractor shall properly write and draw as indicated in the BoQ
