REMOVAL OF TOP LAYER OF THE ROOF AND ITS RECONSTRUCTION

PROPOSAL DRAWINGS

ROOF PLAN

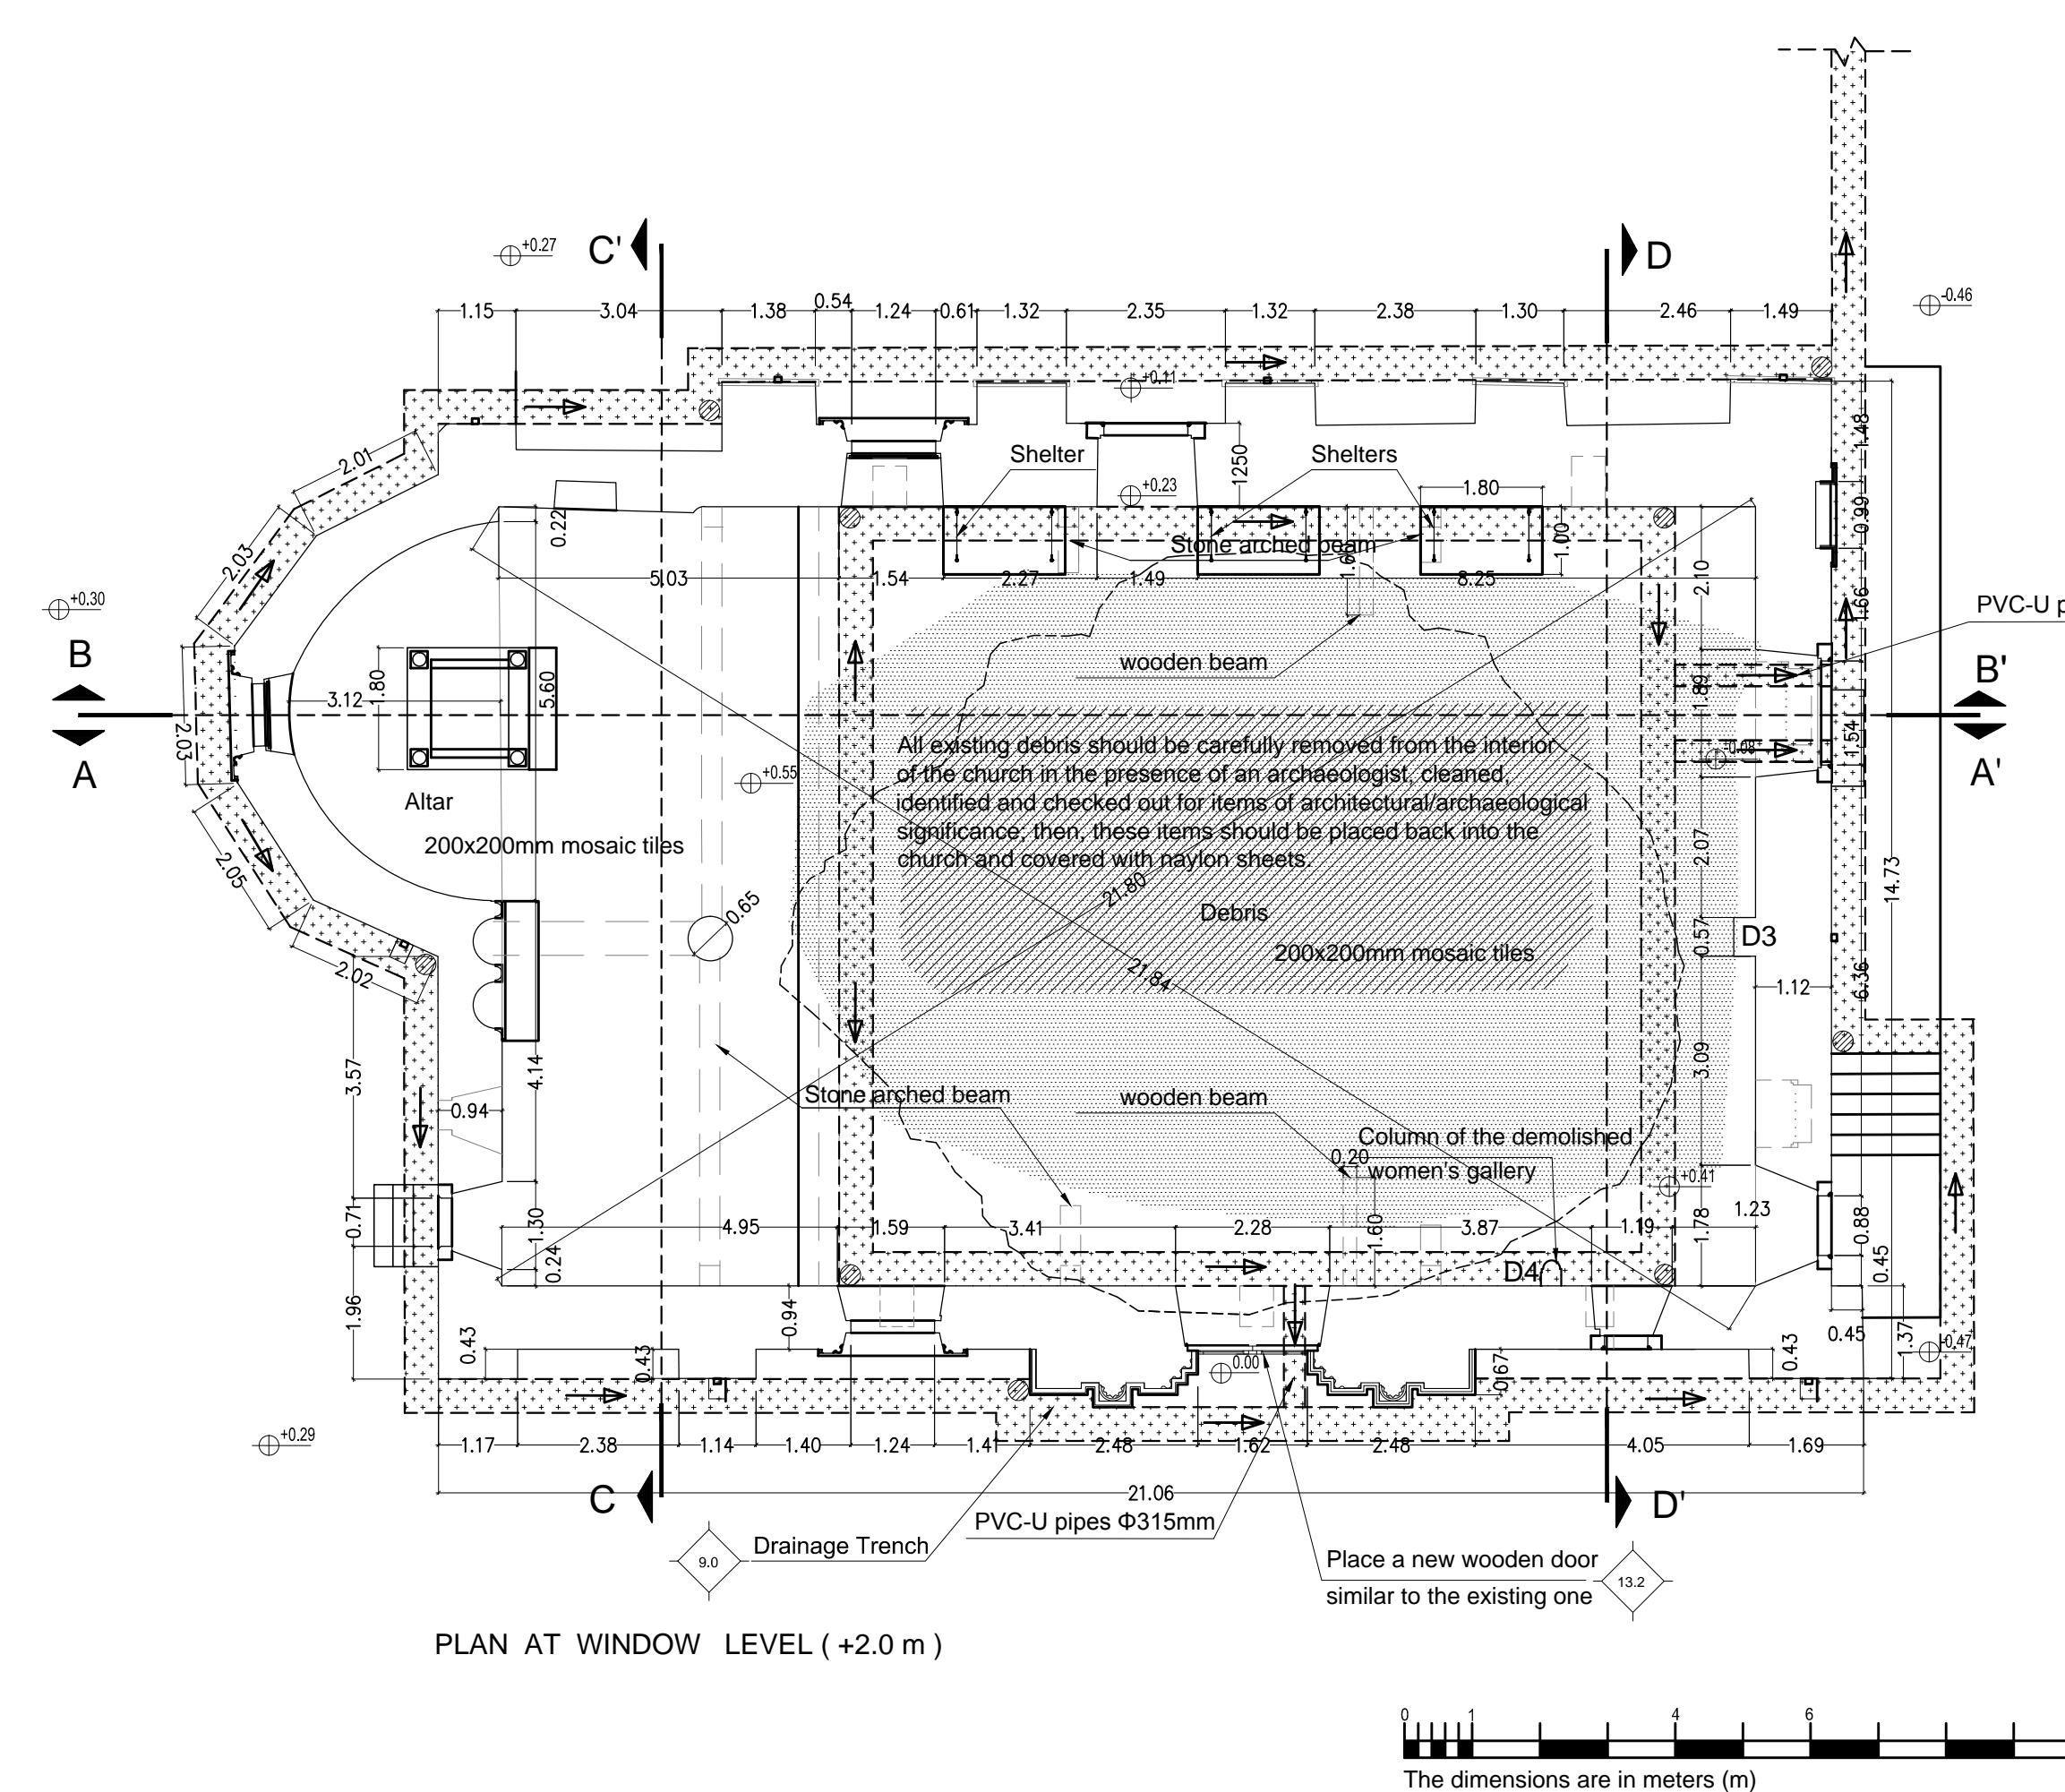
PVC-U pipes Φ315mm

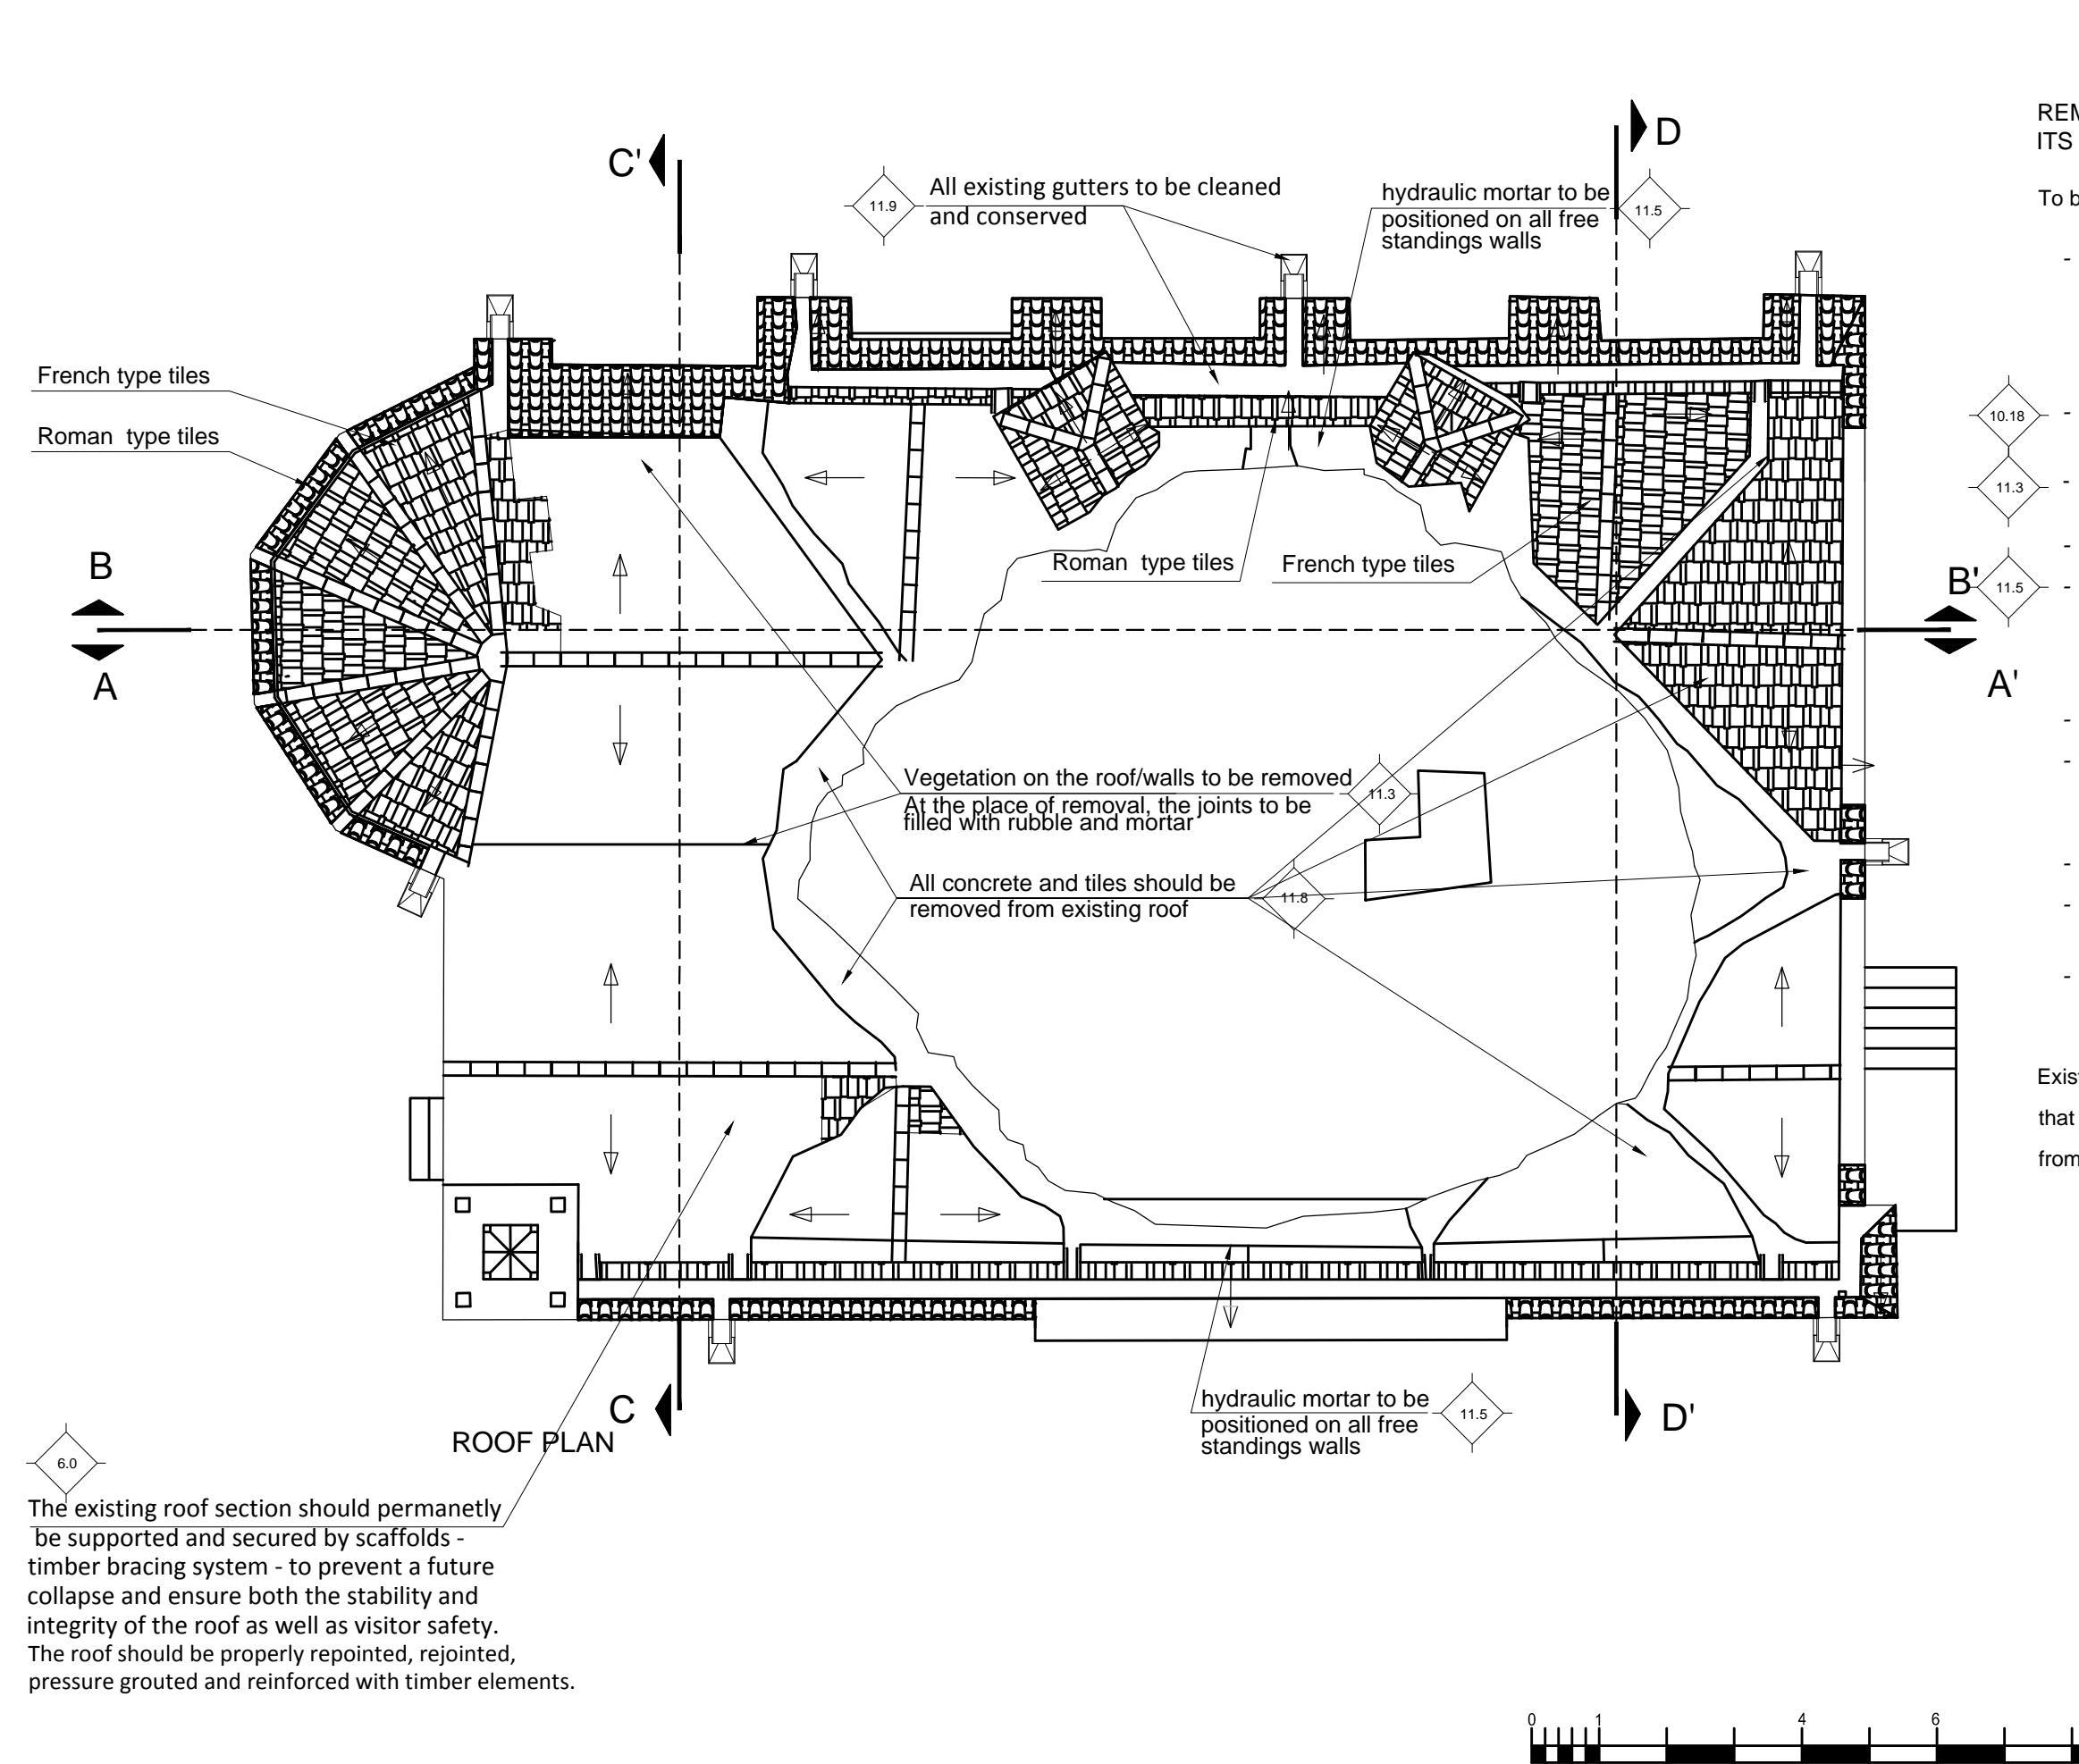
P03

- Supporting of the internal surface of the vaults as shown in structural drawings.
- Carefully removal of the top roof layer with hand tools
- (no heavy machinery tools to be used).

- Replace damaged stones and clean with biocides any deteriorated stones.
- Wherever vegetation is present, growing on either the walls or the roof it should be removed

- Healing stone cracks with Limepor100.
- Preparation of plane for impermeabilization with lime slab
- (Tectoria M15 or Limepor NHL 3.5 reinforced with Kimitech ELASTOFIX or equivalent for approval) at least 3 cm. thick or according to 6.5.

- Smoothing edges to facilitate flow of water,
- Waterproofing after one week with lime based traditional
- finish such as Tectoria TFT or limepor FN or SK or equivalent for approval.

- Placement of new copper gutters as per drawings.
- The slope of the roof will be checked as to not have any
- stationary rainwater
- Anything else needed to produce a perfect finished job

Existing Waterspouts will be consolidated and cleaned and secure that rainwater washed away properly with correct inclination from the roof.

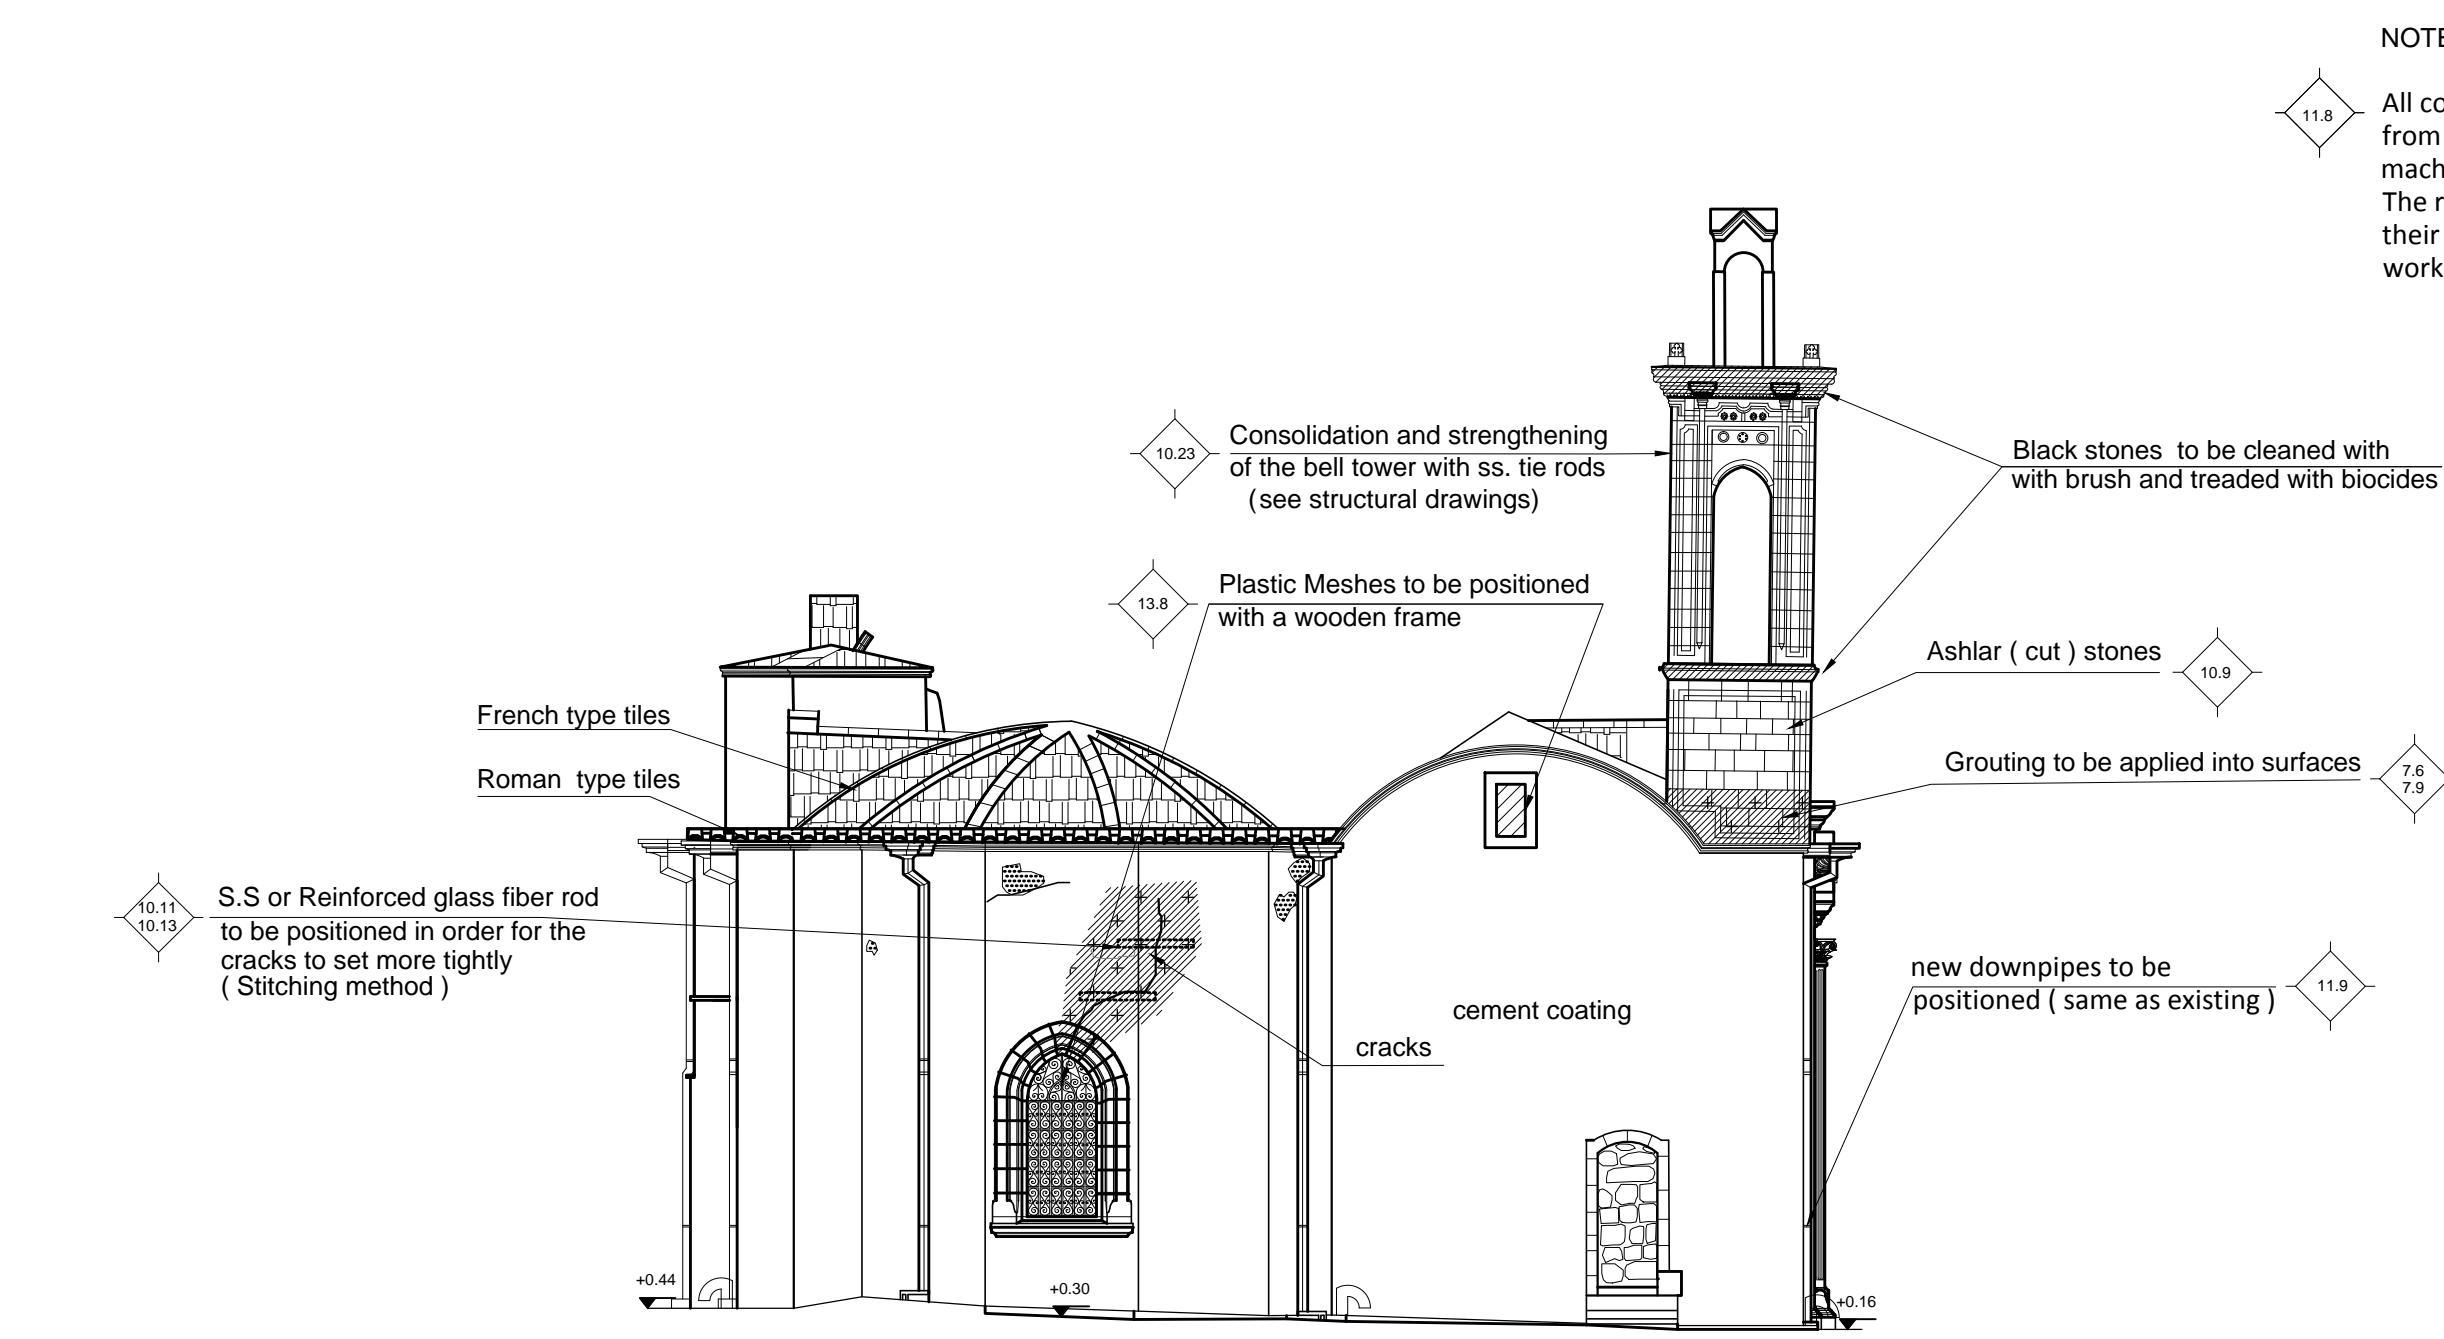
EAST ELEVATION

- 1. At the points where deep and severe cracks are formed, as in the south and east wall, the stones should be carefully dismantled on either side of the cracks.

- Subsequently, the masonry should be rebuilt with stones similar to the original ones in both size and texture using of " stitching". It is suggested that additional s.s beams are positioned in.

- 2. Thereafter, rubble filling and mortar pointing, to be implemented on the masonry.
- 3. and then lime plaster coatings, to its interior face.
- 4. Other smaller cracks to be filled up with solid rubblework and be properly pointed up, so that the stones which are displaced, and the rest of the masonry are 10.19 well - bound together.

- 5. The filling stones which either detached, wheathered, decayed or at risk of collapsing, as well as any eroded and cracked mortarjoints should be repointed, removed or replaced, for instance when the mortar joints go deeper than 3 cm from the surface of the stone, then the stone pointing must be renewed with mortar, after having first removed the original pointing.

- 6. Most of the joints of the walls to be pointed. -(10.21)
- 7. Injection grouting to be applied where indicate on drawings

All concrete and tiles should be removed manually from the existing roof without the use of vibrations machinery.

The removed roof tiles should be set back into their original positions after the insulation work is complete.

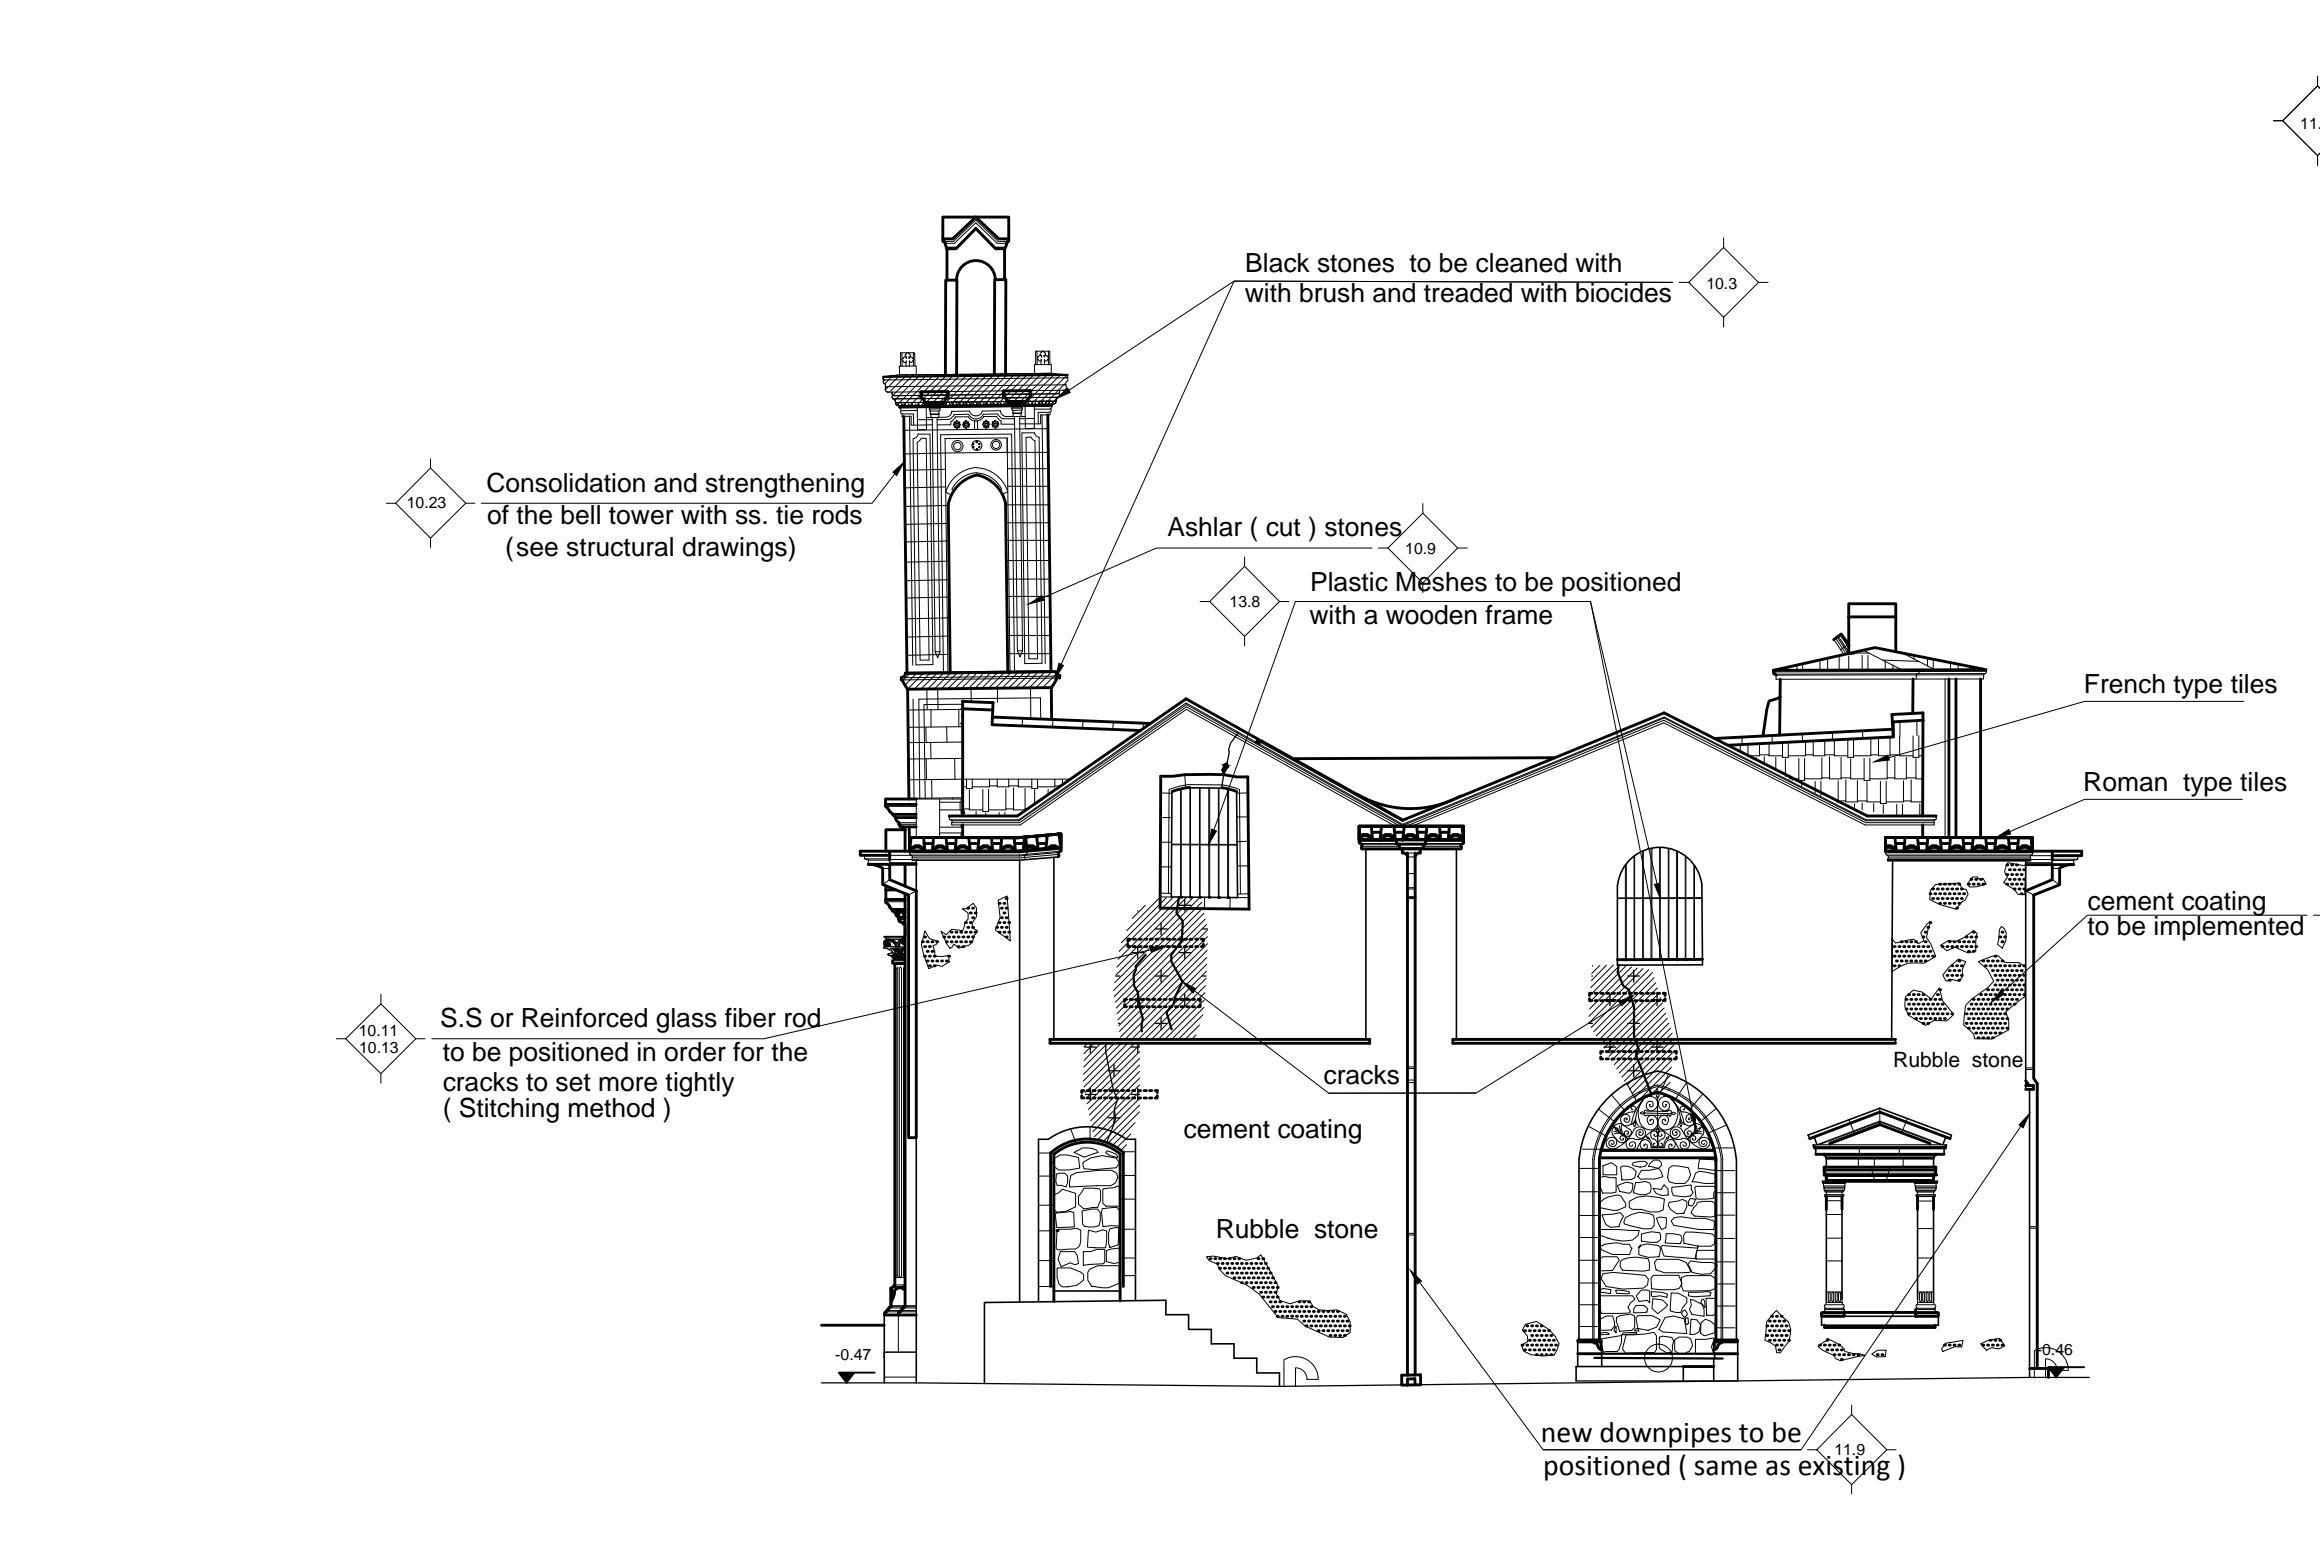
WEST ELEVATION

- 1. At the points where deep and severe cracks are formed, as in the south and east wall, the stones should be carefully dismantled on either side of the cracks.

- Subsequently, the masonry should be rebuilt with stones similar to the original ones in both size and texture using of " stitching". It is suggested that additional s.s beams are positioned in.

- 2. Thereafter, rubble filling and mortar pointing, to be implemented on the masonry.
- 3. and then lime plaster coatings, to its interior face.
- 4. Other smaller cracks to be filled up with solid rubblework and be properly pointed up, so that the stones which are displaced, and the rest of the masonry are 10.19 well - bound together.

- 5. The filling stones which either detached, wheathered, decayed or at risk of collapsing, as well as any eroded and cracked mortarjoints should be repointed, removed or replaced, for instance when the mortar joints go deeper than 3 cm from the surface of the stone, then the stone pointing must be renewed with mortar, after having first removed the original pointing.

- 6. Most of the joints of the walls to be pointed. -(10.21)
- 7. Injection grouting to be applied where indicate on drawings

All concrete and tiles should be removed manually from the existing roof without the use of vibrations machinery.

The removed roof tiles should be set back into their original positions after the insulation work is complete.

black spots on stones

Injection grouting area Injection (indicative) grouting points

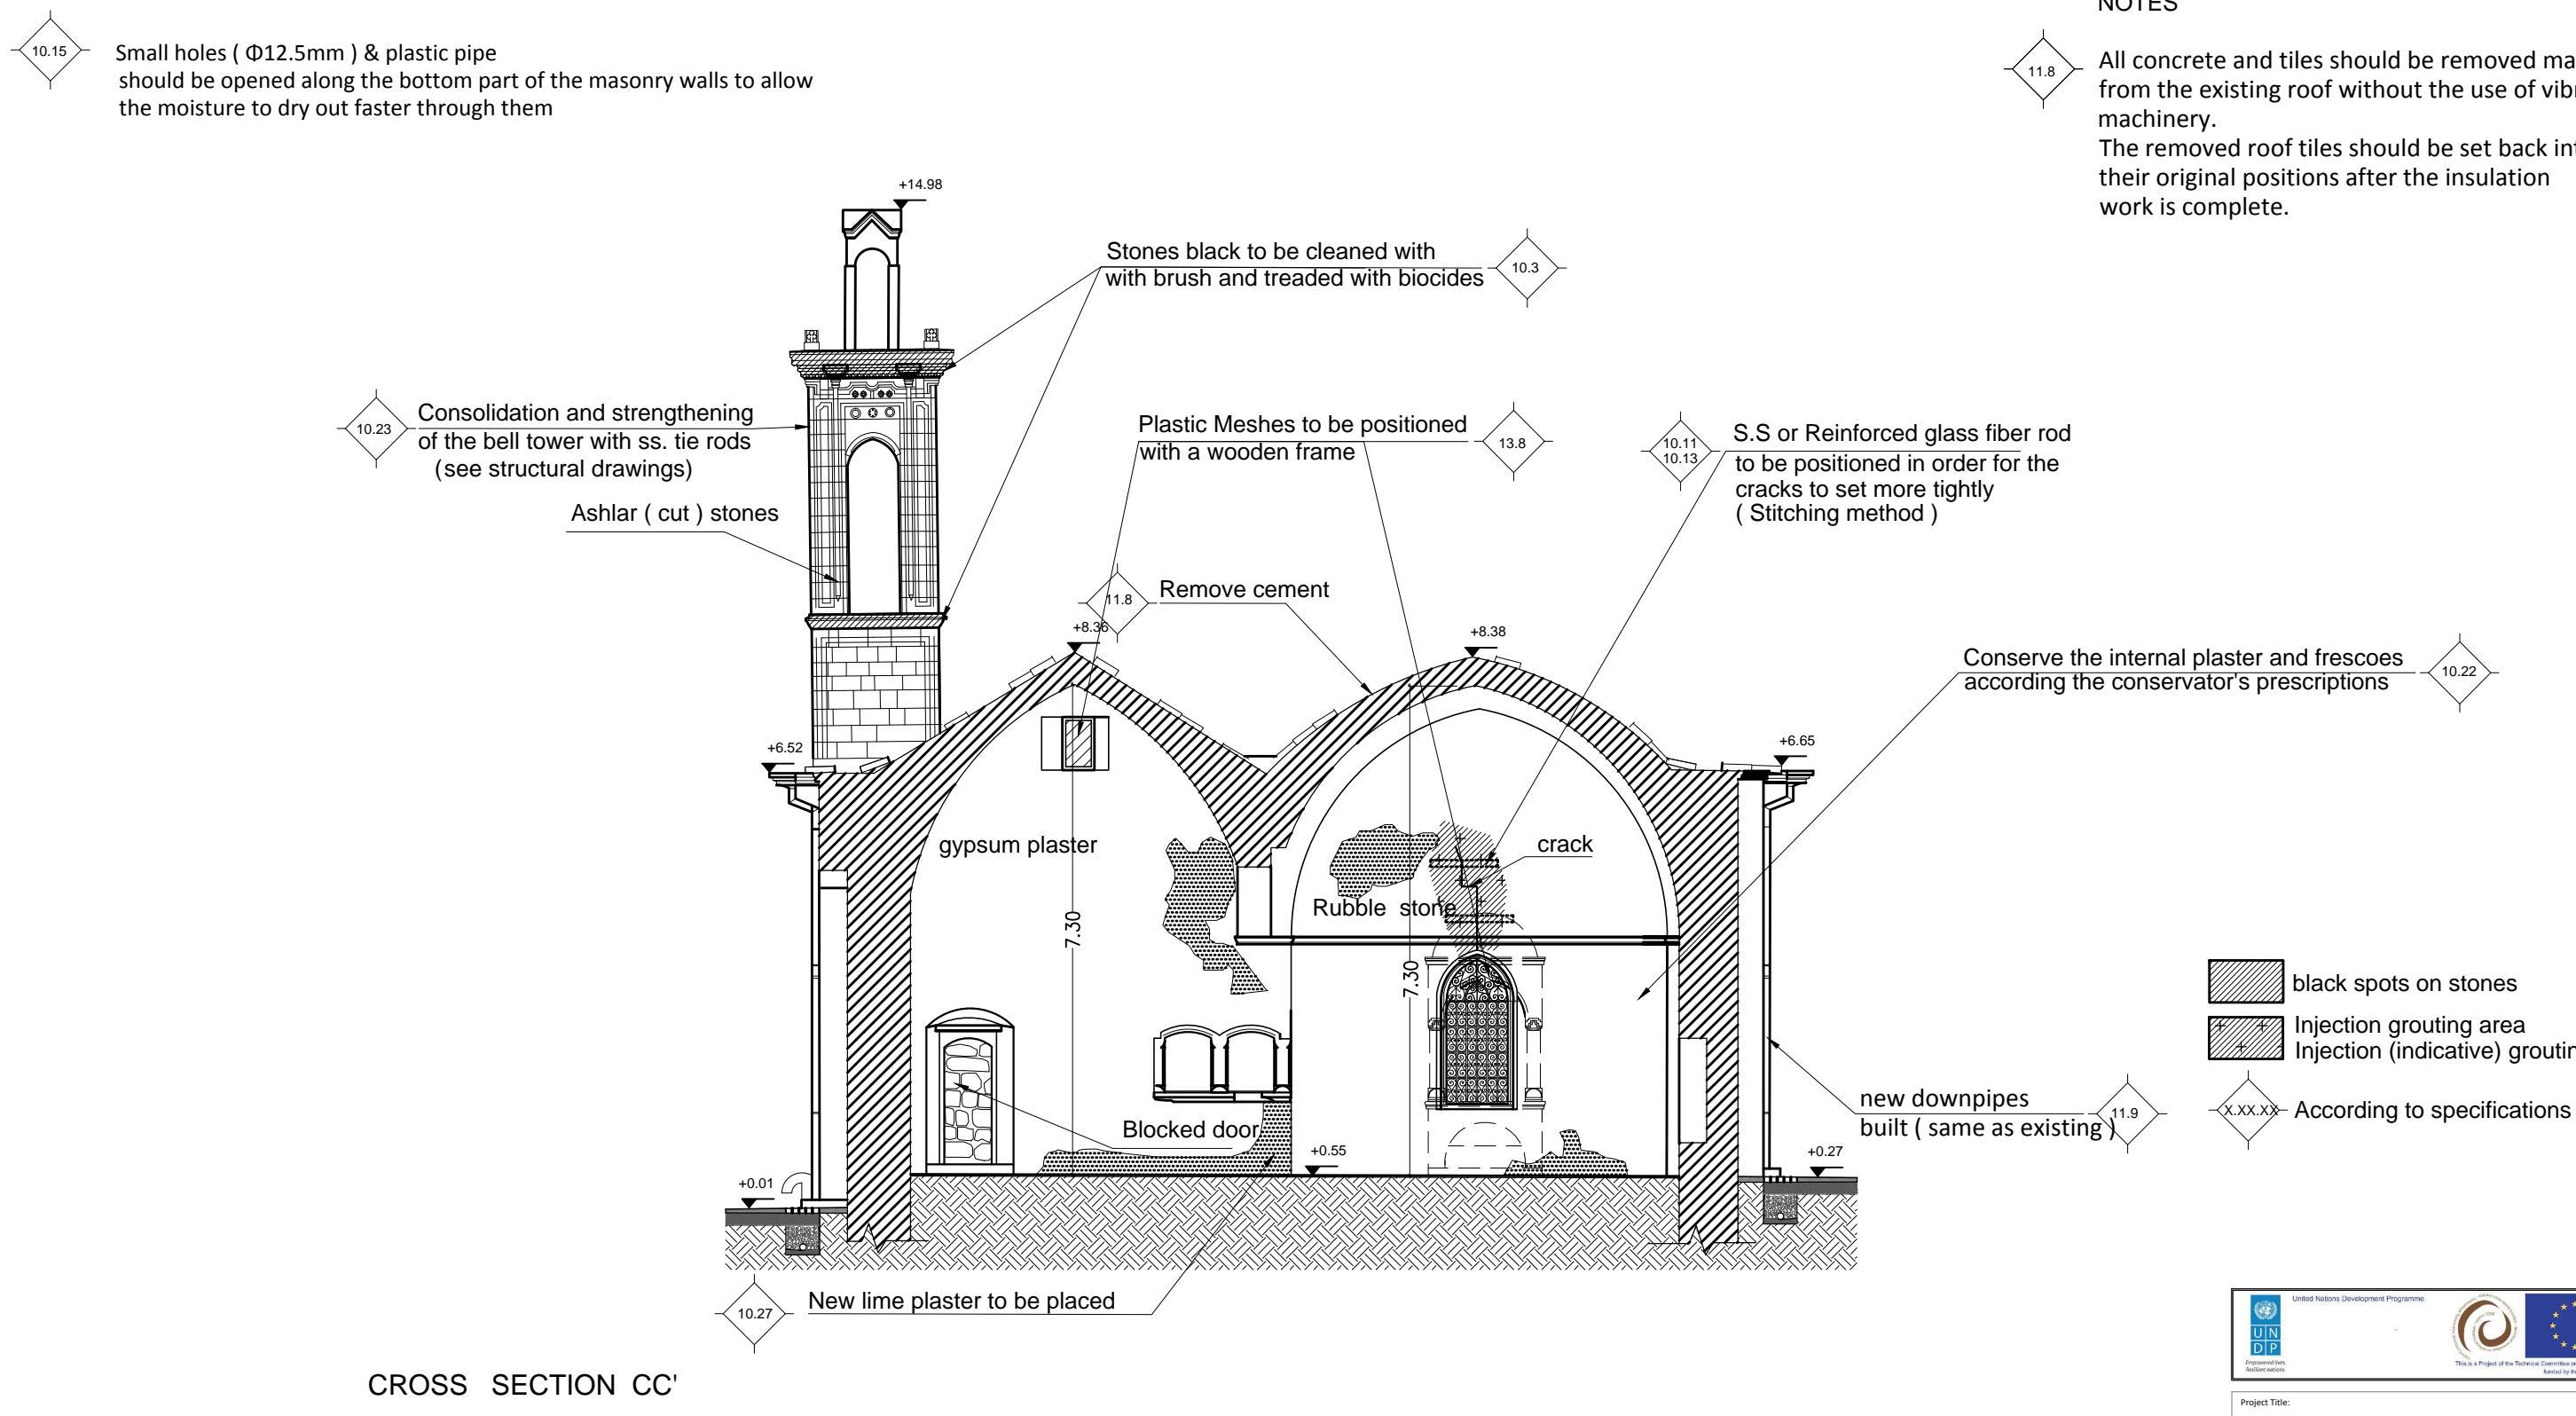
- 1. At the points where deep and severe cracks are formed, as in the south and east wall, the stones should be carefully dismantled on either side of the cracks.

- Subsequently, the masonry should be rebuilt with stones similar to the original ones in both size and texture using of " stitching". It is suggested that additional s.s beams are positioned in.

- 2. Thereafter, rubble filling and mortar pointing, to be implemented on the masonry.
- 3. and then lime plaster coatings, to its interior face.
- 4. Other smaller cracks to be filled up with solid rubblework and be properly pointed up, so that the stones which are displaced, and the rest of the masonry are well - bound together.

- 5. The filling stones which either detached, wheathered, decayed or at risk of collapsing, as well as any eroded and cracked mortarjoints should be repointed, removed or replaced, for instance when the mortar joints go deeper than 3 cm from the surface of the stone, then the stone pointing must be renewed with mortar, after having first removed the original pointing.

- Most of the joints of the walls to be pointed. 6. -(10.21)
- 7. Injection grouting to be applied where indicate on drawings

All concrete and tiles should be removed manually from the existing roof without the use of vibrations The removed roof tiles should be set back into

black spots on stones

Injection (indicative) grouting points
