REMOVAL OF TOP LAYER OF THE ROOF AND ITS RECONSTRUCTION

PROPOSAL DRAWINGS

ROOF PLAN

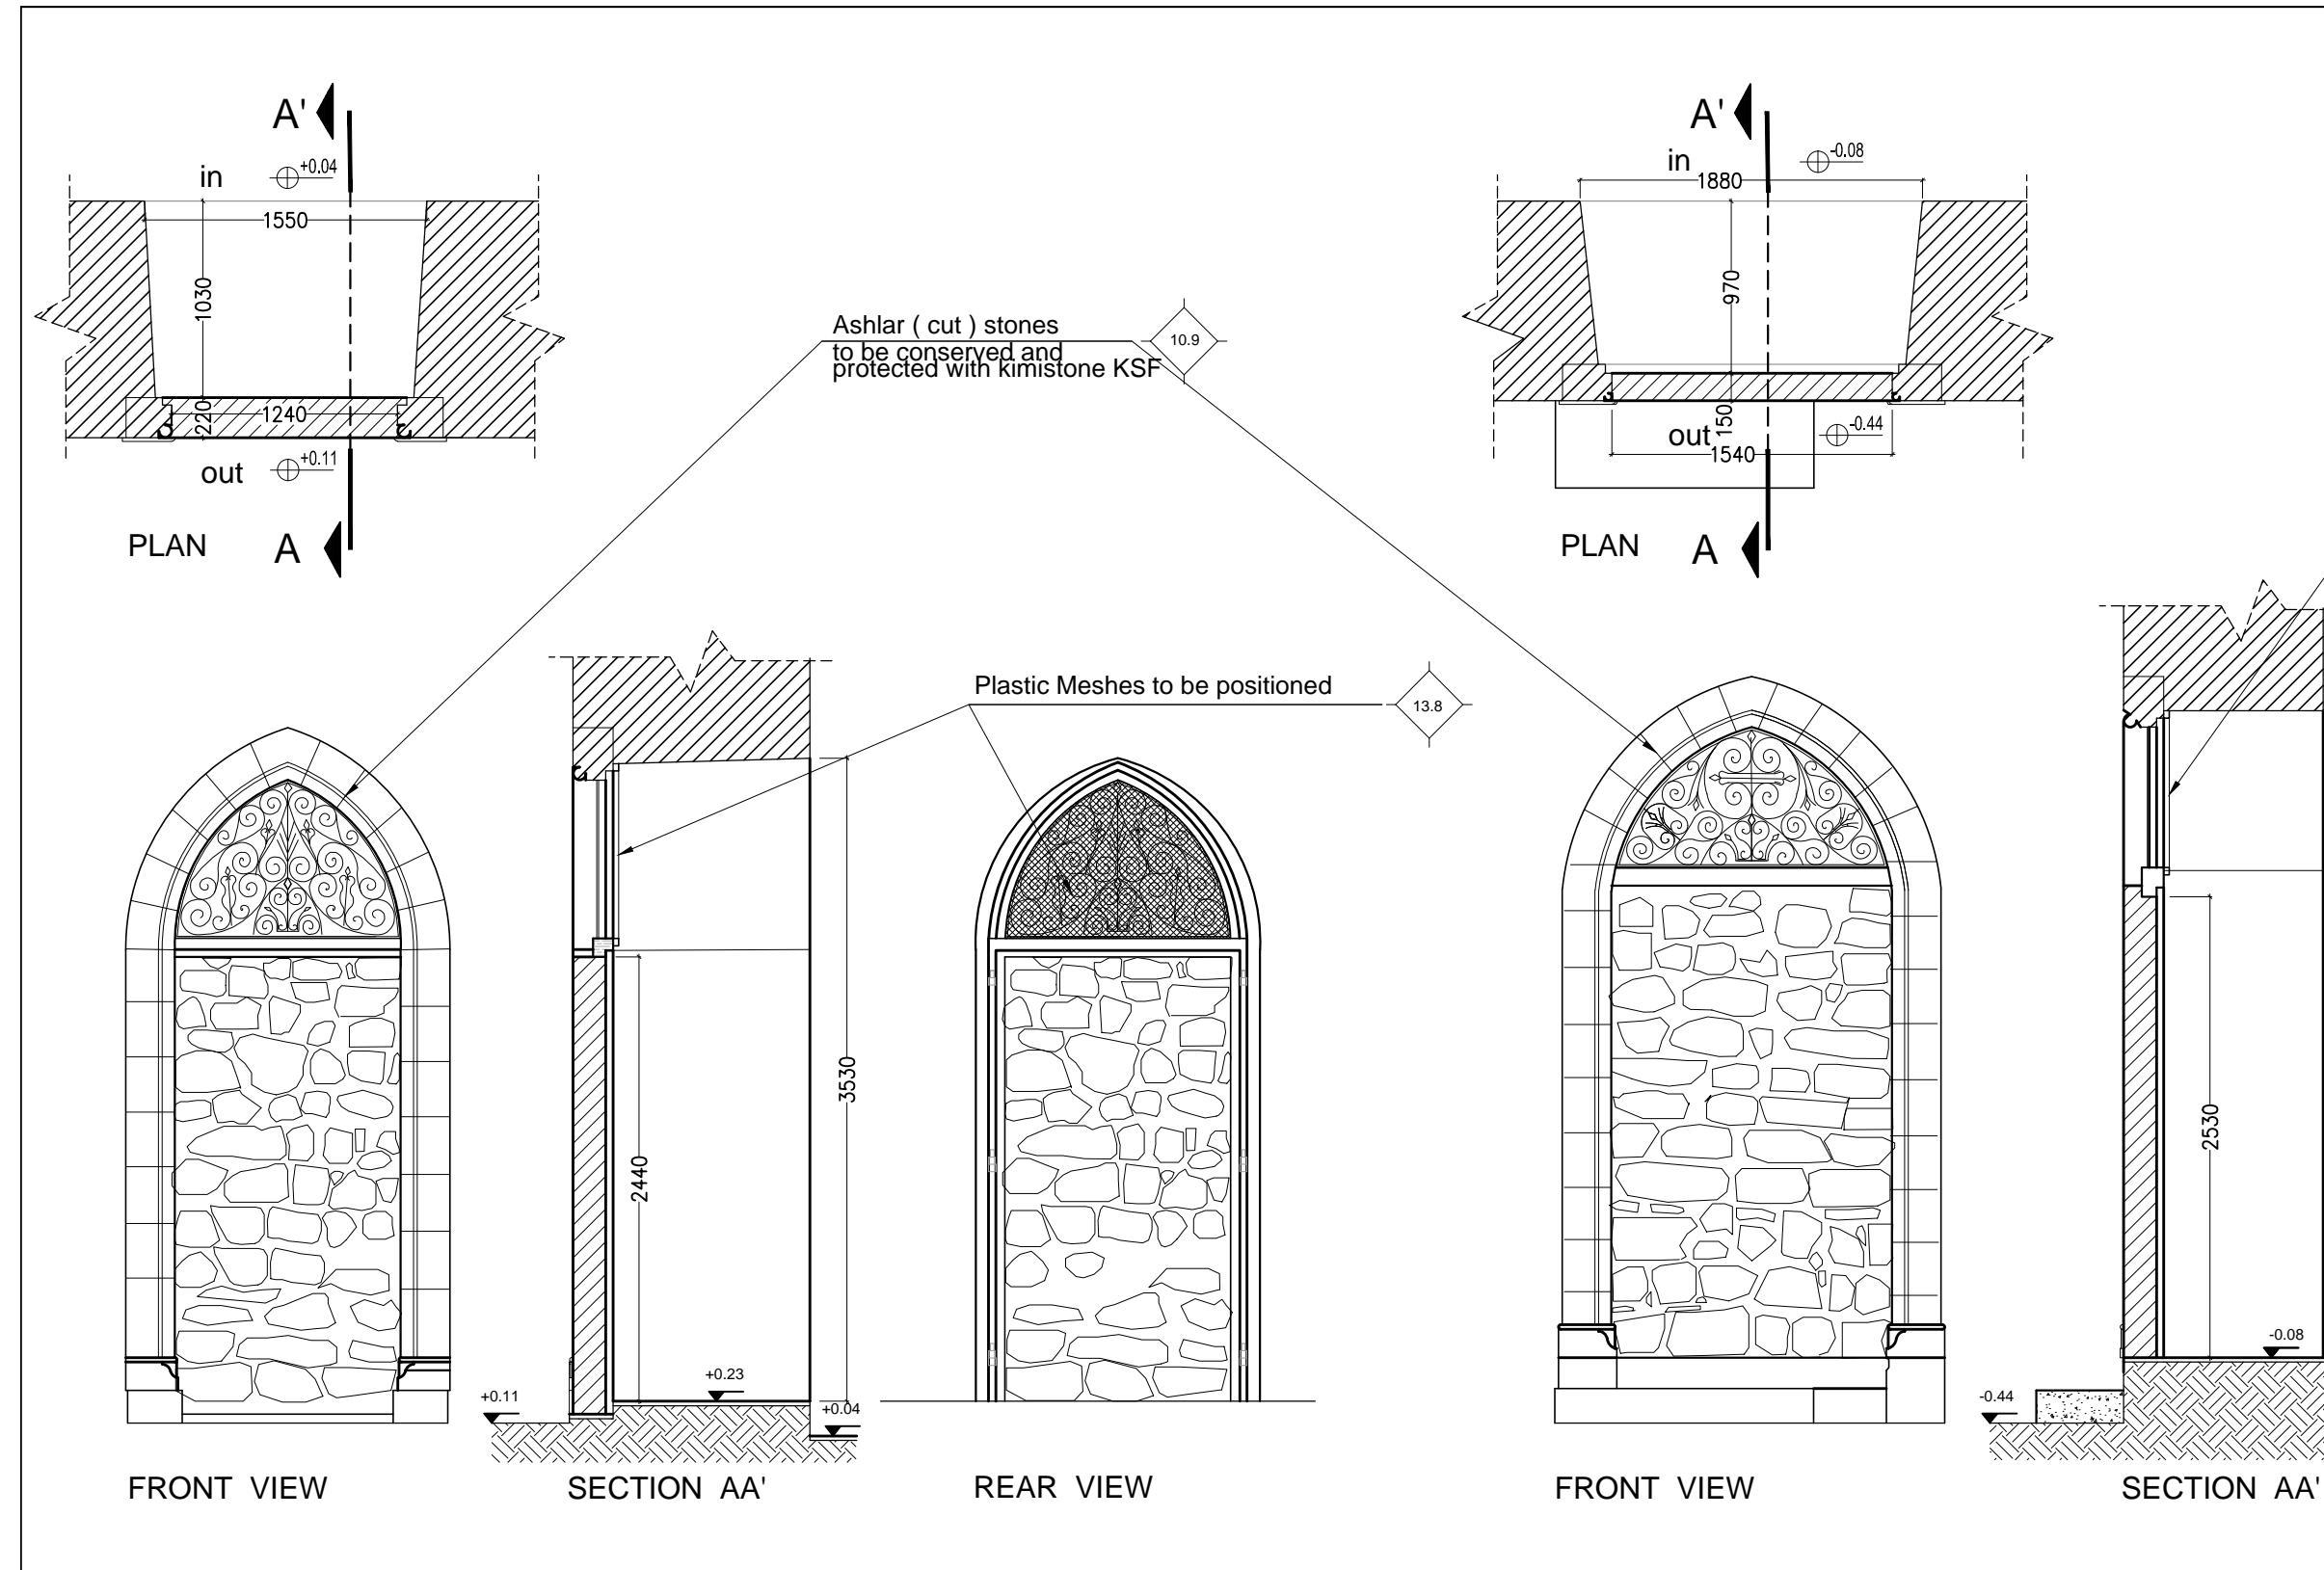
SOUTHERN DOOR (blocked)

WESTERN DOOR (blocked)
