Site Assessment and Feasibility Study of the Nubarashen Burial Site of Obsolete and Banned Pesticides in Nubarashen, Armenia

Phase 1 and 2 investigation report

Final Draft, 17 September 2013

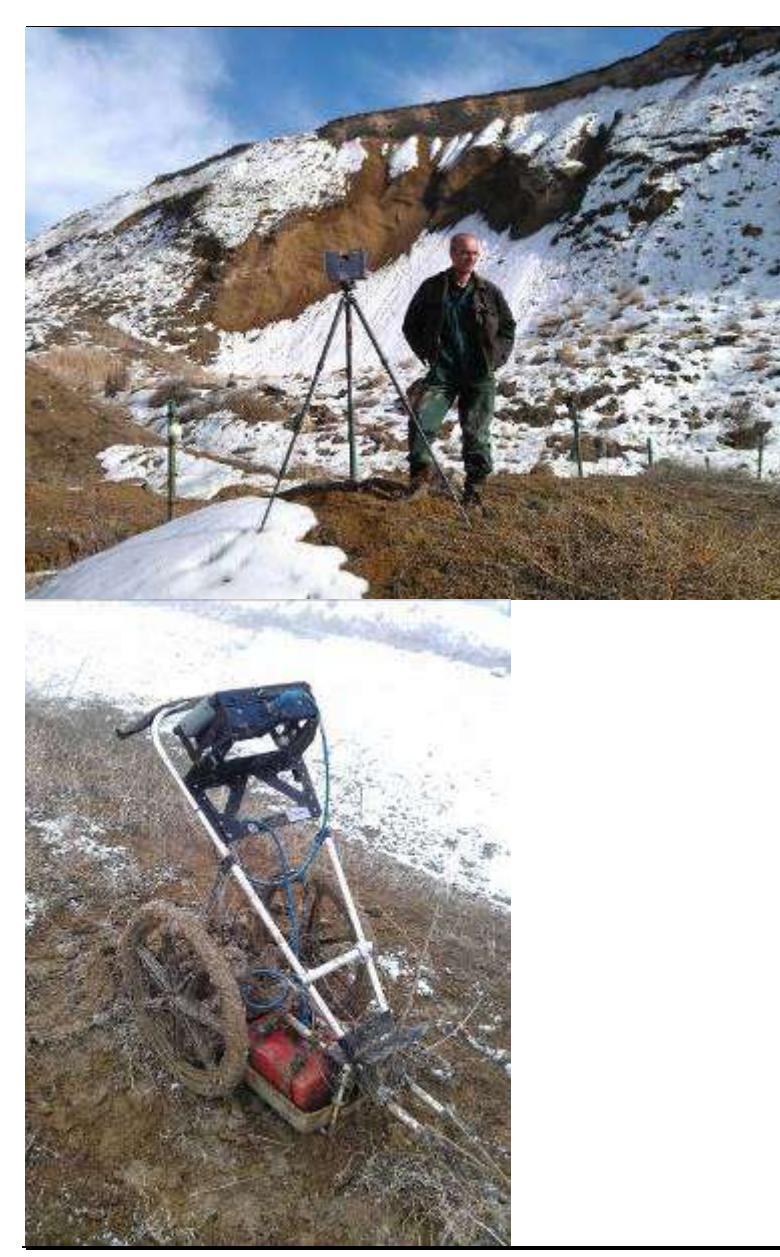
Figure 2.1 Left: 3D Lasser scanning. Right the GPR survey cart

For verification of the structure of the landfill it was planned to apply GPR in a grid over the landfill body and the fenced area with a GSSI 400 MHz GPR antenna, with gridlines of $1 \times 1 \text{ m}$ (see figure 2.1). Because the soil conditions were far from optimal, the measurements started with the most important area, the landfill body itself and the area between the concrete surface runoff drains. The total area covered with the GPR is around 0.5 hectare.

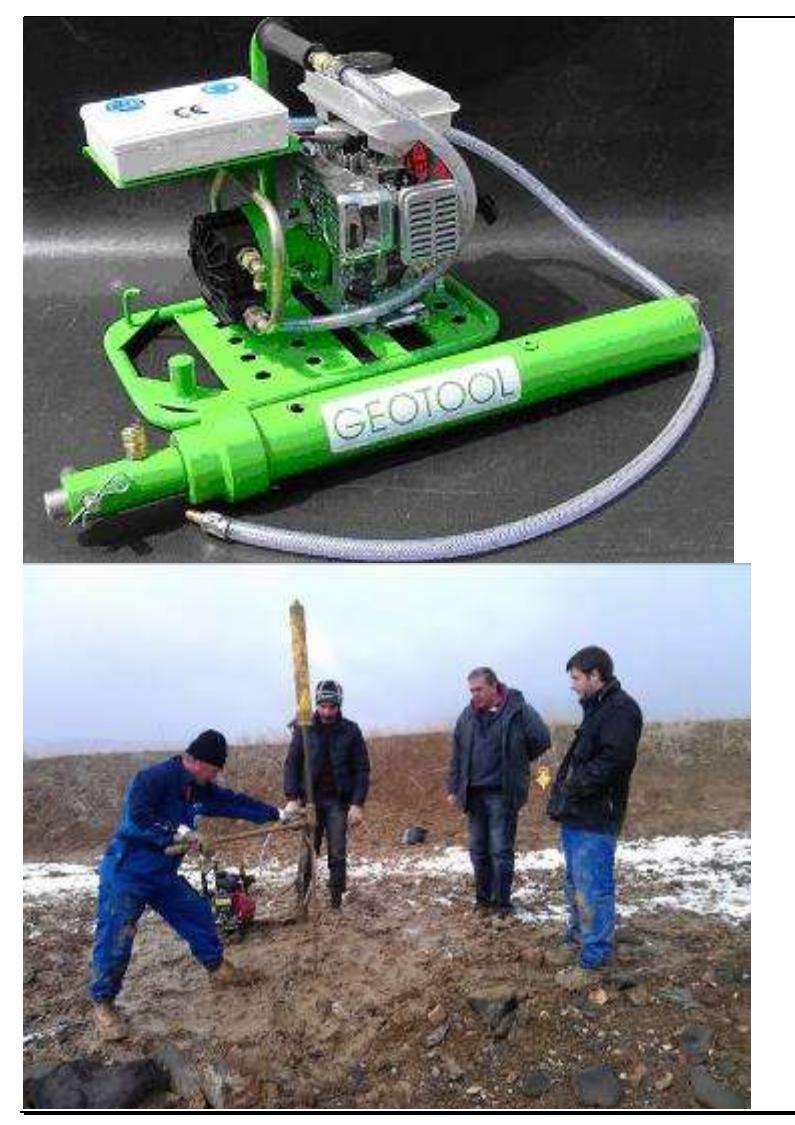
Figure 2.2 A Left: the DCPT Geotool. Right: DCPT measurement

17 DCPTs were carried out in one longitudinal and three cross sections to establish the surrounding soil structure of the landfill body. Figure 2.2 gives a field setup of a DCPT and the locations of the DCPTs are given in figure 2.3. The DCPTs are performed using a standard 60 degree apex cone connected to' A size' drill rods with the same standard fall height and weight as the Standard Penetration Test.

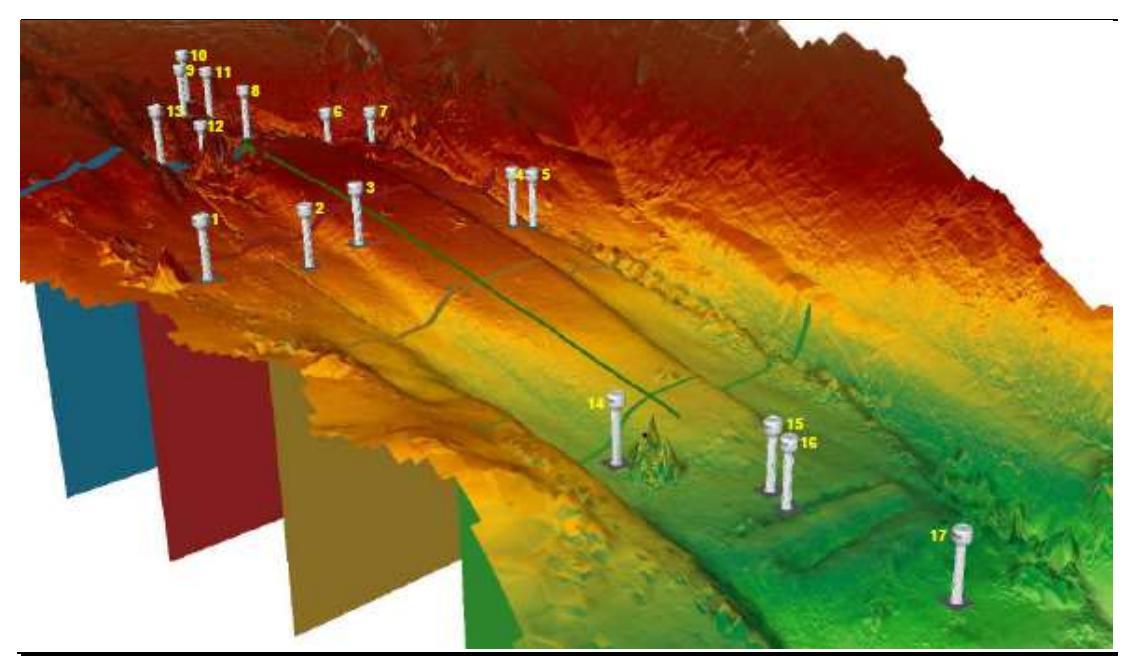
Figure 2.3 Landfill site topogarphy with 17 DCPTs locations

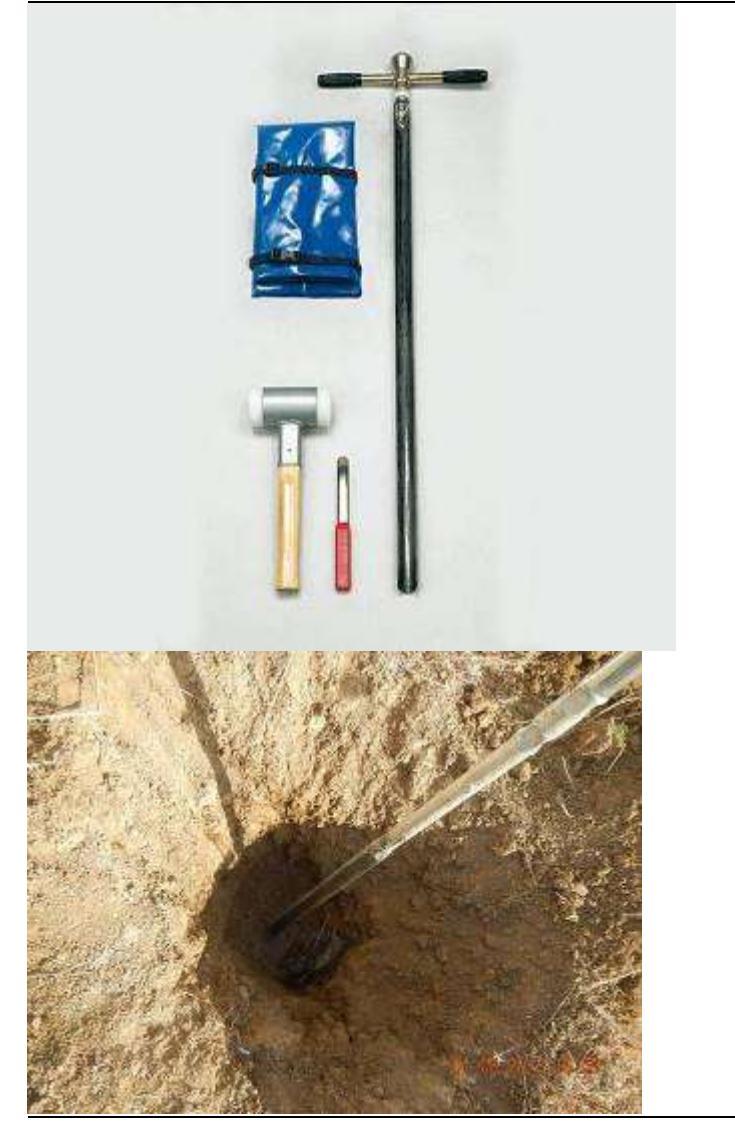
Figure 2.4 Left: Small diameter gouge auger kit comprising of a hamer, gouge knive. Right: Gouge auger in pit with small diameter borehole through the ruberoid

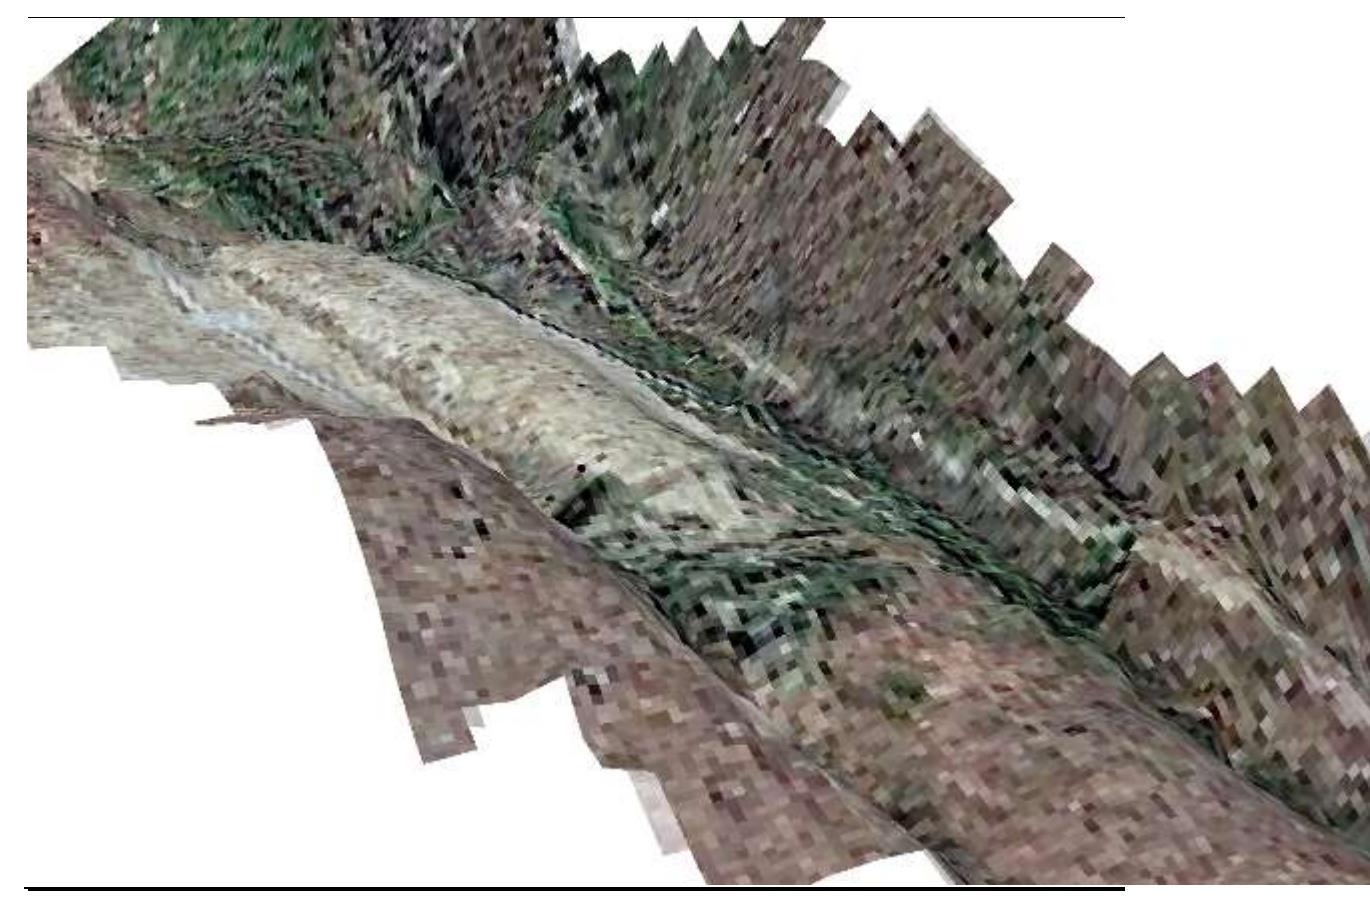
Figure 2.5 Google eath image overlaying the DTM landfill site topogarphy

Figure 2.5 is the same image but now with a satellite image from Google Earth. With the results of the scan longitudinal and cross sections can be produced at any position. These cross sections support the description of the CSM. Appendix 2 gives a topographical map made with the information from the laser scan, the longitudinal and cross sections of the landfill body.

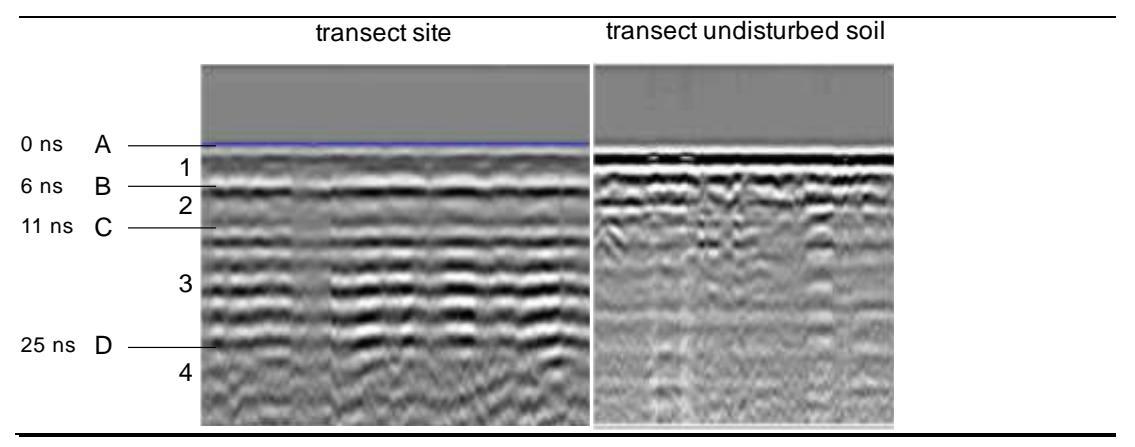
Figure 2.6 Left: GPR image landfill body. Right: GPR image outside landfill body.

By using a rigorous frequency filtering (and thereby removing 90 % of the signal), a layering on the landfill body that differs significant from the layering in the area outside the landfill body was observed (figure 2.6). Based on the travel time and the expected velocity in the soil material the minimum and maximum thickness of the layers is calculated (see table 2.1). The landfill body appears to be constructed by the following layers:

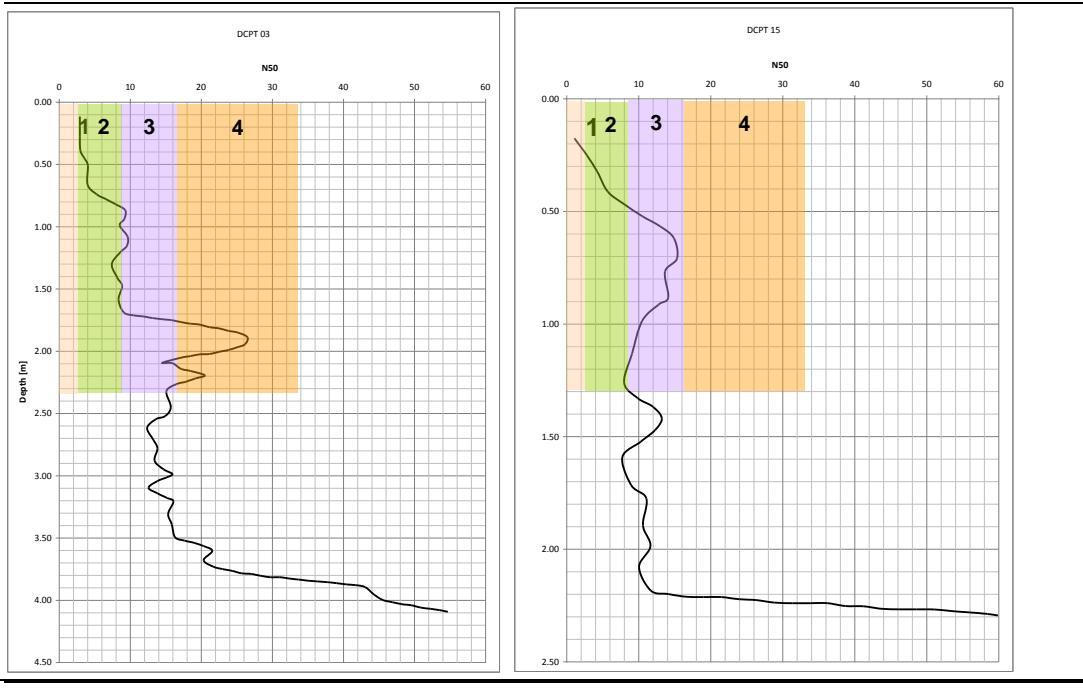
Figure 2.7 DCPT results 03 and 15

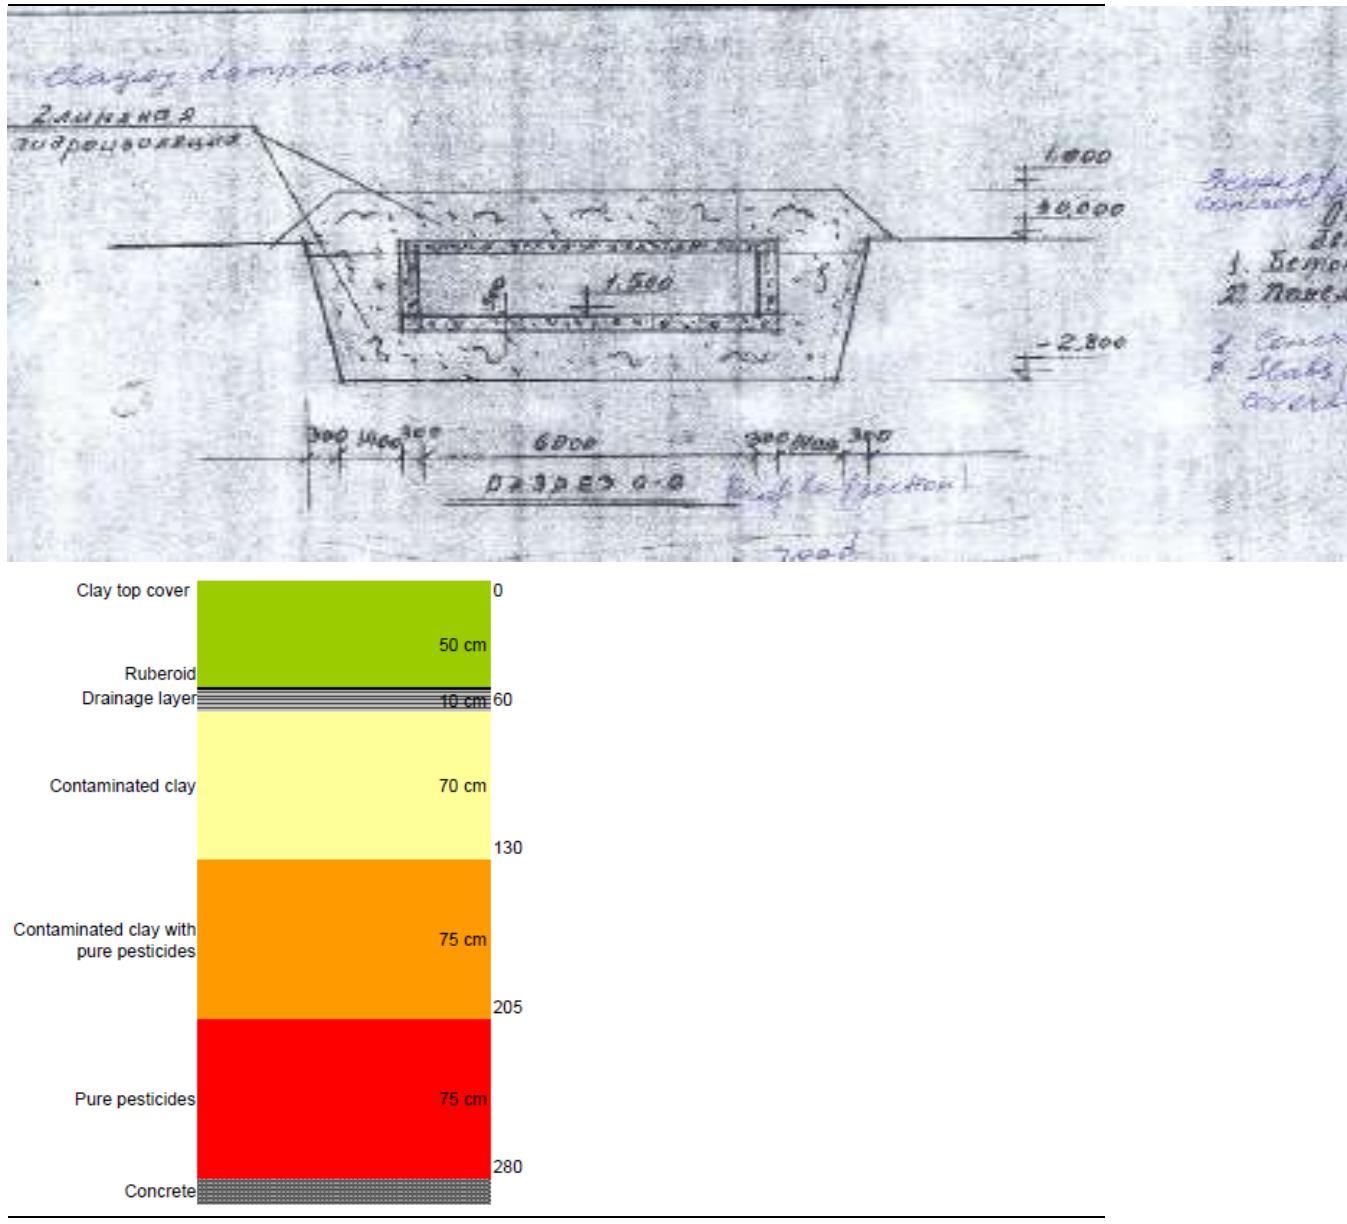
Figure 2.8 Top: Design Cell 1. Bottom: Bore profile of bore hole 337 installed in Cell 1

Cell 1 is made out of bricks and or concrete and probably constructed as presented in the annex 02 of the TOR (see figure 2.89) but the lid is missing. The cell is located at the very east part of the hillock. The inner dimensions of the cell are 600 x 600 cm. The cell is covered by a purple coarse sand drainage / support layer of 10 cm, a ruberiod liner and a clay cover of 50 cm. The drainage layer is on top of a contaminated clay layer of 70 cm on a clay layer with around 50 % of pure pesticides of 75 cm followed by a 75 cm thick wet layer of 100 % pesticides (see figure 2.8). The bottom of this cell is at 280 cm below the top of the hillock. The top of the cell is at 160 cm minus the top of the hillock. The calculated volume of pure pesticides in Cell 1 is ($600 \times 600 \times 75 \text{ cm}$) 27 m³.

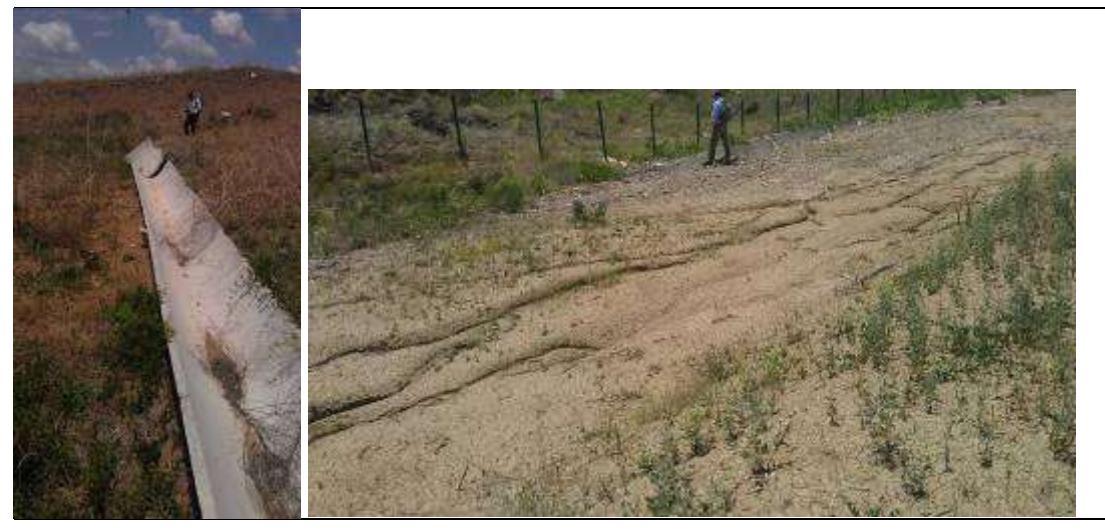
West, 10 m down slope the landfill body inside the fenced area, are two trenches of approximately 1 m deep, 18 m long and 1.5 m wide. These trenches are probably remains of a construction were in the old days liquid pesticides were burned to reduce the volume of the waste to be dumped. Currently these trenches function as runoff traps and are filling up wit runoff material.

The fenced area has a grass/herbs cover and there are a few small trees and bushes. During the fieldwork bare patches of land were observed. The vegetation of the surrounding is also grass with few trees and bushes in the gullies. Reed is growing at flat areas which are pools with standing water during wet periods. The area is used for grazing; the pools are used for watering cattle. Women and children are picking flowers looking for herbs and mushrooms in the surrounding of the landfill. The surrounding area has many features of soil erosion such as gullies, landslips and landslides. The landfill body is located on an active landslide, the landslide debris. The site erosion features are discussed in Chapter 5.

Figure 2.9 Left: Dislocated drainage element. Right: Eroded topcover landfill body

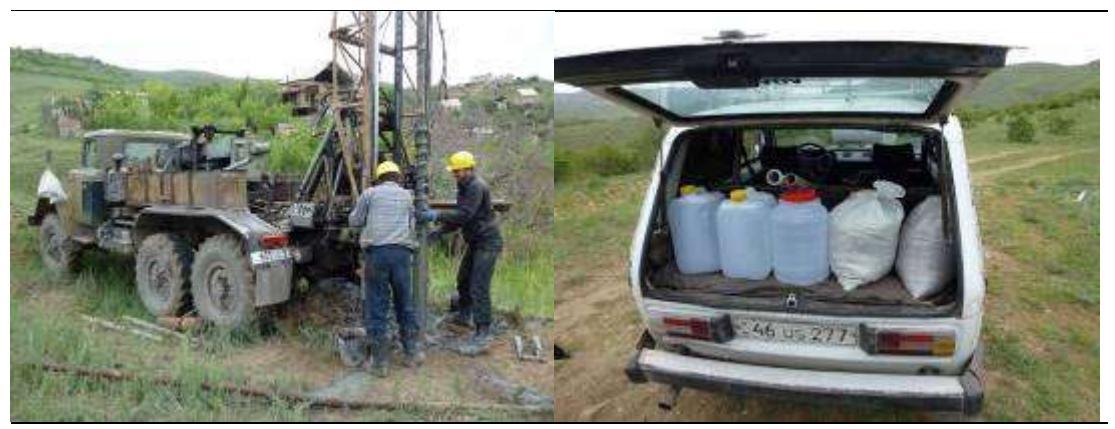
Figure 4.1 Left: The Zil mechanical drill rig in action. Right: Well tubing, clean water, filter gravel and bentonite were transported to the site from Yerevan

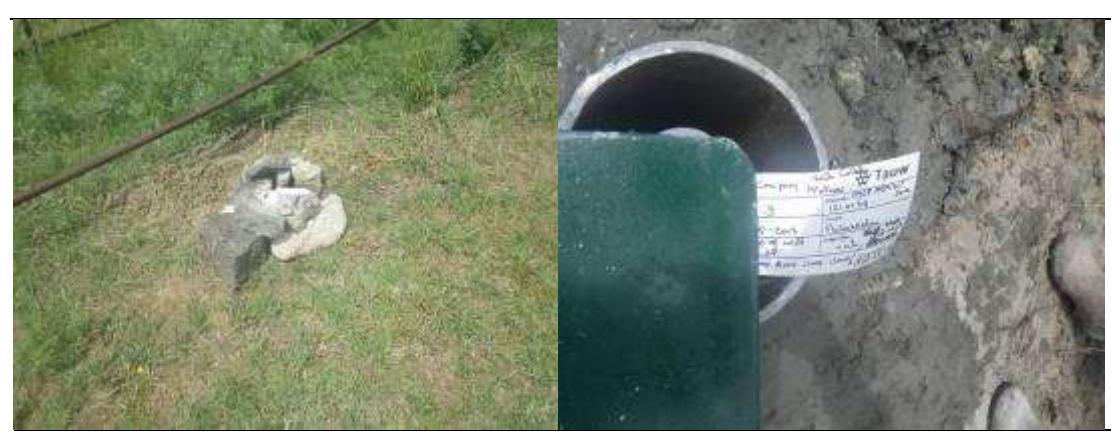
Figure 4.2 Left: Monitoring well 8, protected by rocks. Right: Monitoring well 9, protected with steel well head. All monitoring wells are equipped with weather proof labels providing details on the monitoring wells

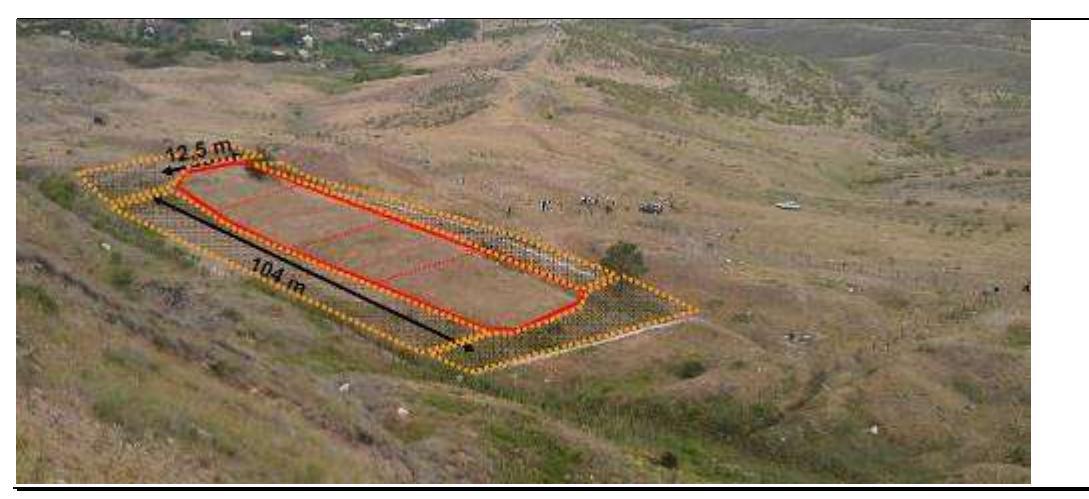
Figure 4.3 Composite soil samples topsoil landfill body are presented in red (from right - east- to left - west - 201 to 204. The areas in the orange coloured section are discussed in section 4.3.3

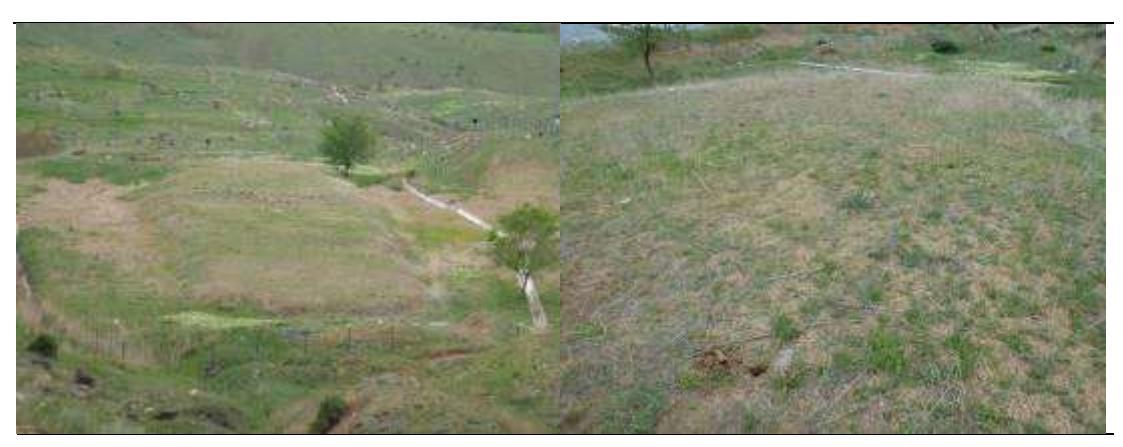
Figure 4.4 Left: the landfill body seen in a westerly direction. Right: drilling point on topcover

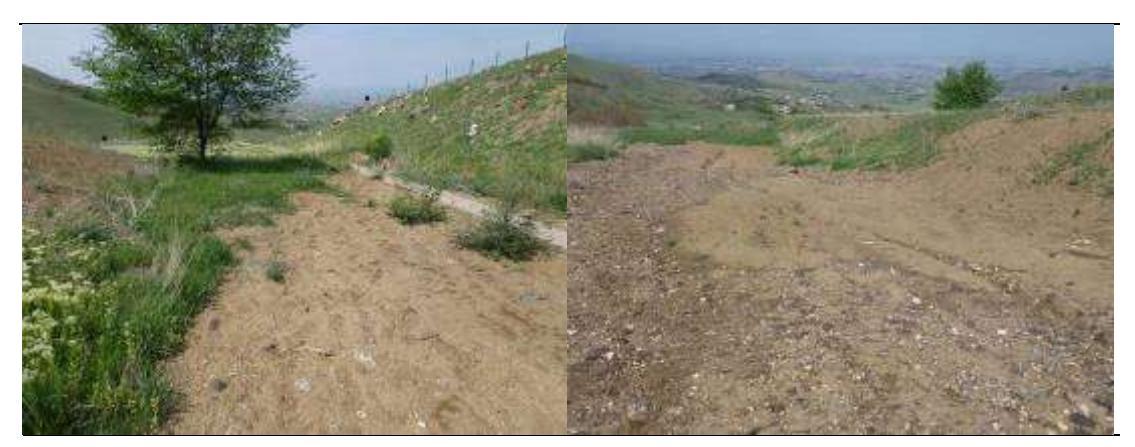
Some of the analysed samples from the top soil were collected from areas with plant cover (CSS 102, 104, 106), and some from areas with bare soil (CSS 103, 105 and 107). This is illustrated in figure 4.5. Appendix 2 presents maps with the sample locations. The analytical results are given in the tables A8.2 and A8.3 of Appendix 8.

Figure 4.5 Surface areas with - and without - plant cover, within the fence, next to the landfill body

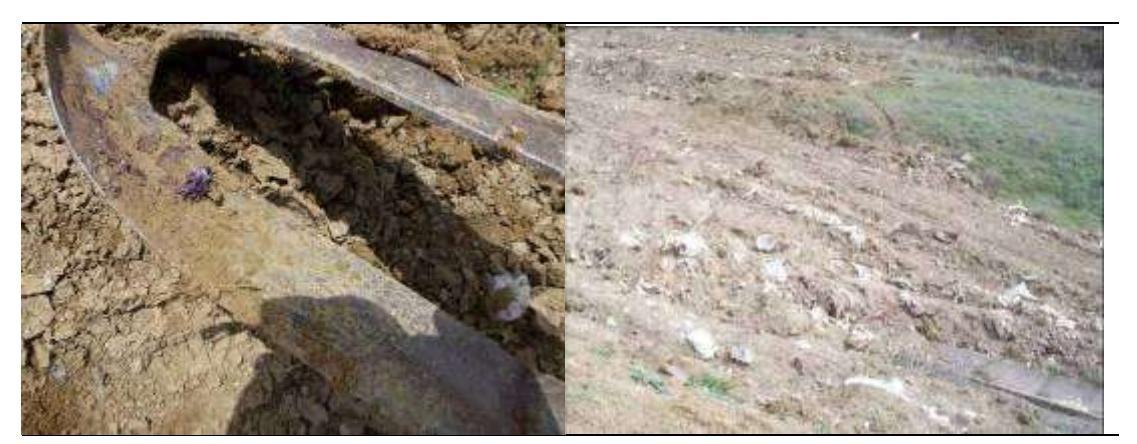
Although the absence of plant cover may not necessarily be related to only POPs pesticides, it does relate to the presence of some of the substances buried in the landfill such as herbicides. The total volume of the contaminated topsoil (0.5 m bgl) around the landfill body is 3,000 m³ which is 3,600 m³ excavate (factor 1.2) and is 5,100 ton (specific weight 1.7 ton), see also table 2.6 Chapter 2.

Figure 4.6 Left: pure product particle on auger head (likely Granosan). Right: The situation (April 2010) before closing of the landfill, with pesticide waste scattered around the current landfill body.

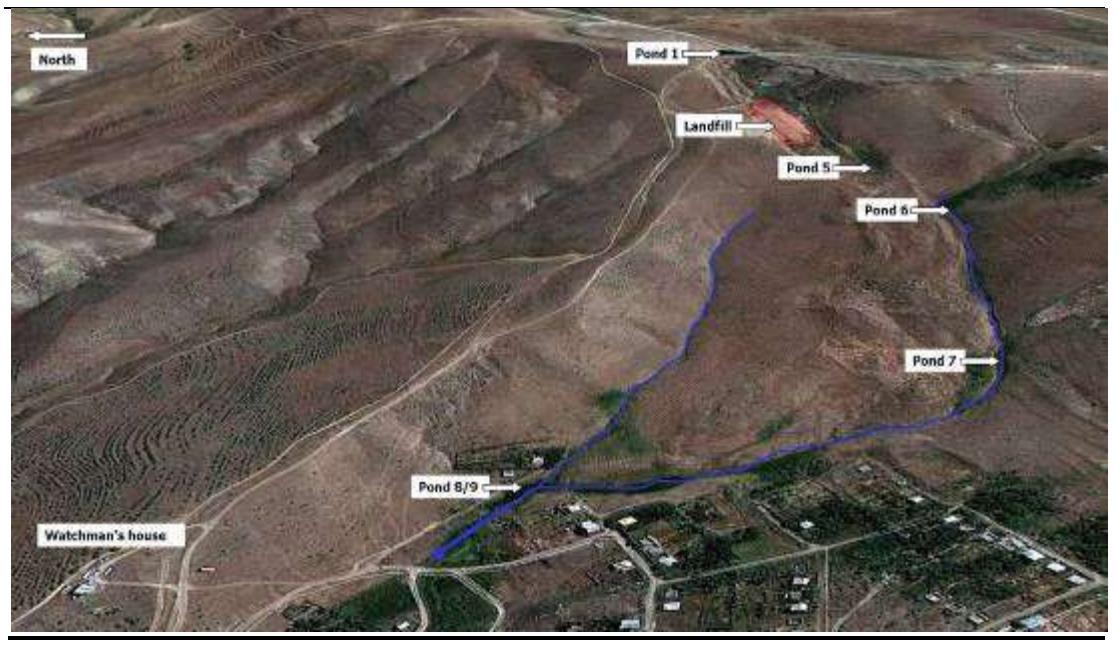
Based on visual inspection in the field, Ponds 6 and 7 (and possibly 8/9) appear not to be directly connected to the potential surface run-off from the landfill area (see figure 4.4). Concentrations of DDT, range from detectable (below the 'slightly contaminated' limit value) in Pond 7, to slightly contaminated in Pond 6. The sediments in Pond 8/9 were measured to contain the highest levels of DDT of the five ponds. The second gully meets the first gully (with Ponds 6 and 7) at Pond 8/9. The second gully (the left one in figure 4.3) also does not appear to be directly connected to the potential surface run-off from the landfill area, based on visual inspection of the terrain topography (see figure 4.3). It does however drain the upper part of the valley close to the landfill. Although the gullies appear to not be directly connected to the runoff water from the landfill, it cannot be excluded that one or both gullies are (also) fed with water that has infiltrated into the landslide area.

Figure 4.3 Bird eye's view image of the area. Both gullies merge at Pond 8/9

Upstream just across the watershed is pool, earlier called Pond 1 (see figure 4.3). This pool has for a large part of the year standing water because a water main is forming a barrier to drain completely. If the water level in the pool is higher than the top of the water main (see figure 5.2), the water flows towards the culvert under the Geghadir - Jrashen grassland dirt road passing 300 - 400 meter upstream the landfill. This culvert is half blocked with sediments and prevents rapid drainage of the standing runoff water. The standing water in the Pond 1 and the standing water between the water main and the blocked culvert infiltrate in the soil and percolate lateral in the landslide body in the catchment area of the landfill site, contributing to the instability of this landslide body. Saturation of the landslide body, in addition to atmospheric precipitation, takes place.

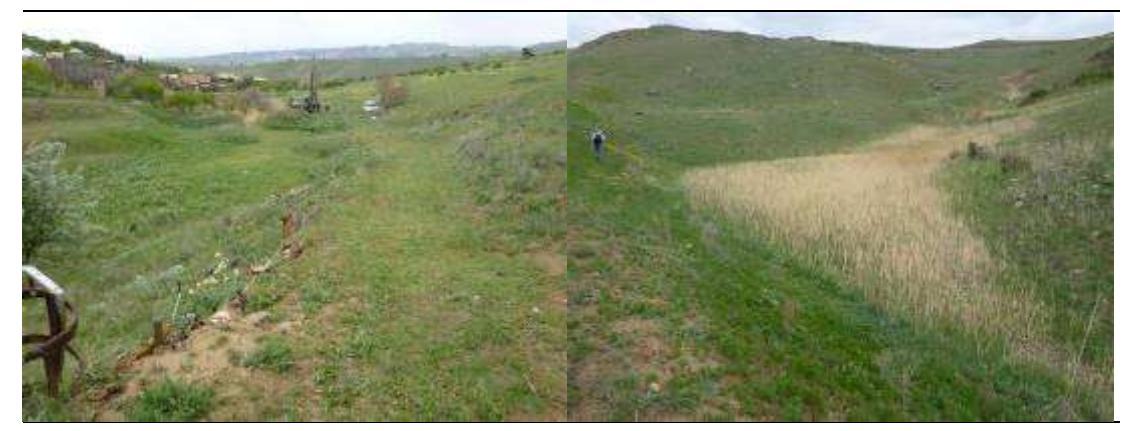
Figure 4.4 Left: Reed Pond 8/9 with the drilling rig installing monitoring well 9. Right: Reed Pond 6. This photo indicates that the gully is likely not connected to the landfill run-off. The landfill is located up-gradient, to the left, from the Tauw colleague walking in the top left of the picture, whereas the water feeding the gully appears to come from the top right of the picture

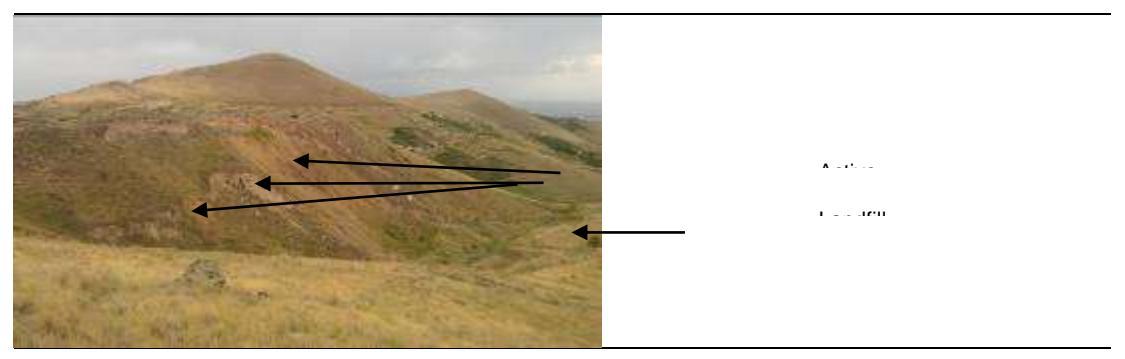
The catchment area of the landfill is formed by the valley enclosed by the surrounding ridges. The drainage pattern of the catchment area is (unstable) dendritc. Due to very active erosion process (see figure 5.1) such as landslides and gully erosion, natural drainage gullies are blocked and new gullies are formed. Erosion is initiated by cracks (swell and shrink cracks) and cavities in the (Montmorillonitic) clay surface after the dry summer.

Figure 5.1 Active erosion of the landfill site valley

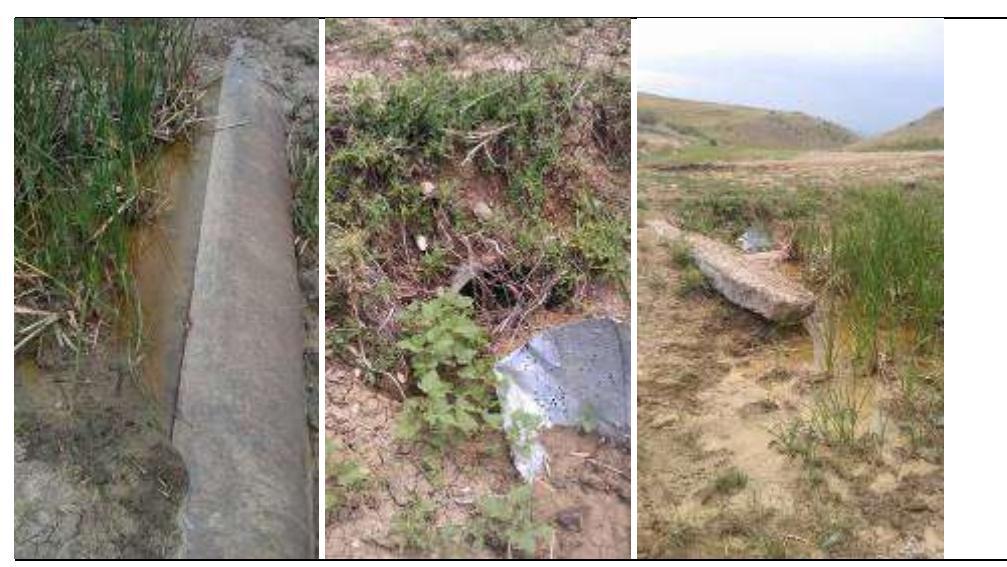
Uphill the landfill site is a dirt road passing the landfill site 300 - 400 m east. A culvert installed under this dirt road drains the runoff water from a large uphill separate catchment area. This culvert is nearly filled up with sediments. Parallel on the north side of this road runs a water main with a diameter of half a meter (see figure 5.1). This water main is probably leaking and is blocking the natural drainage pathway of the uphill catchment area. Because the drainage way is blocked, Pond 1 is having standing water till the top of the water main. Water from Pond 1 and the pool in front of the blocked culver infiltrates in the soil and is drained into the valley of the landfill. If the water level in the pond is higher than the top of the water main, the water percolates is drained slowly through the culvert filled with sediments.

Figure 5.2 Left: The water main preventing the water to flow to the colvert Middle: The blocked culvert Right: Pond 1, the water main, the blocked culvert and the dirt road

The Nubarashen landslide is characterized by three slipping surfaces, three landslide head terrace-shaped formations, cracks on the lateral surface lengthwise and cracks of up to 1 m width transverse on the landslide body, as well by involvement of large-scale erosion phenomena. The length of the landslide is about 1,000 m and it is notable for elevated accumulations in the tongue part. Slope movement upstream of the landfill site is the mechanism behind the observed mass movement in the landfill site and its surrounding area. The stability of the upstream area of the landfill site is controlled by the perched ground water levels. By lowering the perched ground water table or reducing the influx of water into the slope, the stability of the landslide will improved and the risk for erosion such as mass movement will be reduced significantly. A simple measure is to drain Pond 1 by making a passage for the standing water under the water main and opening the blocked culvert under the road and repair possible leaks in the water main that runs along the

between Pond 1 and the road. This and other recommendations will be taken into consideration in the design of the landfill rehabilitation in the next phase of the project, Phase 3.

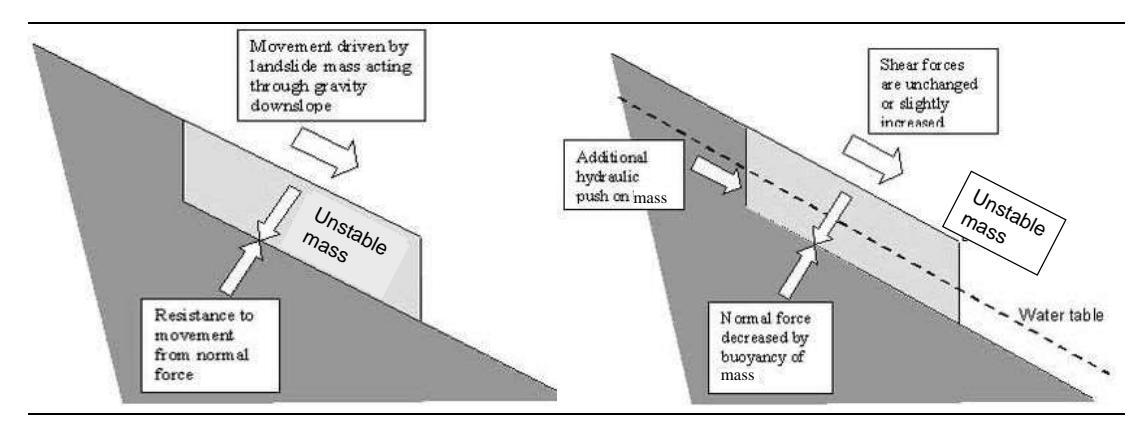
Given the soil stiffness and the low permeability of the silty clays underlying the landfill body, it can be concluded that at around 2 tot 4 m bgl there will be a significant increase in resistance to vertical infiltration of water into the underlying soil. As a result of this a perched water table can be formed in the top layer of the valley and landfill body during wet seasons. This causes horizontal transport of water through the topsoil layer of the landfill site and can also cause overland flow during periods of heavy rainfall causing gully erosion when flowing through cracks and cavities. The formation of a perched water table in the top layer also influences the activity of the landslide. This is schematically represented in figure 5.3.

Figure 5.3 Diagram illustrating the resistance to, and causes of, movement in a slope system consisting of an unstable mass

The leading failure plane is assumed to have a circular type of shape (see figure 5.3 red dashed lines). The trials that analyse the stability analysis are based on a grid of centre points of slip circles and a set of horizontal tangent lines of the corresponding slip circles. The centre of the leading slip circle is normally situated near the top of a slope at a fictive position in the air. Prior to the stability analysis an area wherein the centre of the leading slip circle is situated has to be defined. The input of the expected zoning is presented by all the black crosses in figure 5.4. However, the leading slip circle might very well be situated outside the prior defined zone. In such case, it is possible to perform a stability analysis automatically migrates towards the location where the safety factor is considered minimal. Therefore, the red crosses in figure 5.4 embody the final zones wherein the centre of the leading slip circle is calculated.

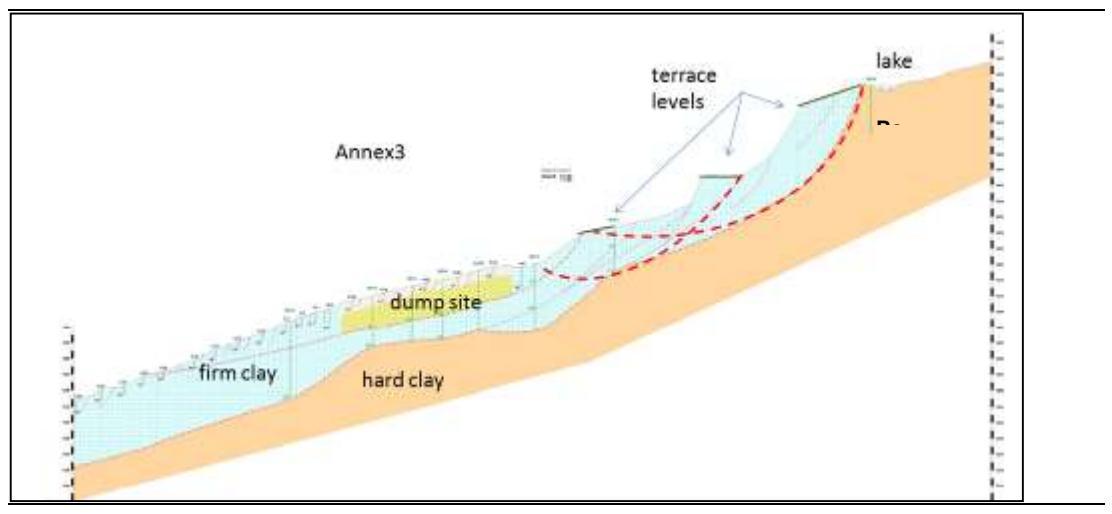
Figure 5.4 Geotechnical interpretation of section (ref. annex 3 by Dr. Yadoyan)

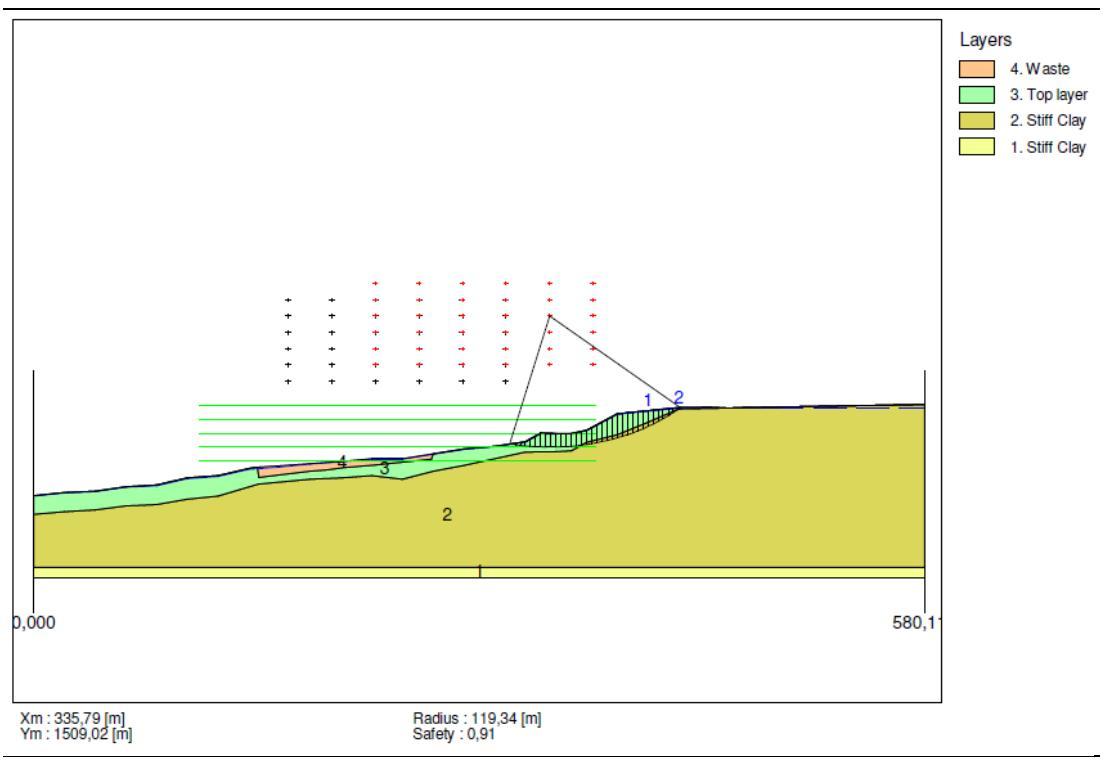
An overall stability analysis is performed with the Bishop Slip Circle failure criterion (see Appendix 9 for the results). Three critical sections are analysed. The governing slip circle is determined. In practice, the leading safety factor of the soil body above the landfill site is determined. Fluctuation in dry/wet soil conditions alternated the stability factor as the vertical effective stress (σ'_v) is adjusted.

- If the slope is completely saturated the slope is not stable in any of the sections (Safety Factor average = 0.86). In this scenario deep seeded sliding plane would result in a slope failure above the landfill area. As a result the newly created surface above the landfill would decrease the stability of the landfill body
- If the slope is dry the overall stability is guaranteed in all three sections (Safety Factor average = 1.28). In all three sections the safety factor changes with fluctuating water levels. Clearly, the water level of the slope (more specific: the top slope area near the lake) has a major impact on the slope stability

Figure 5.5 Critical Circle Bishop
