ADMINISTRATIVE COMMITTEE  
OF THE HOLY MONASTERY  
OF APOSTOLOS ANDREAS  
RIZOKARPASSO, CYPRUS

RESEARCH PROGRAMM FOR THE  
RESTORATION AND REHABILITATION  
OF THE HISTORIC BUILDING COMPLEX  
AND RECONFIGURATION OF THE  
ENVIRONMENT OF THE MONASTERY

PROJECT PHASE B :  
IMPLEMENTATION  
GUEST HOUSE BUILDING (1919)(GH)

Title: PROPOSAL  
TYPICAL WARDROBE  
DETAILS OF THE RAILING  
Scale: 1:10 & 1:2

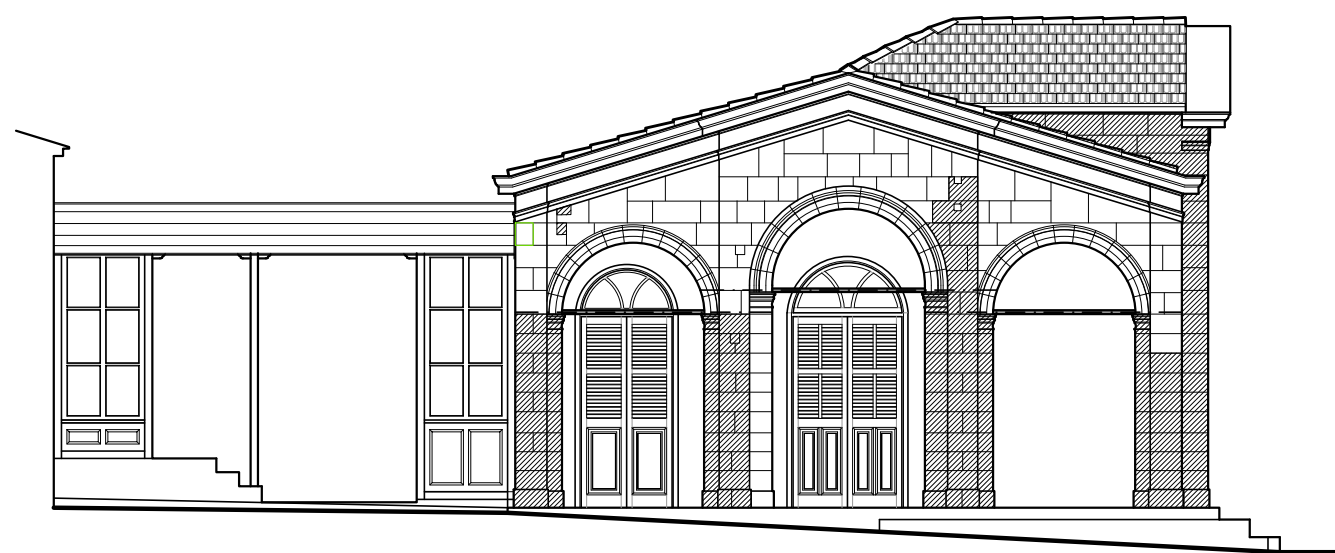
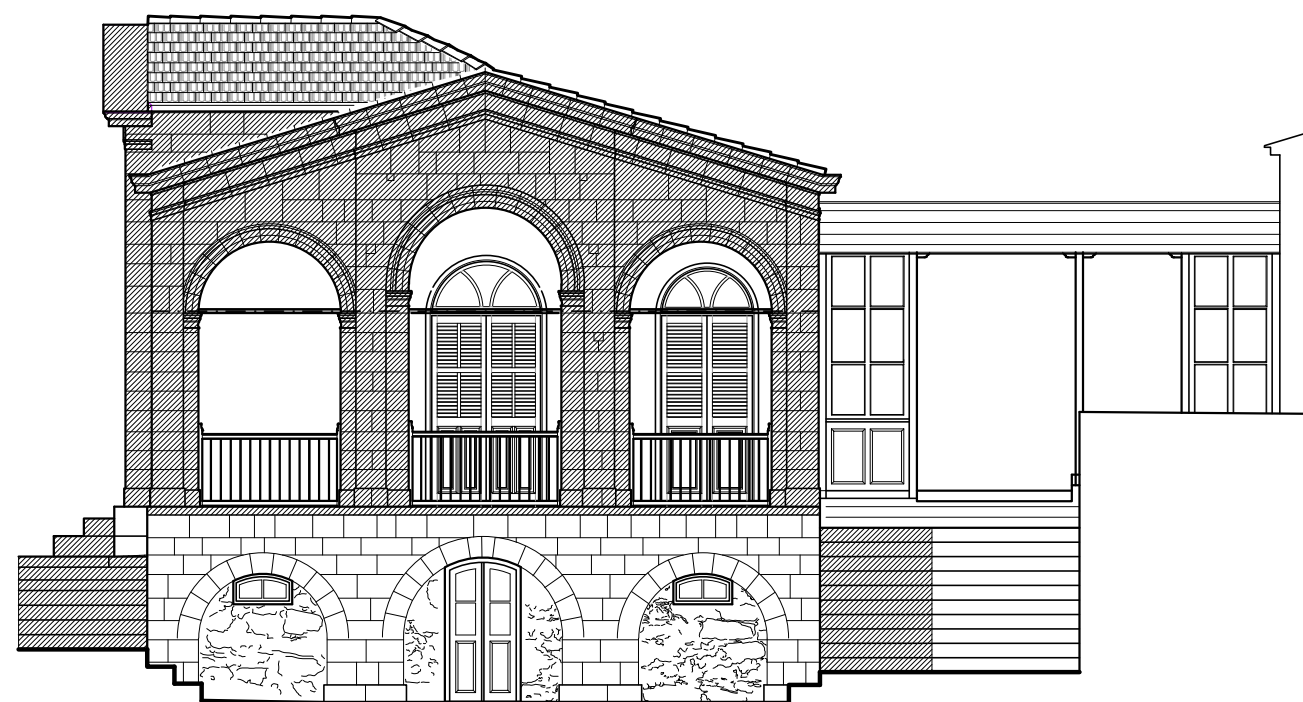
Title: PROPOSAL  
CEMENT-BASED RENDER REMOVAL

KEY  
Removal of cement-based render
